# Fatality Investigation Report

OR 2003-40-1

## Effort to clear rock jam in operating rock crusher fatal

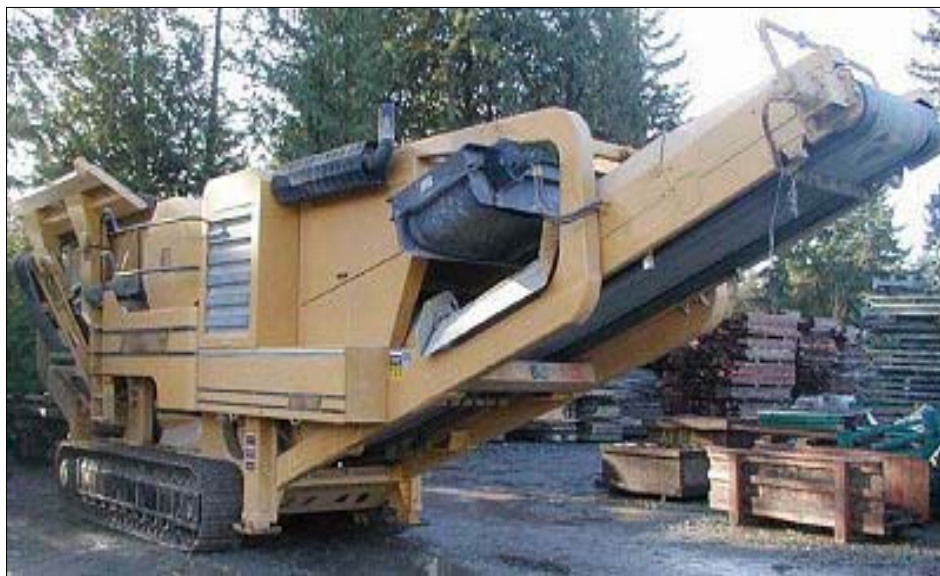
Portable rock crushing system.

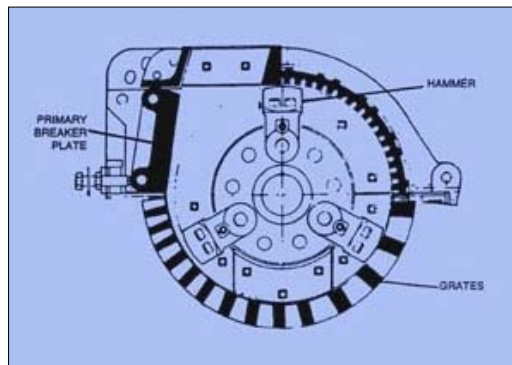
A horizontal impactor crushes rock by repeatedly hitting it with rotating metal hammers. The impactor rotates at a high speed, in this case at about 2400 rpm. A vibratory screen conveys rock toward the intake chute of the impactor. The intake is equipped with two curtains, one of chain and another of rubber, to prevent rocks from being thrown out. Directly below the curtains is the rotating impactor.

Drawing of a horizontal impactor.

At about 2 p.m., the rock-crusher operator apparently tried to clear a rock jam while standing on the top of the impactor housing. He turned off the vibratory bed that feeds rocks into the chute, and inserted a 5-ft pry bar down the chute while the impactor was operating. He either pushed the bar too far or it slipped from his hands and came into contact with the rotating impactor. The pry bar was thrown back with tremendous force and struck the operator in the neck.

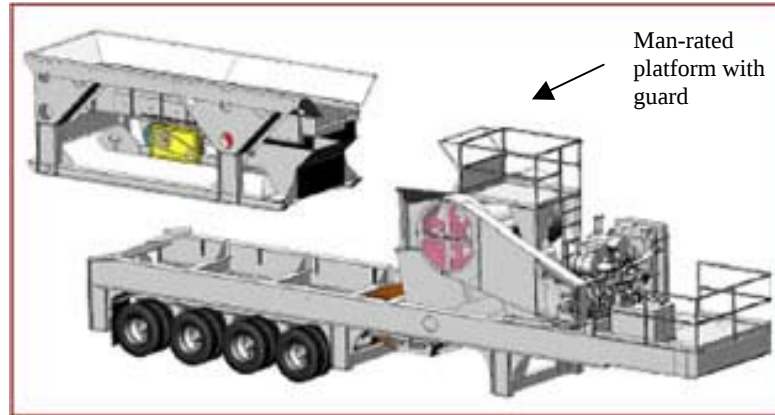
This drawing shows a typical truck-mounted horizontal impactor, with a man-rated viewing platform directly over the intake chute of the impactor unit. The platform is equipped with a guard to protect an observer from flying rock and debris. The guard also discourages any intervention with a tool to break a rock jam.

**Recommendation #3: Manufacturers should consider designing and installing viewing decks where worker's can safely access the equipment to observe operation.**

Installing a man-rated viewing platform is a more certain way to eliminate the incentive for workers to position themselves directly over the intake to observe crushing operations. A

designated platform discourages an operator from attempting to access the machine from any other location. A protective guard of plexiglas or wire screen is typically mounted on front of the platform to protect an observer from rocks or debris ejected from the chute.
