Fatality Assessment and Control Evaluation Project

KY FACE #98KY031

SUBJECT: Factory Worker Caught in Overhead Conveyor While Hanging Transformers

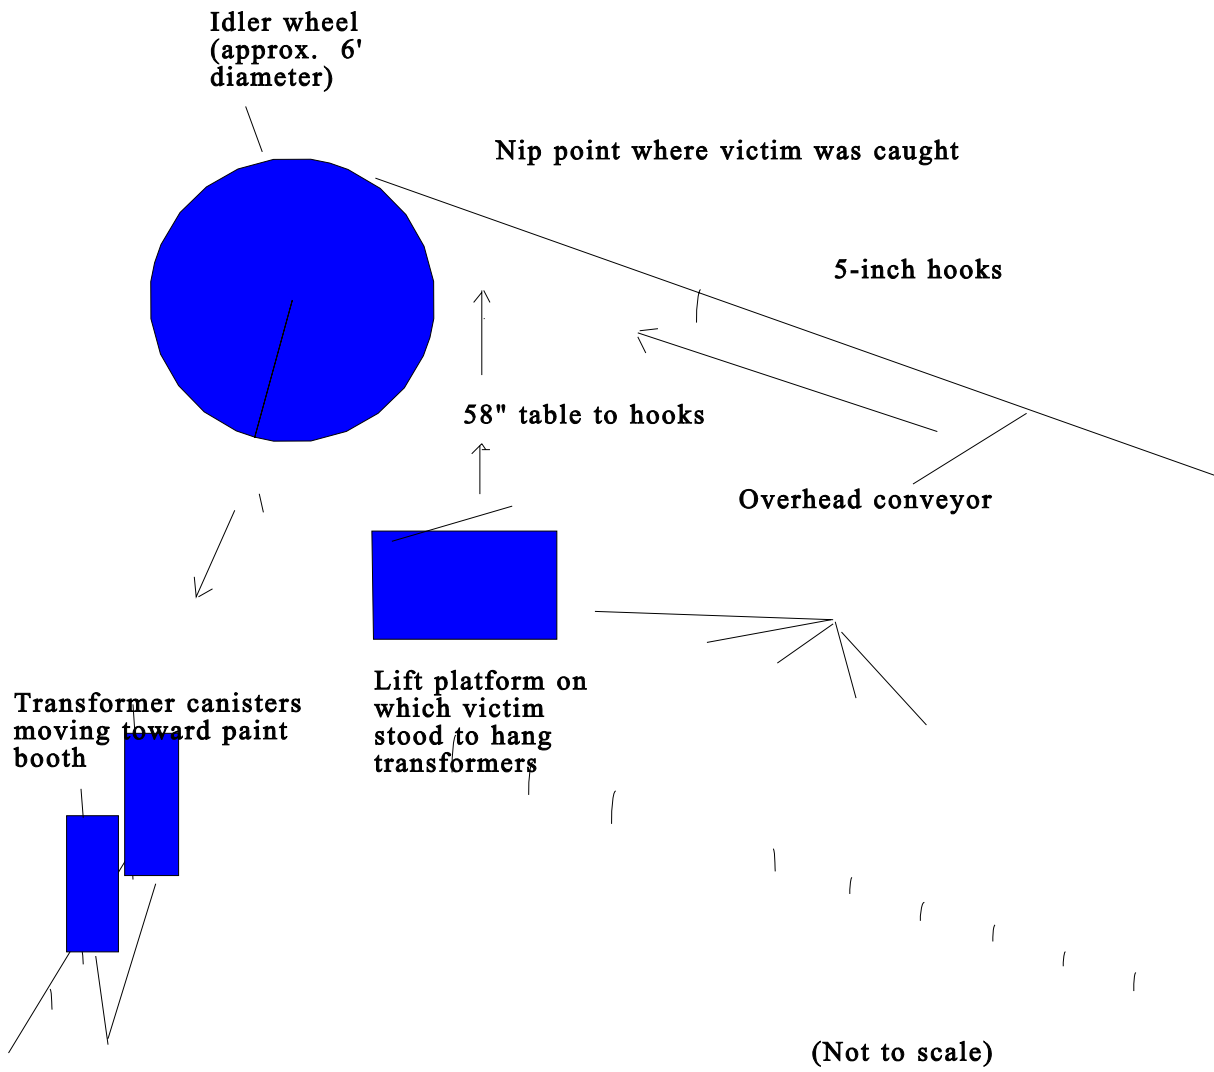
Figure 1.

On the day of the incident, the victim's shift had begun at 7:00 a.m. He was being trained to hang metal transformer canisters on hooks on an overhead chain conveyor for movement through booths where they would be spray painted. The transformers were of varying sizes, and the finish operator would choose a hook proportionate to the size of each transformer. These hooks would be put on the transformers and then attached to other hooks on the overhead conveyor, which were spaced six inches apart. A transformer was to be hung on every other hook. In order to reach the hooks attached to the conveyor, the victim, who was 6'7" tall, stood on a hydraulic lift platform situated directly beneath the nip point where the chain conveyor met the idler wheel that allowed it to turn the corner. The idler wheel had never been protected by any type of guard. The lift platform had a switch on top that allowed it to be raised or lowered to varying heights (up to approximately 24 inches) by the finish operator's foot. On the day of the incident, the lift platform was situated 58 inches from the 5-inch-long hook on the conveyor. (See Figure 1.)

The incident occurred at 9:50 a.m. The victim was alone, as his trainer had just walked away for a few minutes. The supervisor, who was nearby, heard the victim call out, and ran to push the emergency stop button, which was located on the wall behind the lift platform. The victim's head was caught in the ingoing nip point of the chain conveyor and the idler wheel. Because there was no way to reverse the conveyor, and 30 workers pulling were unable to release the tension, a welder was brought from another area of the plant to cut the chain to extricate the victim. In the meantime, emergency medical services (EMS) had been called. As their post was

Recommendation #1: Employers should ensure that platforms allowing workers to reach overhead conveyors (i.e., work zones) are a safe distance away from ingoing nip points.

Discussion: If this platform had not been directly underneath the ingoing nip point created where the chain conveyor met the idler wheel, the victim would have been outside the danger zone. The platform had been used in this position since 1991. However, the victim was unusually tall (6'7") - probably the first person tall enough to become caught. Following this incident, the company moved this work zone a safe distance away from the idler wheel.

Recommendation #2: Guarding should be placed around ingoing nip points.

Discussion: A fixed metal guard placed over the idler wheel would prevent workers from being caught in the ingoing nip point created by the chain conveyor. Although the idler was more than seven feet above the floor, it was not more than seven feet above the raised lift platform, and thus should have been guarded (29 CFR 1910.219(b)(1)). The day following this incident, the company installed a barrier guard to shield the area where the conveyor chain meets the idler wheel.
