KY FACE 95KY12201

Subject: Farmworker Killed When Caught In Power Take-Off (PTO)

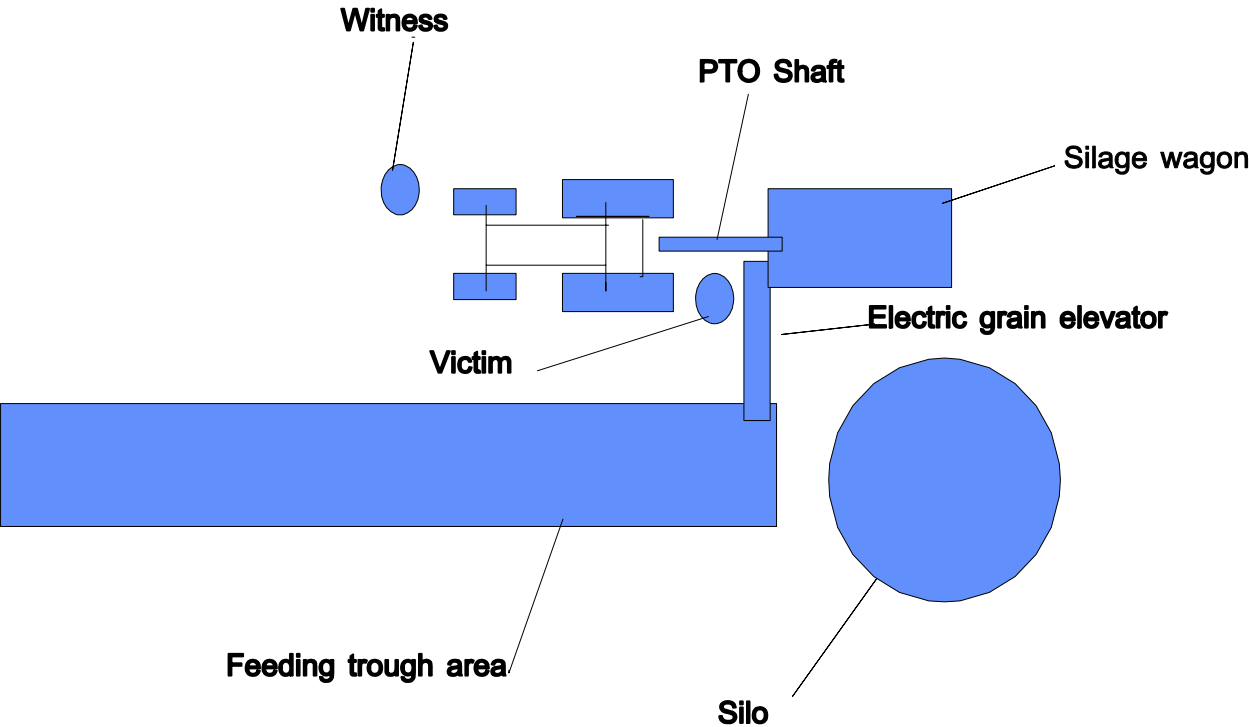
Figure 1.

An International tractor, Model 574 (52 hp), manufactured in 1976, was used to pull the silage wagon and supply power for emptying the wagon. The silage wagon was manufactured by Gehl. The PTO shaft was 24 inches from the ground and it was not covered by a protective safety guard. Operating at full power, the PTO ran at approximately 540 RPM. Safety decals were intact and visible on the front of the silage wagon where the PTO was attached.

To unload the corn, the tractor and wagon were located parallel to the feeding trough (see Figure 1). Recent rain had made the area slick with 3-4 inches of mud, water, and manure. Weather was cold and the victim was wearing coveralls. The farm owner related that he had last seen the victim standing near the grain elevator that carried the corn from the silage wagon to the feeding trough. The process was nearly complete when the owner heard a yell and turned around to find the victim caught in the PTO shaft, which was operating at full power. The shaft continued to rotate, causing severe damage to the victim's head, spine, and leg, killing him immediately.

Recommendation #1: PTO shafts should be covered by a safety guard.

Discussion: It is not known exactly how the victim became caught in the PTO shaft; it is possible that he slipped in the mud and fell into the PTO or his clothing became caught as he stood too close to the machinery. With either possibility, a guard covering the PTO could have prevented the victim from becoming entangled in the moving shaft. This model tractor can be retrofitted with a PTO guard, costing approximately \$65. An equipment dealer should be contacted for further information.
