Fatality Investigation Report

OR 2003-39-1

Worker is thrown from cab of crane and is crushed.

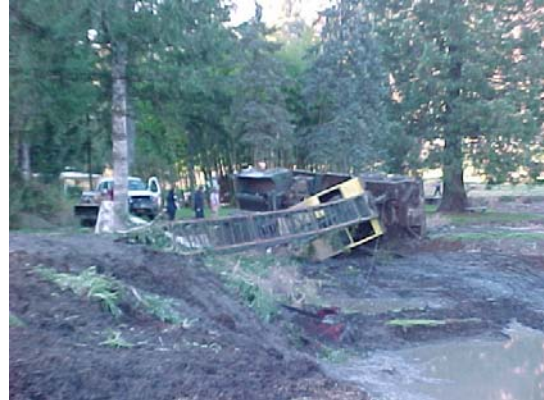
On November 6, 2003 at approximately 1430 hrs, a carrier-mounted lattice boom crane toppled over killing the operator. The 66-year old victim had more than 30 years of experience operating heavy equipment in the logging industry.

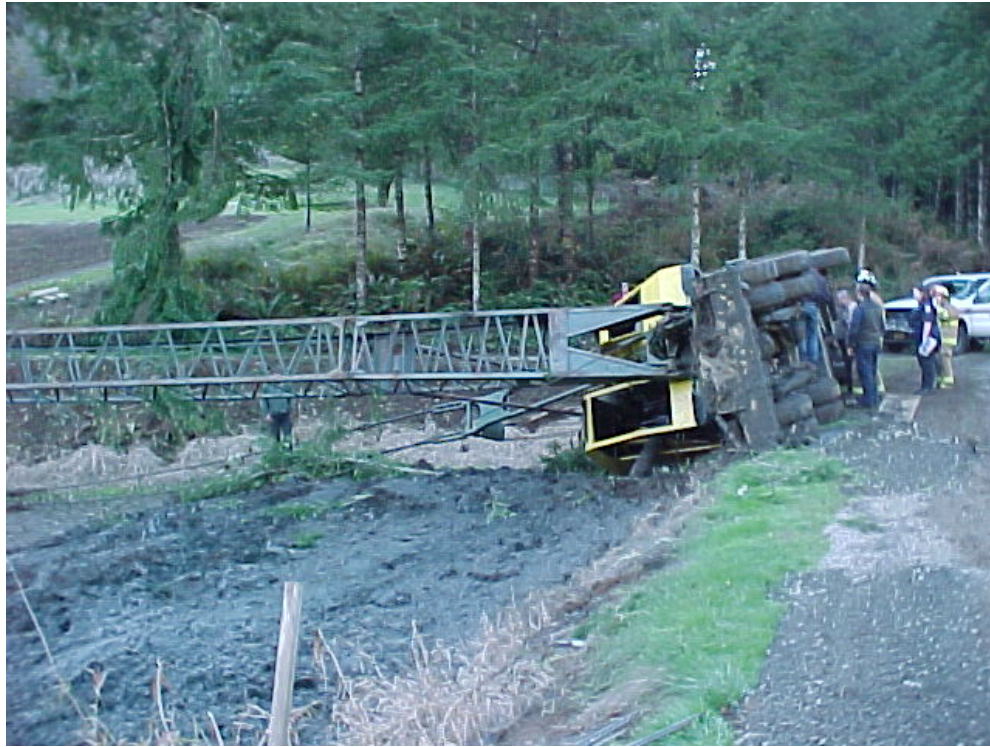
Photo 2. Crane topples over, crushing worker, while dredging dry fish pond.
Note: outriggers were not deployed.

- ✓ **Proper set-up is essential to safe crane operation. Always deploy outriggers before operating the crane. Understand the center of gravity of the load being lifted and avoid side or end pulls.**

The crane was equipped with outriggers. The victim had stopped to bring some silt material closer to shore so that he could then finish dredging the pond from the shore presumably with the outriggers deployed.

The crane operator over extended the operational envelope of the dredging system when he attempted to dredge at an approximate 30-degree angle to the centerline of the crane's carriage without using the outriggers. The dredging bucket was being dragged back to the crane, when the crane became unbalanced and tipped over.
