# Fatality Investigation Report

OR 2003-19-1

## Farmer is killed when he falls beneath moving combine.

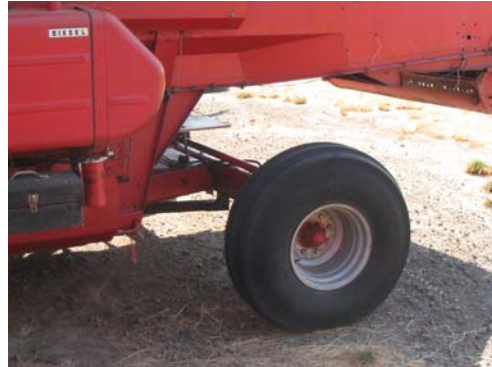
processing crop. The rear steering wheels allow the slow moving machine to track well over short distances. The combine continued down the row while the victim walked slowly to the rear so that the combine appeared to travel past him, according to the other operator and the father. As the victim approached the rear of the combine he is reported to have either fallen or tripped into the area immediately in front of the left rear steering wheel.

The father reported that his son was wearing a western style “cowboy boot” on this day instead of his more typical sports shoe or “sneaker” and felt that this may have contributed to him falling or tripping. Grass fields often contain “clumps” of dense grass making them difficult to walk in. He did not appear to be carrying a shovel that was routinely used to sample for seed loss therefore his father believes that he was checking the overall operation of the combine rather than assessing the amount of seed loss. Due to the nature of his injuries it appears that he may have stumbled, and as he stumbled tried to catch his balance by reaching out for a part of the body of the combine. The victim fell onto the left rear tire and was pulled under and run over.

More recent models of combines have had engineering improvements to reduce the risk of this kind of incident: (1) the rear steering wheels have been placed more forward on the combine and track with the front drive wheels, and (2) the width and length of the deflection shield (Fig. 3) has been increased to throw chaff and seed further behind the rear wheels making it unnecessary to stand near or in front of them. Additionally, by placing the rear wheels towards the front of the combine the space between the rear wheels and body of the combine is reduced preventing operators from entering into this area while the combine is moving.

Photo 2. Space between rear tires and combine body and short narrow deflection shield.

**Recommendation 1: Farm operators should not assess for seed loss while the combine is operational or moving. Adjustments should only be made to a combine that is completely shutdown with its engine turned off.**

Discussions with the manufacturer’s representative and a review of the operating manual provided the following recommended procedure for adjusting the combine to minimize seed loss. The manufacturer suggested that the combine should be operated a sufficient distance (this may be interpreted minimally to be 3-4 lengths of the combine) to assess its performance after the initial set-up adjustments are made. The operator should then shutdown the combine and turn off the engine before leaving the operator’s platform. The operator should observe the area immediately behind the header and in front of the drive wheels, looking for seed that might be on the ground. Next, the operator should check behind the combine approximately 1-2 lengths to again assess for seed loss. If there is more seed on the ground behind the combine (than behind the header) the farmer may want to make adjustments to the machine to retain more product. Adjustments should only be made to a combine that is completely shutdown with its engine turned off. Reassess after making adjustments, until satisfied with the results.

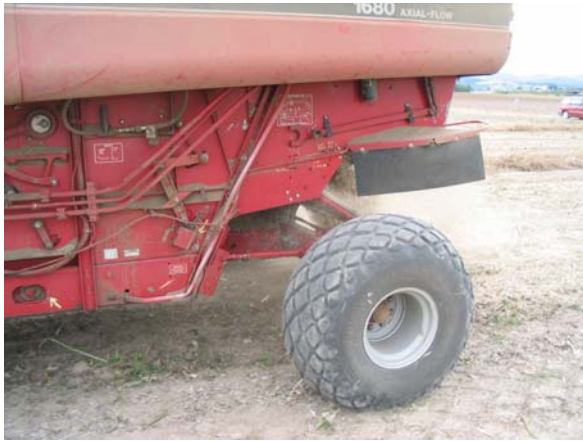
Note. Newer models like the one in these photos, direct the outflow behind the rear steering wheels. Newer models also have deflection shields that are much wider than those on older machines. Wider shields are better at getting the chaff over the rear axles and past the rear steering tires. Proximity to the spinners makes it extremely dangerous to be in this area for any reason.

Photo 3. Above/Below. Newer combine and larger straw deflection shield.
