# Fatality Investigation Report

OR FACE 2003-15-01

## Construction worker dies when he leans out of the protective cage of a skid steer forklift and is crushed.

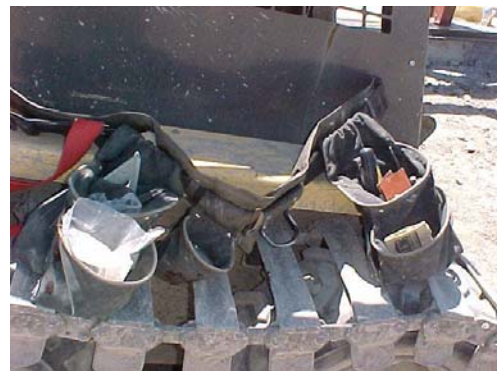
operating this equipment. The tool belt is depicted in Photo1. The tool belt is large and bulky and could easily interfere with safe operation or egress in the cramped operator's cage.

- ✓ **Take care to remove or properly stow items that could interfere with the safe operation of equipment. (e.g., loose clothing, tool belts, etc.)**

Discussion: The company is reported to have a policy requiring employees to remove tool belts before operating equipment. The victim was wearing his tool belt while he was

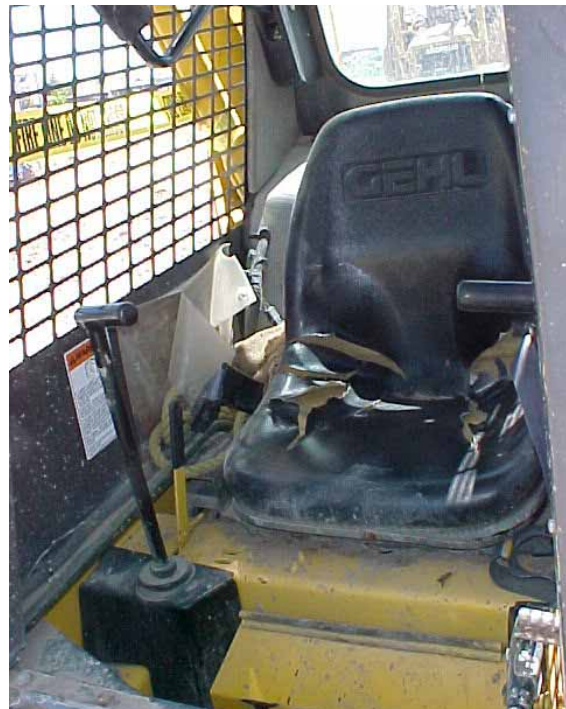
**Photo 2.** Position of safety bar following the incident.

A representative of the equipment manufacturer stated that the seat and the safety bar had an interlock function that should have prevented the lift mechanism from raising or lowering. Interviews with witnesses suggest that the safety interlock was not functioning properly at the time of the incident and may have been deactivated.

- ✓ **Never modify, defeat, or override safety features. Similarly, never operate equipment in which safety systems or features have been modified or are not working properly.**

Discussion: Check all equipment and ensure that all safety systems are operational. All safety features that are not working properly should be reported and the equipment should not be used until repaired. Before returning equipment to service, check to ensure that all systems are operational and functioning as intended.

Discussion: The protective cage is designed to keep the operator safe while operating the skid steer loader. The front of the cage is open to maximize visibility from the operator's seat. The safety bar is designed to deactivate the hydraulic systems if the worker leaves the seat and to remind the operator to stay seated inside the protective cage when operating the equipment.
