NIOSH HEALTH HAZARD EVALUATION REPORT

HETA 96-0100-2636
Harley-Davidson Motor Company
Tomahawk, Wisconsin

**Health Hazard Evaluation Report 96-0100-2636
Harley-Davidson Motor Company
Tomahawk, Wisconsin
April 1997**

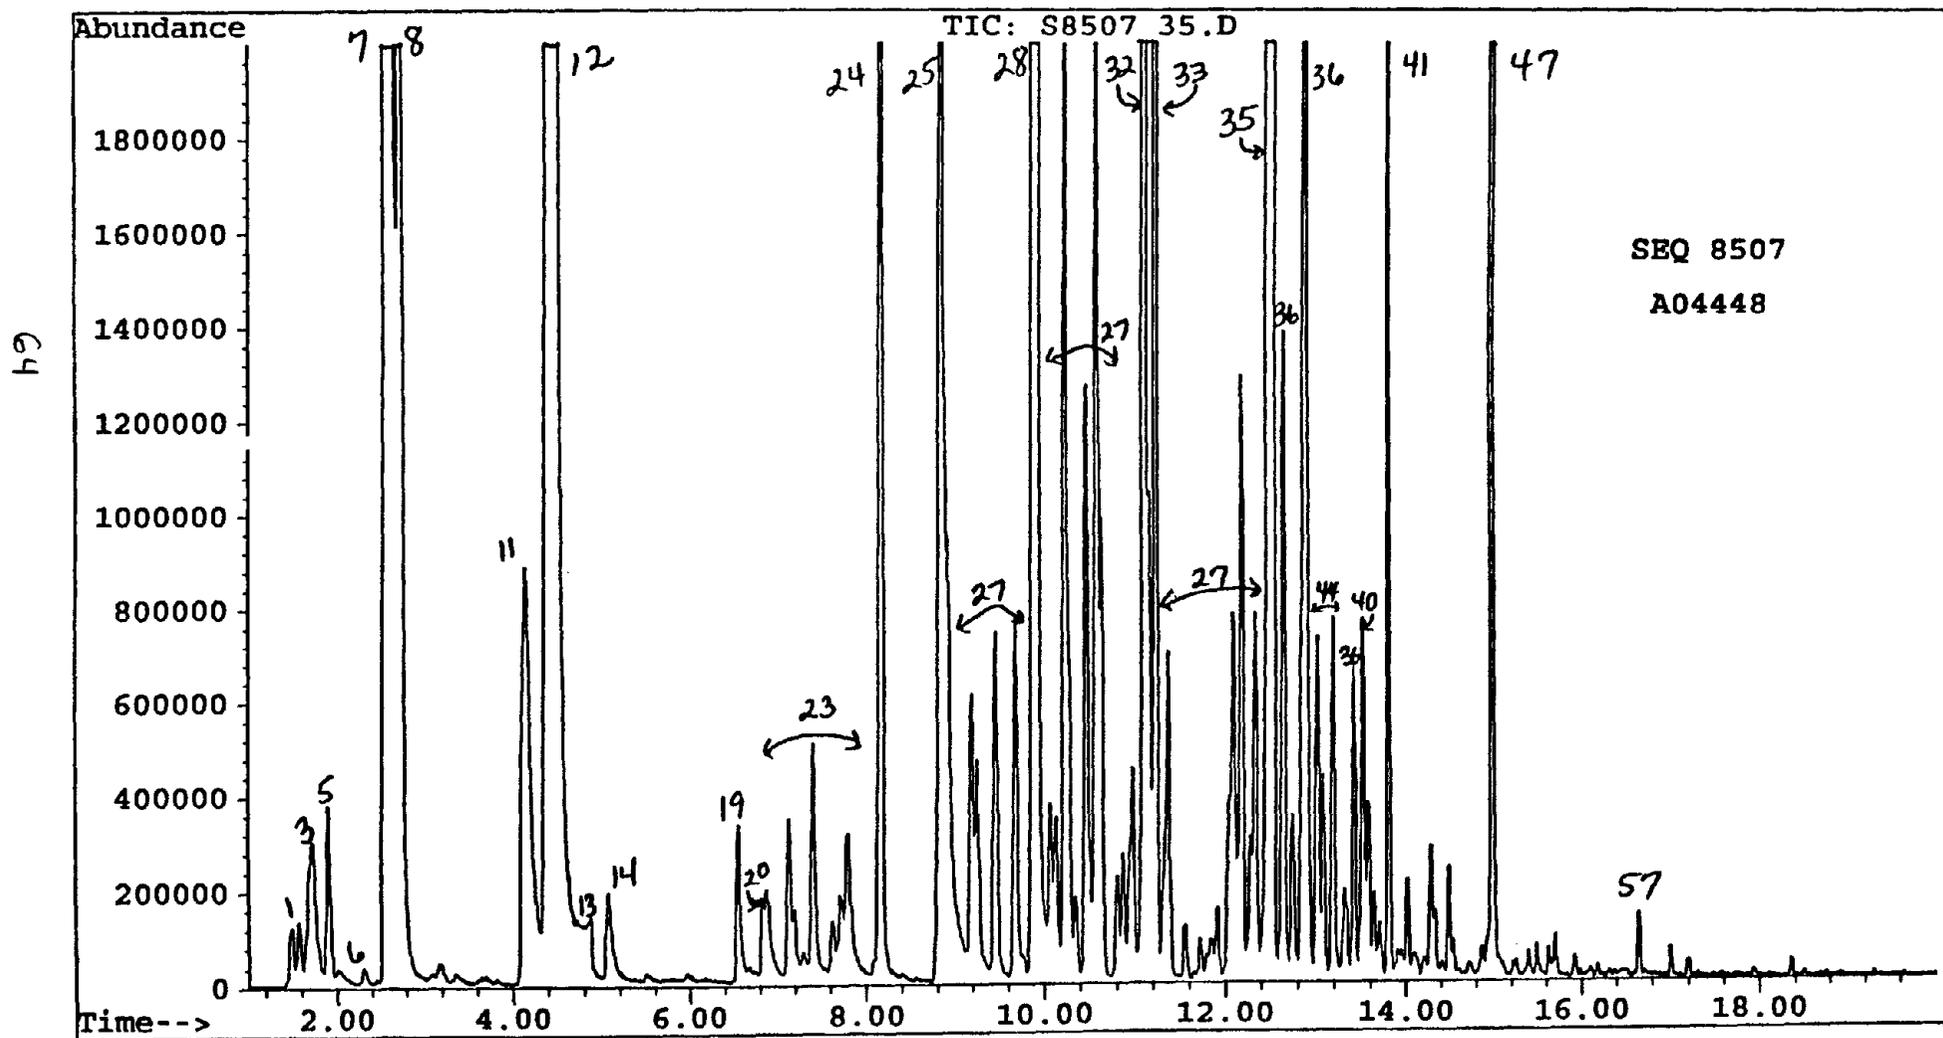
Touch-up Spray, day 3

File : C:\HPCHEM\1\DATA\S8507\S8507_35.D
Operator : AAG
Acquired : 20 Aug 96 8:45 pm using AcqMethod TOTAL
Instrument : 5970 - In
Sample Name: SAMPLE A04448 100CC/45MIN
Misc Info : 30 M DB-1 SC20-400 TP35-300
Vial Number: 31

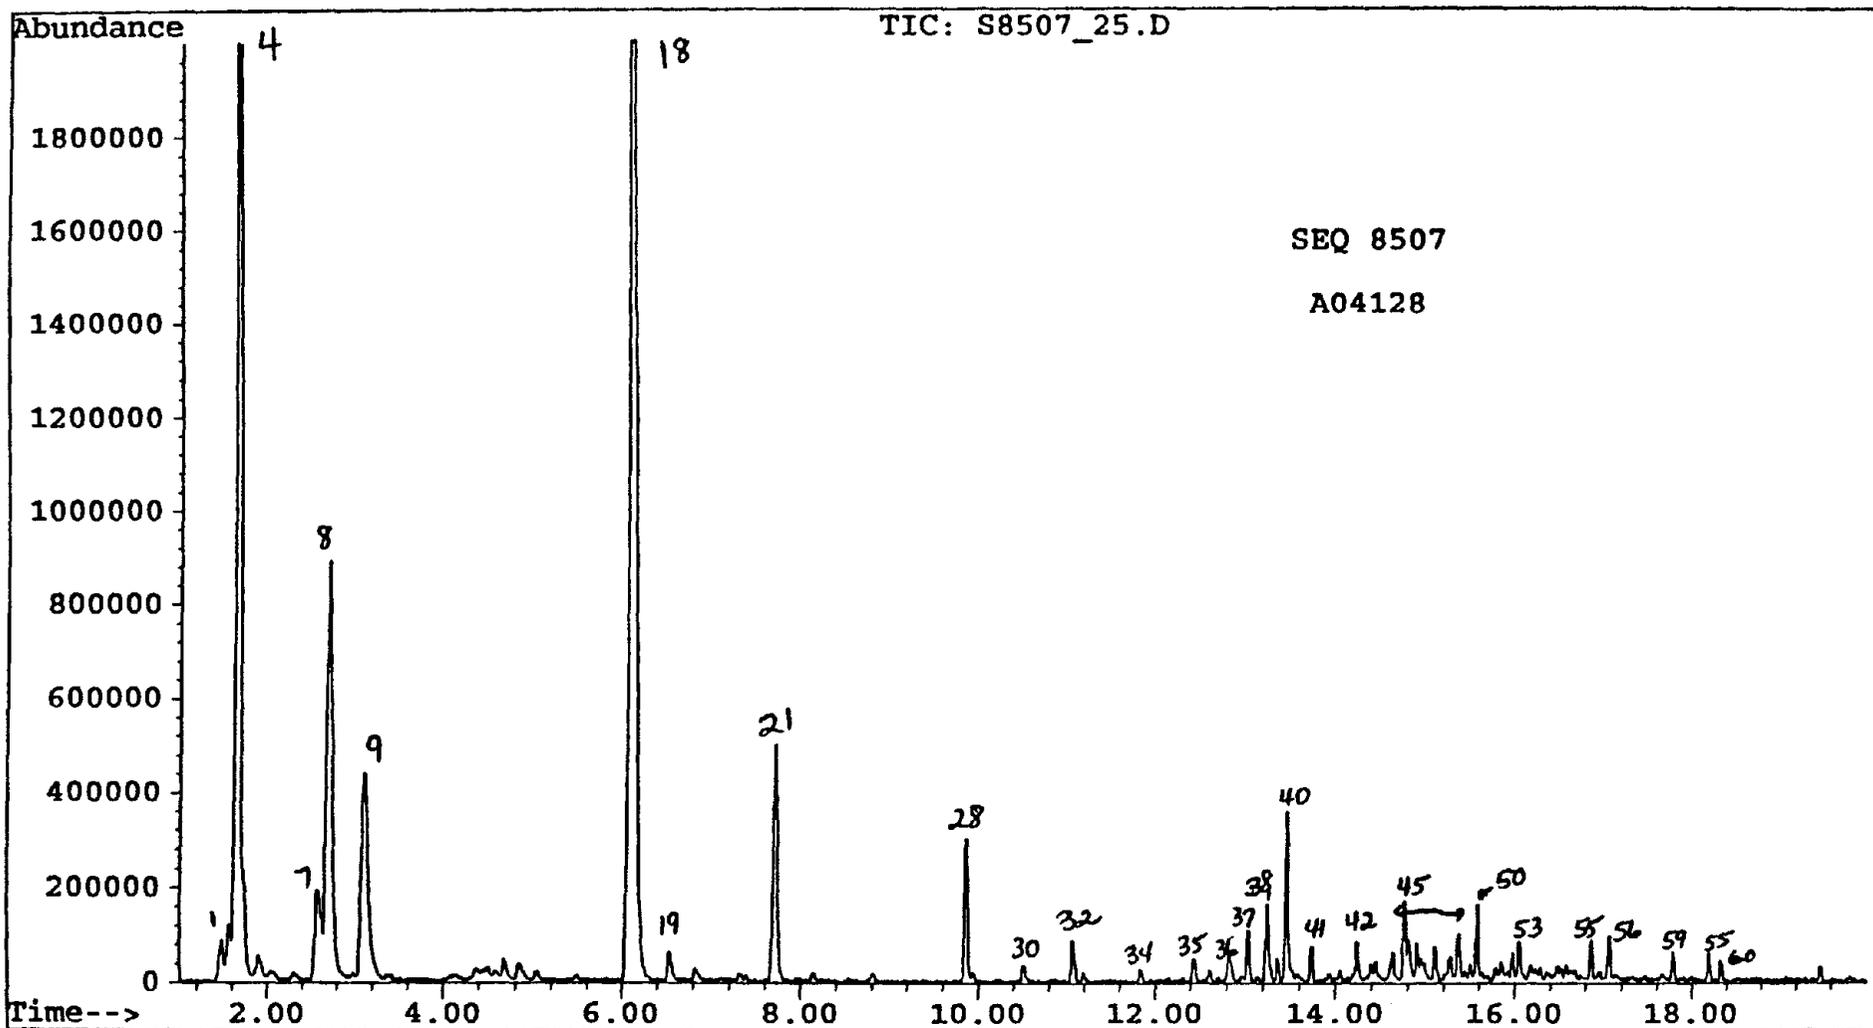
conf room, day 1

File : C:\HPCHEM\1\DATA\S8507\S8507_25.D
Operator : AAG
Acquired : 20 Aug 96 12:22 pm using AcqMethod TOTAL
Instrument : 5970 - In
Sample Name: SAMPLE A04128 100CC/45MIN
Misc Info : 30 M DB-1 SC20-400 TP35-300
Vial Number: 21

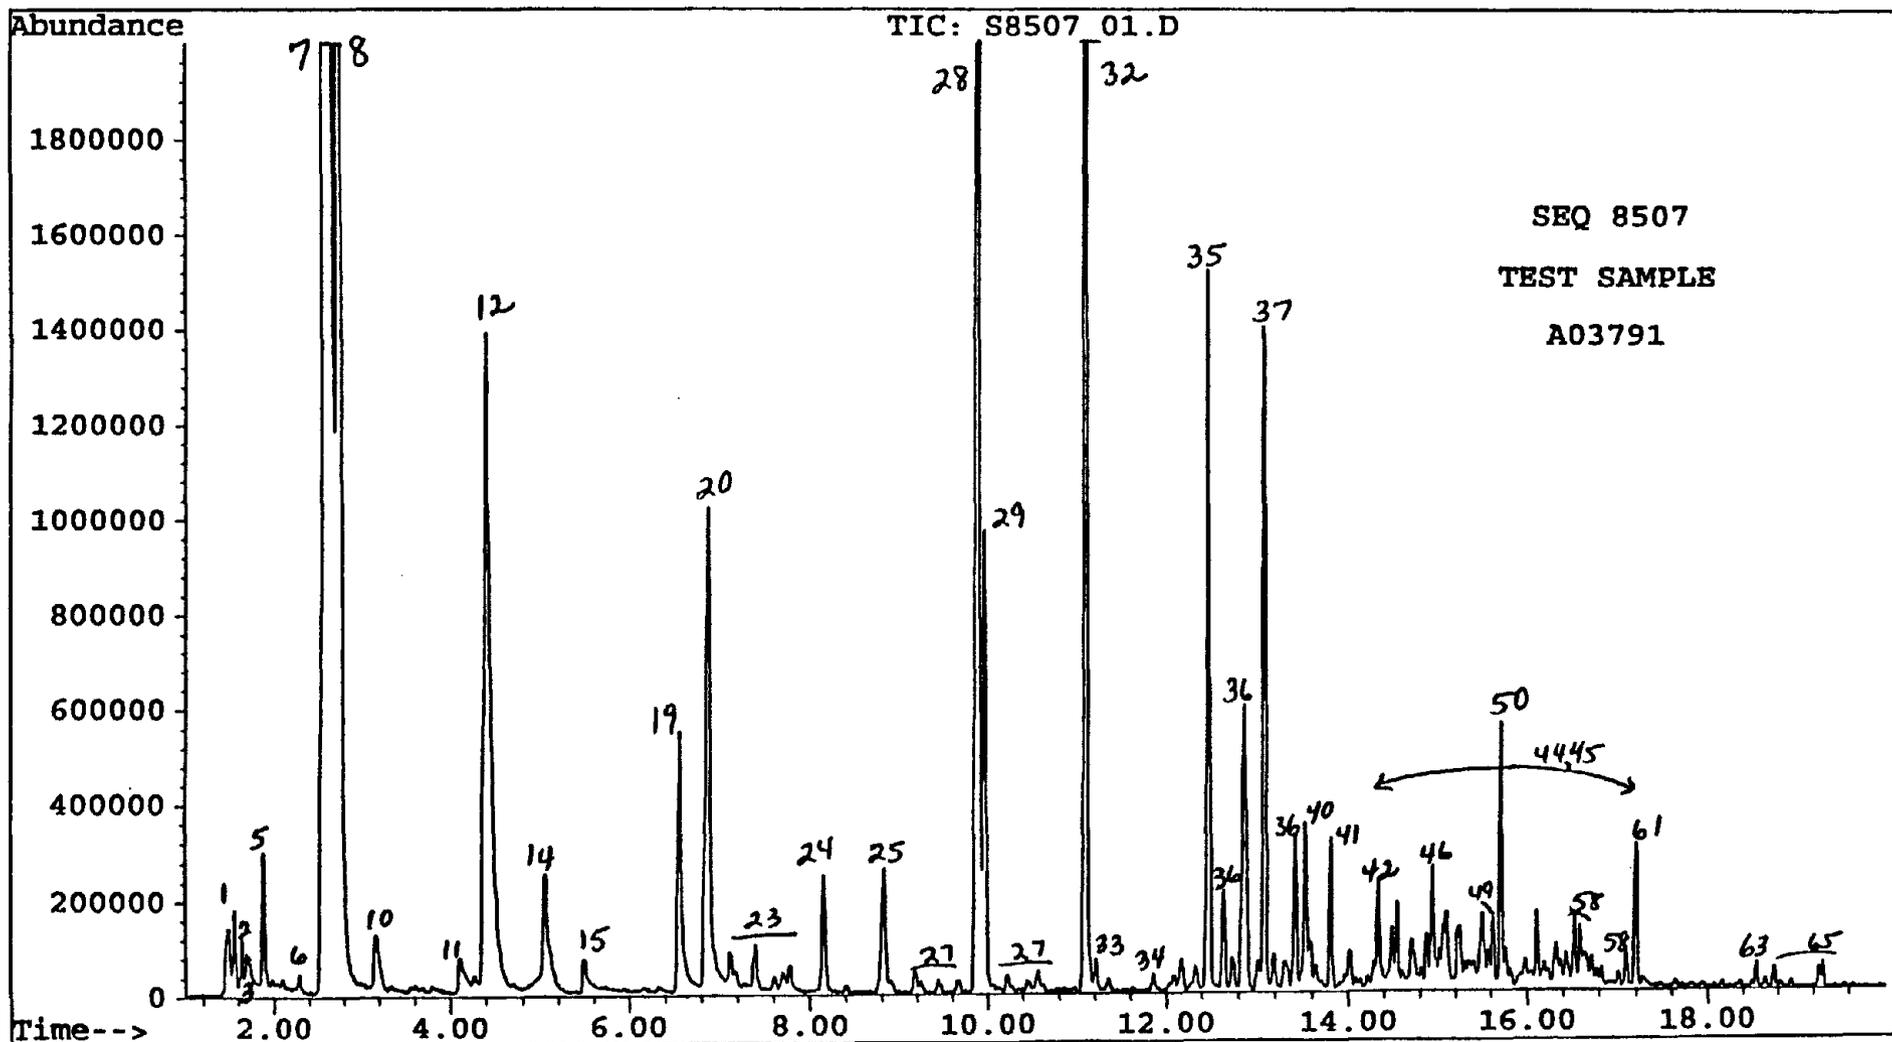
north line , day 1
(duplicate)

File : C:\HPCHEM\1\DATA\S8507\S8507_01.D
Operator : AAG
Acquired : 15 Aug 96 12:40 pm using AcqMethod TOTAL
Instrument : 5970 - In
Sample Name: SAMPLE A03791 NO PURGE
Misc Info : 30 M DB-1 SC20-300 TP35-300
Vial Number: 1

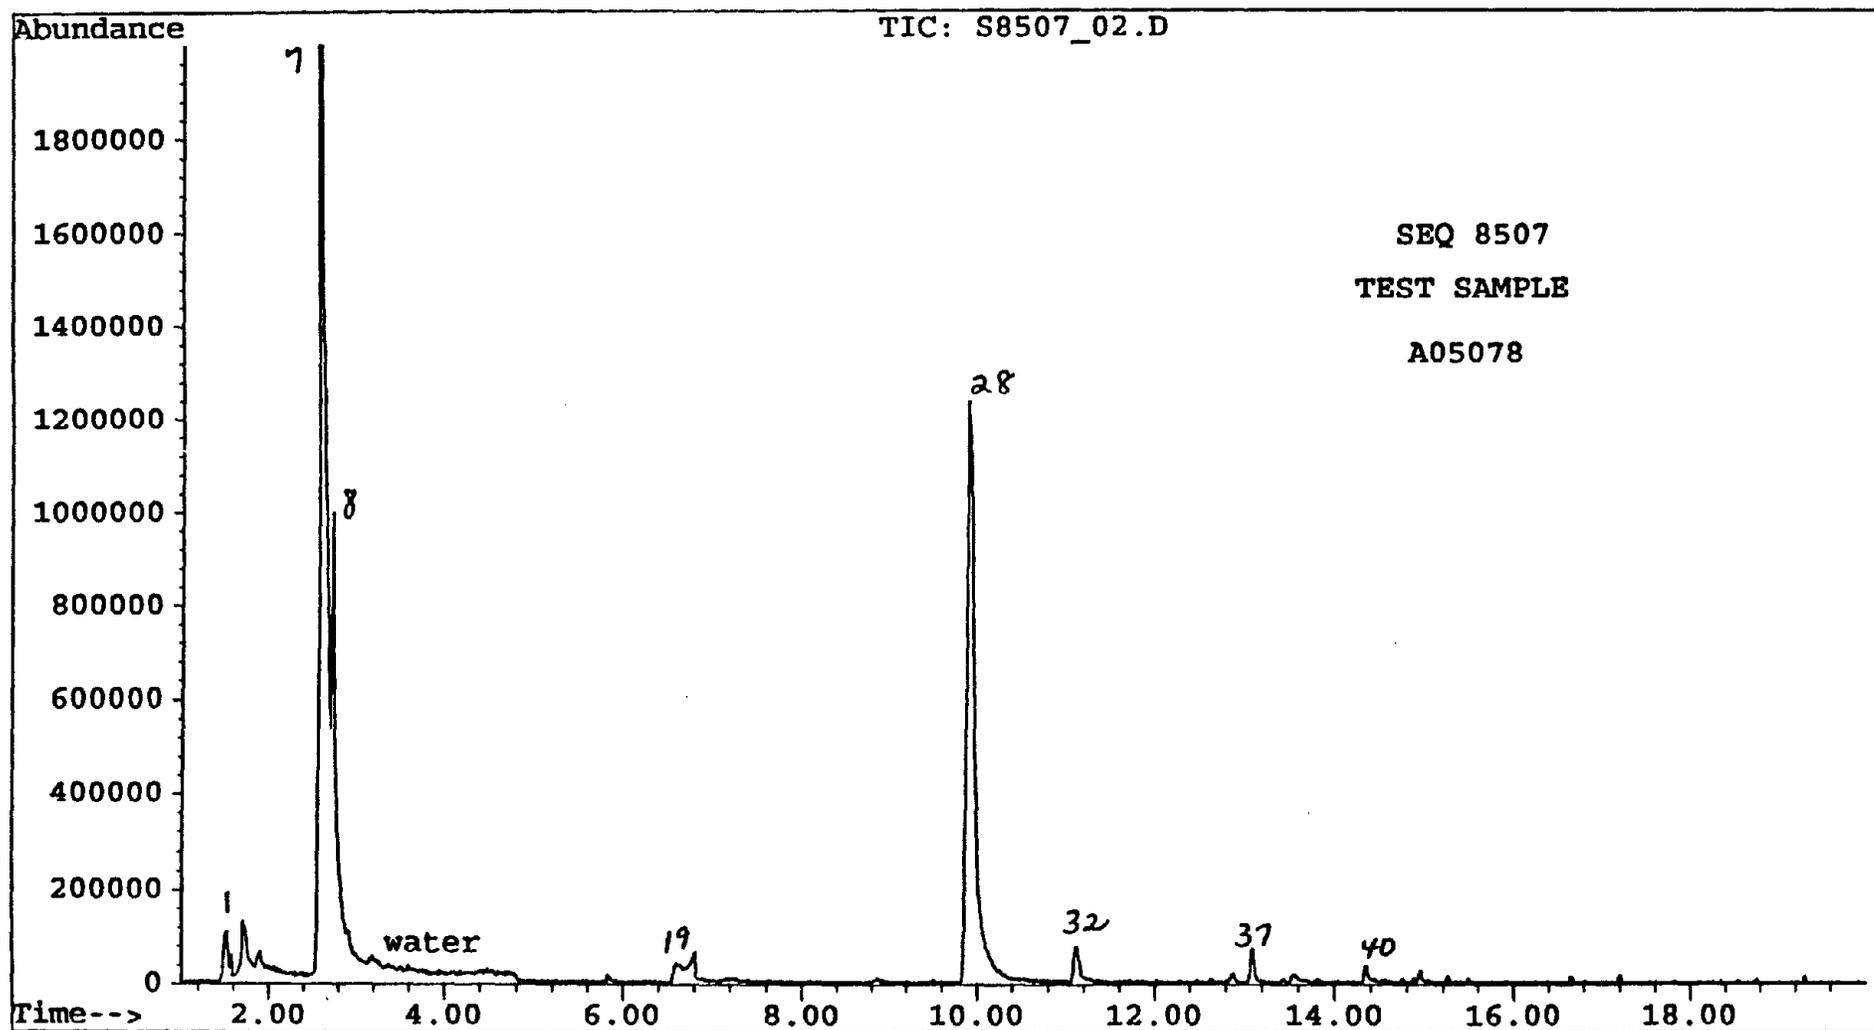
clear line, day 1
(duplicate)

File : C:\HPCHEM\1\DATA\S8507\S8507_02.D
Operator : AAG
Acquired : 15 Aug 96 1:38 pm using AcqMethod TOTAL
Instrument : 5970 - In
Sample Name: SAMPLE A05078
Misc Info : 30 M DB-1 SC20-300 TP35-300
Vial Number: 2

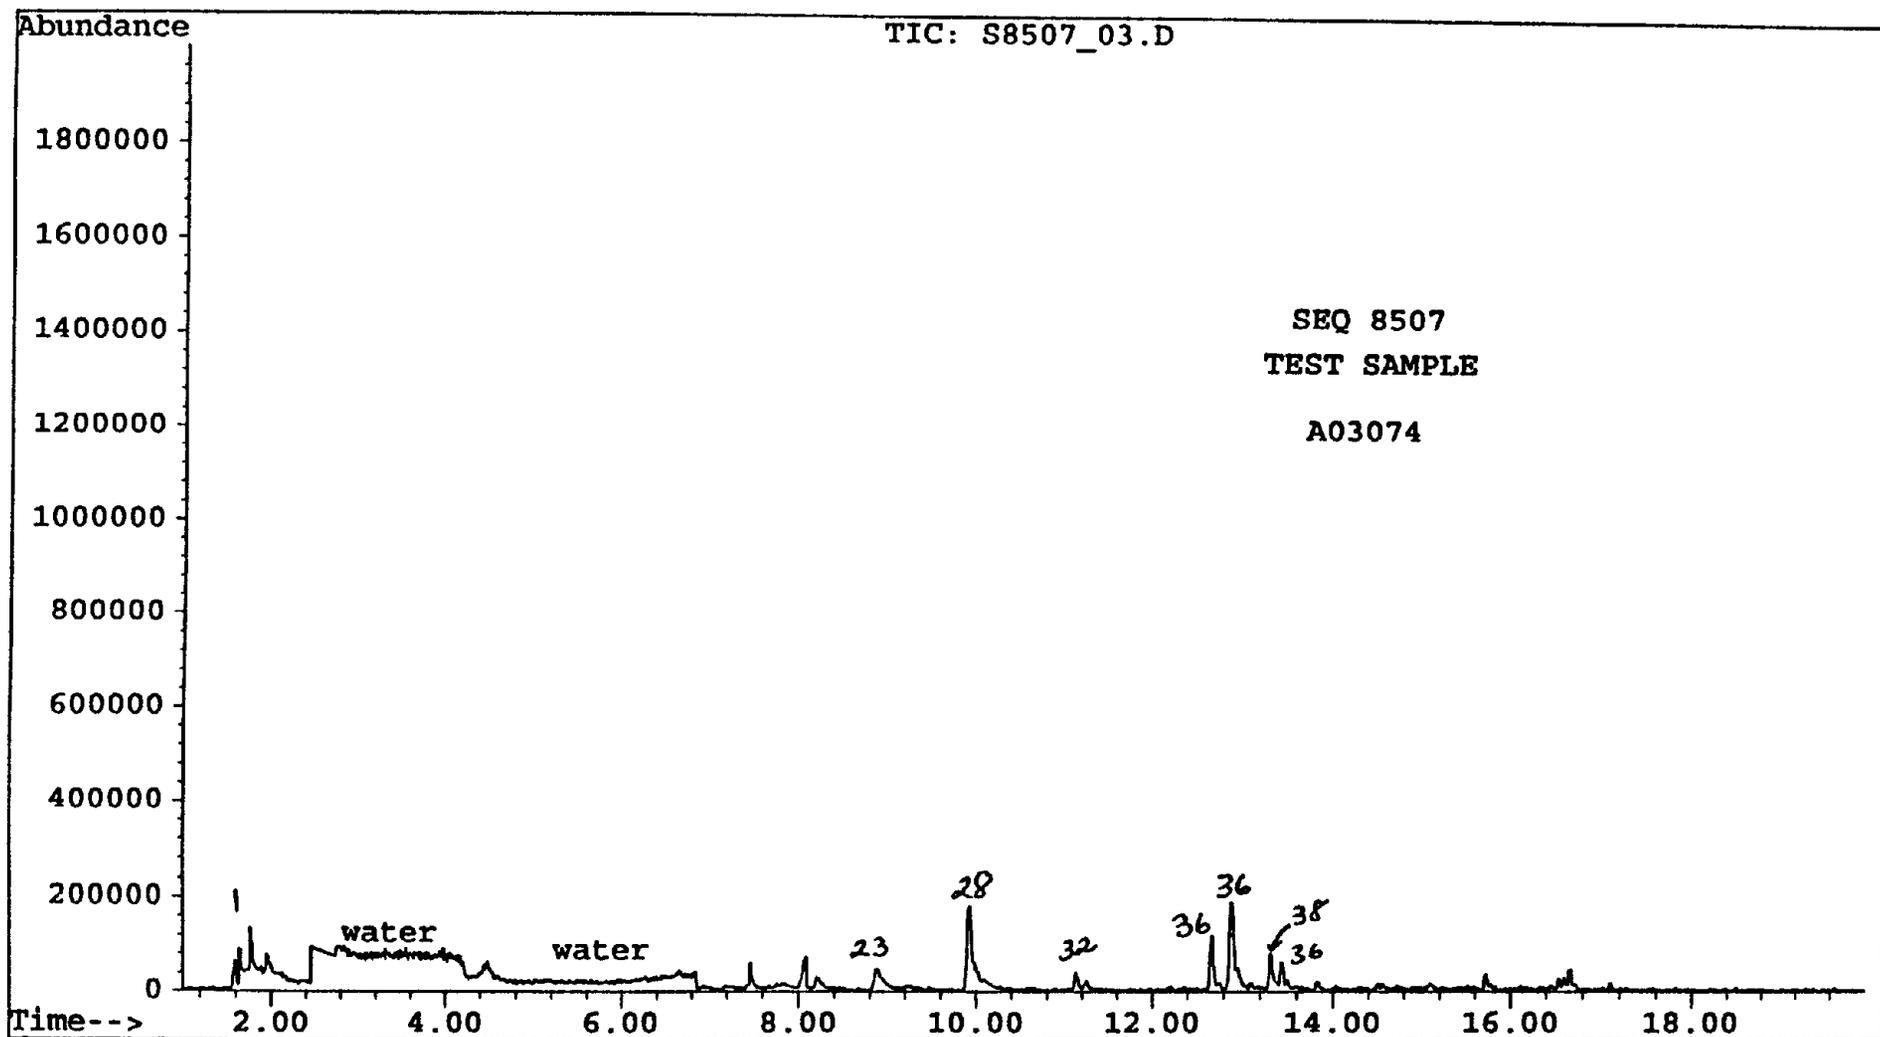
east line, day 1
(duplicate)

File : C:\HPCHEM\1\DATA\S8507\S8507_03.D
Operator : AAG
Acquired : 15 Aug 96 2:28 pm using AcqMethod TOTAL
Instrument : 5970 - In
Sample Name: SAMPLE A03074 FIELD BLANK
Misc Info : 30 M DB-1 SC20-300 TP35-300
Vial Number: 4

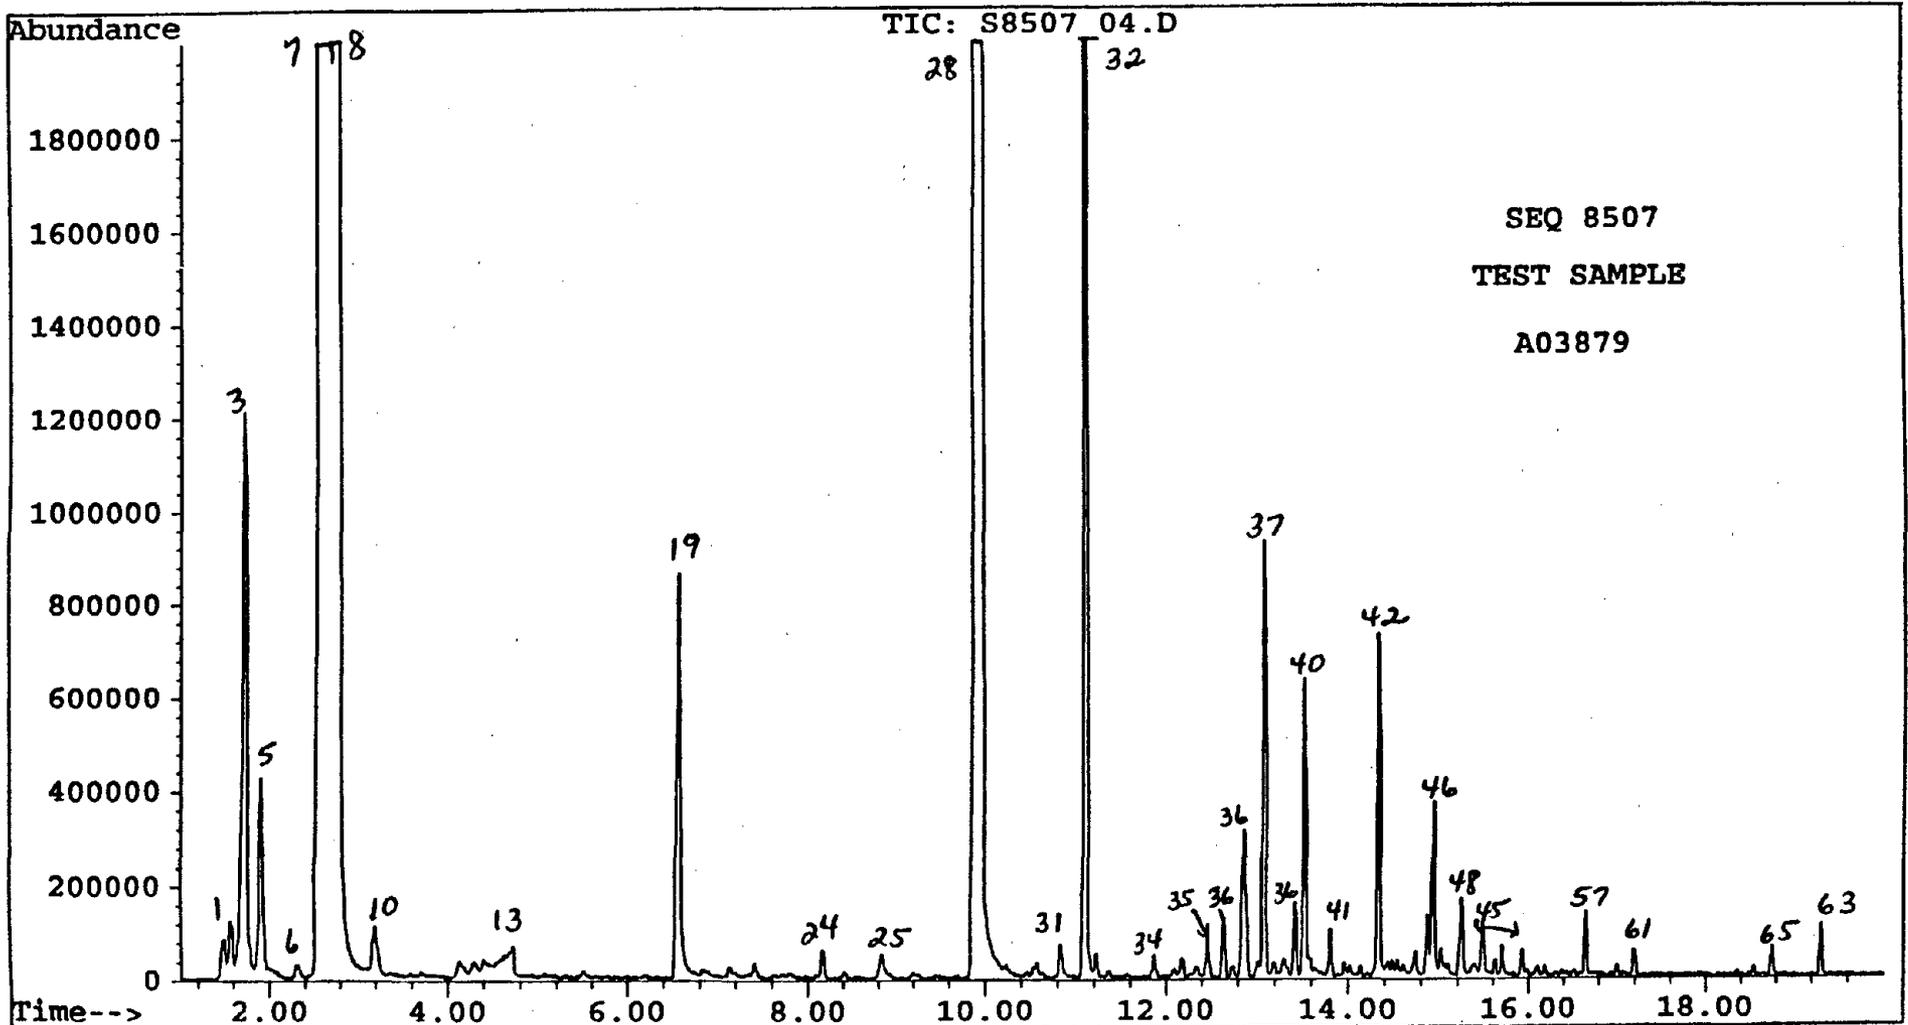
pinstriping, day 1
(duplicate)

File : C:\HPCHEM\1\DATA\S8507\S8507_04.D
Operator : AAG
Acquired : 15 Aug 96 3:18 pm using AcqMethod TOTAL
Instrument : 5970 - In
Sample Name: SAMPLE A03879 PURGED
Misc Info : 30 M DB-1 SC20-300 TP35-300
Vial Number: 5
