# Evaluation of Potential Exposures to Railway Hazardous Material Inspectors

HHE Report No. 2022-0049-3387

August 2023

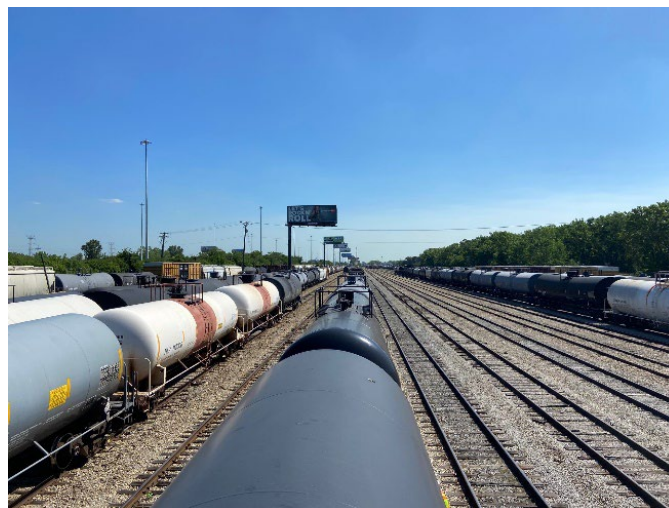
Figure 1. Rows of tank cars at the railyard, some containing hazardous materials, surrounded by active tracks. Photo by NIOSH.

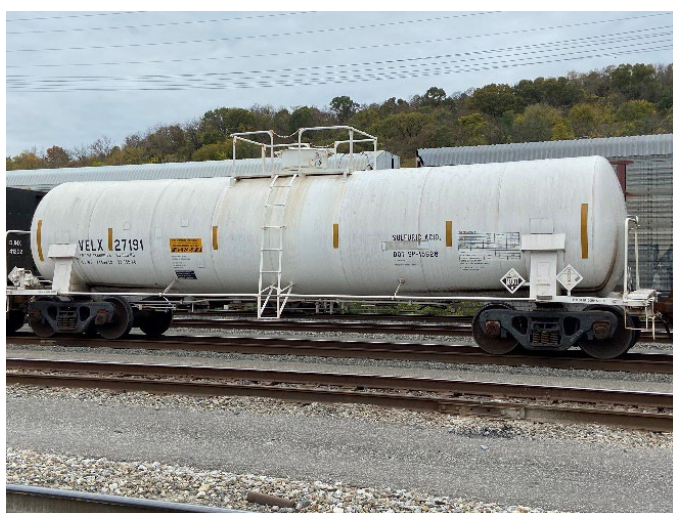
Figure A2. Cylindrical hazardous materials tank car. Photo by NIOSH.

To complete the HM inspection of the tank car, inspectors first identified a train track that had HM-containing tank cars. Railroad tank cars (pressurized, non-pressurized, or low-pressure) were typically cylindrical and included top fittings with filling and inspection ports located inside a protective housing (Figure A2). In addition, most of the cars had a bottom outlet valve. Another type of tank car was more rectangular with multiple outlets on the bottom of the car (Figure A3).

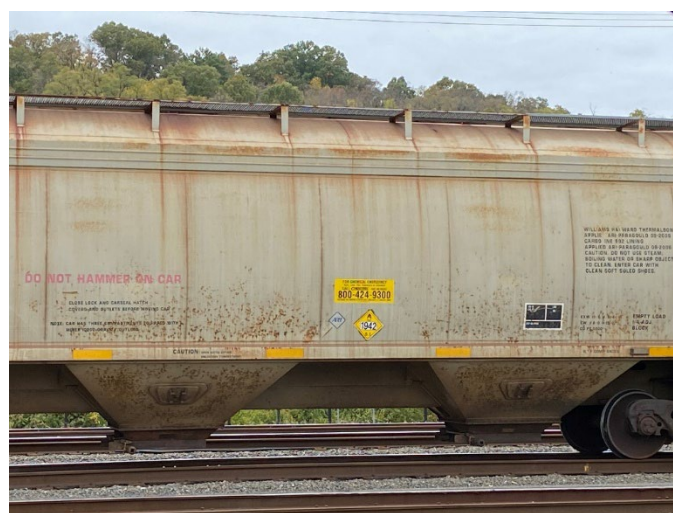
Figure A3. Squared tank car containing ammonium nitrate. Photo by NIOSH.

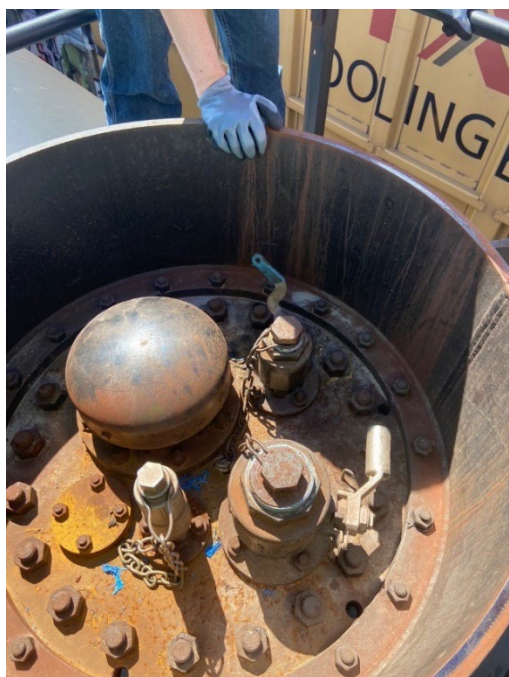
Figure A5. Inside the valve housing on top of the tank railcar containing hazardous materials. Photo by NIOSH.

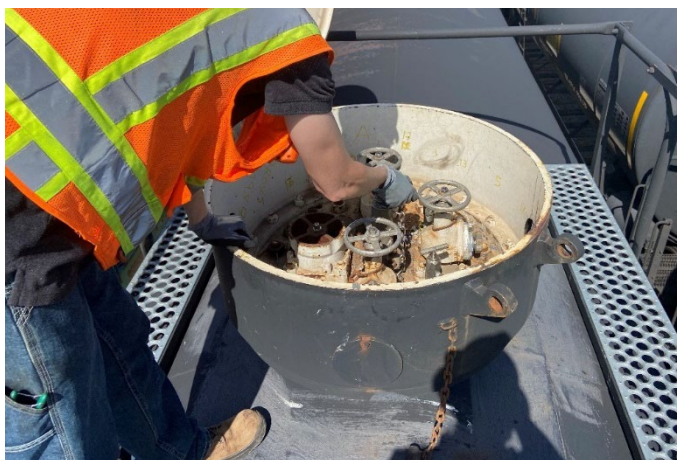
Figure A6. Inside the protective housing on the top of the tank car. Photo by NIOSH.

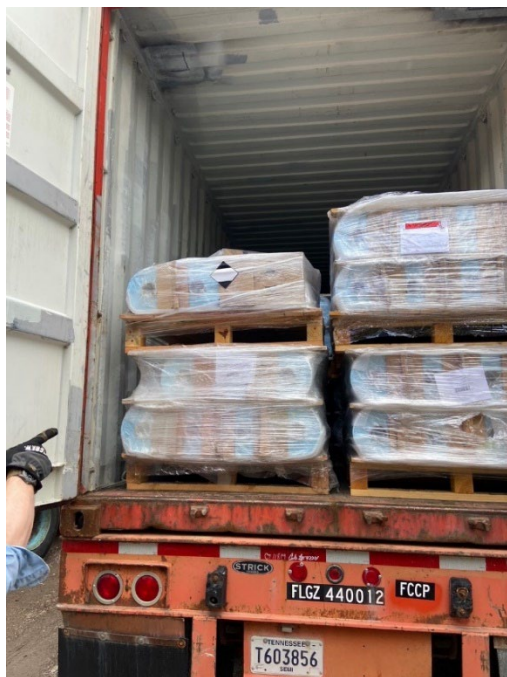
Figure A7. HM inspector affixing a strap to the back of the intermodal container. Photo by NIOSH.

After the inspector identified an intermodal container with HM, the inspector noted the DOT Placard and UN number. The inspector attached a strap to the back of the container so that when it opened, the contents (which may have shifted during transportation) did not fall onto the inspector (Figure A7). The inspector then removed the metallic zip tie and opened the container. All intermodal containers are inspected from the outside because they are considered confined space, and the inspectors are not permitted to enter (Figure A8). After inspection, the inspector resealed the intermodal container with a zip tie.

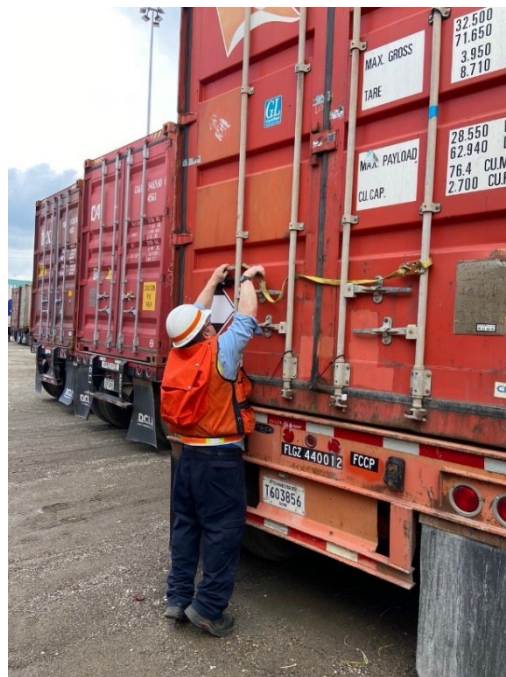
Figure A8. Inspection of an intermodal shipping container containing hazardous materials. Photo by NIOSH.

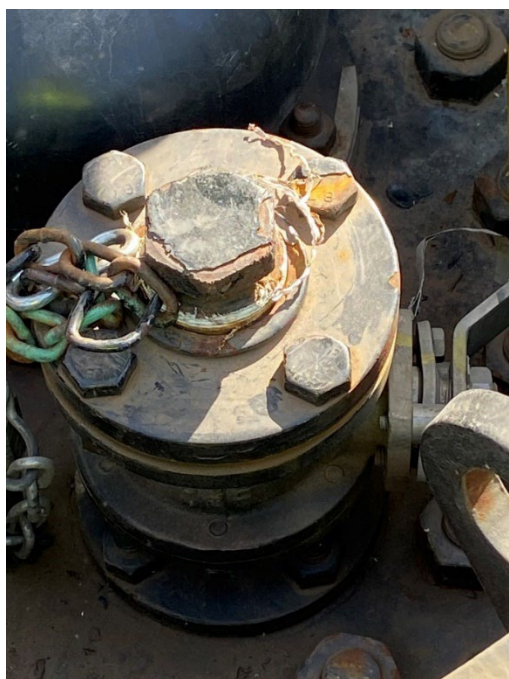
During the inspection of tank cars containing HM, an inspector encountered a damaged valve that could cause leakage around the seal (Figure B9). During another tank inspection, the inspector found a valve that was not closed “hand tight.” Upon further inspection, it was discovered that the valve threading had been stripped, likely because someone had used a tool to attempt to seal the valve. This damaged valve could no longer seal tightly, allowing fumes and vapors from inside the tank to expose the HM inspector (Figure B10). During this inspection, a prominent odor was detected. The inspector notified the yard master of these noncompliant cars to prevent them from departing.

Figure B9. Valve inside the housing with a damaged seal on the valve cover. Photo by NIOSH.

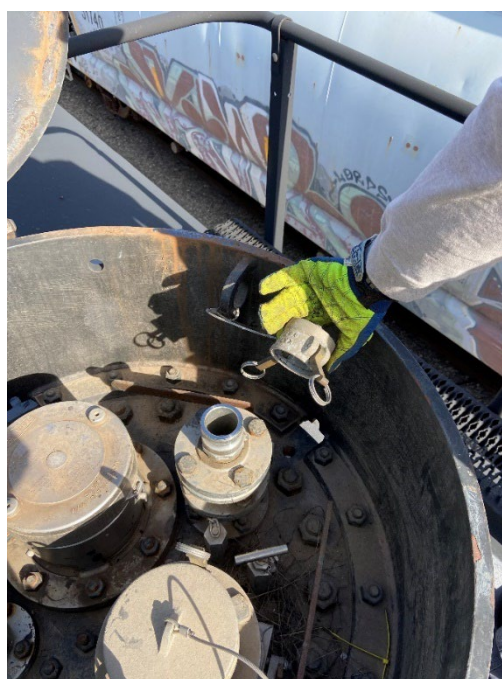
Figure B10. An open valve inside of the housing. Photo by NIOSH.

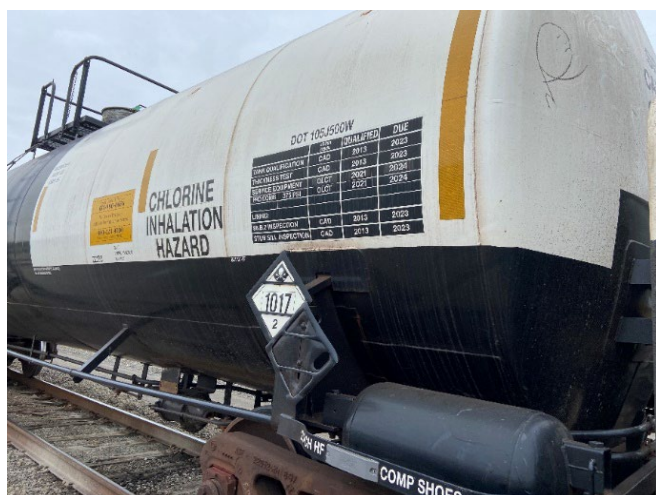
Some cars that contained inhalation hazards were clearly labeled as such (e.g., the chlorine car in Figure B11). However, for other tank cars that contained inhalation hazards, the information was not as obvious. For example, Figure B12 shows a tank car filled with fuming sulfuric acid, which is both corrosive and an acute inhalation toxicity. However, for this tank, the “fuming” label was covered with a magnet (Figure B13). Therefore, the only way to know that the contents were fuming sulfuric acid was to look up the UN number (1831) on the DOT placard. Because these tank cars can be used to transport both fuming and non-fuming sulfuric acid, the magnet was likely in place for a previous time when the car was filled with non-fuming sulfuric acid.

Figure B11. Chlorine tank car labeled inhalation hazard, including the inhalation pictogram on the DOT placard. Photo by NIOSH.

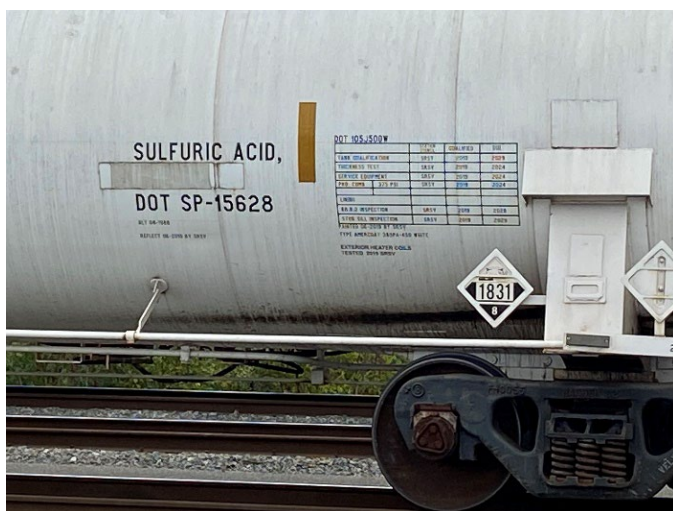
Figure B12. A tank car labeled “Sulfuric Acid” displaying a DOT placard with UN Number 1831 and the corrosive chemical pictogram. Photo by NIOSH.

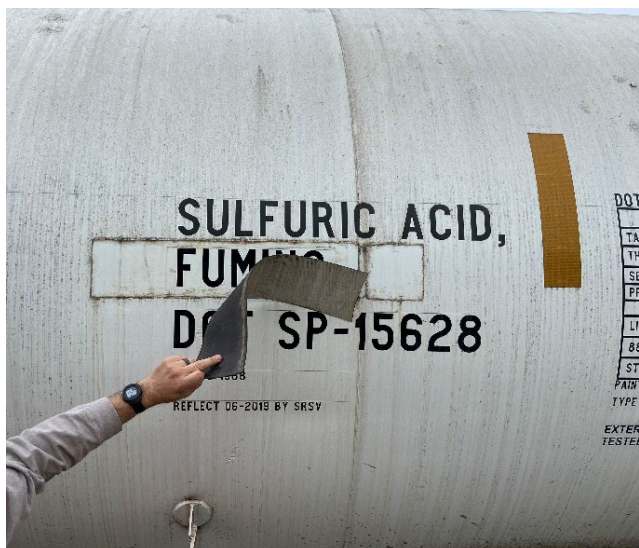
Figure B13. A magnet covering the word “fuming” on the label of the tank car. Photo by NIOSH.

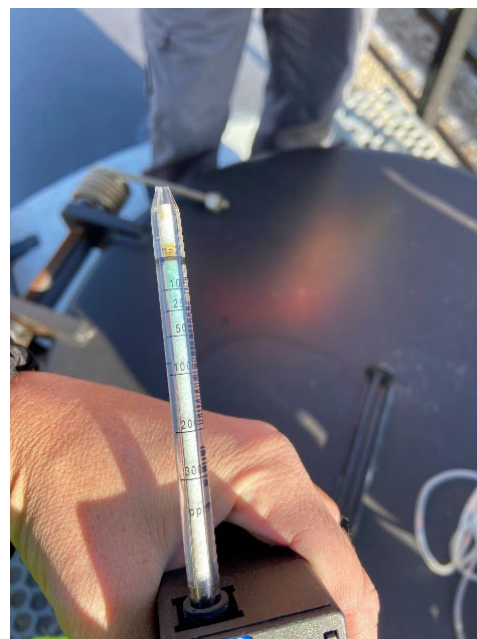
One of the five hydrocarbon indicator tubes had a detectable result of approximately 50 ppm (Figure B14). Once the housing was opened, there was a strong odor that dissipated after about 2 minutes. This was the inspection that had the stripped valves. None of the other indicator tubes showed a color change.

Figure B14. Colorimetric indicator tube for petroleum hydrocarbons showing ~50 ppm. Photo by NIOSH.
