Evaluation of Indoor Environmental Quality in a Medical Office Building

Aalok Oza, MPH
Mark Methner, PhD, CIH

Report No. 2012-0266-3210
May 2014

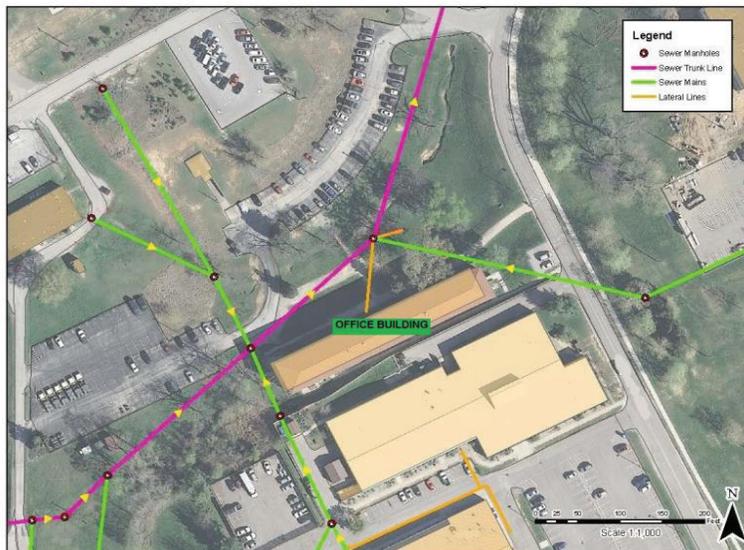
The four-story concrete masonry office building was constructed in the 1960s and originally commissioned as a military barracks. The building had been renovated twice since then, once to house a military police department and a second time, in 2012, to serve as a medical office building. At the time of our evaluation, the three main floors of the building had been converted into offices and exam rooms. Half of the basement level remained a dirt floor crawl space, and the other half was storage and mechanical rooms. The building sat in a valley and was within 30 feet of a 24-inch sanitary sewer trunk line that carried sewage from approximately 60% of the surrounding area toward the wastewater treatment facility. The building was surrounded by manholes that had been previously identified as sources of odors by former occupants as well as the health and safety department. Figure 1 is an aerial photograph of the office building with surrounding sewer lines and manholes identified.

Figure 1. Aerial view of building and location of sanitary sewer lines and manholes. Photo by Veolia Environmental Service.

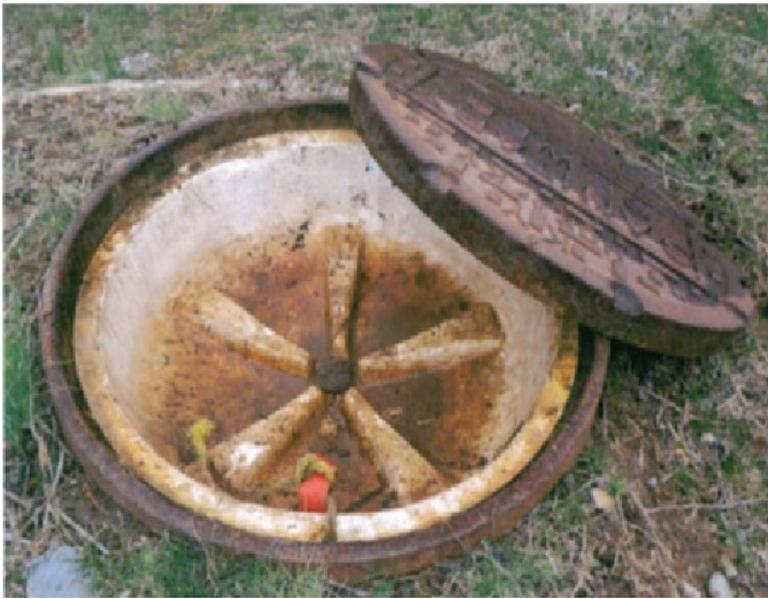
A contractor was hired to inspect and maintain the sanitary sewer and storm water system. The contractor performed a closed circuit television inspection of the sanitary sewer trunk line that bordered the west side of the building. The survey covered 81 feet of pipe. Fractures and pipe joint separations were identified. The contractor used a cured-in-place pipe lining method to repair and seal these cracks and separations. To prevent sewer gas from migrating through the vented manhole covers, all manhole covers were replaced with solid lids equipped with rain guards that allow rain water to enter yet prevent sewer gases from escaping (Figure 2).

Figure 2. Manhole with rain guard intact. Photo by Veolia Environmental Service.

1. Remove unused plumbing fixtures from bathrooms. Cap and seal unused pipes.
2. Replace cast-iron plumbing with polyvinyl chloride pipe.
3. Continue remediating sanitary sewer lines surrounding the facility. Additional segments of the line should undergo camera inspection. If structural deficiencies are located, the pipe segments should be sealed using the same method previously used.
4. Adjust the HVAC system to ensure that adequate amounts of outdoor air are introduced into the building according to ASHRAE guidelines. Additional air exchanges can alleviate stuffiness complaints from employees in these areas [ANSI/ASHRAE 2013]. Conduct additional monitoring to ensure that carbon dioxide levels have been reduced to within ASHRAE guidelines under all ventilation conditions

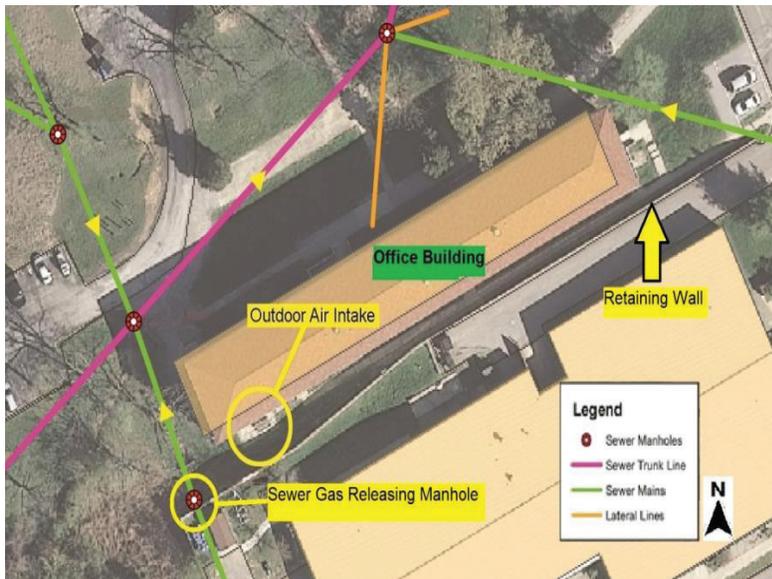
The building's HVAC system outdoor air intake was on the south west corner of the building on the lower level (Figure 3). Hydrogen sulfide measurements taken at the manhole near the southwest corner of the building indicated that an appreciable concentration (33 ppm) was escaping from the manhole. The manhole was within 40 feet of the outdoor air intake. Because of the proximity of the outdoor air intake to this manhole, sewer gas could enter the outdoor air intake, especially if prevailing winds blew escaped sewer gas toward the intake. In addition, a two-story retaining wall that ran the entire length along the back of the building formed an alley way. Thus, odors released from the manhole could be channeled towards the air intake. These configurations and conditions may explain some of the odors reported by building occupants. Following our evaluation, management reported that this manhole was sealed with an epoxy grout to prevent further sewer gas release.

Figure 3. Location of building outdoor air intake and odor generating manhole. Photo by Veolia Environmental Service.

Our evaluation found several odor sources and ventilation deficiencies that likely contributed to the odor complaints reported by employees. Carbon dioxide concentrations measured at multiple locations were above ASHRAE guidelines. The HVAC system outdoor air intake

was located adjacent to a manhole known to emit odors which may also have contributed to odors in the building. Several restrooms were positively pressurized relative to the adjacent hallway allowing odors to migrate to other areas in the building. Various components of the HVAC system were malfunctioning including heat-pump units, individual office air vents/diffusers, and multiple duct dampers. Upon inspection, we found drain traps in several restrooms to be dry and emitting odors. Following our visit, management reported that drain-trap devices were installed on all floor drains, HVAC components were inspected and repaired, cracks in the sanitary sewer lines were repaired, and manholes were sealed or replaced with solid lids and rain-guard devices. Management reported that odor complaints have decreased since our evaluation.
