# Evaluation of Environmental Controls at a Homeless Shelter Complex (City Rescue Mission–McDuff Campus) Associated with a Tuberculosis Outbreak – Florida

Health Hazard  
Evaluation Program

Report No. 2012-0264-3182  
July 2013

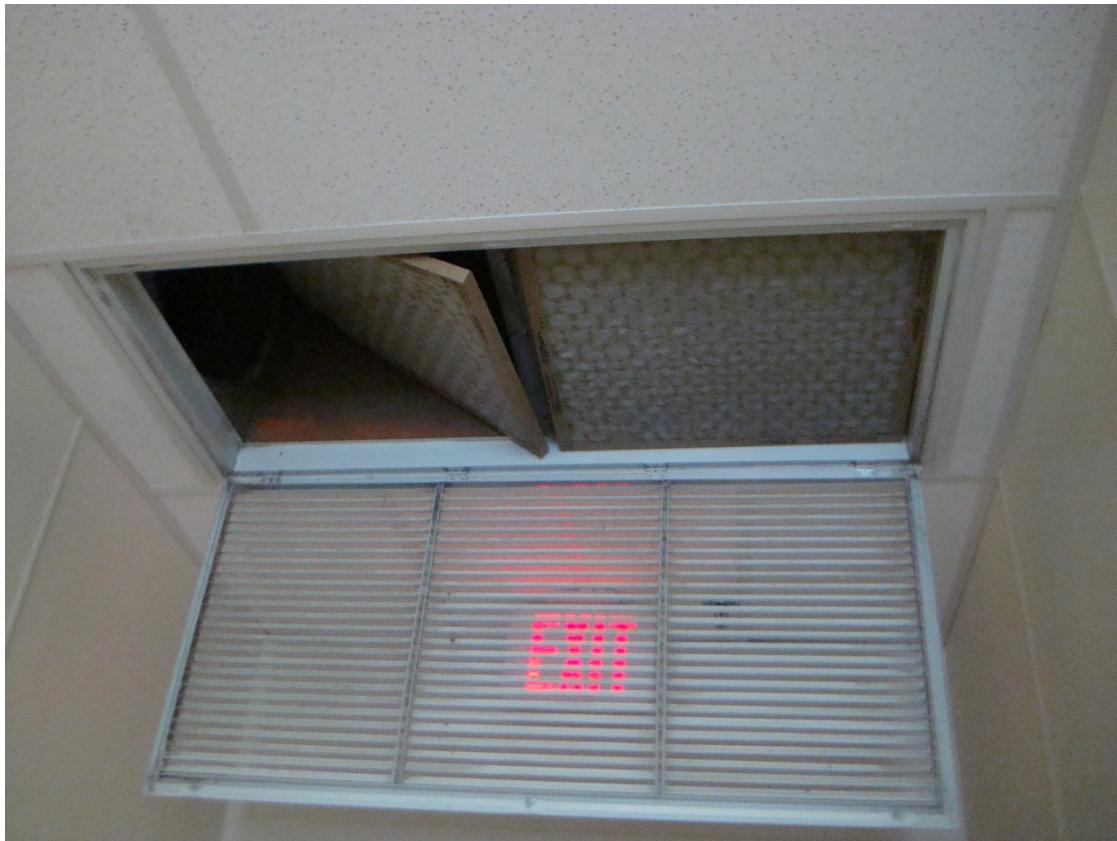
**Figure 1.** Return air grille leading to the AHU serving the women's overnight bunk area (Women-1). Air flow from the fan creates significant filter bypass.

- Install the highest efficiency air filters in AHU Women-2 that will still allow adequate air flow to meet the AHU's conditioning requirements. Adjust and balance the system as necessary to ensure proper air flows at all times when each selected room is individually or collectively used for respiratory separation and normal purposes. Ensure that adequate outdoor air is supplied to each space at all times (see Recommendation 2 above).

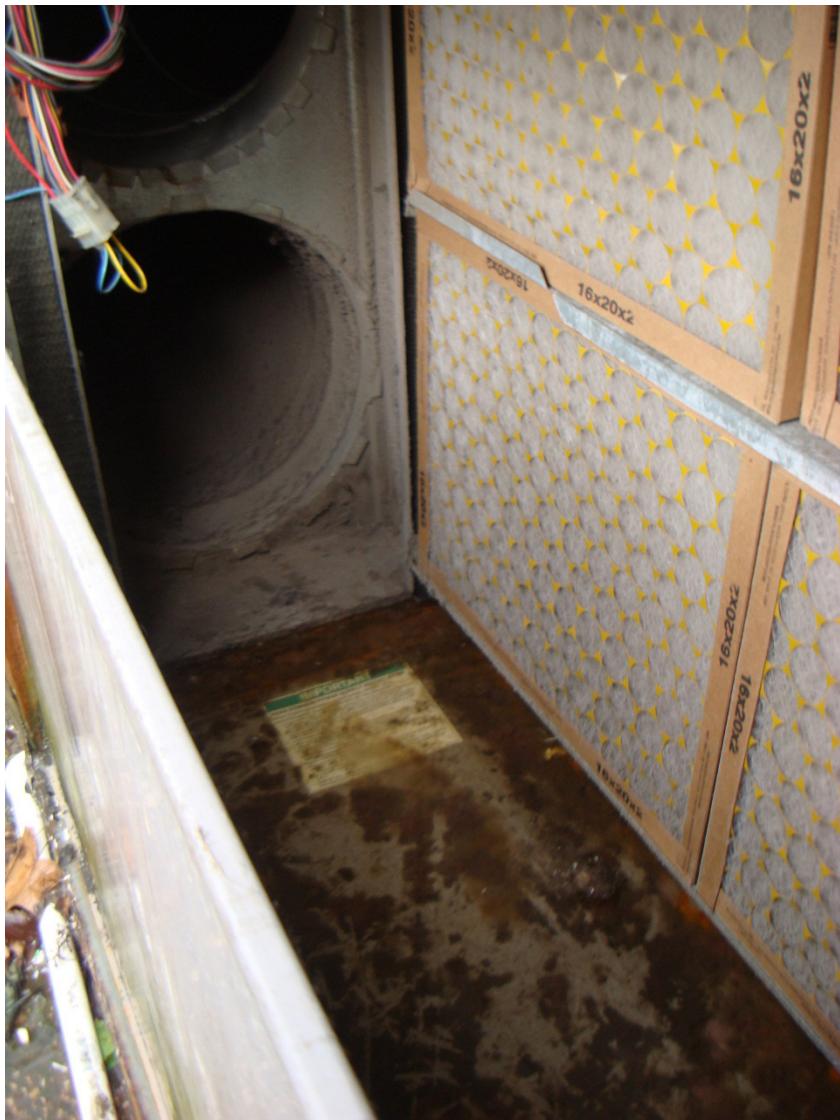
**Figure 2.** Standing water and apparent microbial growth in the drain pan of AHU Men-2.

- Determine and fix the cause of the standing water inside AHU Men-2. Develop a monitoring strategy to prevent further occurrences of water buildup within the unit.

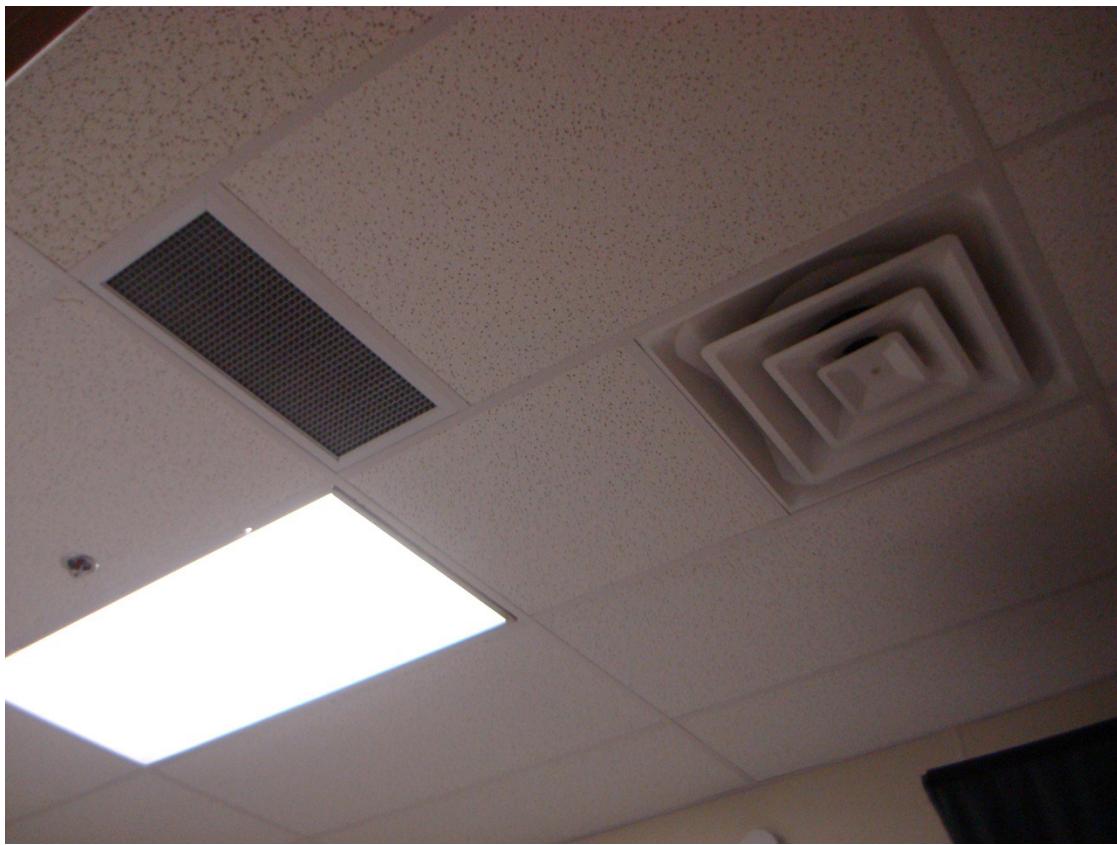
**Figure 3.** Supply vent and return grille in ceiling of family sleeping room #1 in the women's overnight facility. The close proximity of the supply to the return can result in short-circuiting of air, where supply air is immediately pulled into a return grille without providing any useful ventilation.

- Strategically reposition supply and exhaust grill locations to improve air flow patterns in occupied spaces, particularly in the women's overnight bunk area.
- Install the highest efficiency air filters possible that is consistent with the proper operation of the air-handling units.
- Modify at least one family sleeping room in the women's overnight facility for alternate use as a respiratory separation area.
- Develop and implement a written respiratory protection program that meets the requirements of the Occupational Safety and Health Administration's respiratory protection standard 29 Code of Federal Regulations 1910.134.
- Repair or replace non-functional bathroom exhaust fans.
- Develop and implement a written operation and maintenance plan for all complex heating, ventilation, and air-conditioning systems, to include a filter replacement schedule.

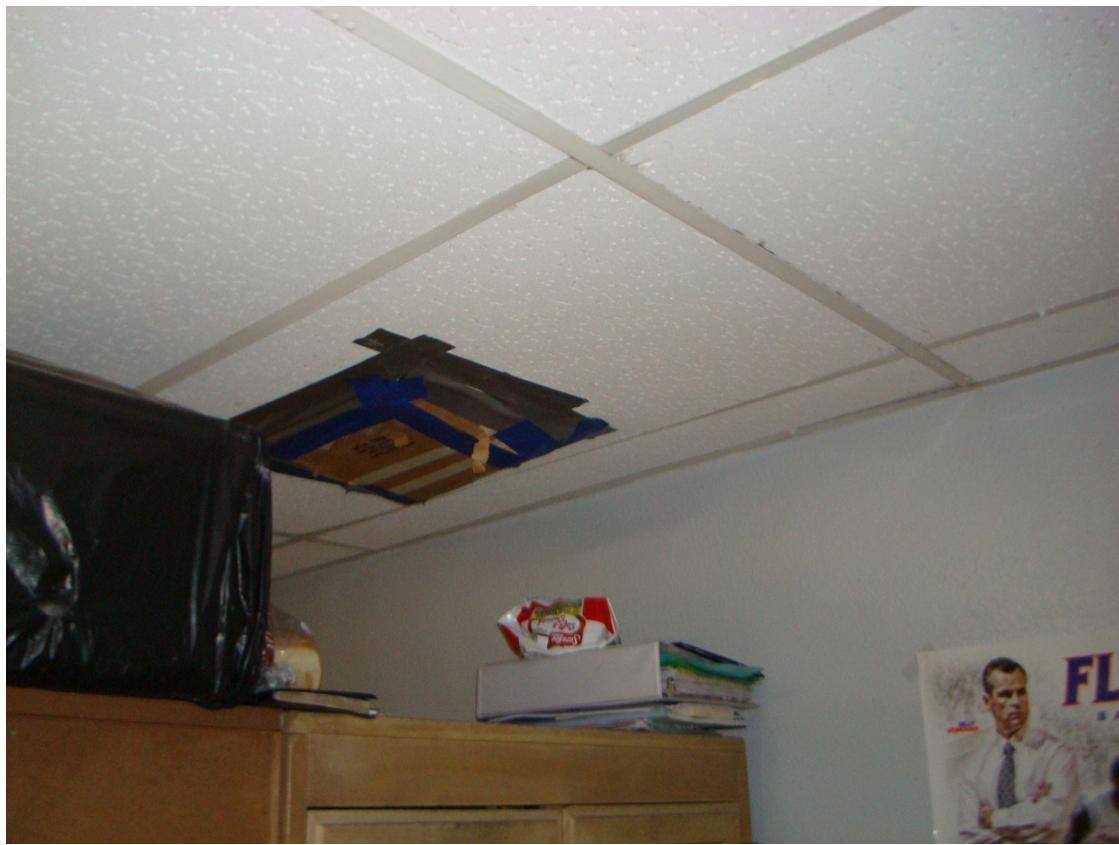
**Figure 4.** Supply vent covered with cardboard and tape in room #9 of the men's sleeping area.
