# Evaluation of Environmental Controls at a Homeless Shelter (City Rescue Mission–New Life Inn) Associated with a Tuberculosis Outbreak – Florida

Report No. 2012-0155-3180  
July 2013

U.S. Department of Health and Human Services  
Centers for Disease Control and Prevention  
National Institute for Occupational Safety and Health

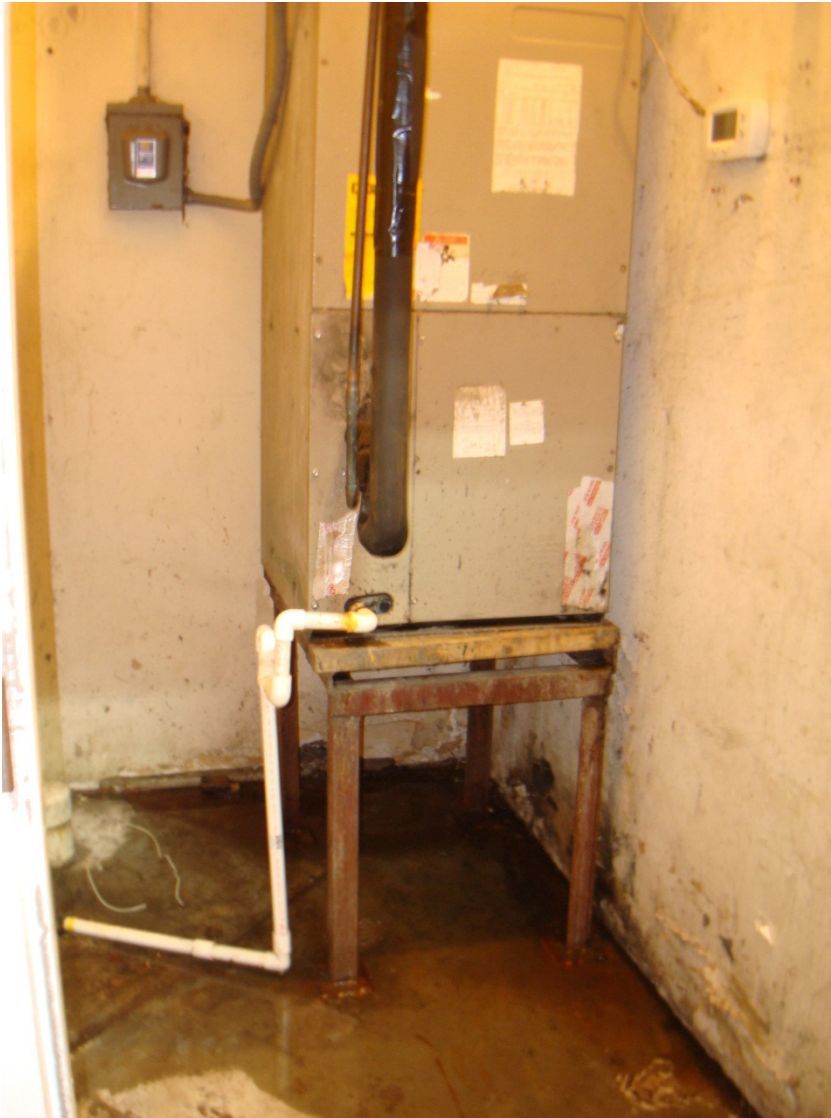
With the exception of the Annex, the mechanical spaces housing the AHUs were clear and free of clutter. All AHU air filters were changed just prior to the NIOSH visit. As shown in Table 1, AHU-1 did not have a filter installed in the unit itself. Four other AHUs had filter sizes/configurations that differed from manufacturers' recommendations. While these filters provided some filtration, the level was uncertain as the deviation from intended design provides ample opportunity for filter failure and bypass. On the day of our visit, all of the AHUs were operational and capable of maintaining temperature set points and air flow. However, there were some issues with controlling condensate from the cooling coils. AHU-1 on the first floor was dripping substantial amounts of condensate onto the floor of the mechanical room (Figure 1). Similarly, AHU-6 on the second floor was dripping condensate inside the mechanical room, including inside the return air ductwork of the AHU (Figure 2). Finally, the drain pan on AHU-8 (third floor) was completely full of water and was overflowing into the mechanical space (Figure 3). The excess moisture resulting from these condensate leaks is a recognized contributor to the development of microbial growth of public health concern [NIOSH 2013]. Proper slope of mechanical room floors, condensate pans, and clean unobstructed drain lines that route condensate into mechanical room floor drains should eliminate these moisture accumulation problems.

**Figure 1.** AHU-1 in the central mechanical room on the first floor of the shelter. The photograph shows standing water and apparent microbial growth due to condensate from the AHU leaking onto the floor of the mechanical room.

- Determine and fix the cause of condensate leaks with AHU-1, AHU-6, and AHU-8. Develop a monitoring strategy to prevent further occurrence of condensate buildup within the mechanical rooms.

- After the condensate issue in AHU-1 is resolved, install a proper filter in that unit, which serves the registration/lobby area of the first floor. The filter through the door into the mechanical room housing AHU-1 can stay in place to provide additional air filtration if desired, but a filter is needed in the AHU itself to protect against aerosols generated within or leaking into the mechanical space.

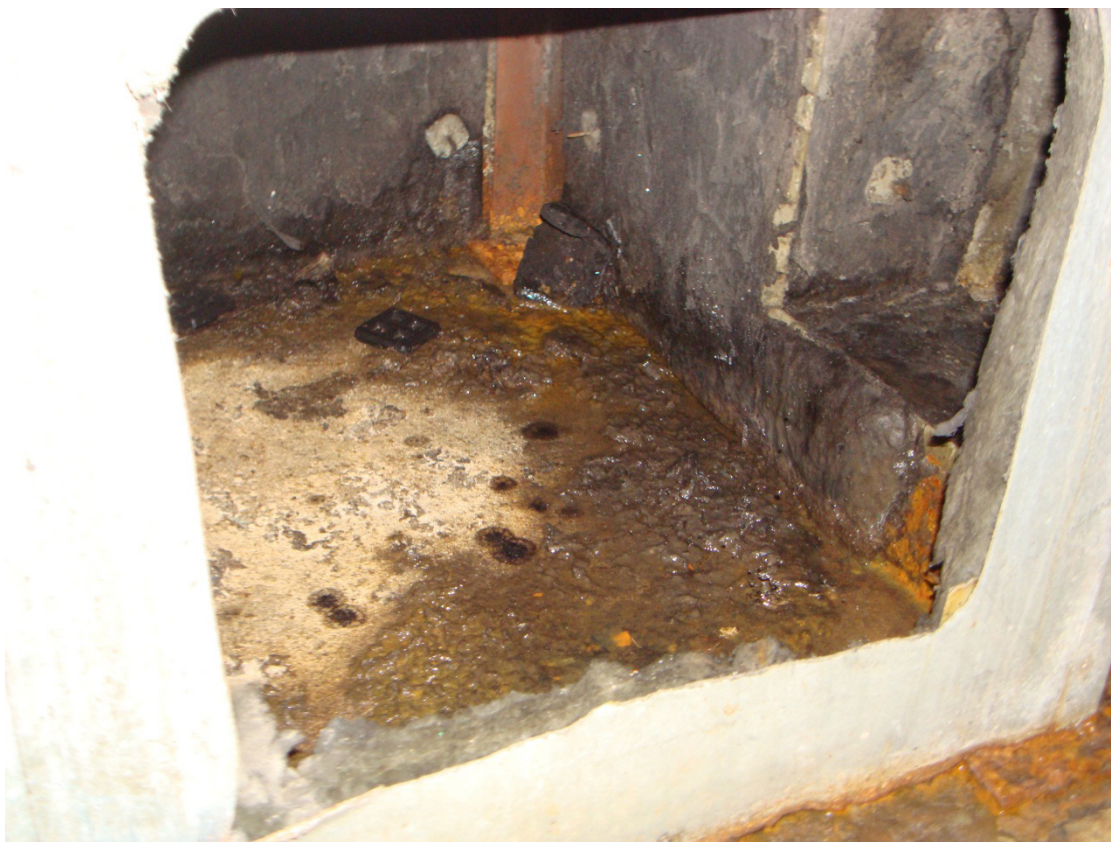
**Figure 2.** AHU-6 in the southeast corner mechanical room on the second floor of the shelter. The photograph shows condensate and debris in the return air plenum under the AHU.

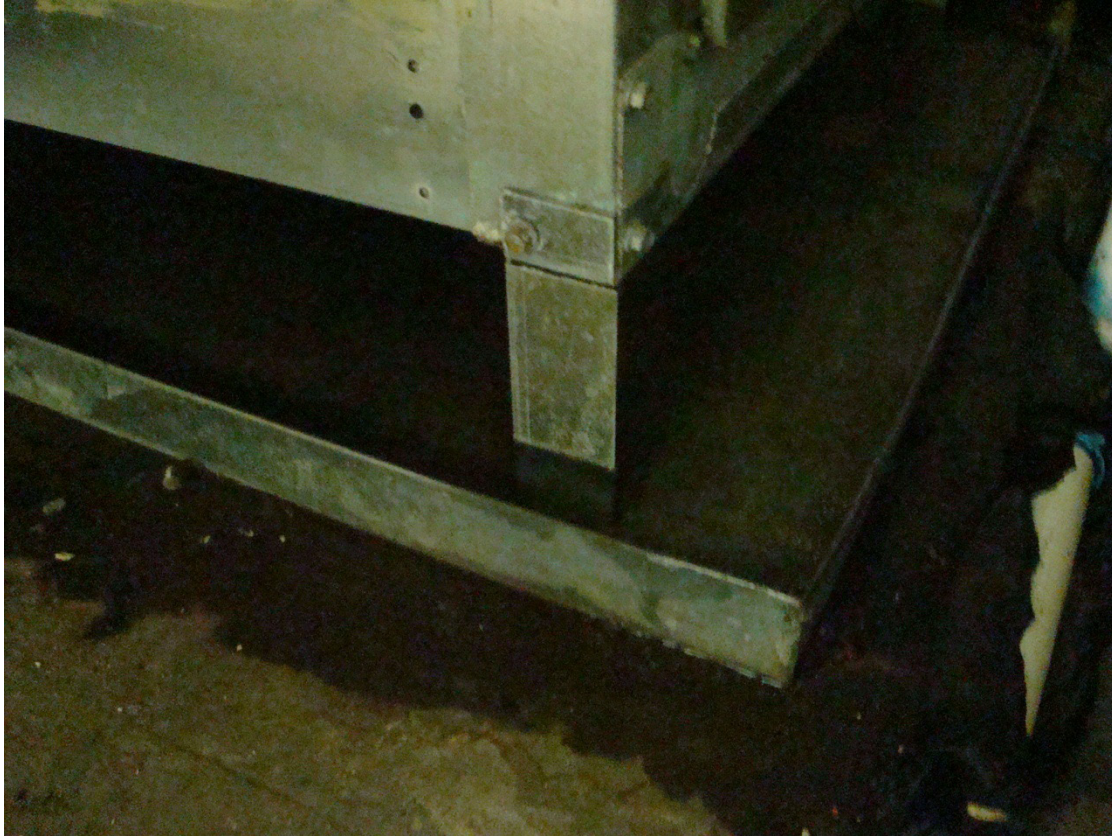
**Figure 3.** AHU-8 in the southeast corner mechanical room on the third floor of the shelter. The photograph shows a drain pan overflowing with condensate, which is covering the floor of the mechanical room.
