*AN INDUSTRIAL HYGIENE SURVEY*

*GSA PRINTING PLANT*

*CINCINNATI, OHIO*

PROJECT *JA 76-9*  
DATE OF REPORT: *12/2/75*

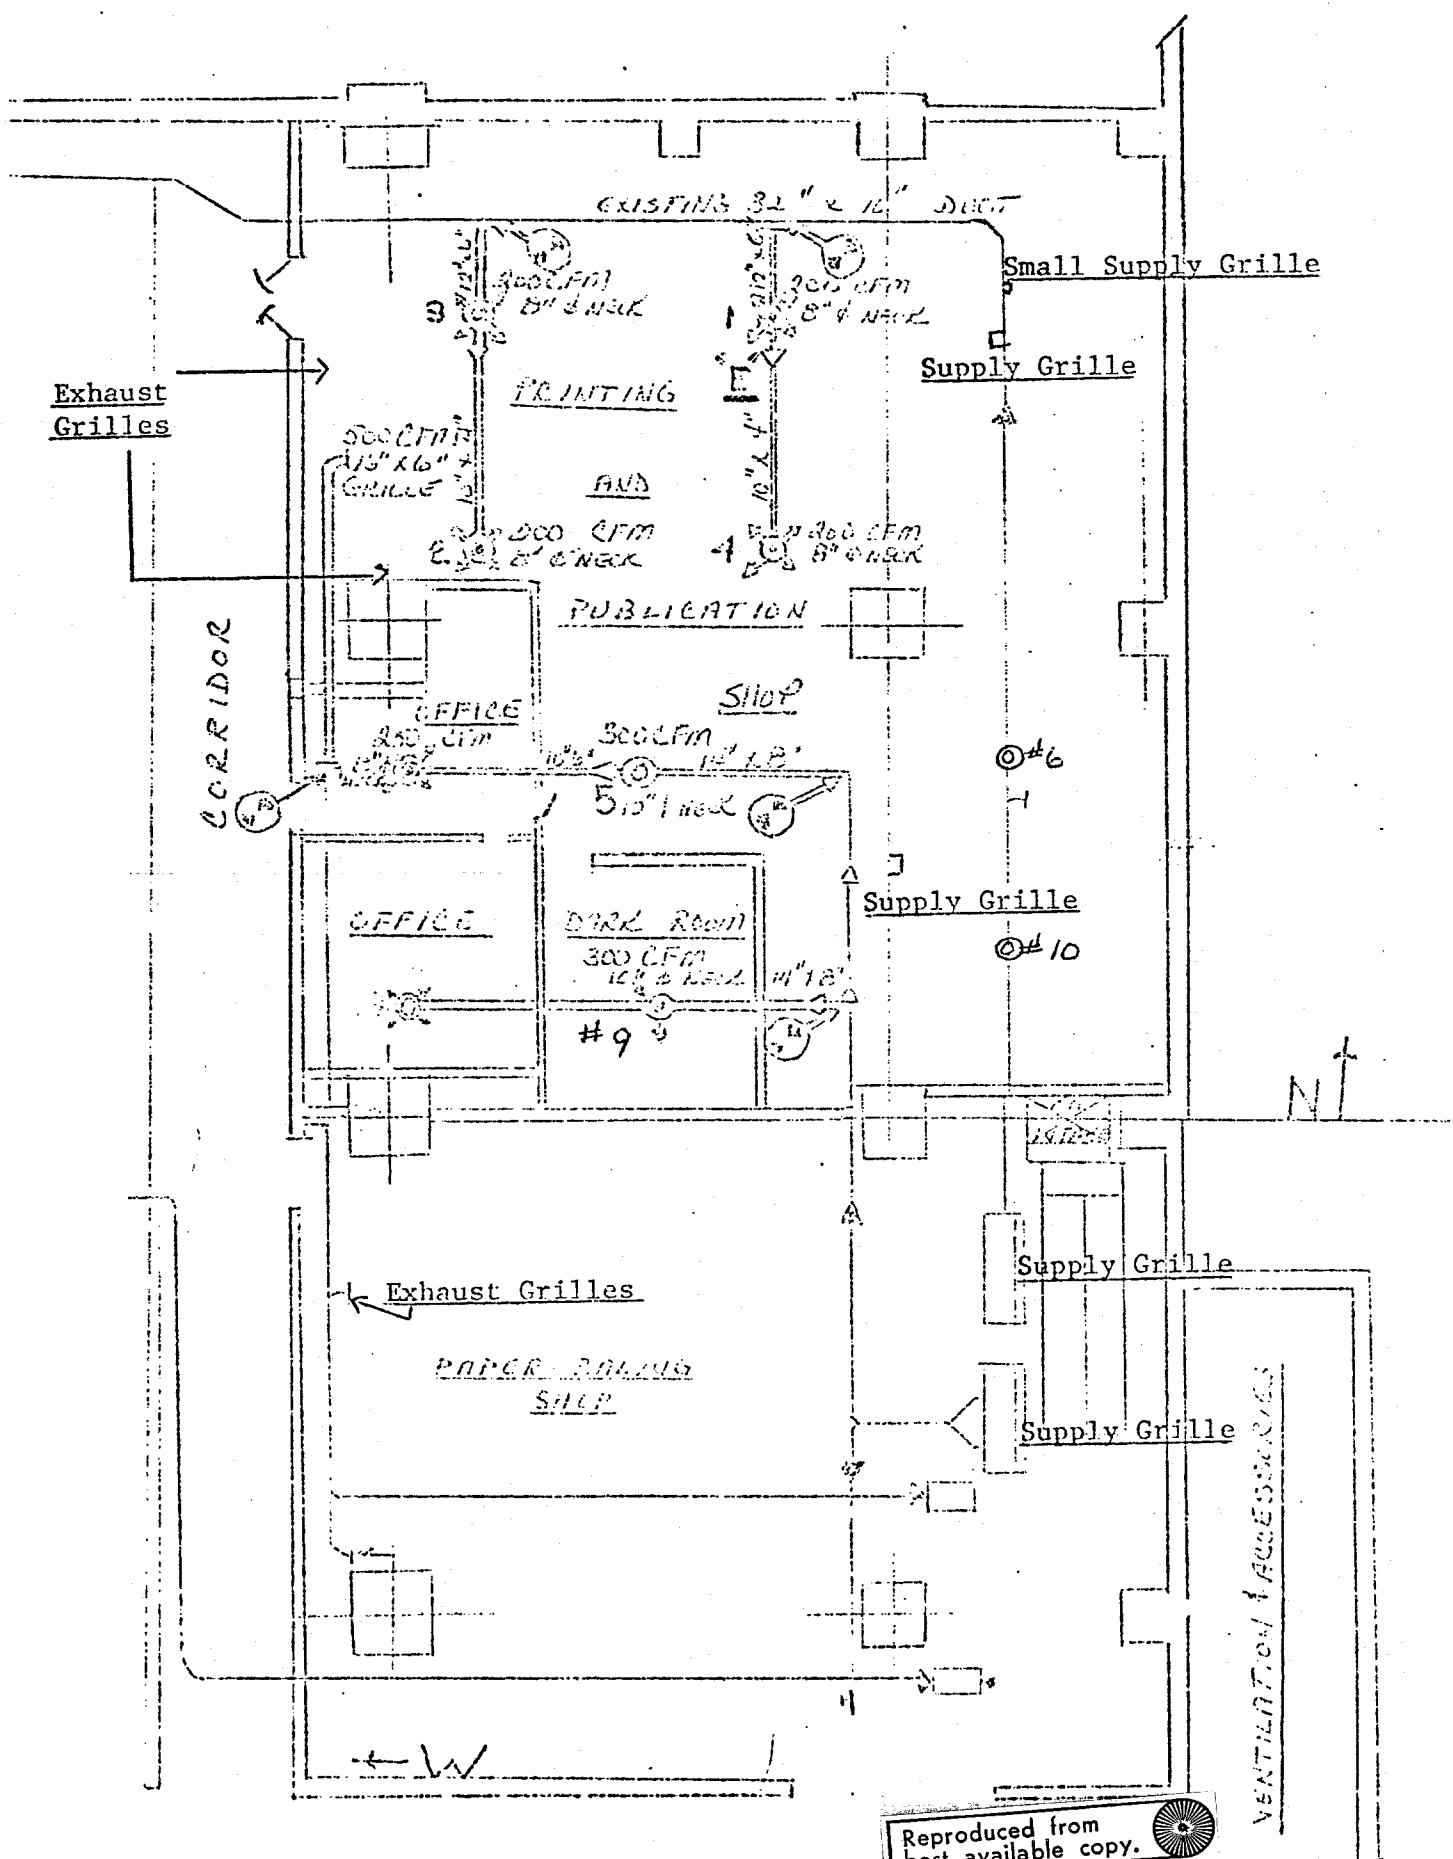
FIGURE 1  
GENERAL SERVICES ADMINISTRATION  
PRINTING PLANT  
FOB, CINCINNATI, OHIO

The GSA printing plant consists of a printing shop, paper baling shop (storage) and two offices. In the print shop approximately six (6) employees perform printing and related duties. During printing operations small amounts of benzene and perchloroethylene are used to clean the rollers on the multilith machines. The paper baling shop is used predominantly as a storage and plate making room. Employees are very seldom in this room. (Figure 1).

Samples were taken for carbon monoxide (CO) using an Ecolyzer, Model 2400. The Ecolyzer was located on a table top in the printing shop near Point "E". (Figure 1) Samples were also taken for nitrogen dioxide and carbon monoxide using Draeger length-of-stain detector tubes. (Tables 1 & 3)

A substantial amount of air which should be exhausted through ductwork located in the print shop is actually being exhausted by ductwork located in the paper baling shop. This is evidenced by the measurement of 2900 CFM in the doorway leading to the baling shop. As a consequence, air from supply grille #10 is being short-circuited into the paper baling shop. The even distribution of air into the print shop is decreased by this condition.

1. The inlet supply grille should be located at a minimum height of 25 feet above ground level.
2. The ventilation system for the printing shop should be balanced. Additional exhaust ducts should be installed and located to facilitate even air distribution.
3. All vehicle engines should be turned off during loading, unloading or while waiting.
