# Evaluation of Exposures to Styrene During Ultraviolet Cured-in-place Pipe Installation

Ryan F. LeBouf, PhD, CIH  
Dru A. Burns, MS

Report No. 2018-0009-3334  
March 2019

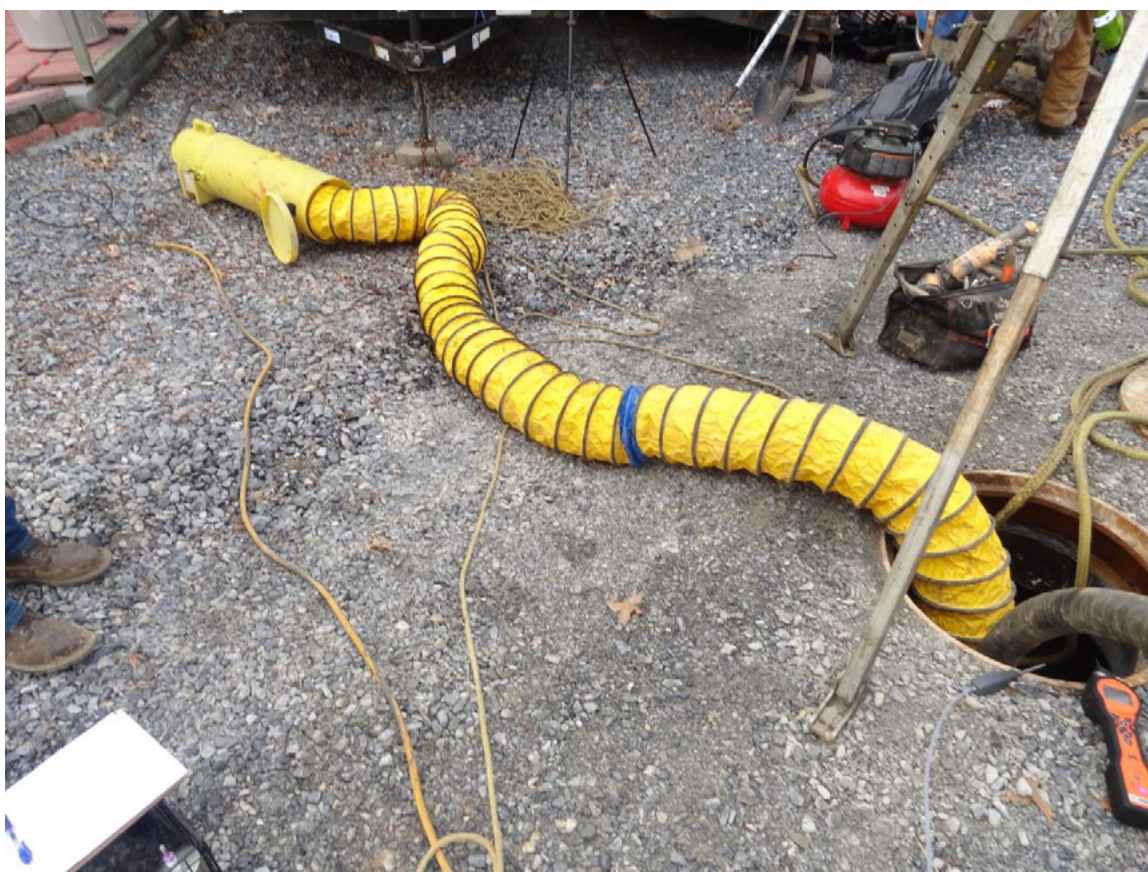
Figure 2. Manhole ventilation blower used to provide dilution ventilation to manhole during CIPP installation tasks, February 6, 2018.

The company reported immediately bagging excess liner and contaminated gloves to help control exposures to styrene. Ventilation of manholes was not part of the company's current practices; however, the company shared with NIOSH they were considering using a blower ventilation fan to help reduce styrene air concentrations in manholes.
