# Ergonomic Hazards and Controls for Elevating Devices in Construction

Christopher S. Pan, Sharon S. Chiou,  
Hongwei Hsiao, and Paul Keane

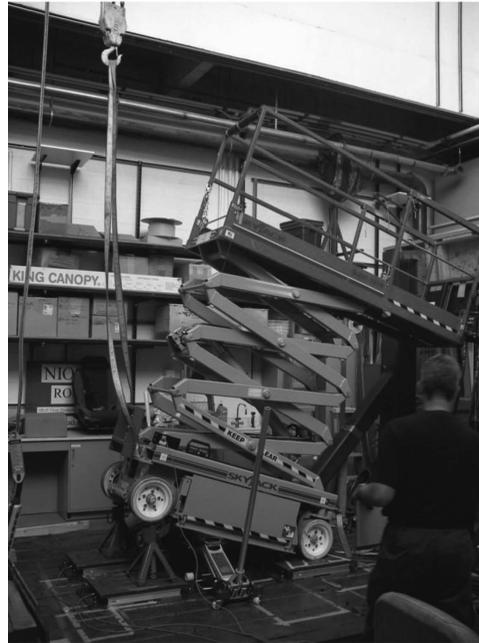
FIGURE 25.4 Center of gravity tests.

NIOSH has conducted research into various conditions of exposure related to the use of aerial lifts. Constraints on this research chiefly are found in conducting research that puts human subjects at risk of fall injury. NIOSH researchers have responded to this risk by conducting a significant part of their research in the form of computer simulation and modeling of various hazardous exposures. Preliminary computer model development was conducted using input from the static test results of the center-of-gravity and horizontal-stability tests from the standard promulgated by ANSI A92.6 (2006) [23]. Additional human subject tests were conducted to collect side force information for the computer model [15]. The center-of-gravity (Figure 25.4) and horizontal-stability tests (Figure 25.5) generated data for developing a computer simulation model for the SkyJack model 3219 with manufacturer's lift part mass/geometric information using the SolidWorks™ software program. The computer model was generated based on data from automated dynamic analysis of mechanical systems software (*ADAMS™* 2005, MSC Software Corporation, Santa Ana, CA). In order to calculate the center of gravity, four force plates (Bertec Corporation, Columbus, OH) were placed under the wheels of the scissor lift (Figure 25.4), and the lift was tilted using hand pump jacks and jack stands (Figure 25.4). Platform height

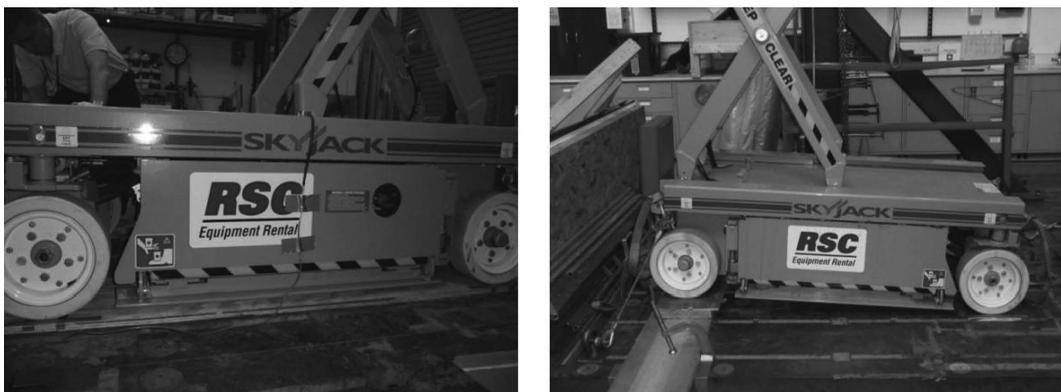
FIGURE 25.13 Lift tilting angles setup during the drop tests (1.5° on the left and 3.5° on the right).

Two fall conditions were tested: 6-foot falls and 11-foot falls. The latter represented a common misuse scenario, in which operators stand on the midrail. Fall arrest loads of 2400 lb were selected to exceed the ANSI Z359.1 standard, which calls for loads of 1800 lb. Various anchorage point locations were chosen in the platform. To determine the free-fall height for these tests, the lanyard attachment point to a fall arrest harness was assumed at approximately chest height for a 95th percentile worker, 53.7 in. (1.364 m) (MIL-STD-1472D, 1989). Total fall height was 139 in. (3.53 m) when anchored to the midrail and 122 in. (3.10 m) when anchored to the toprail. The scissor lift maintained structural and dynamic stability for all drop tests under various test conditions (Figure 25.13).

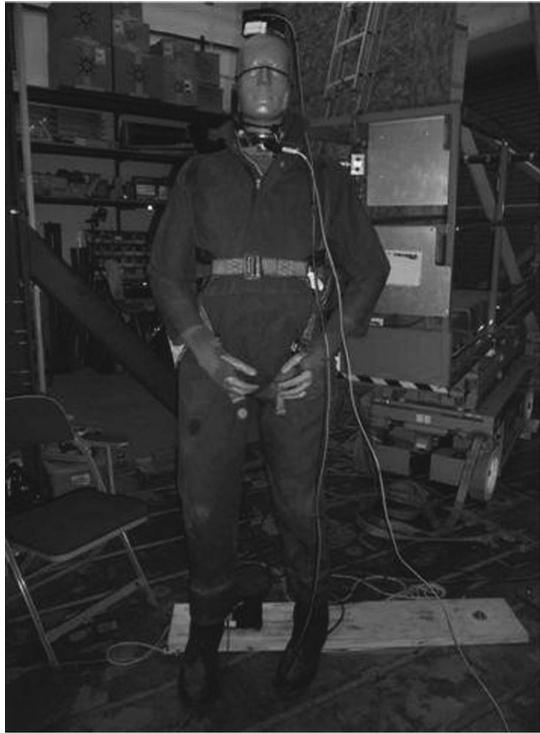
FIGURE 25.14 The advanced dynamic anthropomorphic manikin (ADAM) system.

This study measured drop forces on an anthropomorphic manikin (ADAM™, Veridian, Dayton, OH) (Figure 25.14) under loads mediated by four safety harnesses. Acceleration forces were measured by embedded triaxial accelerometers (Kionix, Inc., Ithaca, NY), which were positioned at three locations—head, middle of spine, and torso. A load cell

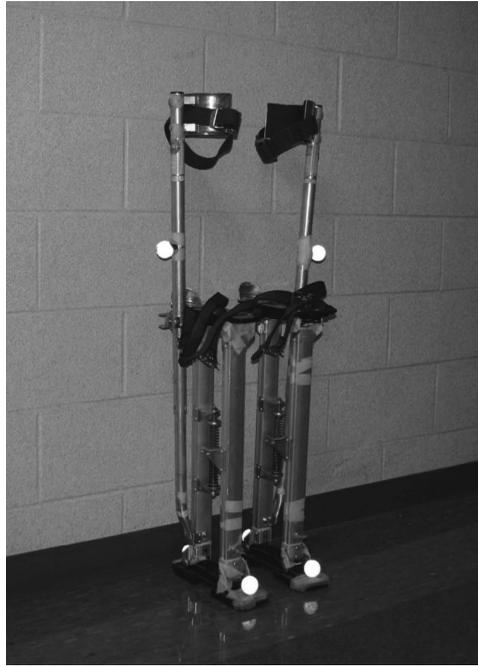
FIGURE 25.15 Construction stilts with four reflective markers attached to each side for motion study.
