The Impact of Maintenance and Design for Ventilation Systems

National Institute for Occupational Safety and Health, Cincinnati, Ohio

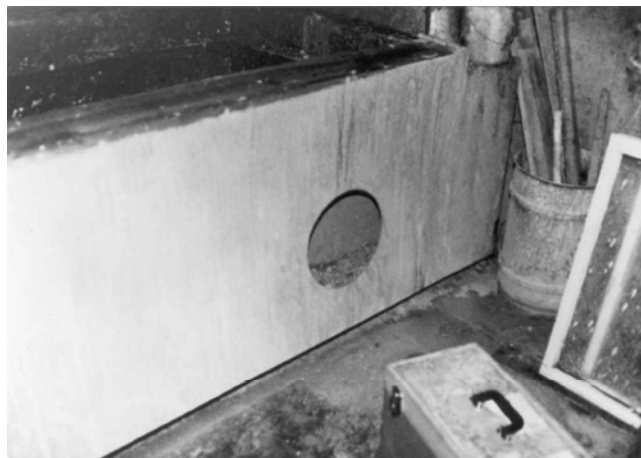
FIGURE 2

Hole in front plenum showing debris in the plenum. Holes were covered to provide subsequent access.

The dip tank ventilation system was modified before the third survey to rectify the problems with the system. The exhaust plenums were cut out and hinges were added near the slots so that they could be opened for cleaning (Figure 4); two 10-inch diameter access holes were also made toward the bottom of each plenum for cleaning (Figure 2); the T-duct fan outlet was replaced with a 90° wide-sweep duct to reduce static pressure losses and because it was rusted through; and the weather cap was replaced with a vertical discharge outlet to reduce static

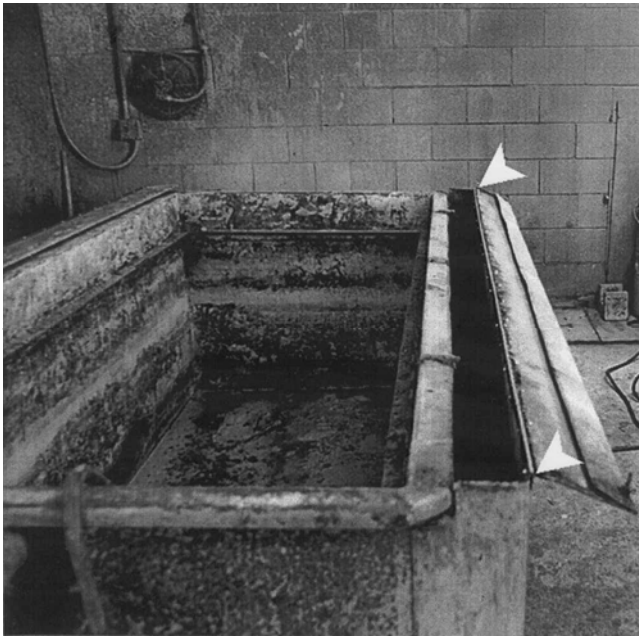
FIGURE 4

Hinges (shown at arrows) added to the exhaust plenums for opening slots to aid in cleaning.

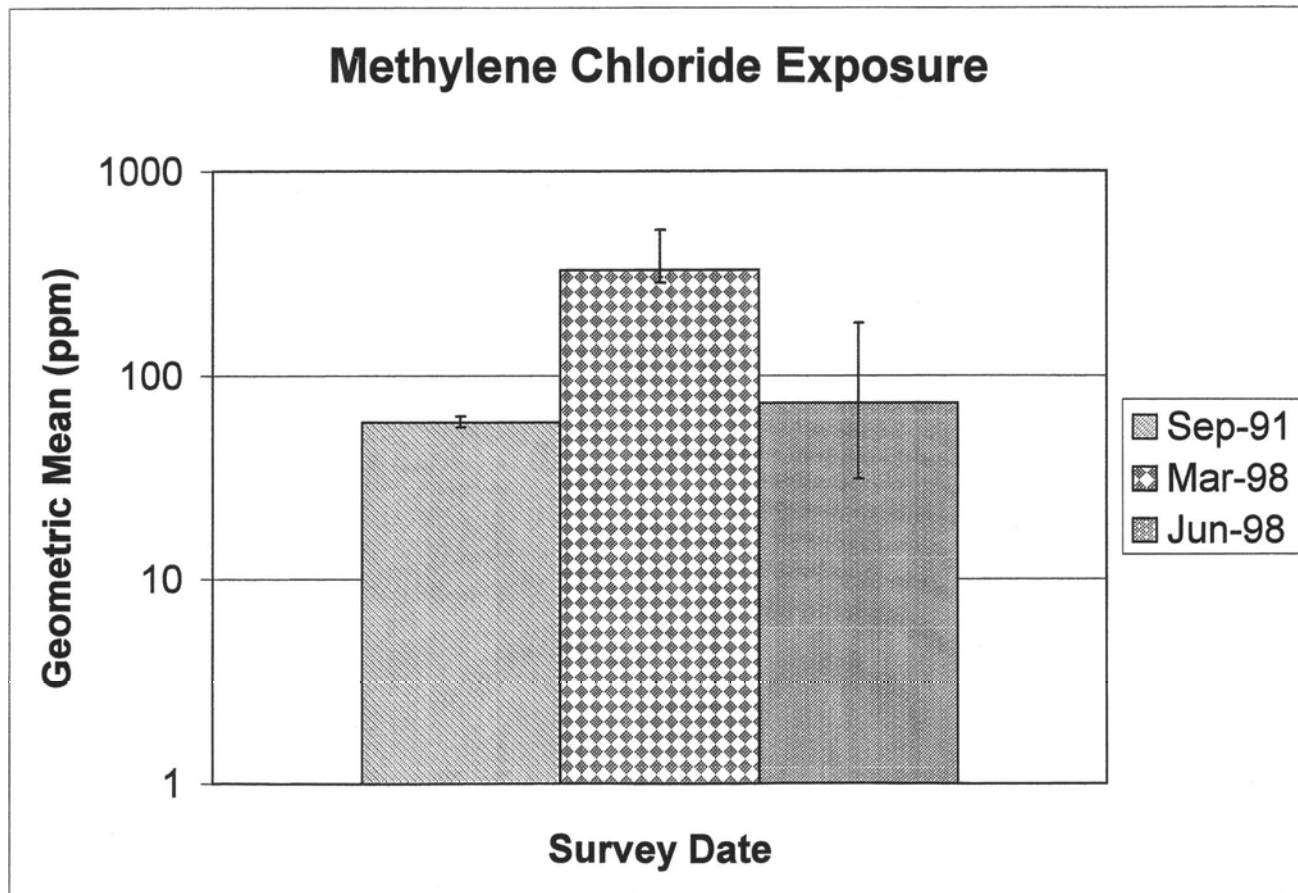
FIGURE 5

Graph of methylene chloride worker exposures during the three surveys.

Methylene chloride personal breathing zone and area sample results for the surveys are shown in Table I. Figure 5 shows the workers' exposures over the three surveys. Personal breathing zone results show a substantial increase from the first (59 ppm) to the second survey (332 ppm). Because of nonoverlapping 95 percent confidence intervals, the survey two breathing zone geometric mean exceeds the survey one breathing zone geometric mean at least with 90 percent confidence. A statistically significant reduction of 78 percent (CI 45%, 91%; $p = 0.0036$) was shown between the second and third (73 ppm) surveys. Exhaust volumes and air velocities show the opposite pattern (Table II). Exhaust volume decreased between the first (2900 cfm) and second (1060 cfm) surveys, followed by an increase during the third (2075 cfm) survey.

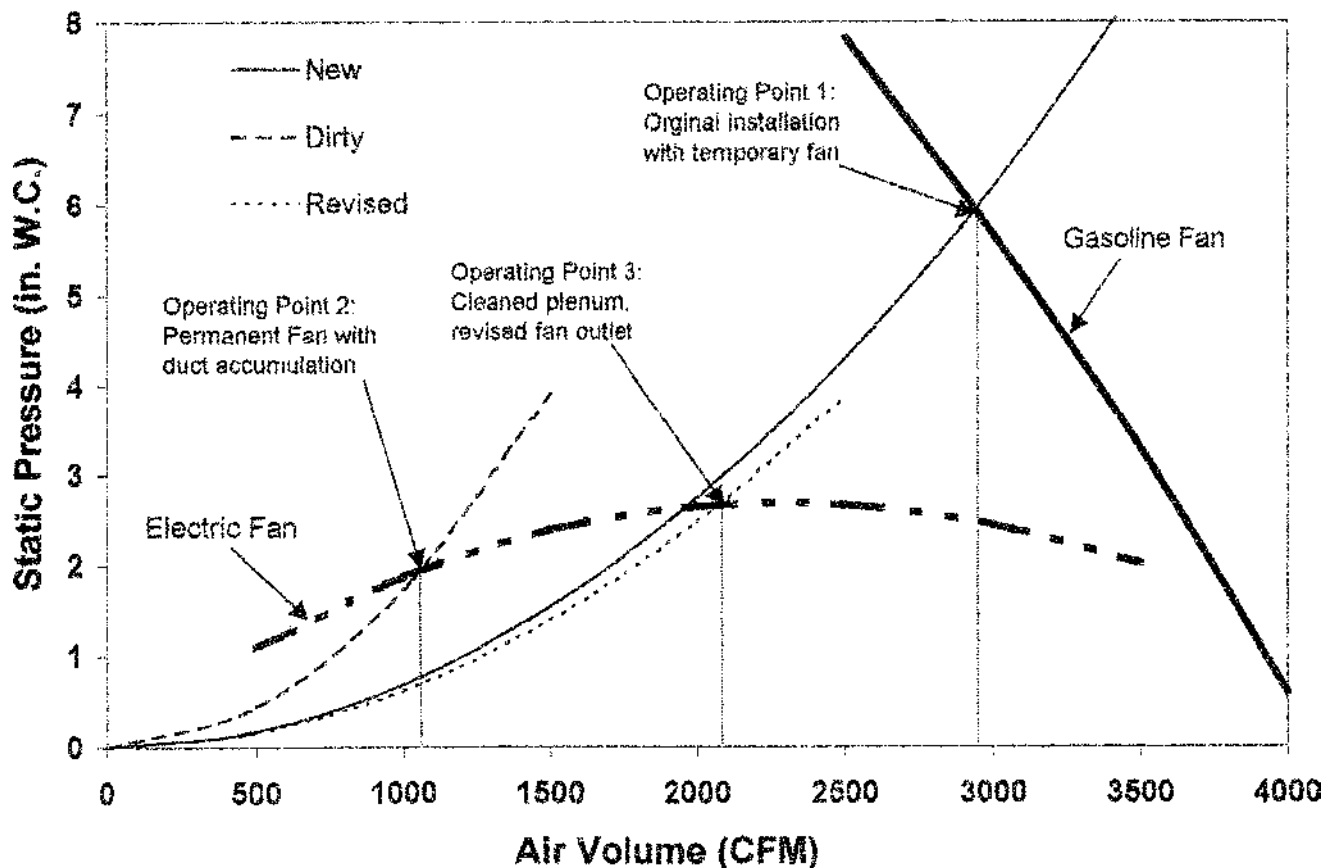
FIGURE 6
Fan and system changes.

Figure 6 illustrates the history of the fan and duct system installed at the furniture stripping facility. The first survey was conducted at the conditions indicated in Figure 6 (operating point 1). During this study a gasoline-powered fan was utilized as an air mover. The design flow rate was 2900 cfm at fan static pressure of 5.5" WC. This fan was selected so that the point of operation would be located at a point on the fan performance curve with a steep negative slope, so that any misestimation of pressure loss would result in a relatively minor change in flow. The gasoline-powered fan was installed as a temporary measure, as the owner did not want to invest the needed capital for what was then a yet-to-be-proven benefit.

but no fan curves.) Under ideal conditions, the fan selected would have exhausted approximately 1900 cfm from the stripping tank. Unfortunately, the operating point of this fan/duct system was located near the top of the fan performance curve. The result of this selection was a system that was extremely sensitive to increases in pressure. Measurements taken during the second study at this facility indicated that the system operating point had shifted due to the buildup of materials in the duct and plenum (operating point 2, Figure 6). For the third study, the modified fan outlet design, together with the duct cleanup made possible by the addition of the access ports, resulted in an increase in flow volume to 2100 cfm (operating point 3, Figure 6).

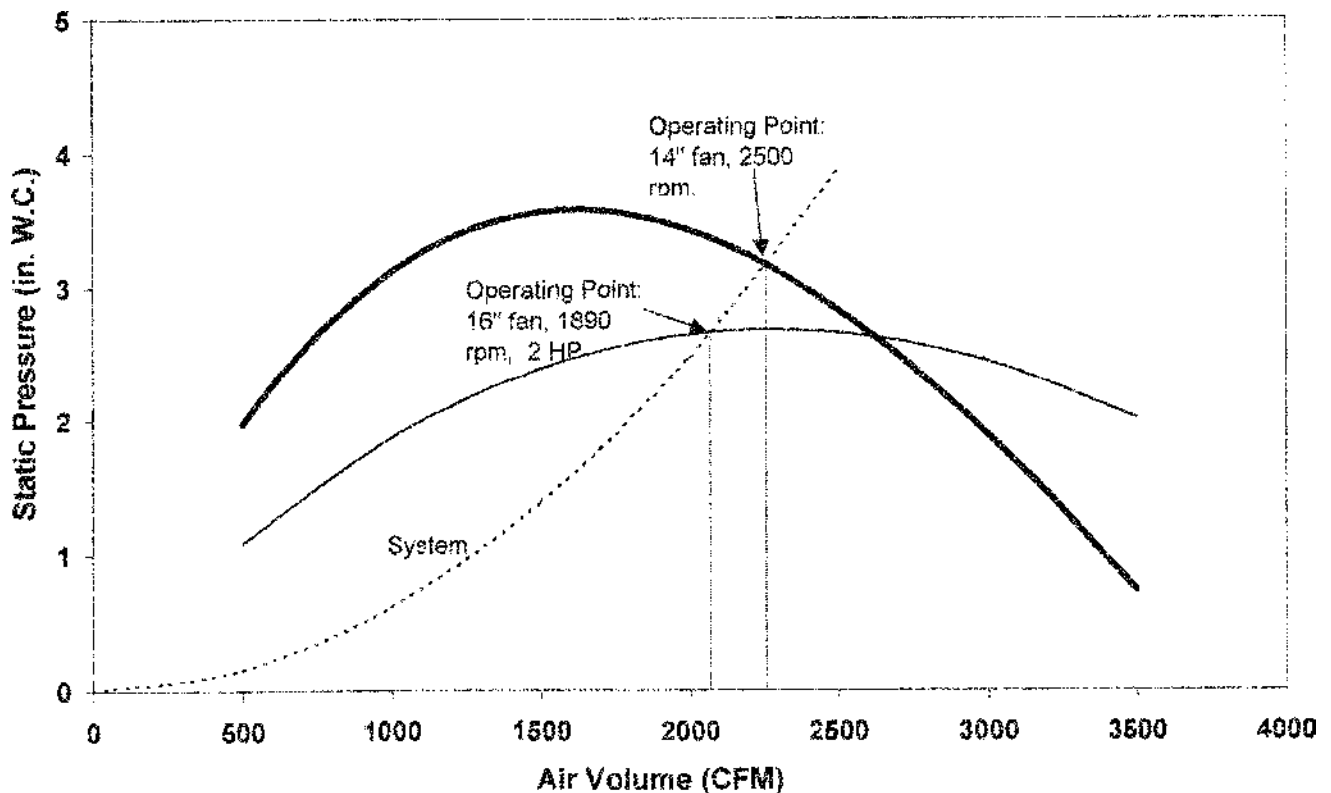
FIGURE 7

Enhanced performance with a smaller fan.

Figure 7 contains the system curve and fan performance curves for the 16 inch, 1890 rpm fan used during the second and third surveys, and a smaller, 14 inch, 2500 rpm fan, both utilizing 2 HP, single-phase motors. Figure 7 demonstrates that, had the smaller, higher speed fan been selected, the total flow would have been increased by about seven percent over the larger unit, and a more stable operation would have been achieved. The lesson learned: If no fan curves are available, plot your own—the smaller fan would have performed better at a lower first cost!
