Applied Occupational and Environmental Hygiene

Respirable Concrete Dust—Silicosis Hazard in the Construction Industry

Kenneth D. Linch

Division of Respiratory Disease Studies, Surveillance Branch, National Institute for Occupational Safety and Health, Morgantown, West Virginia

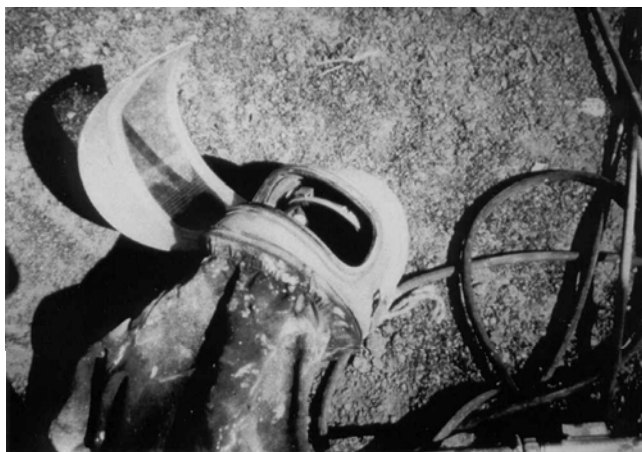
FIGURE 1

Altered type CE continuous flow abrasive blasting respirator.

Table I summarizes the concrete abrasive blasting samples for this study. Samples 1–3 were obtained during sandblasting of a concrete wall outdoors. Samples 4–7 and 15–22 were obtained during sandblasting of prestressed concrete building structures inside a ventilated blasting shed. Samples 8–14 were obtained during abrasive blasting of the steel structure under a bridge. Coal slag was used as the abrasive in an unventilated curtained enclosure to abrasive blast the steel structure and presumably the surrounding concrete. Samples 8–14 in Table I indicate a potential for quartz concentrations to exceed the assigned protection factor (APF = 25)⁽⁷⁾ for the continuous flow type CE respirator being used.

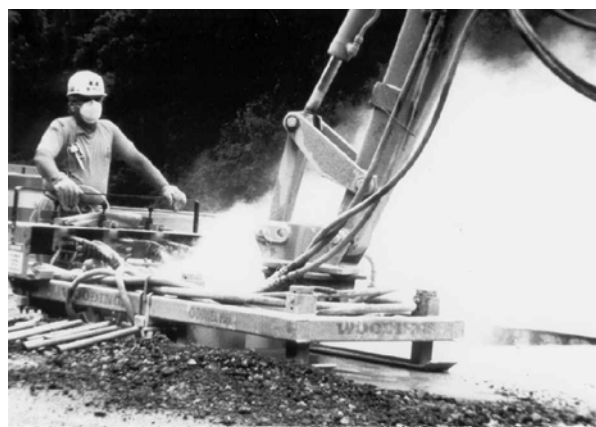
FIGURE 2

Table II presents data from two interstate highway construction sites (samples 1–8 and 9–22) where this concrete drilling procedure was being performed. In Figure 2, a laborer is seen stationed at the pneumatic drills. A heavy equipment operator is stationed in the cab of the backhoe (not seen, but off to the right in Figure 2). Typically, this drilling is done dry without any dust control. Clouds of dust can be seen drifting from these types of operations. The laborer at the controls of the drill works in higher dust concentrations than the operator of the backhoe; however, the laborer can, at times, move out of the direction that the dust is moving, while the operator has to sit in the cab.

Drilling dowel holes into concrete pavement.

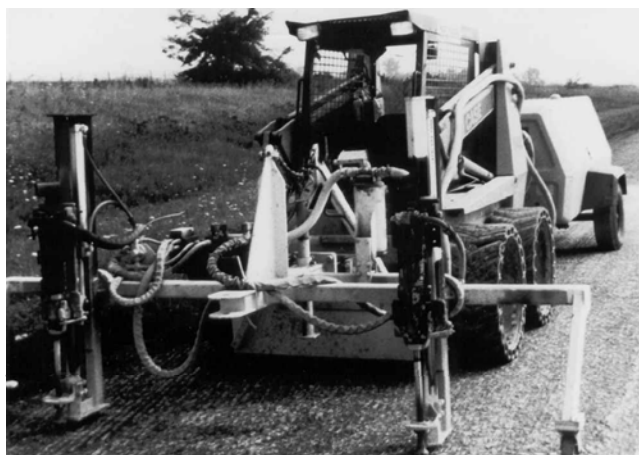
Figure 3 shows two pneumatic drills mounted on a piece of mobile equipment so that vertical holes can be drilled into blocks of concrete pavement. The holes were used to attach a gripping device so that a small crane could lift the concrete block out of the pavement.

FIGURE 3
Two pneumatic drills mounted to mobile equipment being used to drill concrete pavement.

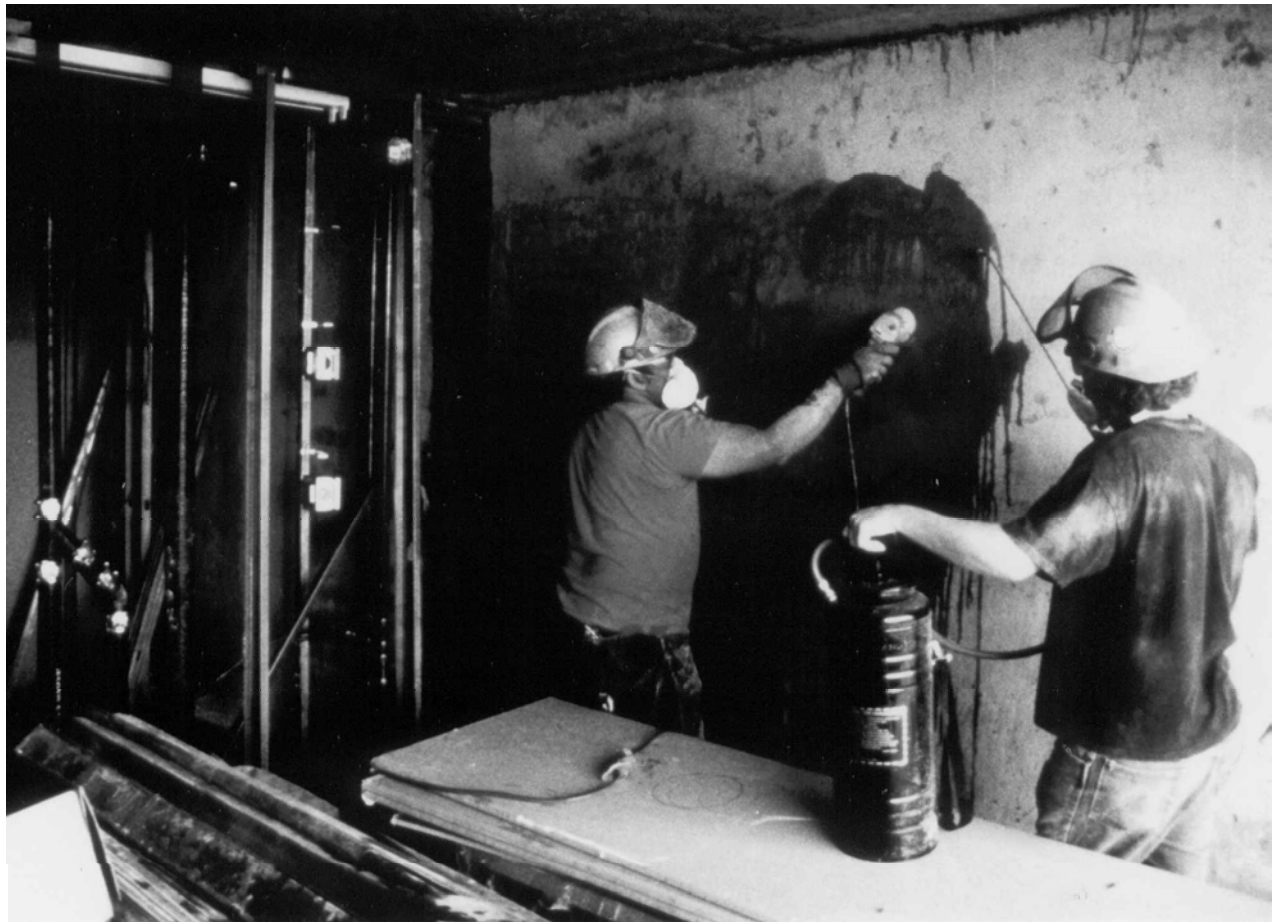
FIGURE 4

Wetting concrete wall during grinding without local exhaust ventilation.

Samples 7–14 in Table III were obtained during wet grinding. Separate personal breathing zone samples were obtained for the grinder and for the helper. The helper used a new, clean, pesticide-type spray can filled with tap water to wet down the surface of the concrete wall just ahead of where the worker using the grinder was working (see Figure 4). For the grinder, the 342-minute personal breathing zone sample indicated a respirable dust concentration of 0.36 mg/m³ and a respirable quartz concentration of 0.02 mg/m³, which was between the limit of detection and limit of quantification for the sample. For the helper, the personal breathing zone sample indicated a respirable dust concentration of 0.16 mg/m³ for the 225-minute sample duration. Respirable quartz dust was not detected. To be detected and quantified, at least 0.01 mg and 0.03 mg of quartz, respectively, must have been on the filter. The two high-volume area samples (9.0 L/min.) indicated respirable dust concentrations of 0.16 and 0.26 mg/m³ and respirable quartz concentrations of not detectable and 0.02 mg/m³, respectively. The data indicate that the respirable quartz concentrations were low but measurable during full-shift sampling. Sample time for the grinder

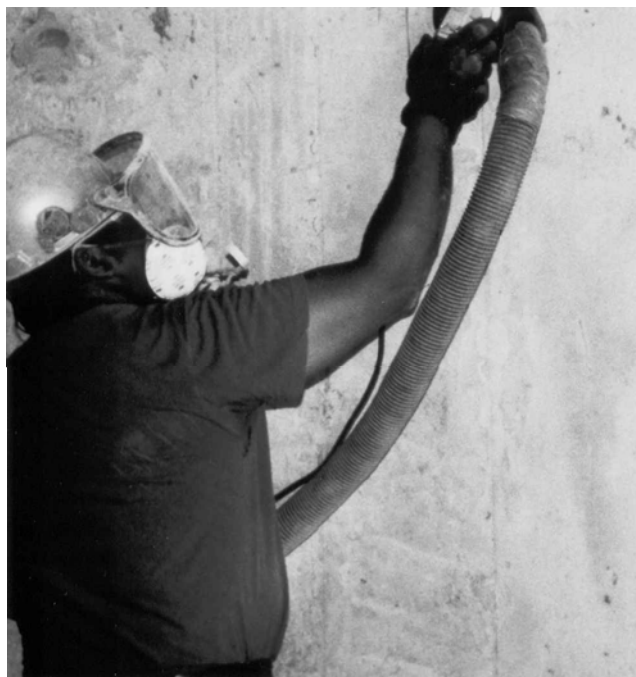
FIGURE 5

Three different local exhaust dust control systems were used (Micro mini-vac, Maxi-vac, and WAP) (see Figure 5). Micro mini-vac and Maxi-vac are two vacuum-type dust collection systems that were made by the same manufacturer. Table IV summarizes the exhaust control system sampling data.

Local exhaust used on a concrete grinder with four-inch disk.

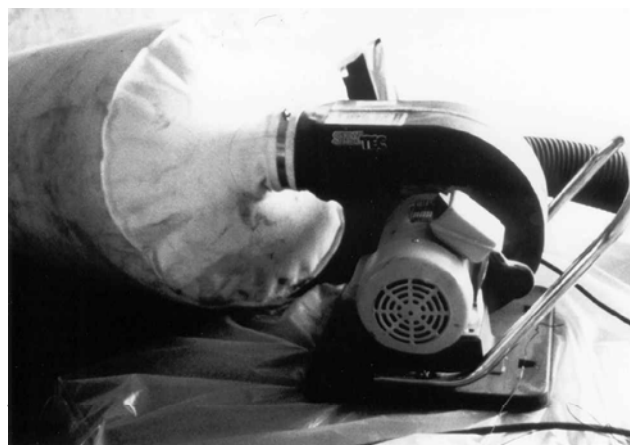
FIGURE 6

Micro-mini vacuum.

Samples 1–6 in Table IV were obtained while using a dust collection system sold by SawTec named the Micro mini-vac. The system weighs approximately 46 pounds, is 14"W × 52"L × 16-1/2"H and produces 760 CFM air flow at 8.5" maximum static pressure according to SawTec. The vacuum has one 4" inlet for a flexible tube. The system uses a bag to collect the suctioned dust. Information with the equipment states that the bag "filters concrete dust to 0.5 micron" (see Figure 6). A metal shroud was attached to the grinder, and a flexible tube connected the vacuum to the shroud. Neither respirable quartz nor respirable dust were detected by the 127-minute personal breathing zone sample. Due to tool and/or system problems the estimated grinding time was 77 minutes. The high-volume area sample (9.0 L/min.) indicated a respirable dust sample concentration of 0.66 mg/m³ and a respirable quartz sample concentration of

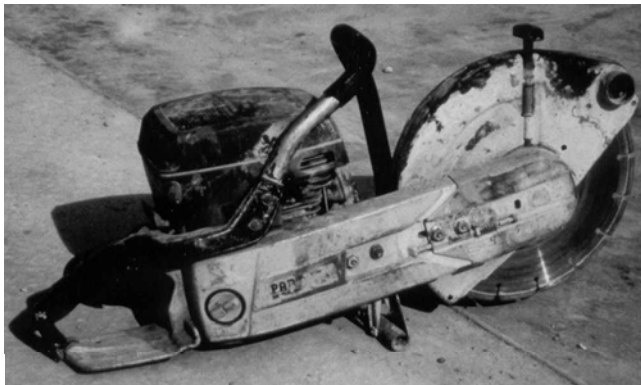
**FIGURE 7**

Table V summarizes the concrete sawing data. Samples 1–4 were obtained at an office building remodeling project. A worker used a gasoline-powered handheld masonry saw (see Figure 7) to saw indentations in the concrete floor on each of the 16 floors of the building so that restroom floor drains could be installed. The concrete cutting was done by a plumber. The saw was used without water being applied to the blade or using a dust collector. The only attempt to control the dust was with the use of a floor stand fan directed toward an open window. The investigators found a respirable concentration of quartz for the concrete cutter operator of 14.0 mg/m^3 during a 350-minute sample. The area samples for this operation were found to be 4.1, 3.4, and 3.2 mg/m^3 respirable quartz. Three bulk samples of the concrete dust were found to be 38, 47, and 43 percent silica.

Hand-held gasoline powered concrete saw.

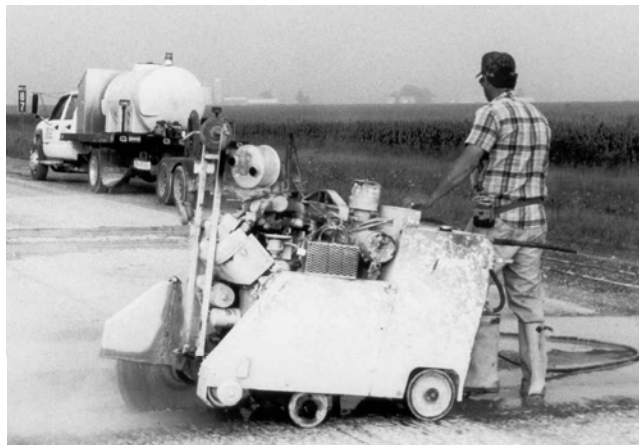
**FIGURE 8**

could be poured (see Figure 8). This operation consisted of two workers operating two concrete saws to saw blocks of concrete pavement. Each of the saws was equipped with a water supply that provided water to the diamond-tipped saw blades. For each saw, water was obtained from 725-gallon water tanks mounted on trucks. The water source for the two saws was under pressure from 3.5 and 4.0 horsepower water pumps. The workers did not use respirators.

Walk-behind concrete saw with water truck.

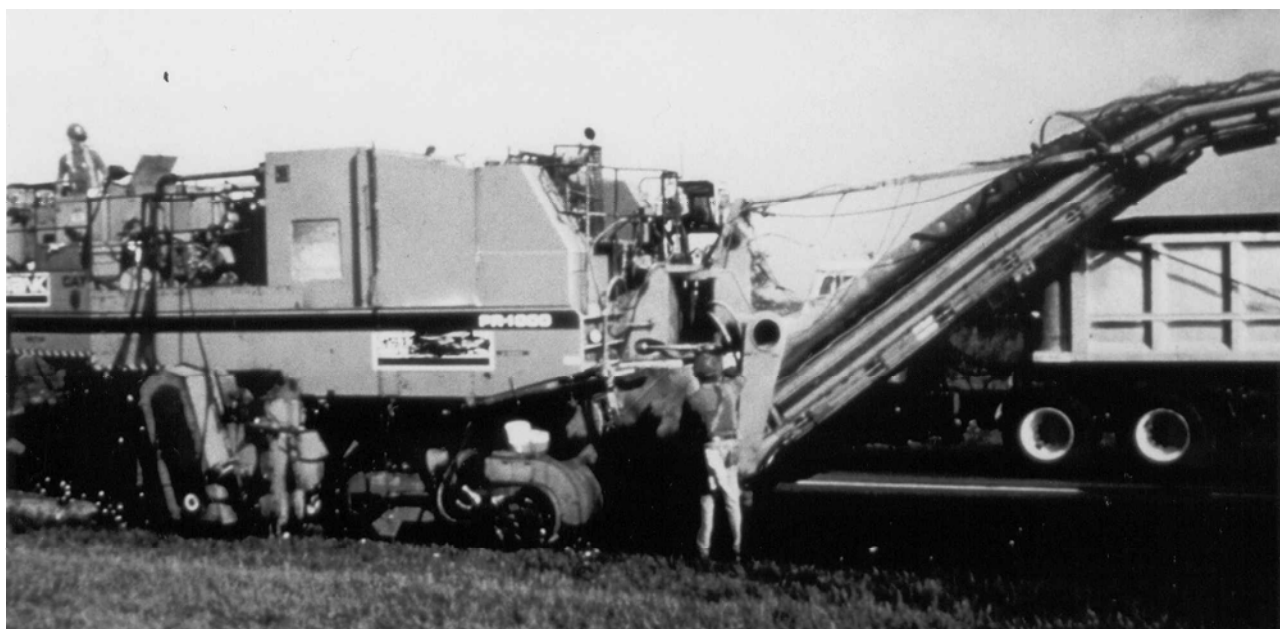
**FIGURE 9**

Table VI summarizes data obtained during two shifts of asphalt milling. This operation consisted of three workers operating an asphalt mill to remove old asphalt from an interstate highway (see Figure 9). This machine operates similarly to the continuous mining machines used in coal mining with a

horizontal drum studded with carbide bits and a water spray system to wet down dust. The mill is set to remove a predetermined depth of asphalt or concrete. For the operation reported here, the entire thickness of asphalt was removed from the underlying concrete pavement, thereby abrading the concrete surface in the process. The operator spent almost all of his time on top of the mill in the open. A laborer spent his time walking alongside the machine, as did the foreman. None of the workers used respirators.

Asphalt/concrete mill.

The results show that the laborer walking beside the machine was being exposed to respirable quartz at levels above the NIOSH REL and the OSHA PEL. The mill was provided with water from a water truck. During these types of operations maintenance of the water spray system is essential to assure that it is working as intended. Possible problems may include spray nozzle misalignment or water not being provided at high enough pressure. Dust may leak out the sides of the machine, and
