RI 9455

REPORT OF INVESTIGATIONS/1993

Blast Vibrations and Other Potential Causes of Damage in Homes Near a Large Surface Coal Mine in Indiana

By David E. Siskind, Steven V. Crum, and Matthew N. Plis

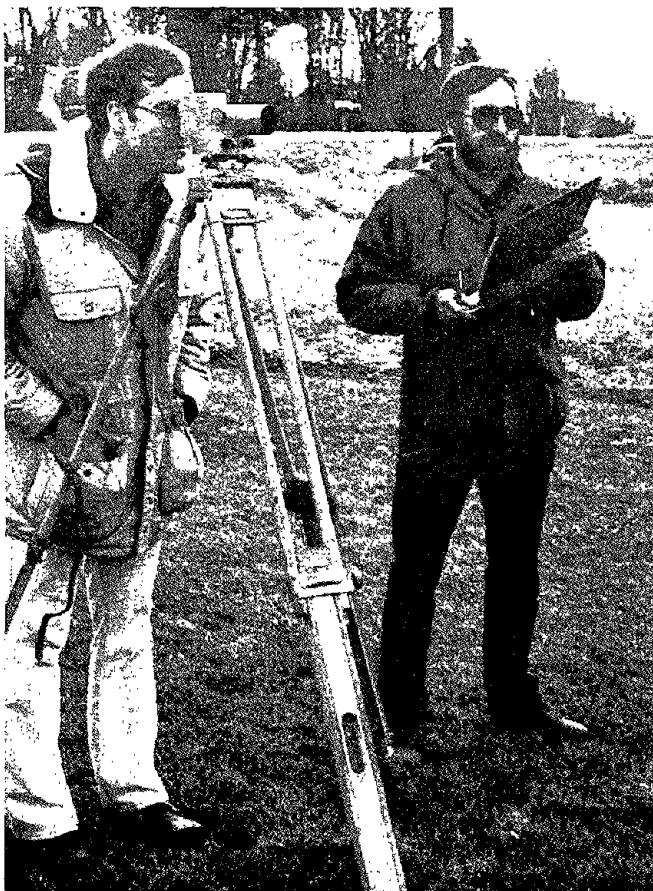
Figure 12.—Survey crew performing level-loop analysis.

A review was made of the 115 homes inspected and catalogued by OSM. Of these, 16 were selected as candidates for instrumenting and preliminary level-loop surveying (fig. 12). Selection criteria were based on representative samples for both damage condition and location. Regular accessibility was important for both damage inspections and access to instrumentation. In McCutchanville, two homes were selected that were located on east-facing slopes (toward the mine), for maximum airblast-induced structure responses. The full 2-month inspection and

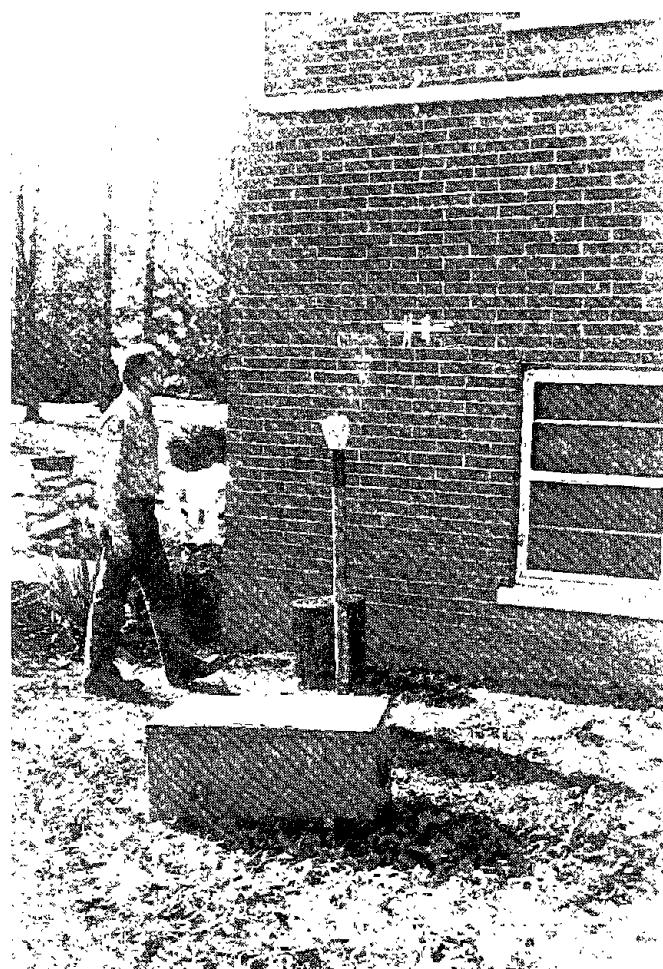
Figure 23.—Displacement gauge placed across outside crack in house 108 prior to Bureau's study.

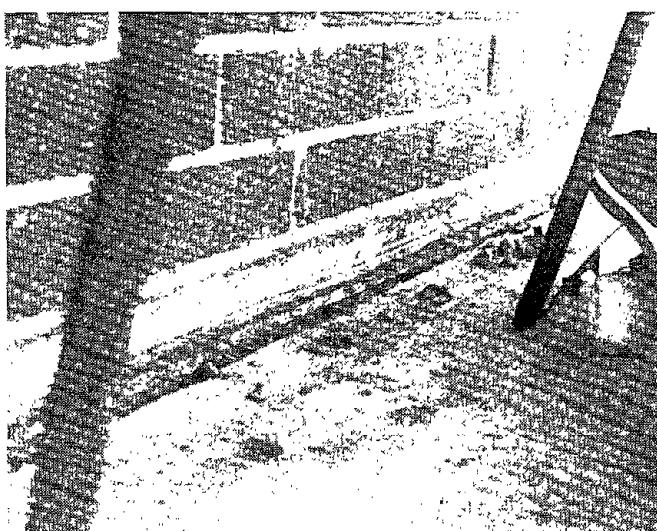
Figure 26.—Junction of north wall and patio of house 201 showing evidence of settlement.
