# **Detonation of a Flammable Cloud Following a Propane Pipeline Break**

**The December 9, 1970, Explosion  
in Port Hudson, Mo.**

**By D. S. Burgess and M. G. Zabetakis  
Pittsburgh Mining and Safety Research Center, Pittsburgh, Pa.**

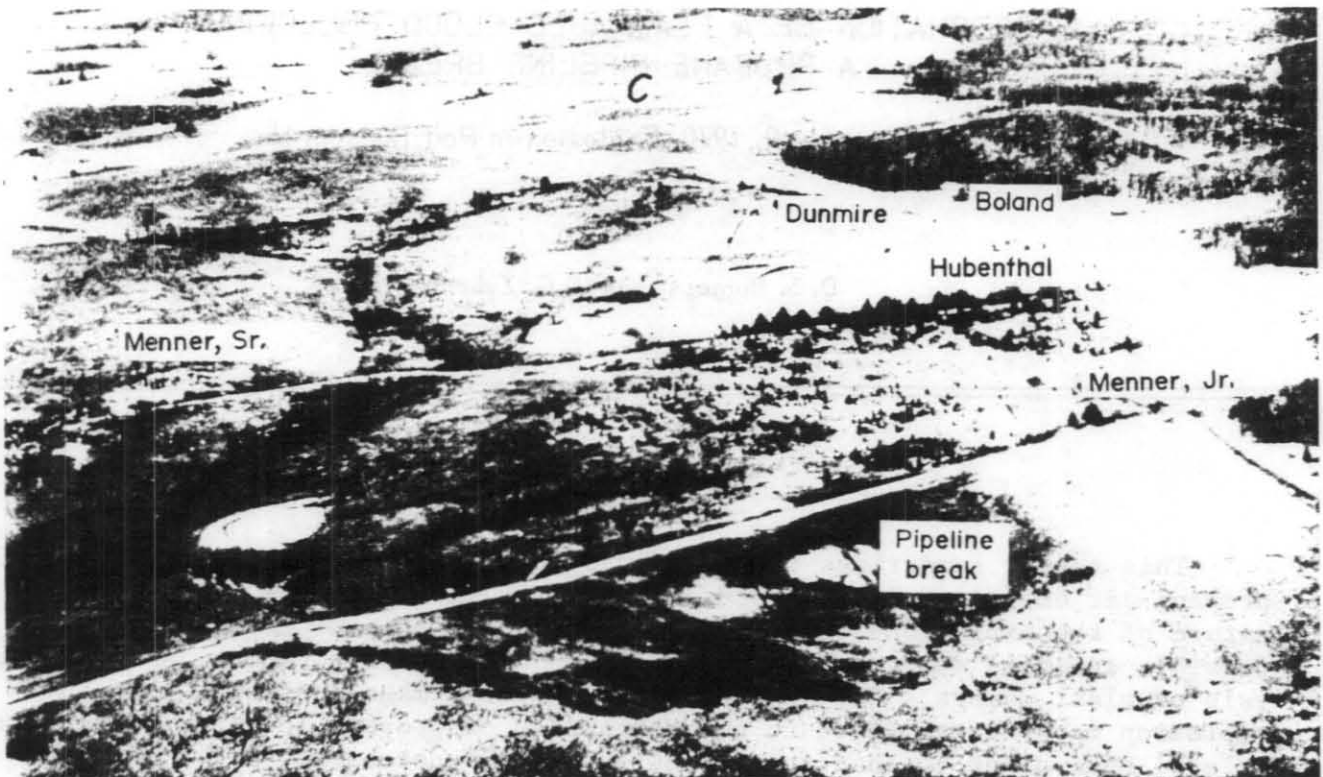
FIGURE 1. - View of Port Hudson aftermath looking west.

Several witnesses became aware of the noise of the escaping propane jet at about 10:25 p.m. A plume of white spray (presumably droplets of propane and of condensed atmospheric moisture) was observed to be rising 50 to 80 feet above ground level. The crater dug by the escaping liquid, said to be about 4 feet deep and 10 feet in diameter (subsequently enlarged by repair crews), is shown in the right foreground of figure 1.

By 10:44 p.m., four families had evacuated their homes and were assembled in their automobiles at the intersection of highway C near the top center of figure 1. (See also the contour map of fig. 2.) From this high ground they observed a white cloud settling into the valley around the complex of buildings owned by A. Menner, Sr., which buildings were about 1,000 feet southwest (down-wind) of the propane spray and perhaps 20 to 30 feet lower in elevation. Two estimates of the dimensions of the detonable cloud are shown in figure 3; by either estimate, the Menner, Sr., buildings could have been well within the zone of detonable mixture.

In general, the area of wind damage was also the area that showed scorching in aerial photographs. Note, for example, in figure 1 the many small evergreens at the right center. Similar trees within the blackened area were uprooted and pointing along the axis of the vapor plume. The sharp localization of the windstorm area is even more evident in figure 4. Scattered around the residence on the unscorched lawn are many hundreds of board feet of roofing lumber. This area does not look as though it had been swept by any hurricane-strength wind; however, about 100 feet beyond the residence, the garage that had housed the two automobiles has disappeared. To the left of the photograph (just beyond the parked truck) is a utility pole that has been snapped off at ground level; like most of the debris, it points toward the outbuilding area where we surmise that the detonation was initiated.

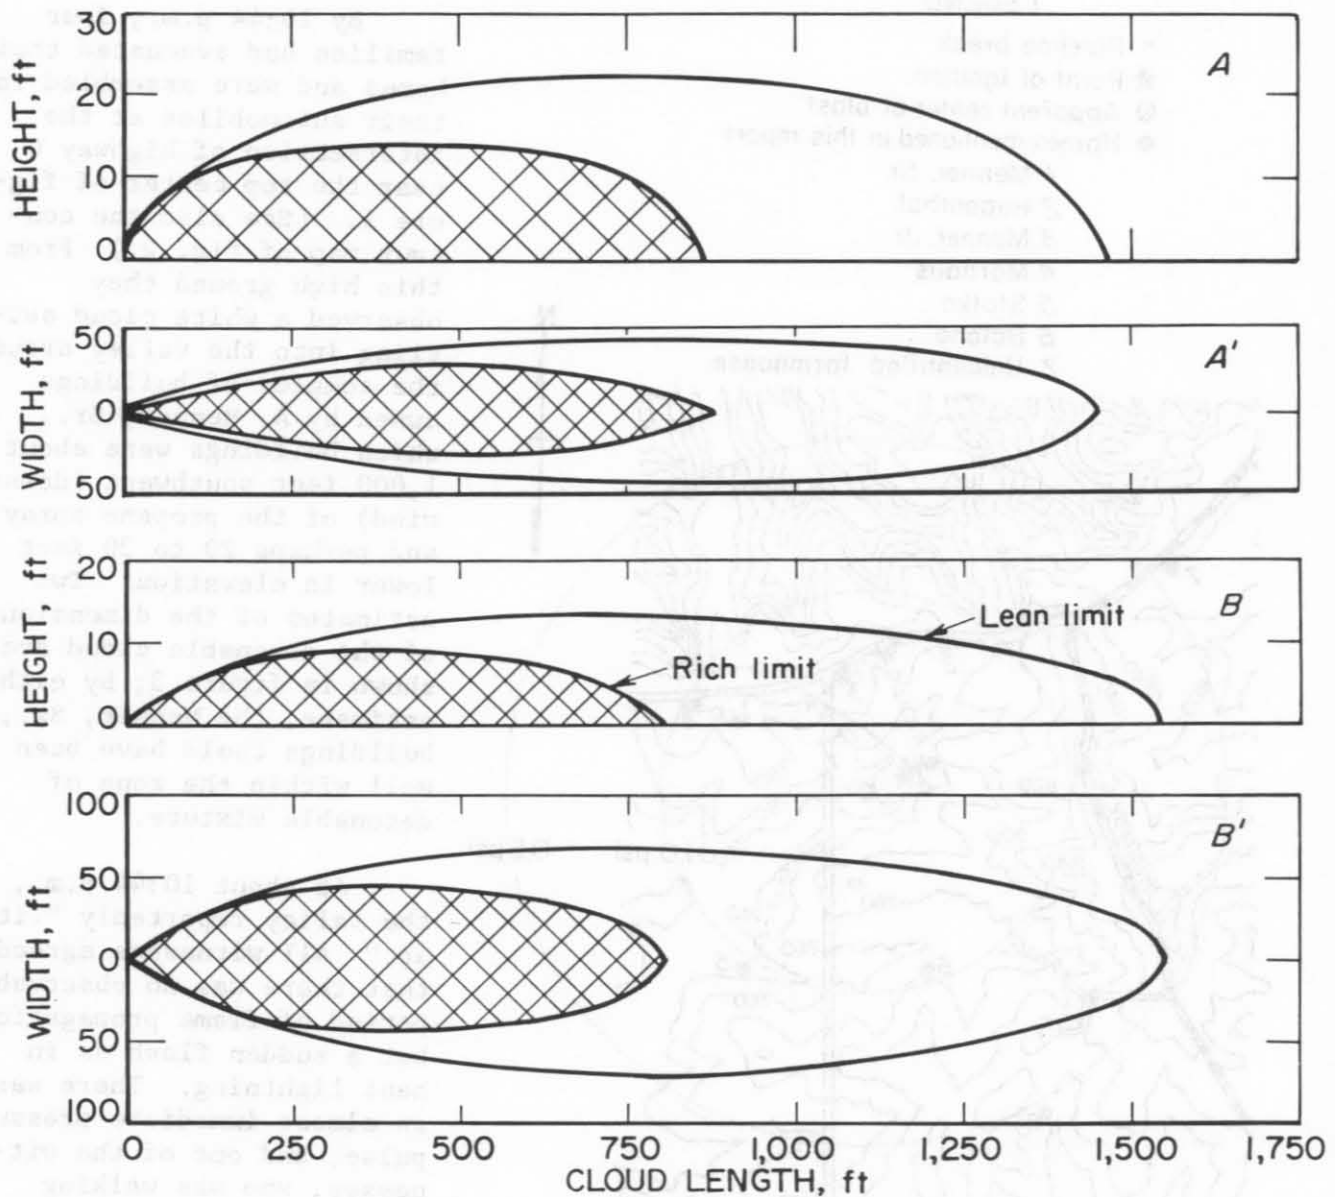
FIGURE 3. - Side views and top views of propane-air cloud as estimated (A, A') by methods of footnote 8, and (B, B') from equations of footnote 13.

The total volume of the detonable zone is estimated to be 1,100,000 cubic feet. Assuming the average mixture strength to be 4.9 percent propane, the volume of propane in the detonable zone is 54,000 ft<sup>3</sup> or about 4.2 percent of the total leakage at the time of ignition.<sup>10</sup> Approximately the same volume of propane is contained within the overrich (hatched) zone of figure 3 (A, A'); therefore, the greatest part of the propane has been dispersed beyond the 2.8 percent contour as a nondetonable mixture.

Thus, figure 3 represents a rather unlikely condition of minimum hazard. Each of several factors that are specific to the accident scene would have tended to increase the volume of detonable mixture at the time of ignition.

This value is to be compared with the 97,000- to 150,000-pound estimates derived from near-field damage and with the minimum of 50,000 to 75,000 pounds inferred from the size of the detonable cloud in figure 3.

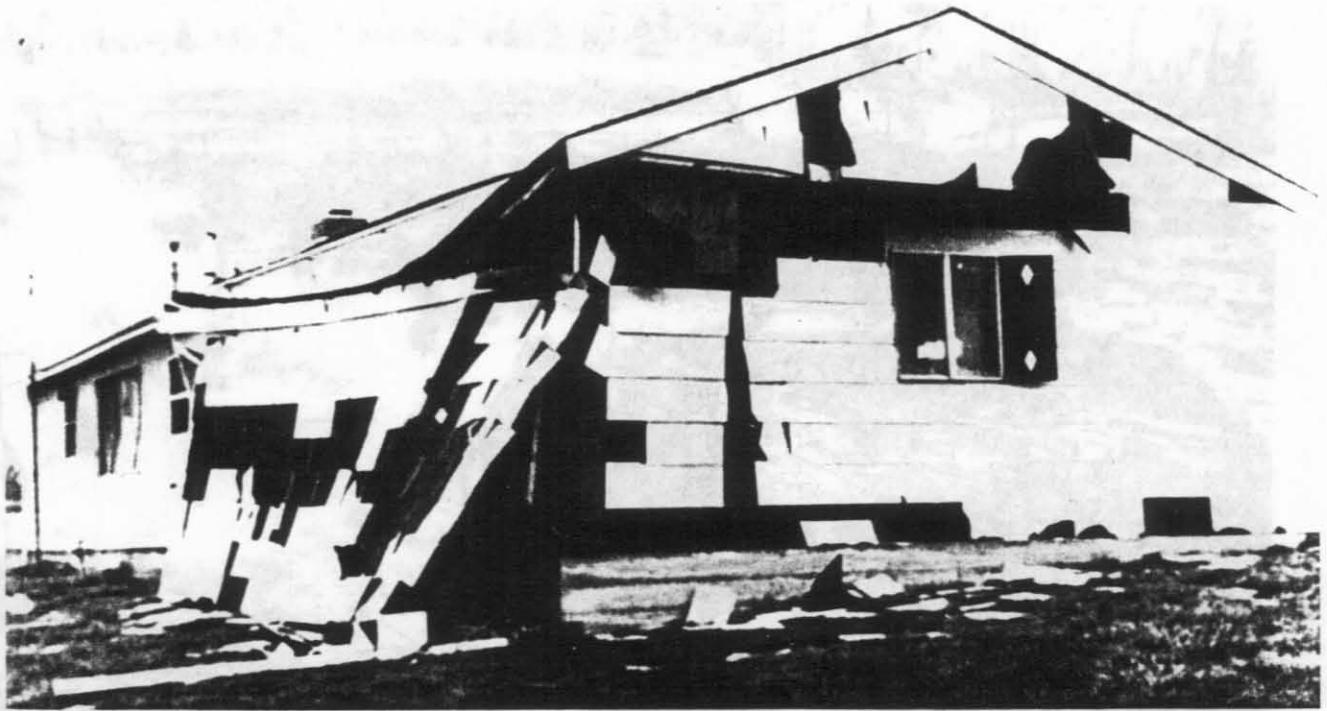
FIGURE 5. - Damage to Hubenthal home, about 1,500 feet north-northwest of presumed center of blast.

Figures 4 through 9 show the aftermath of the explosion in the form of damage to six structures around the detonable cloud. Each of these six locations was assigned a damage category by reference to table 5, which was

Property	Direction	Damage category	Scaled distance, $\lambda$	Distance, ft	TNT equivalent, lb
Menner, Sr...	W	B	16.6	750	97,000
Hubenthal....	NNW	D	28.1	1,500	150,000
Menner, Jr...	N	D	28.1	1,400	125,000
Morhaus.....	NE	D-E	<sup>1</sup> 35	1,700	110,000
Stotko.....	SE	C	25.0	2,000	500,000
Boland.....	S	D-E	<sup>1</sup> 35	1,800	130,000

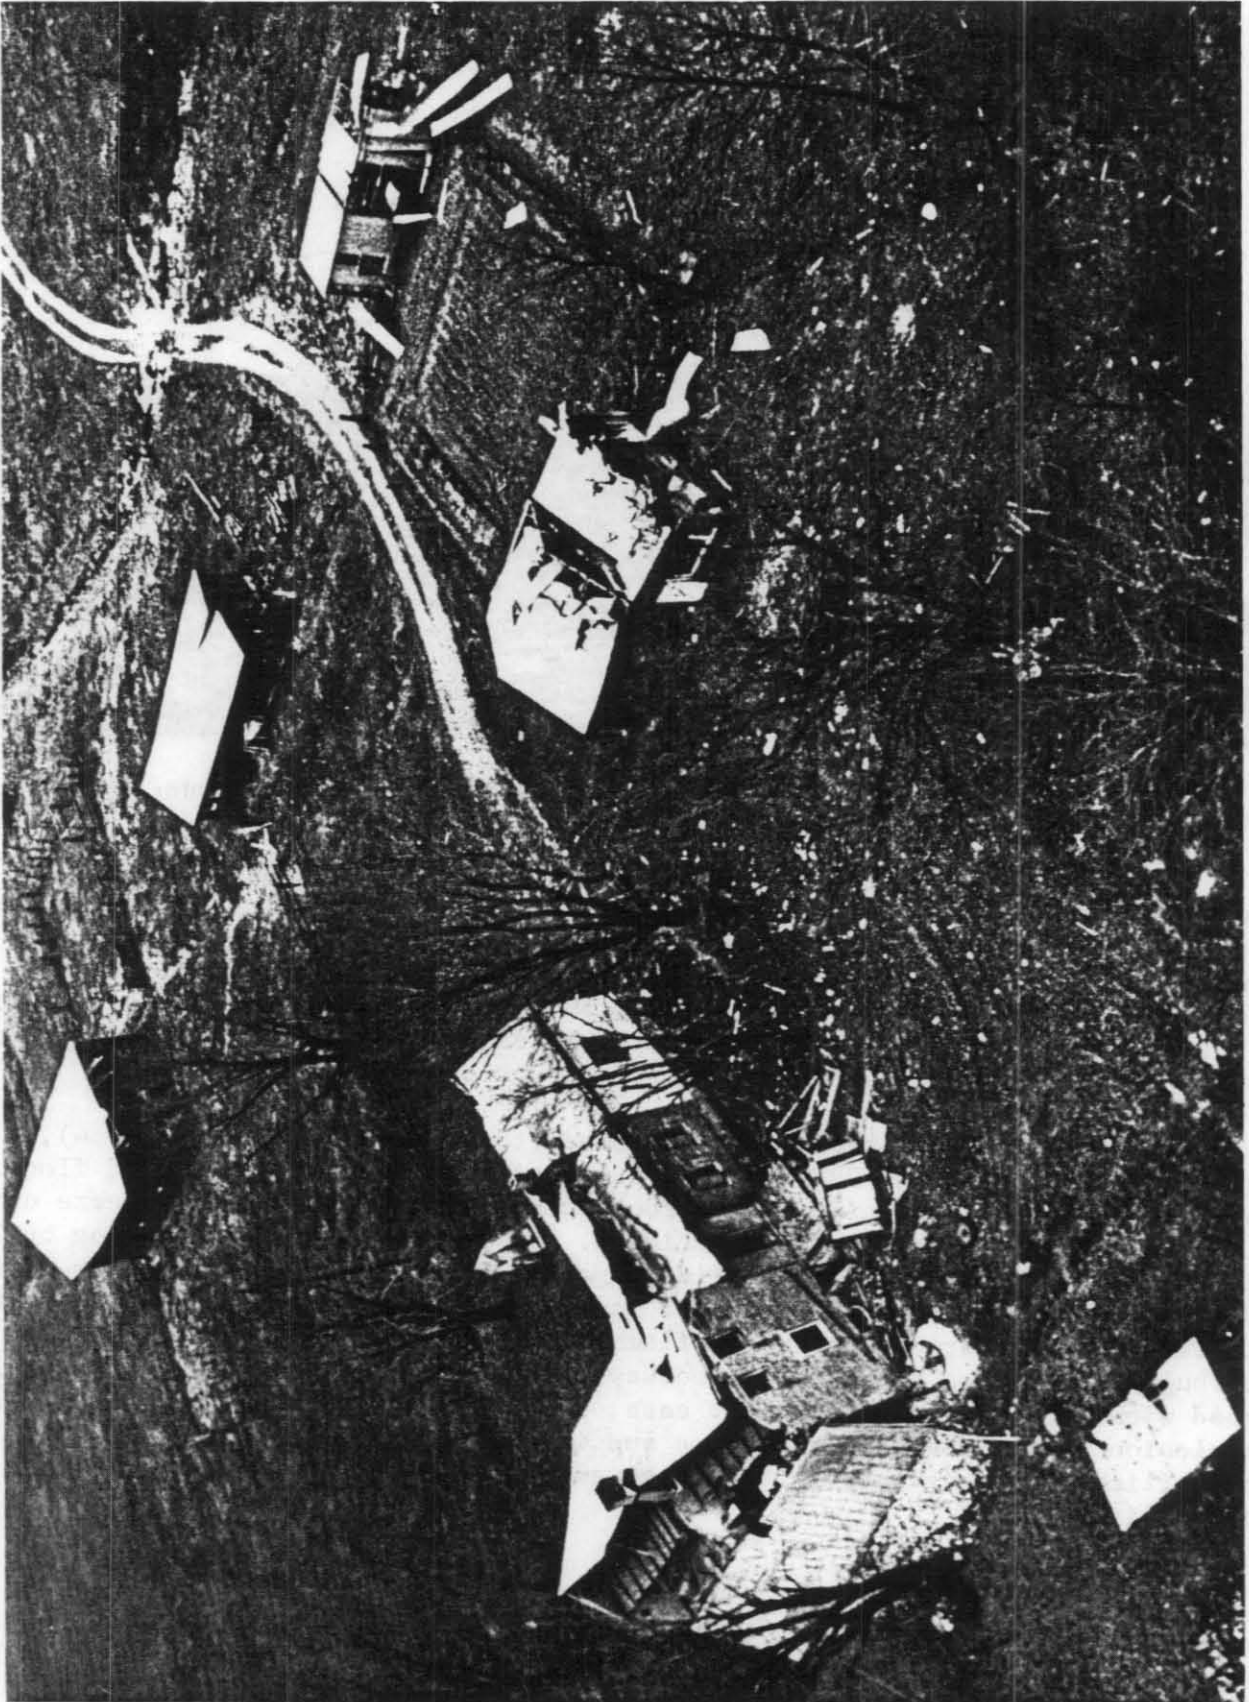
FIGURE 8. - Damage to Stotko farm, about 2,000 feet southeast of center of blast.

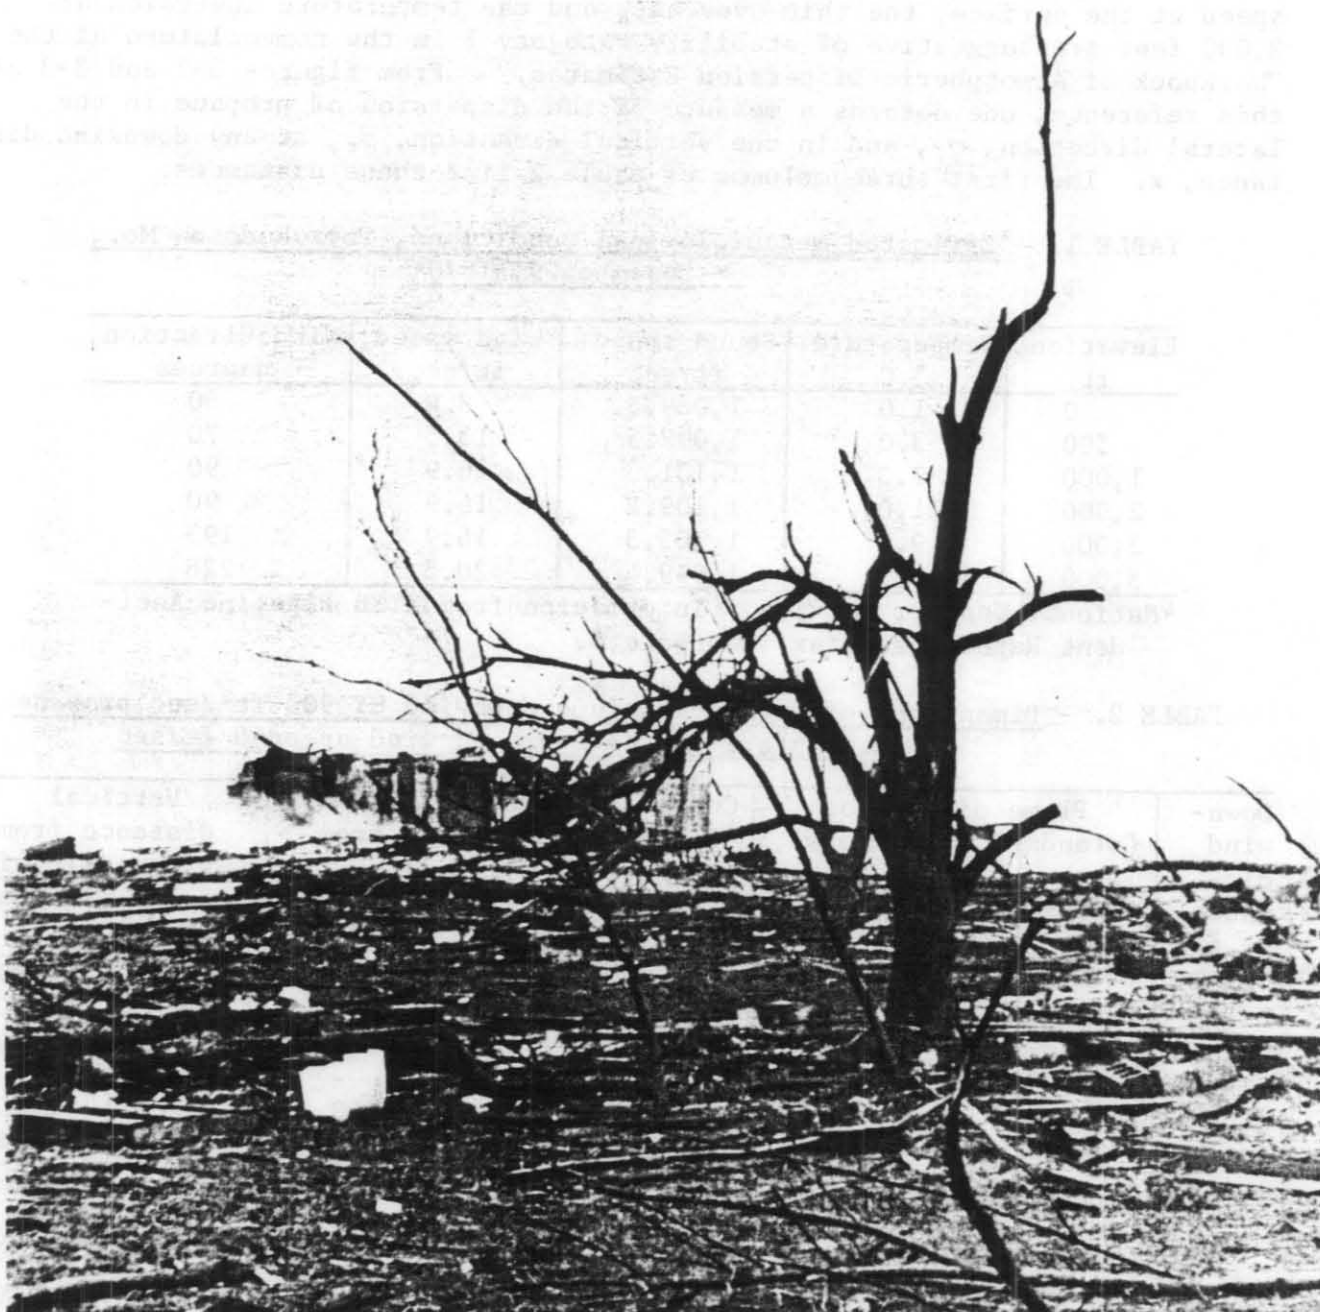
Figure 10 shows typical wind damage in the aftermath of the firestorm. Most of the broken tree limbs and uprooted small trees were left pointing in the direction of the Menner, Sr., outbuilding in which we speculate that ignition occurred. Thus, it appeared as though the winds rushed in from northeast and southeast toward this focal point and then were carried aloft by buoyant forces; there was no evidence of wind from westward of the scene.

FIGURE 10. - Aftermath of detonation and firestorm, near presumed point of ignition.

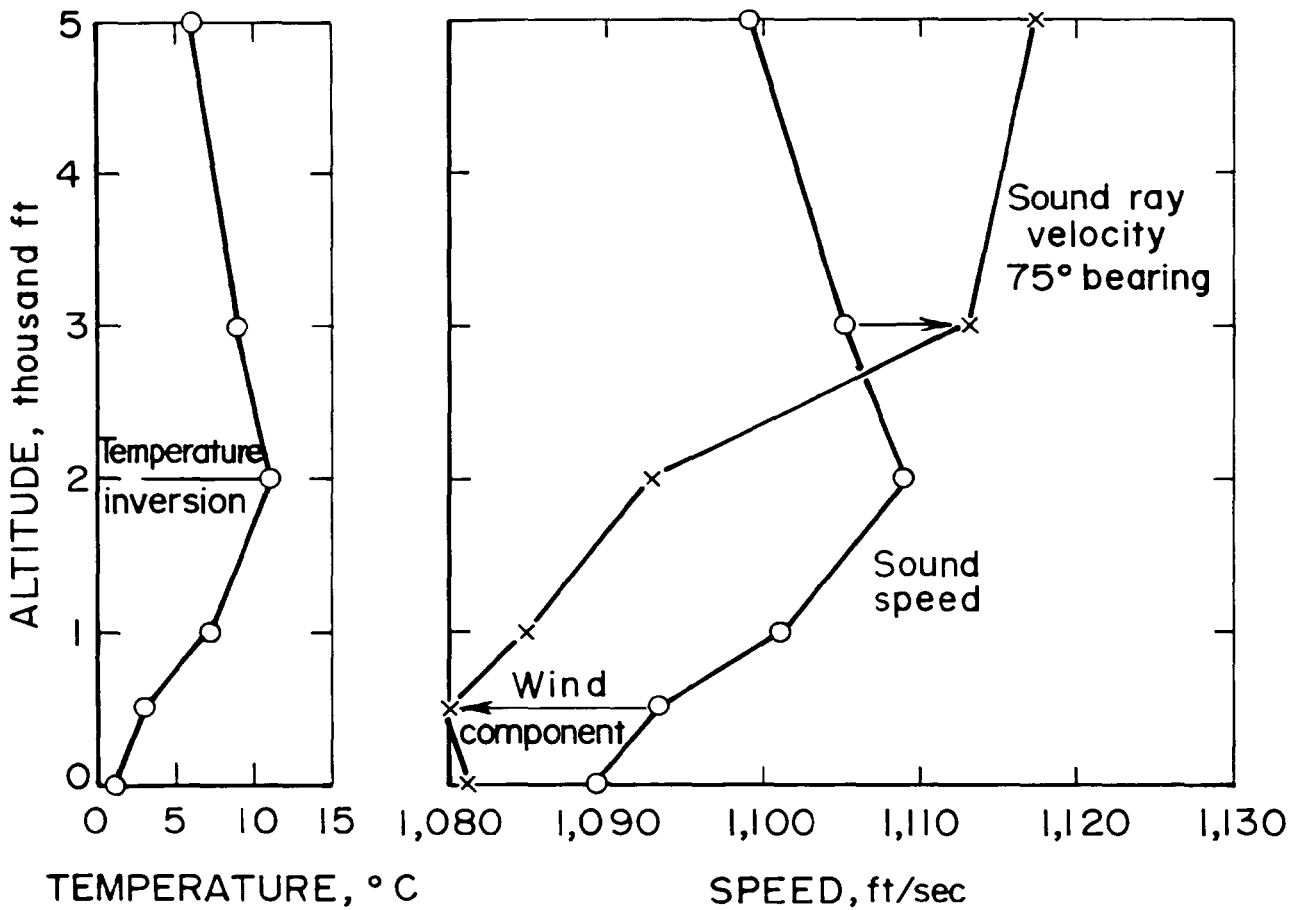
FIGURE 13. - Temperature, sound speed, and sound ray velocity versus altitude (75° bearing).

sound speed are included in figure 13. The resultant velocity of a sound ray (sound speed plus effects of wind) in the east-northeast direction (75° bearing) is also included in this same figure. Note in particular that a horizontal sound ray would be bent upward to an altitude of about 500 feet and then back down toward the earth. An approximate focal point for such a ray may be obtained by noting that the radius of curvature  $\rho$  is given by the equation

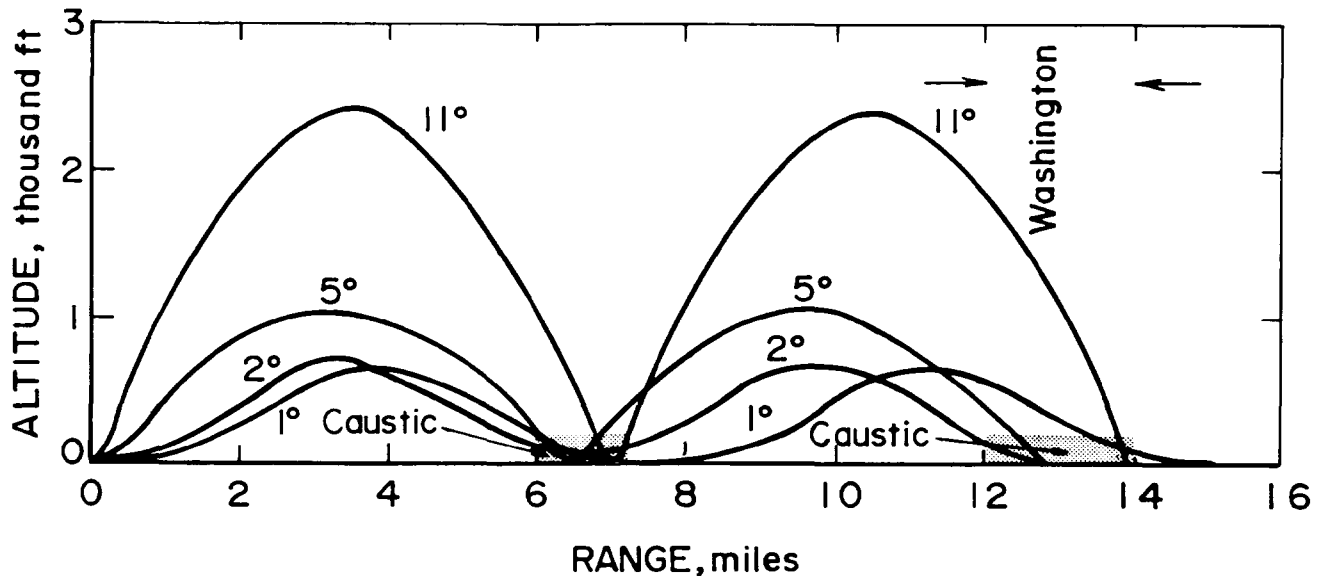
FIGURE 14. - Selected blast ray paths toward Washington, Mo. ( $75^\circ$  bearing).

More recently, Thompson has prepared a program that permits the systematic tracing of rays emanating from a pressure disturbance in the atmosphere.<sup>22</sup> A modification of this program from Dr. Jack W. Reed of Sandia Laboratories was used to obtain the paths of rays along a number of bearings. A summary of some of these results for the  $75^\circ$  bearing (toward Washington, Mo.) is presented graphically in figure 14. This figure illustrates the focusing action and therefore blast magnification of the refracted rays to form caustics at about 6 to 7 and also 12 to 14 miles from the explosion site. These correspond to the clusters of window damage evident in the corresponding areas depicted in figure 12. In particular, note that damage occurred at both the first and second caustics in the neighborhood of the  $75^\circ$  bearing. According to Dr. Reed, this is not uncommon. Similar damage zones were found north of the explosion site, but there was very little evidence of such focusing in the other quadrants (fig. 12).

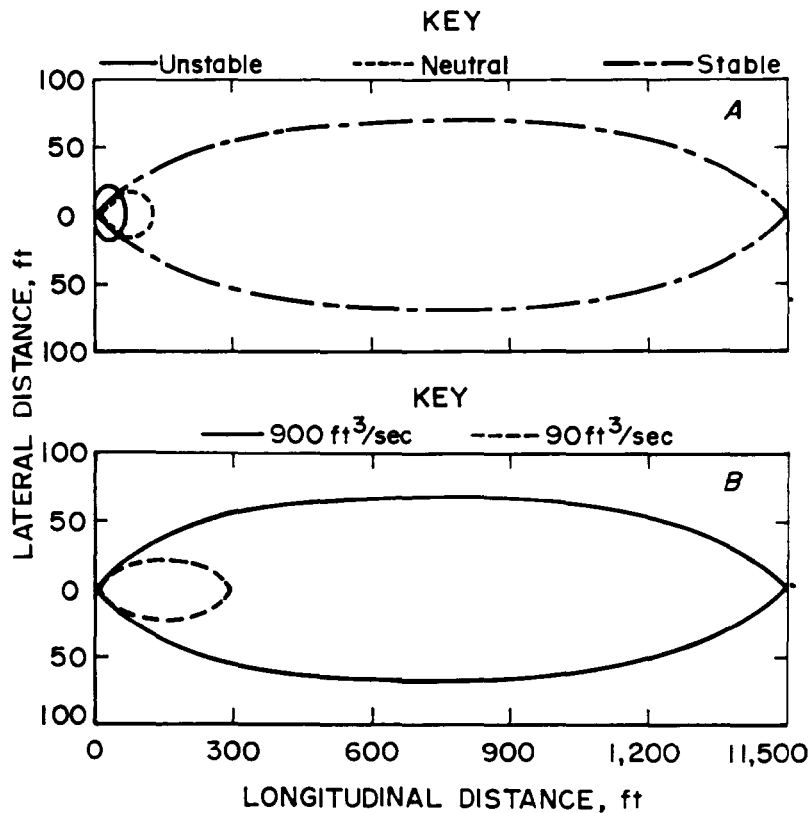
FIGURE 15. - Approximate contours of 2.8 percent propane, as affected by A, atmospheric stability, and B, fuel flow.

the mean wind speeds given in table 3. In figure 15B, the atmospheric variables are constant while fuel flows are 90 and 900 ft<sup>3</sup>/sec. Table 4 summarizes pertinent distances, areas, and volumes, and shows that atmospheric stability can be more important than a tenfold reduction of leak rate.
