bureau of mines  
report of investigations 7392

SPRAY-APPLIED POLYURETHANE  
FOAM TO INSULATE HEATED ROOMS  
EXCAVATED IN PERMAFROST

June 1970

By K. Robert Dorman and Aldon E. Gooch

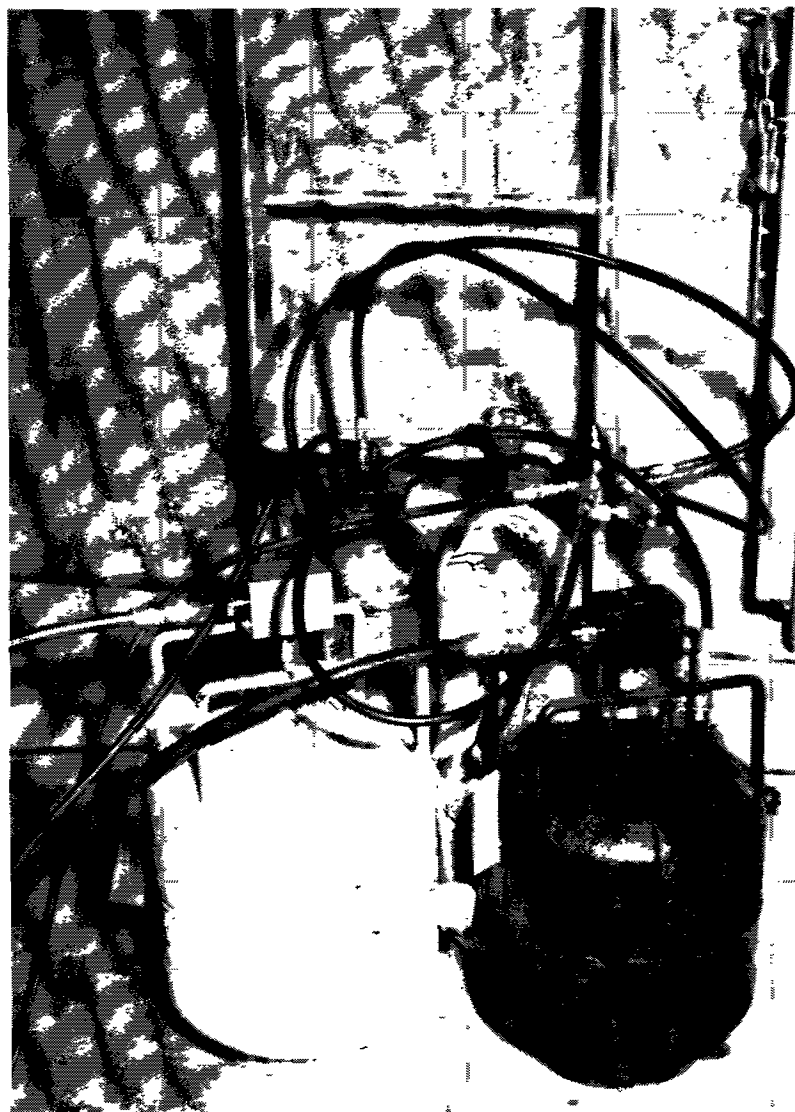
FIGURE 1. - Autofroth-I System.

Two types of rigid urethane-foam systems were employed in laboratory testing, the Olin Mathieson Chemical Corporation's Autofroth-I system<sup>3</sup> (fig. 1) and the Mine Safety Appliances Company's (MSA) Rigiseal system (fig. 2).

The Autofroth-I system employs four material components: resin, catalyst, flushing agent, and nitrogen. Each component in an individual cylinder is fed to the gun through a network of hoses. Nitrogen supplies the driving force required for application. The correct ratio of resin to catalyst is automatically controlled by a preset, metering controller valve located in the gun. The Autofroth-I gun discharges from 30 to 80 percent preexpanded froth foam, dependent upon operating conditions.

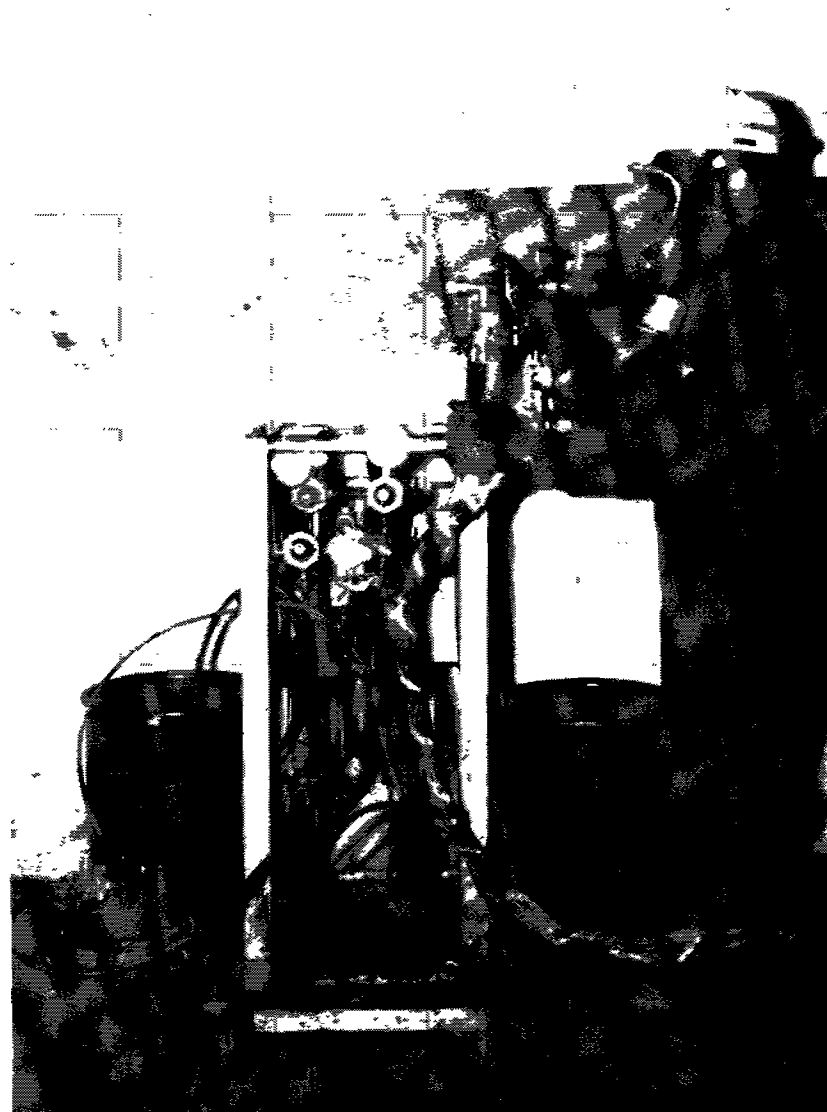
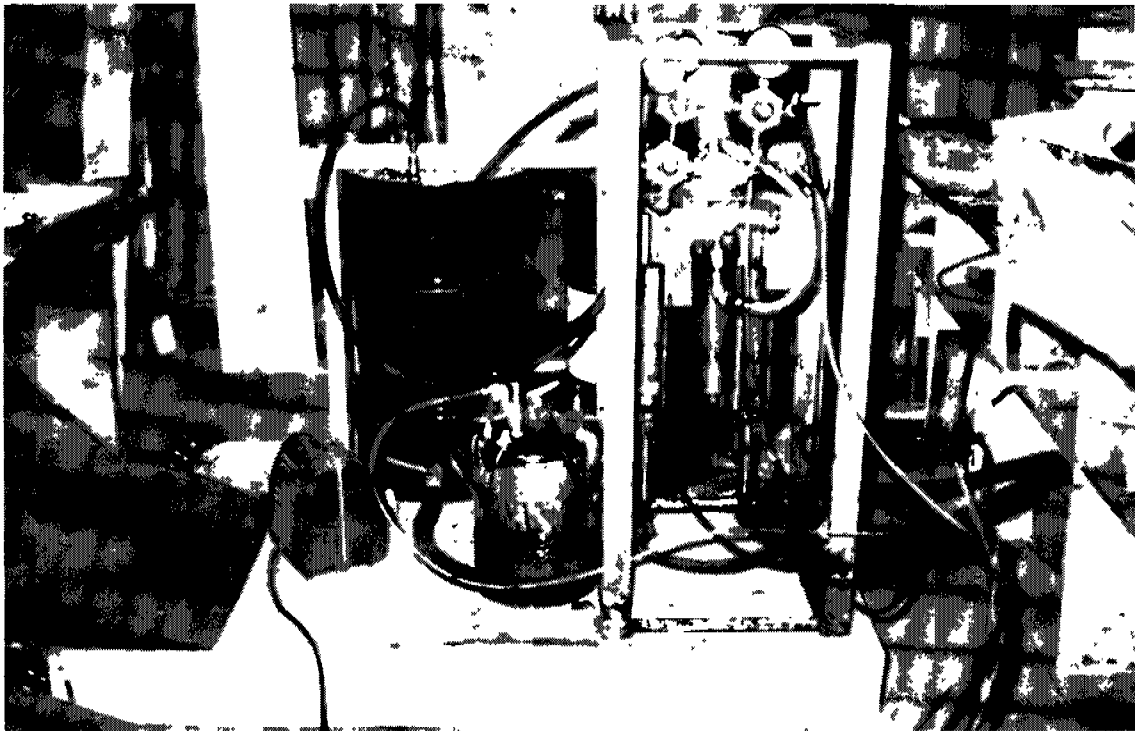
FIGURE 2. - Rigiseal System. A, Operator in lab.

FIGURE 2. - Rigiseal System. *B*, On sled at Fox, Alaska, installation.

The MSA Rigiseal system uses three components: resin, catalyst, and flushing agent. Compressed-air operated, the system requires a supply of air at 30 cfm and 70 psi minimum. The machine consists mainly of supply hoses, a pressure tank for flushing agent, a hand-held gun, and a two-piston pump that pumps the resin and catalyst from the drums to the gun. A correct ratio of the two components is maintained automatically by the relative sizes of the two pistons. In addition to driving the materials pump, the compressed air runs a small mixing motor located in the gun, supplies positive pressure to the flushing agent, and blows the froth onto the surface being foamed.

The same MSA foaming equipment used in earlier laboratory testing was employed in foaming the silt and gravel rooms at Fairbanks. Air was supplied by a large diesel-powered compressor permanently stationed near the portal of the experimental adit. Thermocouple strings to be inserted into drill holes in the walls of the rooms were fabricated by CRREL personnel. A thermocouple string was made by taping fine copper-constantan thermocouples to a 1-1/2-inch-diameter wooden dowel at varying intervals (fig. 10). The length of dowels and spacing of thermocouples were dependent upon the depth of the holes (fig. 11). Insulating rock wool was taped around the dowel at each end of individual thermocouples to prevent convection currents in the unfilled portion of the hole, and thus to insure that the temperature read was that of the ground in the immediate vicinity of the thermocouple. Output from the thermocouples was read in hundredths of a millivolt by a Rubicon, model 2735-S potentiometer and then converted into degrees Fahrenheit.

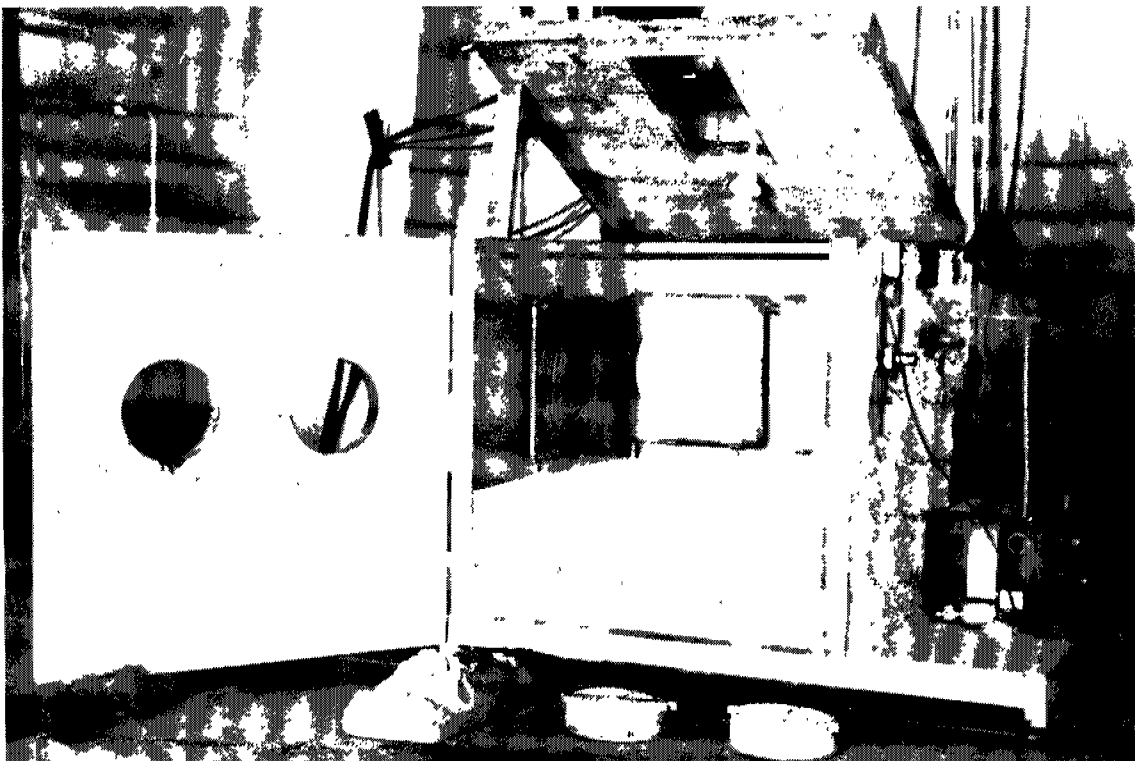
FIGURE 3. - Cold-Environment Box.

The environmental test chamber, fabricated at SMRL, is a 4-foot-square wooden box, 4 feet in height, equipped with the cooling coils, compressor, and motor from a surplus ice cream freezer (fig. 3). The exterior was foamed with a 3-inch minimum thickness of Autofroth-I rigid polyurethane. Personnel wore vapor-type respirators to protect themselves from the toxic isocyanate vapors.

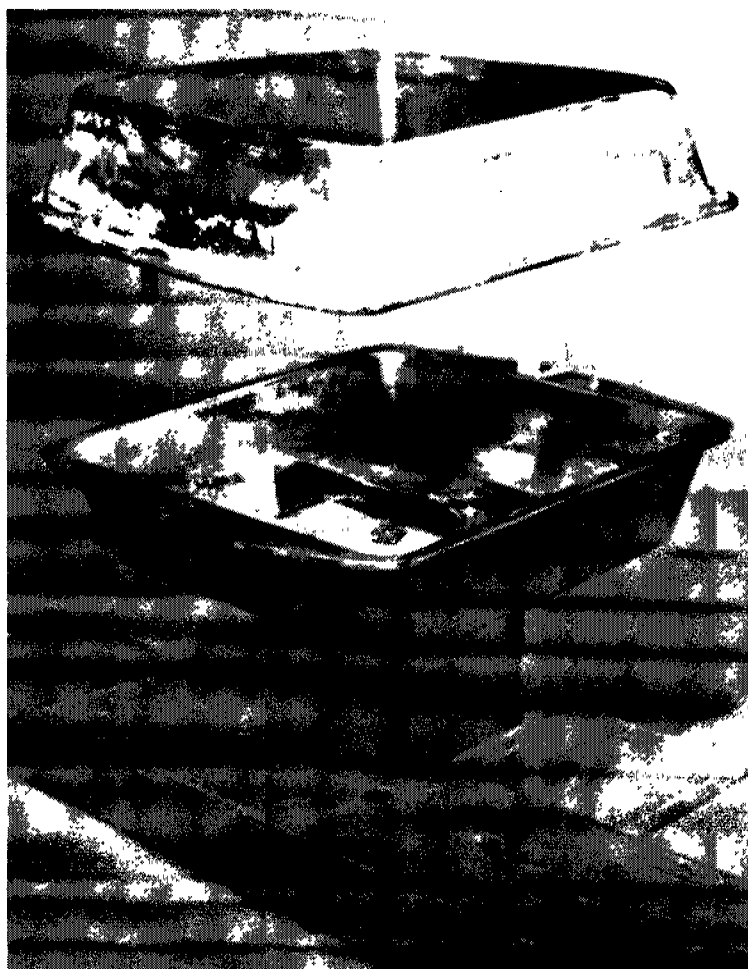
FIGURE 4. - Sample Pans and Hold-Down Device.

Miscellaneous equipment included a 200-pound-capacity pull-type scale, 2- by 2-inch pull plates made of punched steel plate, 8- by 8-inch aluminum sample pans, and a short length of 4-inch channel iron used as a hold-down device during pull testing (fig. 4). The bottom pan, serving as the container for the frozen sample, was bolted to a 36- by 36-inch plywood base in the cold box prior to foaming and to the channel iron for pull testing. The upper pan, from which the bottom had been removed, was placed over the lower pan in an inverted position; they thus served as an open mold for the foam covering.

The 8- by 8-inch aluminum pans, 2 inches in depth, were filled with materials containing varying amounts of water, bolted to a plywood base, and placed in the environmental cold box. Three samples were made of each combination. Table 2 provides a description of the combinations used to simulate permafrost materials. The same combinations were used for testing with the Rigiseal foam as were employed with the Autofroth-I, with one exception: fine mill tailings were used in place of eolian silt for Rigiseal testing. Prior to foaming, the upper pans were wiped with vaseline, inverted, and bolted to the sample pans.

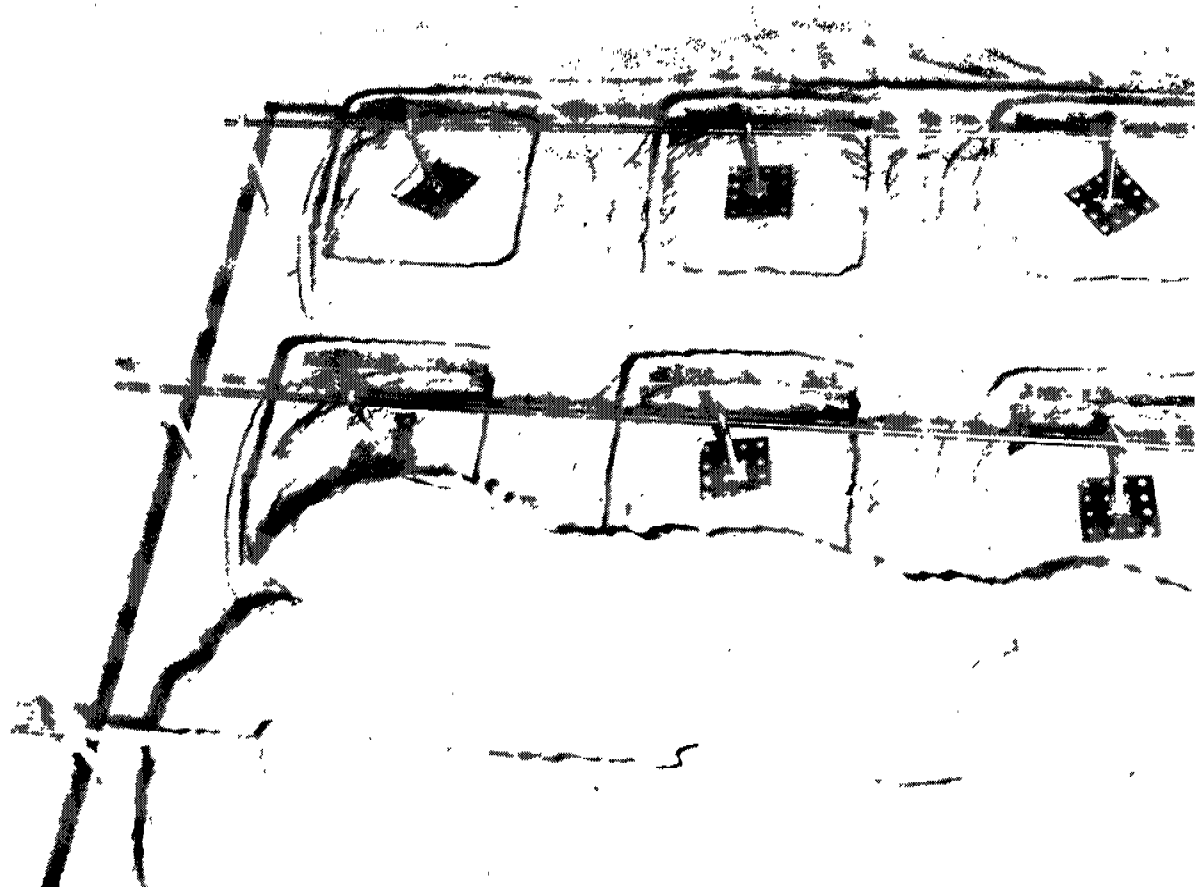
FIGURE 5. - Pull Plates in Position.

Testing procedure was as follows: A test sample was unbolted from the plywood base and freed from the surrounding foam layer by careful cutting of the insulation around the periphery of the pan. The inverted upper pan was next removed. Then the sample was removed from the cold box, bolted to the web of a 4-inch channel iron, and pull tested as illustrated in figure 6. A steadily increasing pull was applied perpendicular to the frozen surface until failure occurred, or until the 200-pound capacity of the scale was reached.

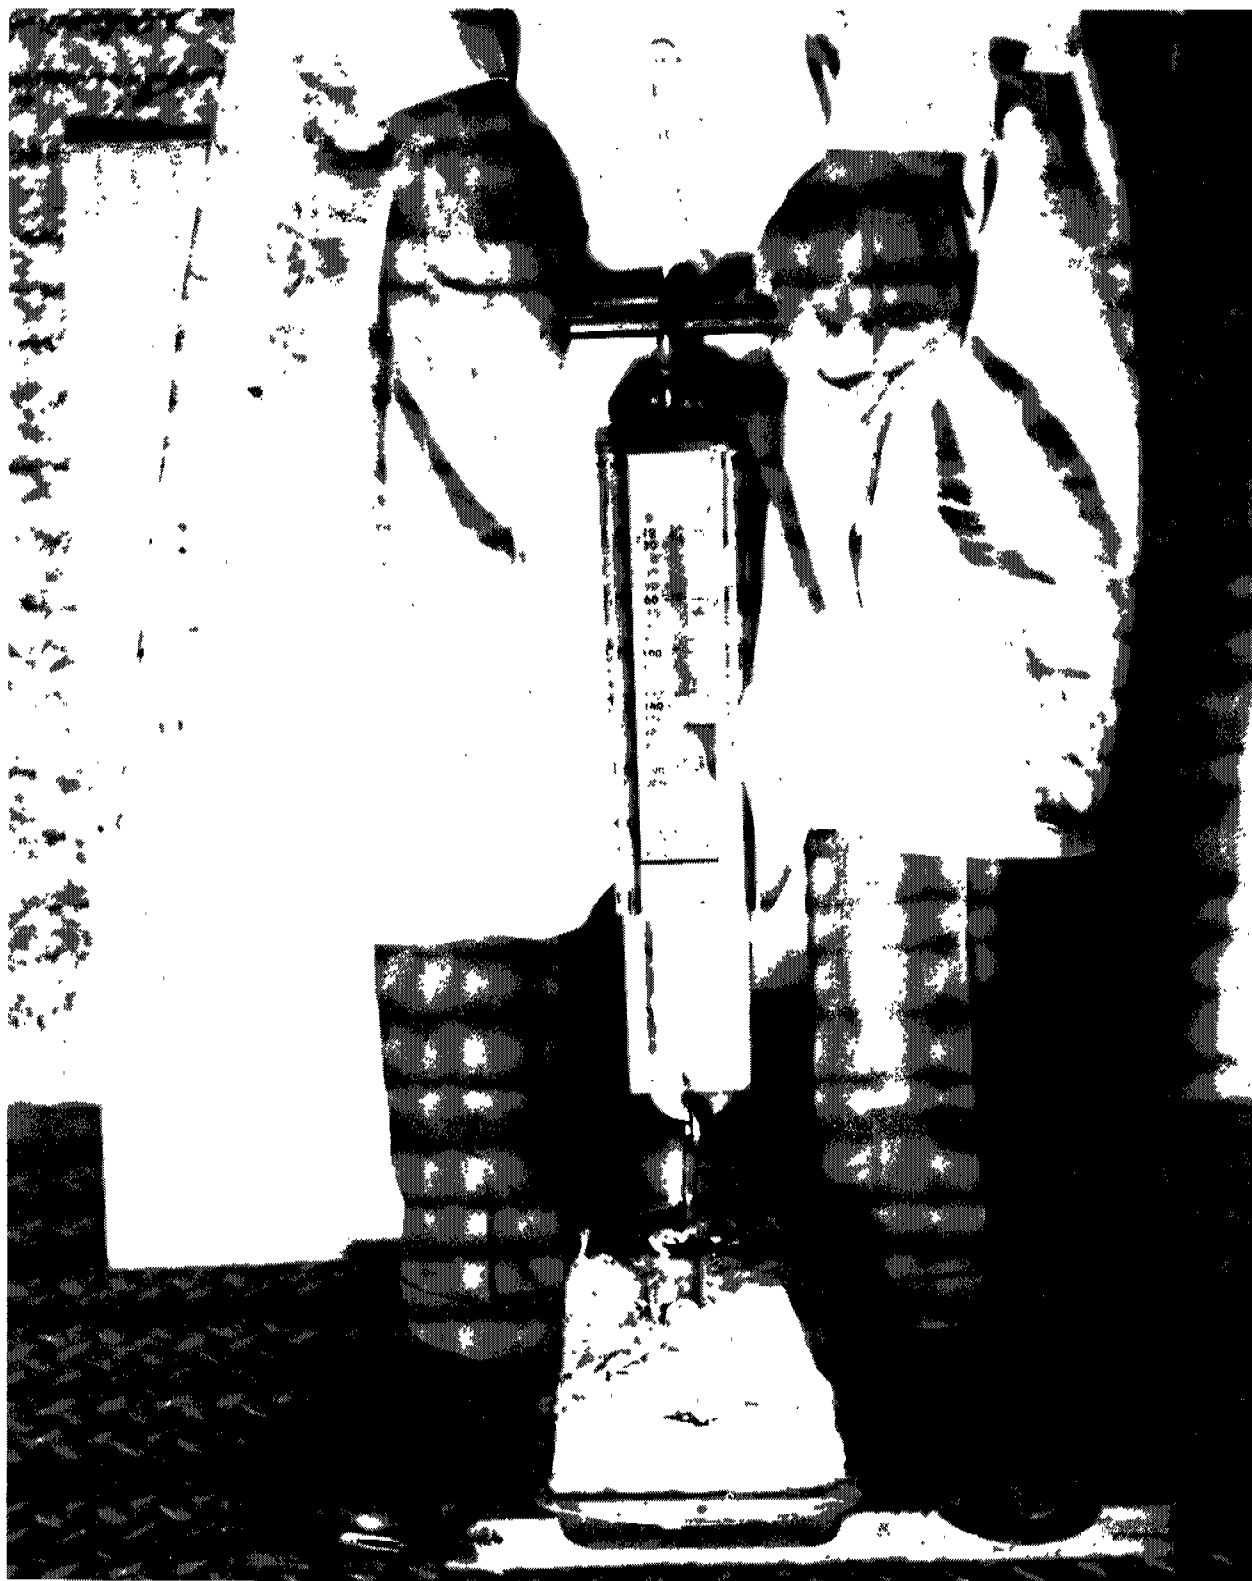
FIGURE 6. - Testing Adhesion Between Foam and Frozen Material.

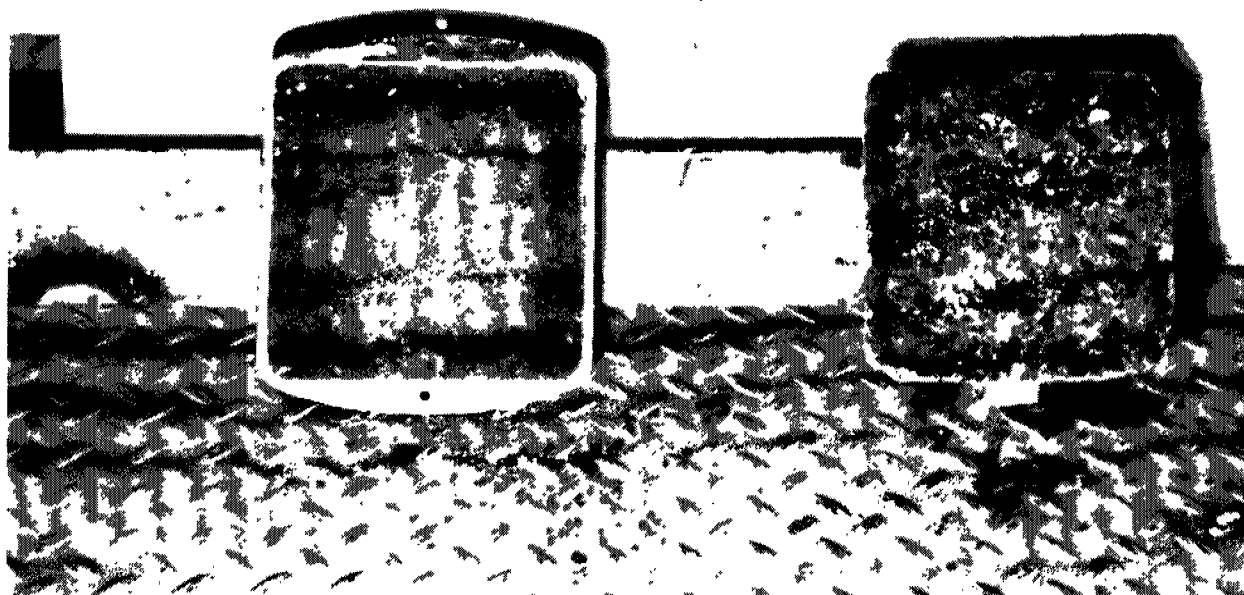
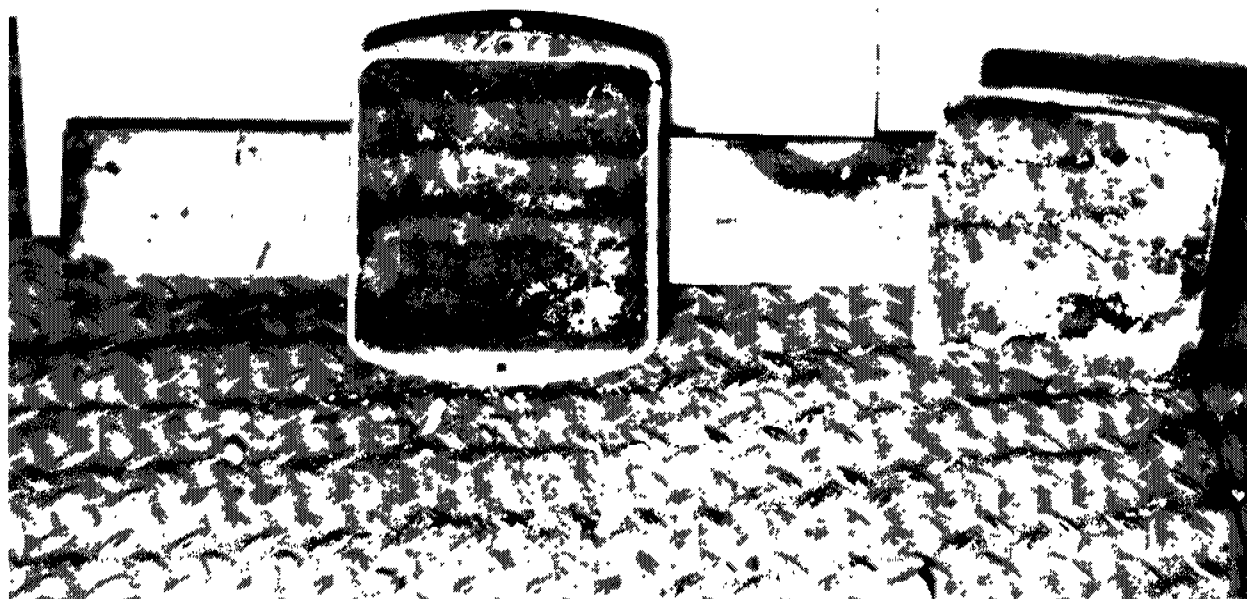
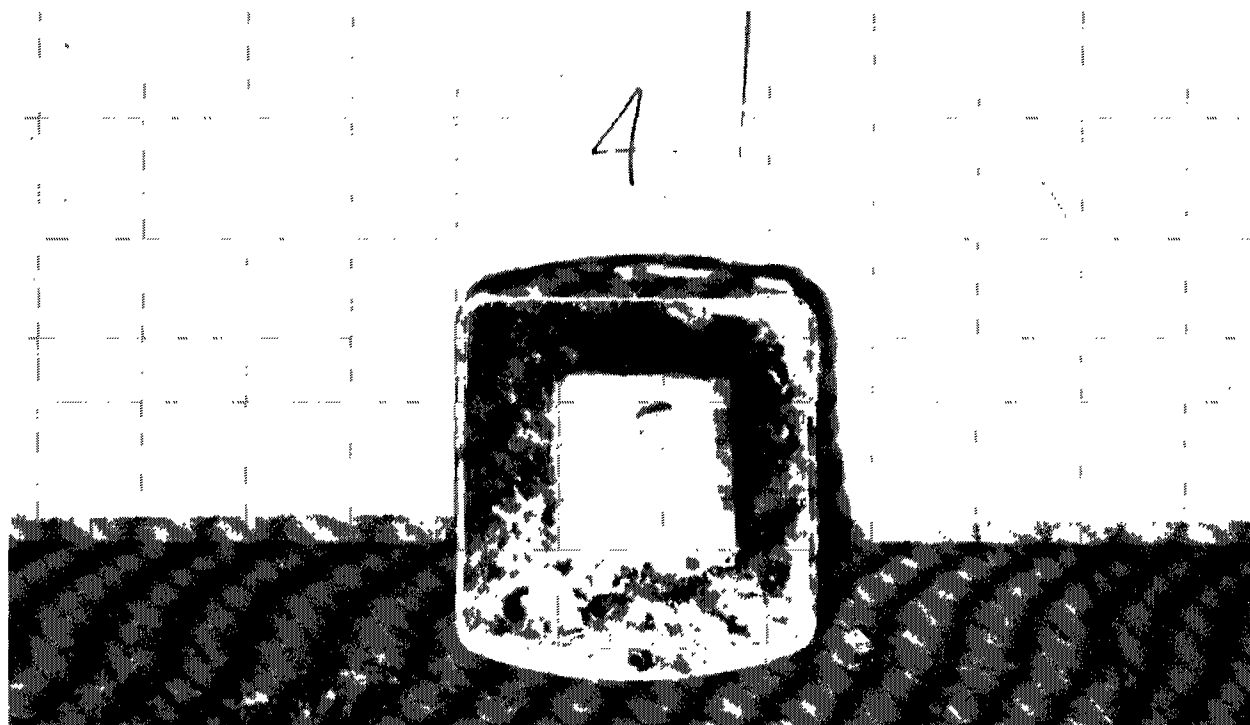
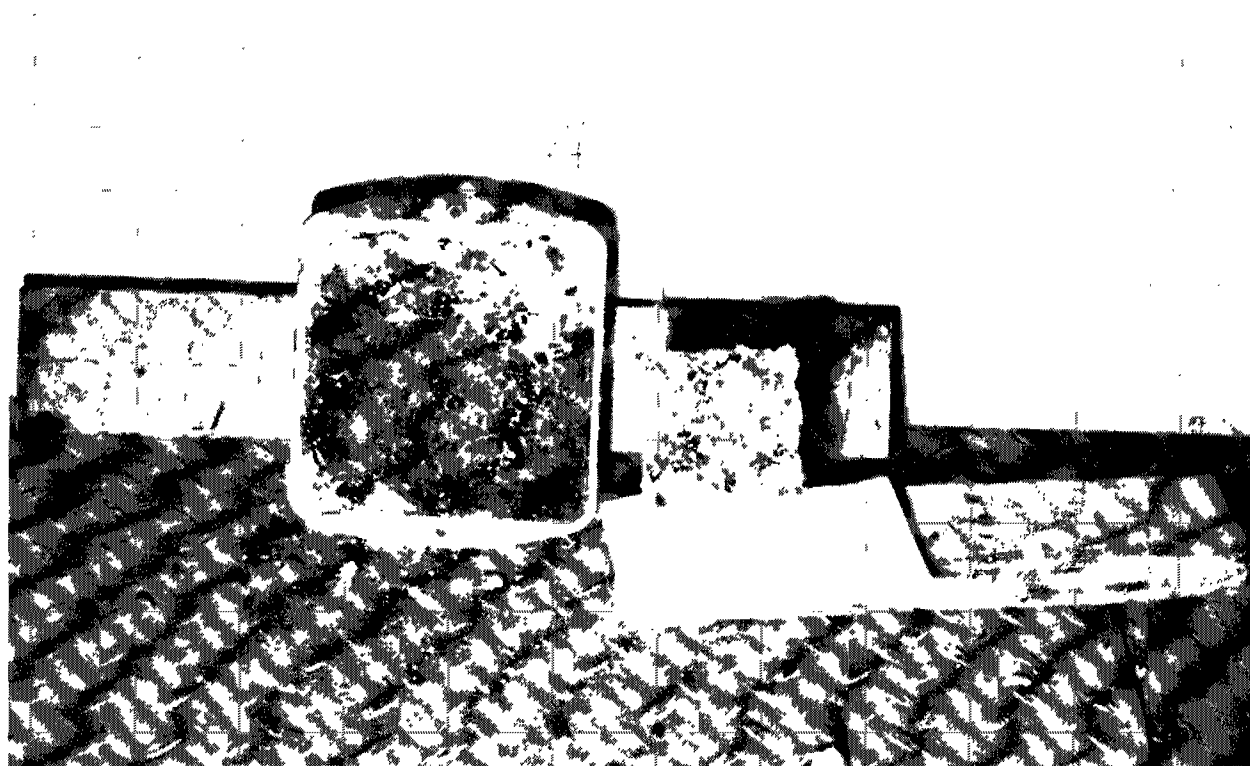
FIGURE 7. - Bond Between Foam and Frozen Material. *A*, Sample 2 after pull test.

FIGURE 7. - Bond Between Foam and Frozen Material. *B*, Sample 7 after pull test.

FIGURE 7. - Bond Between Foam and Frozen Material. *C*, Sample 4 trimmed to 16 square inches.

FIGURE 7. - Bond Between Foam and Frozen Material. *D*, Sample 4 after pull test.

Pull-test results are given in table 2. Visual examination of samples 1, 2, and 3 revealed that the upper portion of the gravel-sand mixture had dried out before the sample became frozen. Consequently, parting occurred within the mixture rather than at the mixture-foam interface. The gravel and sand particles can be seen imbedded in the foam in figure 7A. A pull of 200 pounds was not sufficiently large to cause failure with any of the remaining nine gravel-sand samples. The foam layer on sample 4 subsequently was trimmed to 16 square inches (fig. 7C). A force of 163 pounds was required to pull this reduced section of foam from the frozen material (fig. 7D).

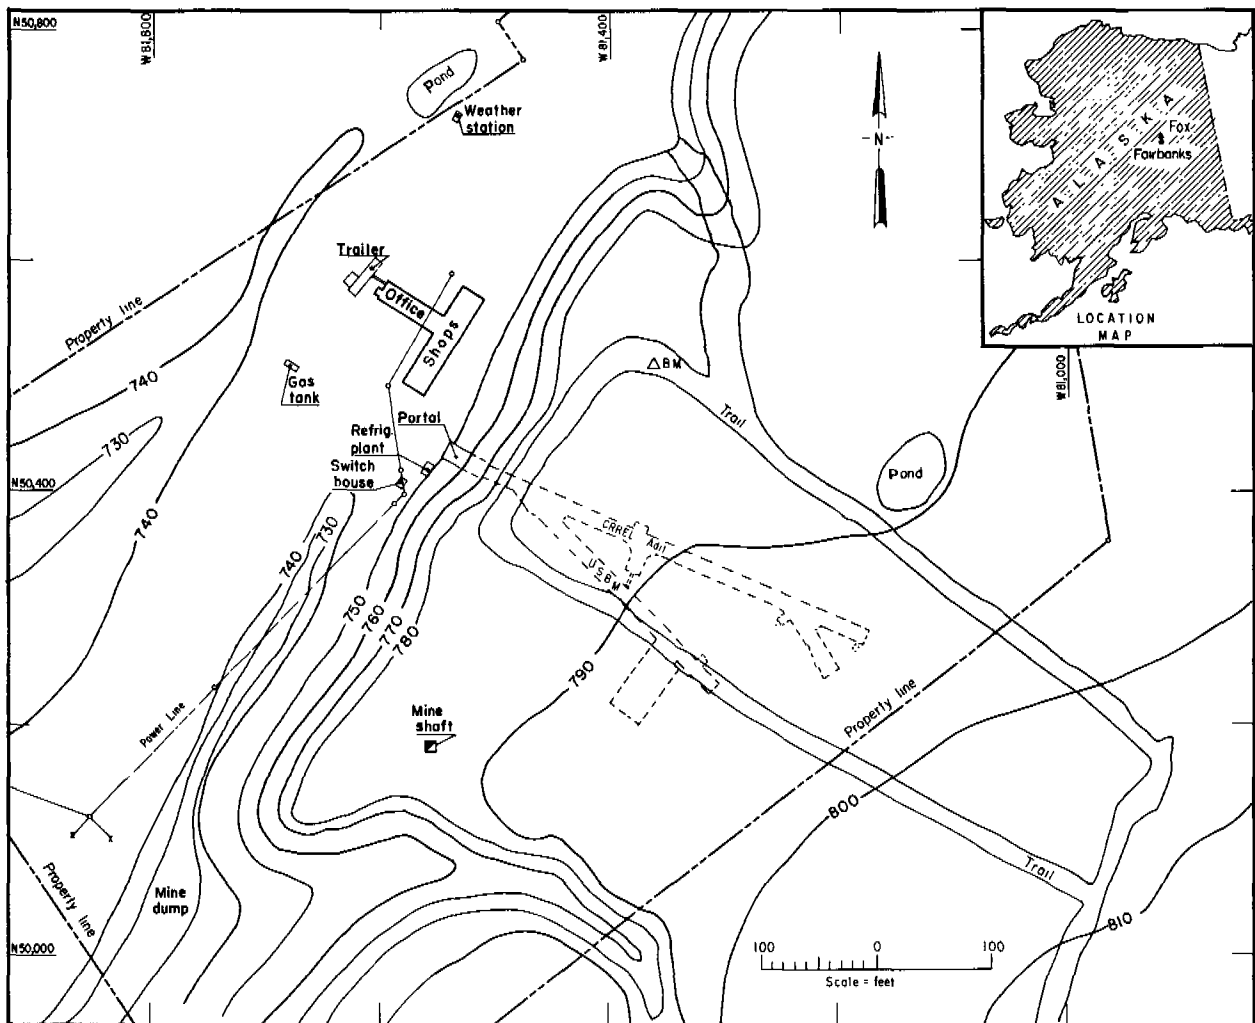
FIGURE 8. - Adit Site, Fox, Alaska.

The experimental adit at Fox, Alaska, approximately 10 miles north of Fairbanks (fig. 8), was driven in 1963 and enlarged in 1966 and 1967. Access to the site is provided by an asphalt-surfaced highway, connecting Fairbanks with Livengood to the north. The facility, which includes an office and shops, is the property of USACRREL. The adit (fig. 8), 360 feet in length, was excavated in perennially frozen silt (permafrost) in the toe of a bench

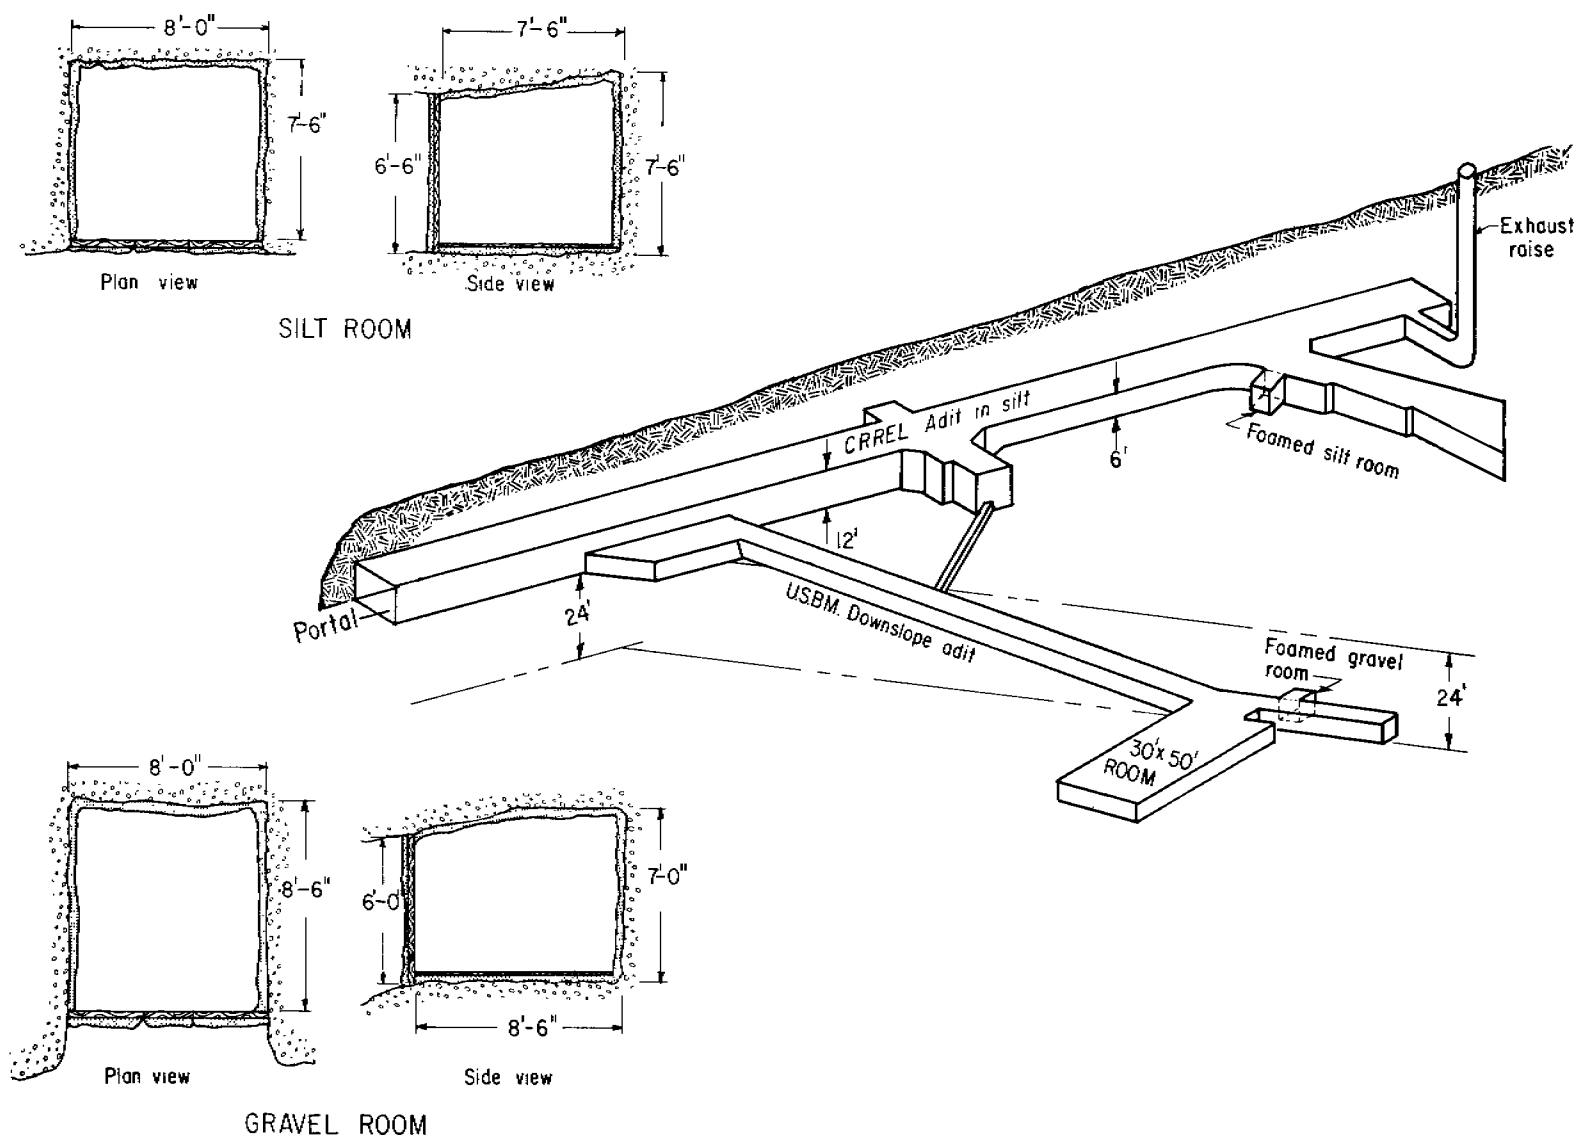
FIGURE 9. - Details of Adit.

left as the economic limit of earlier gold dredging. The small silt room later excavated and insulated by the Bureau is located near the far end of the adit. During the summer months, air within the adit is maintained at below freezing temperature by buried refrigerated pipes that surround the portal area and by fans which circulate the air through cooling coils located inside the adit. Also, the exhaust shaft is kept closed except in the winter.

So that the Bureau could conduct test work in the gravel horizon, Twin Cities Mining Research Center (TCMRC) personnel supervised the driving of an 8- by 15-foot winze on a 14- to 16-percent grade during the latter part of 1968 (fig. 9). The small gravel room insulated by SMRL personnel is situated near the bottom of this opening.

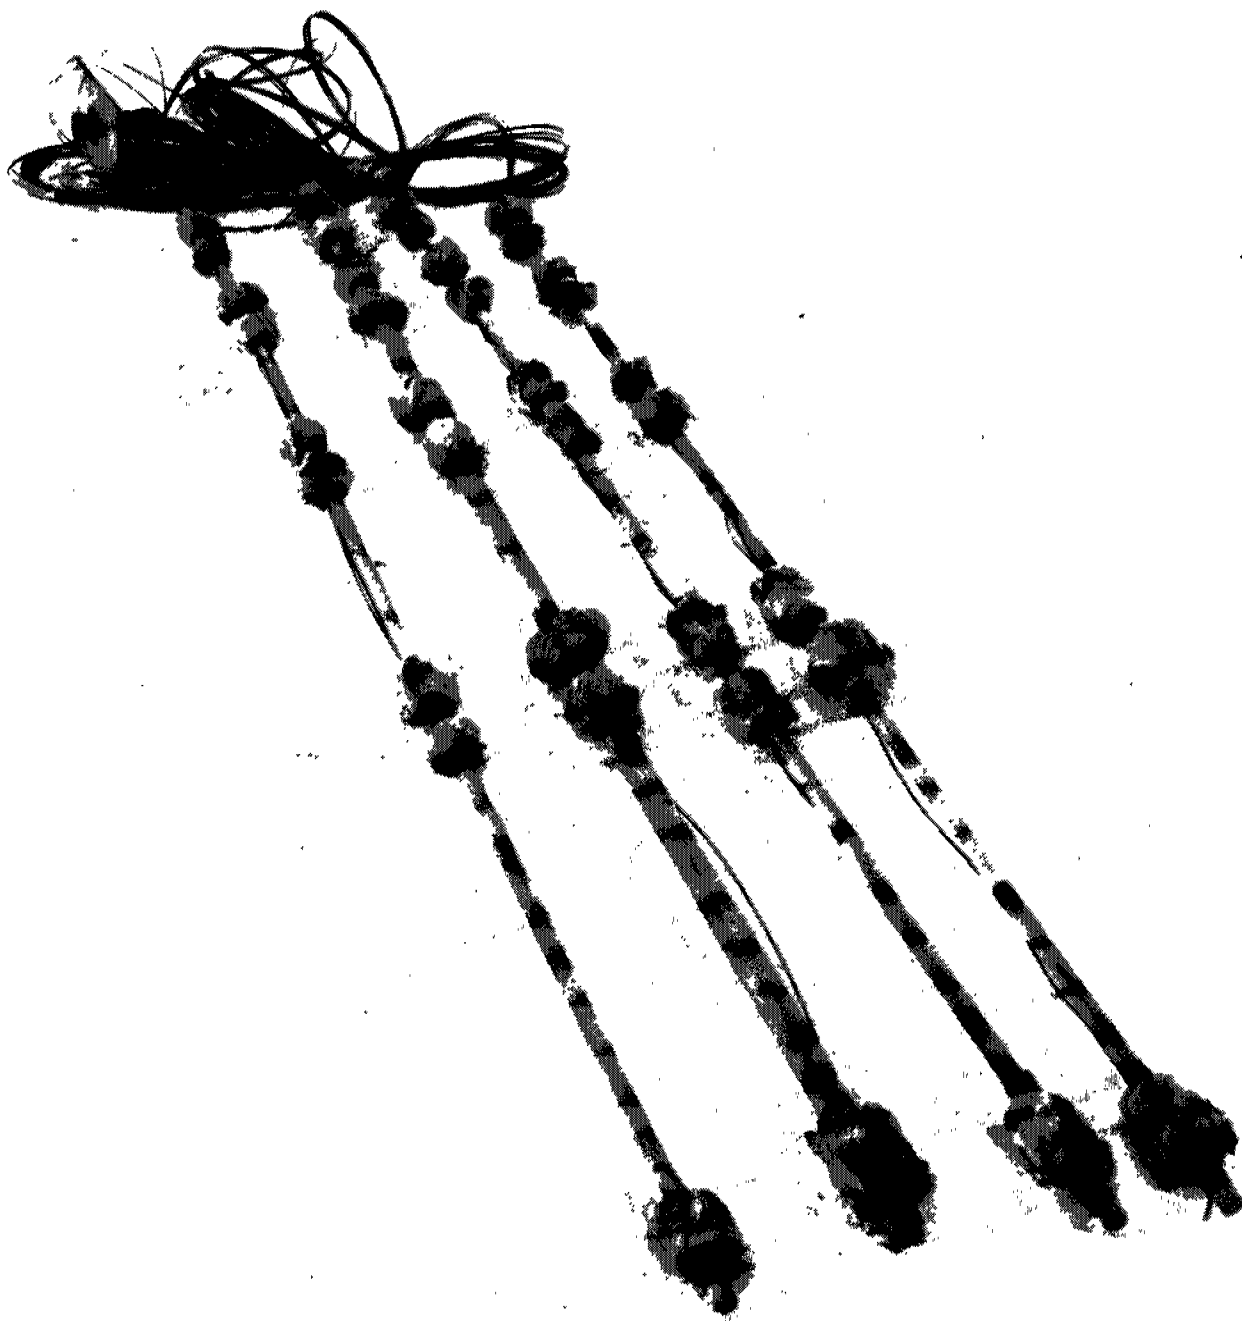
FIGURE 10. - Thermocouple Strings.

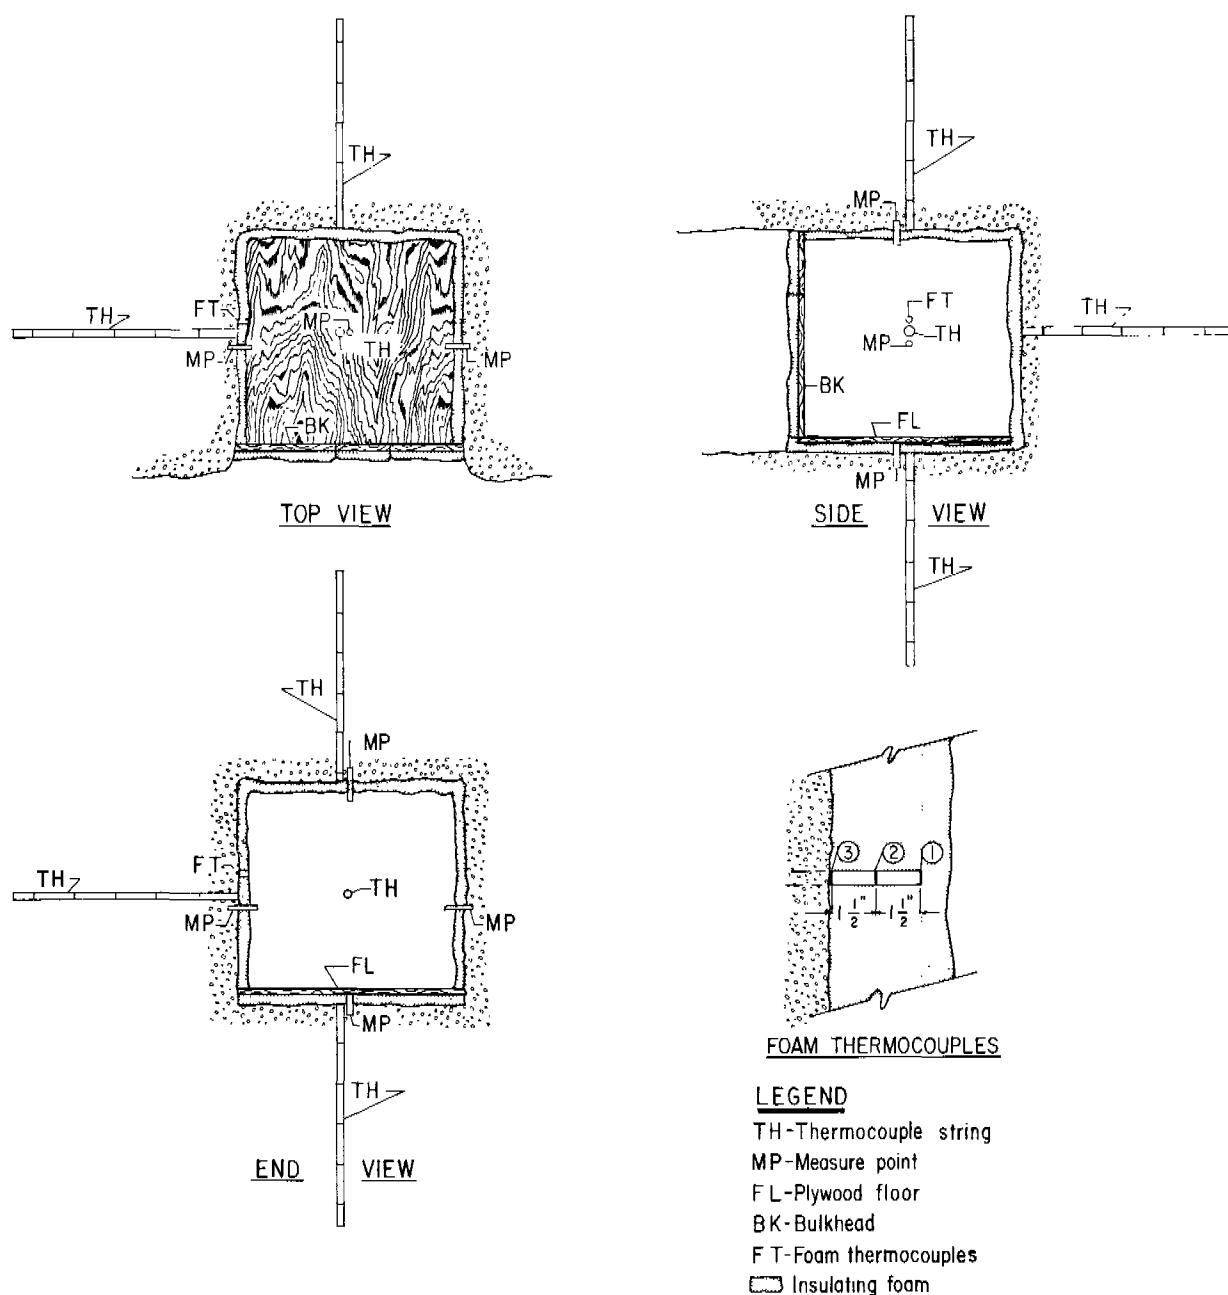
FIGURE 11. - Thermocouple and Closure-Point Location.

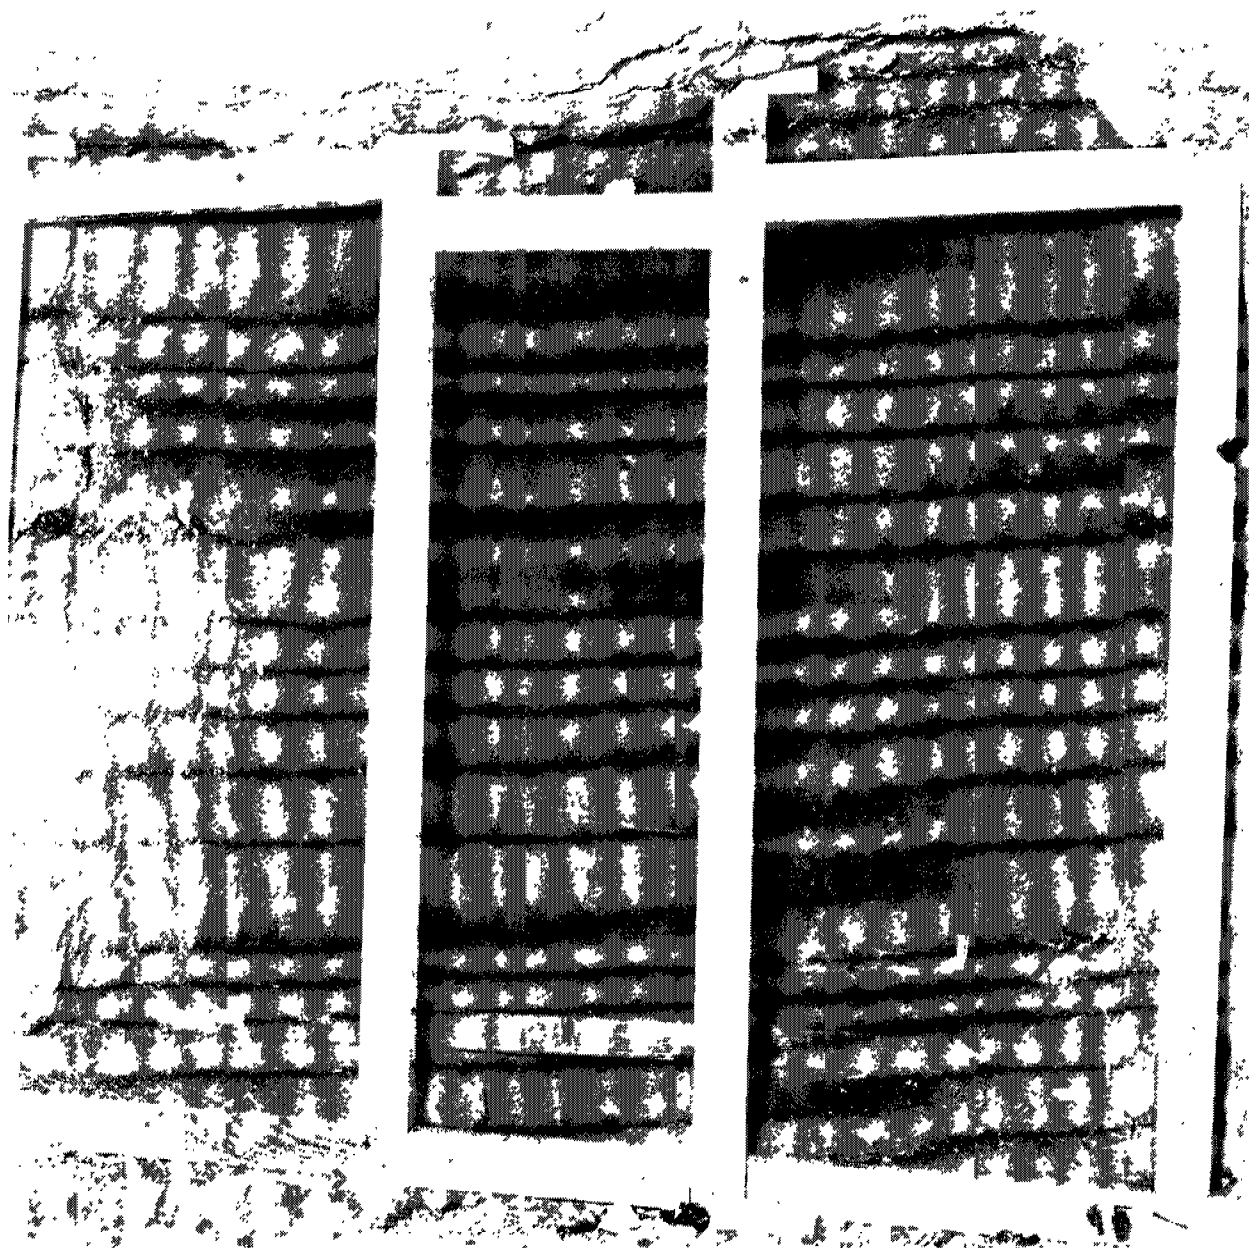
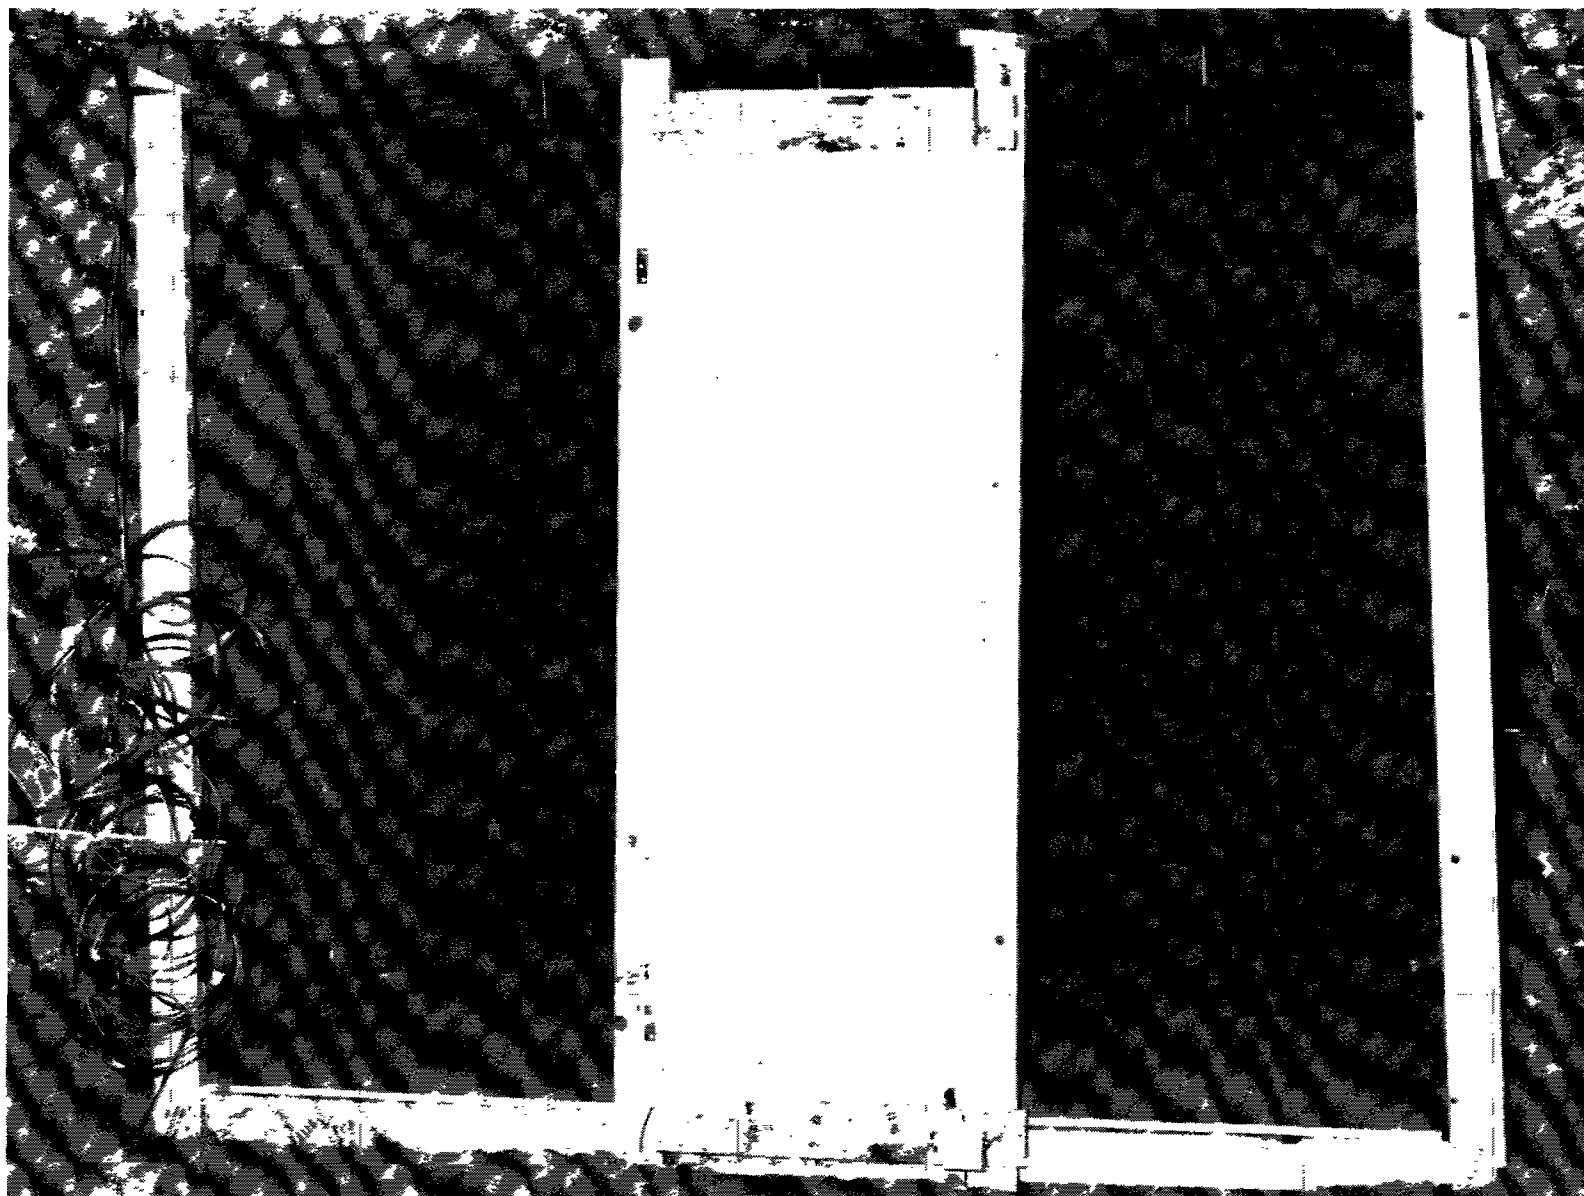
FIGURE 12. - Rooms Before Foaming. 4, Gravel room, showing sill stringers and bulkhead frame.

FIGURE 12. - Rooms Before Foaming. *B*, Silt room, showing door, floor, and thermocouple leads.

Bureau engineers followed the same procedure in foaming both rooms. First, the sill was foamed between and to the top of the 2- by 4-inch stringers, after which the plywood floor was laid over the stringers and nailed in place. The back, end wall, and side walls were foamed next, care being exercised to form a tight seal between walls and floor, and between walls and bulkhead framework. The 1/4-inch bulkhead then was nailed to the outside of the framework. Next, the bulkhead and door were foamed with a monolithic covering from outside the room (fig. 13).
