bureau of mines  
report of investigations 7392

SPRAY-APPLIED POLYURETHANE  
FOAM TO INSULATE HEATED ROOMS  
EXCAVATED IN PERMAFROST

June 1970

By K. Robert Dorman and Aldon E. Gooch

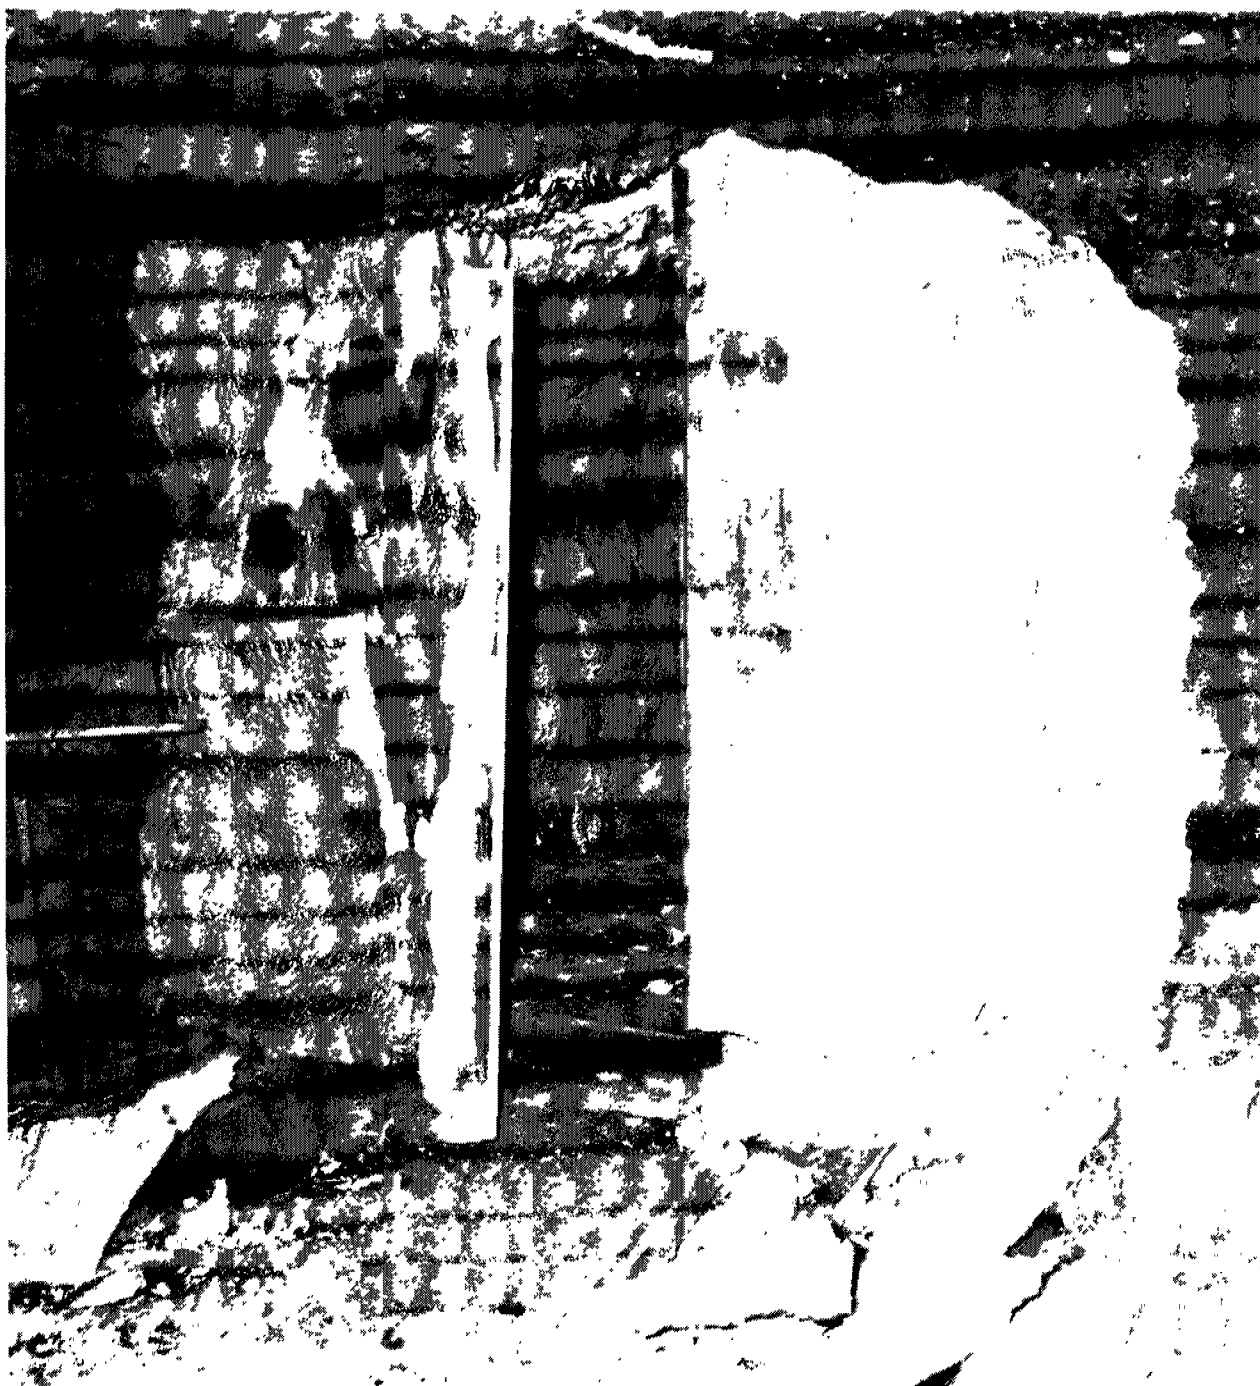
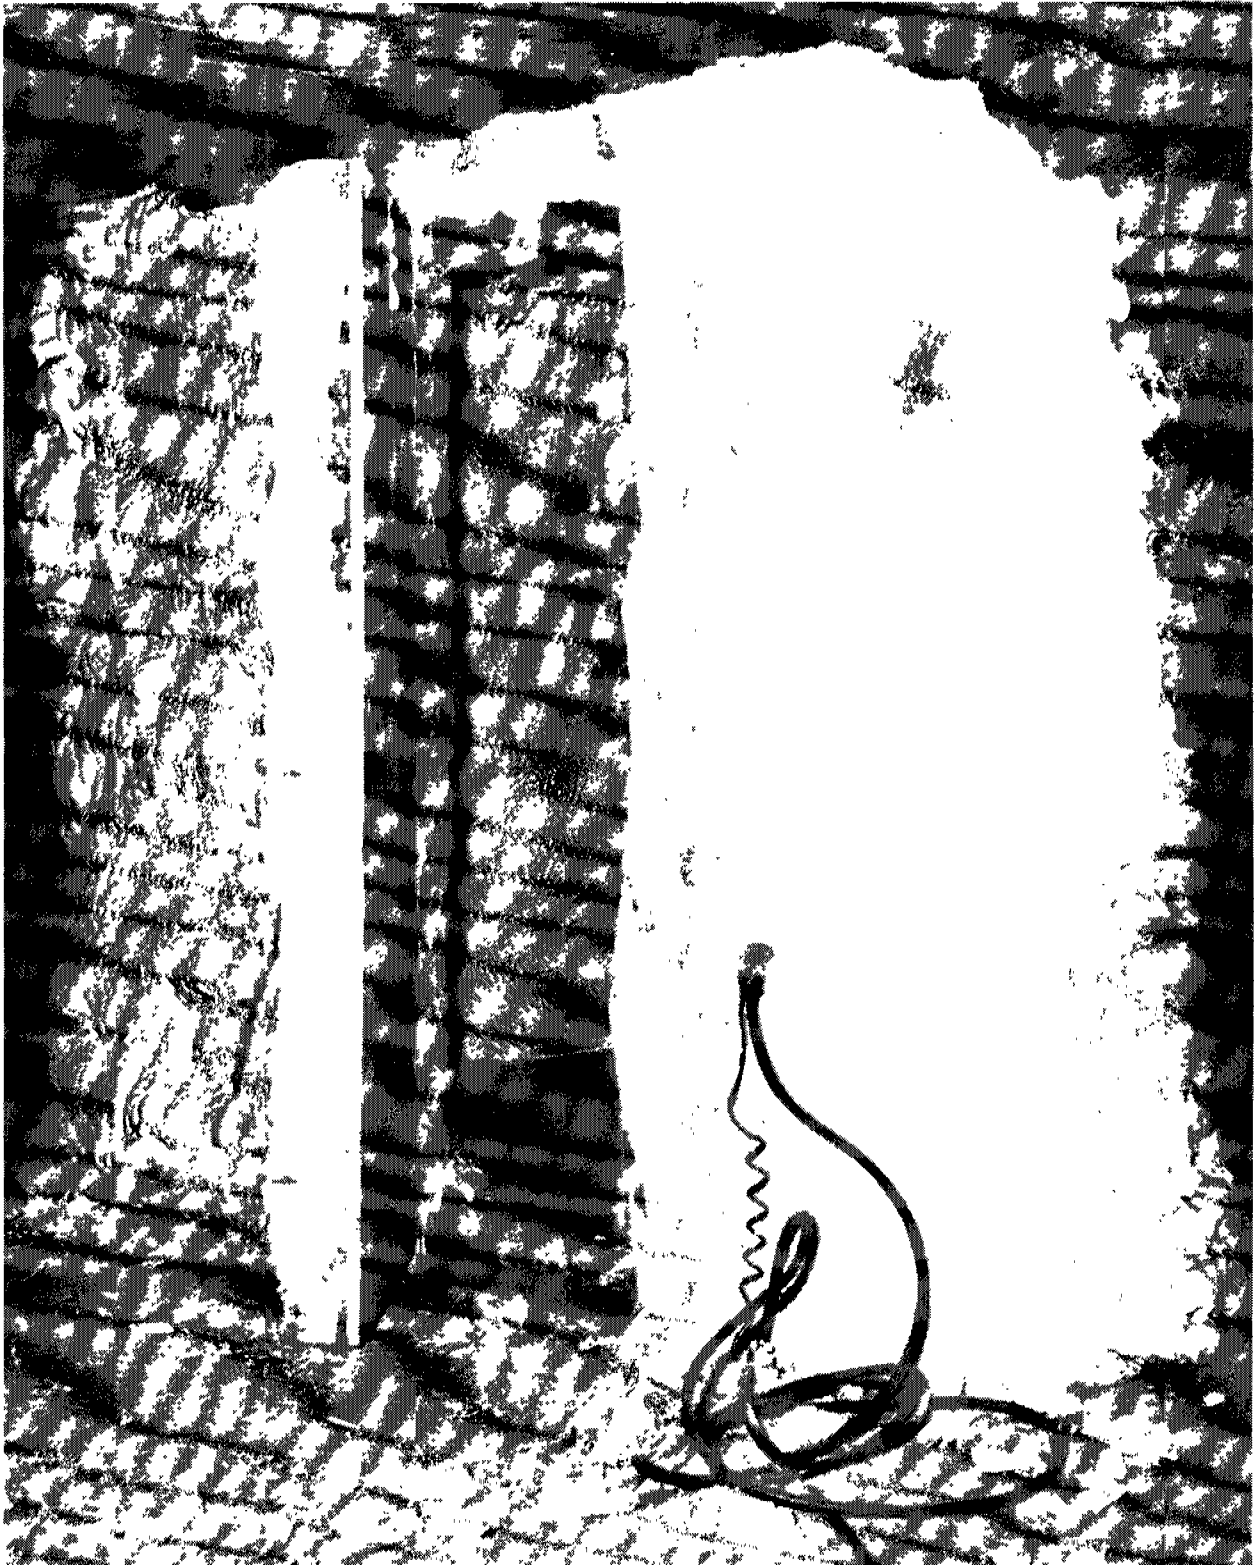
FIGURE 13. - Rooms After Foaming. A, Outside view of gravel room—bulkhead shaken by blasting.

FIGURE 13. - Rooms After Foaming. *B*, Outside view of silt room.

Bureau engineers followed the same procedure in foaming both rooms. First, the sill was foamed between and to the top of the 2- by 4-inch stringers, after which the plywood floor was laid over the stringers and nailed in place. The back, end wall, and side walls were foamed next, care being exercised to form a tight seal between walls and floor, and between walls and bulkhead framework. The 1/4-inch bulkhead then was nailed to the outside of the framework. Next, the bulkhead and door were foamed with a monolithic covering from outside the room (fig. 13).

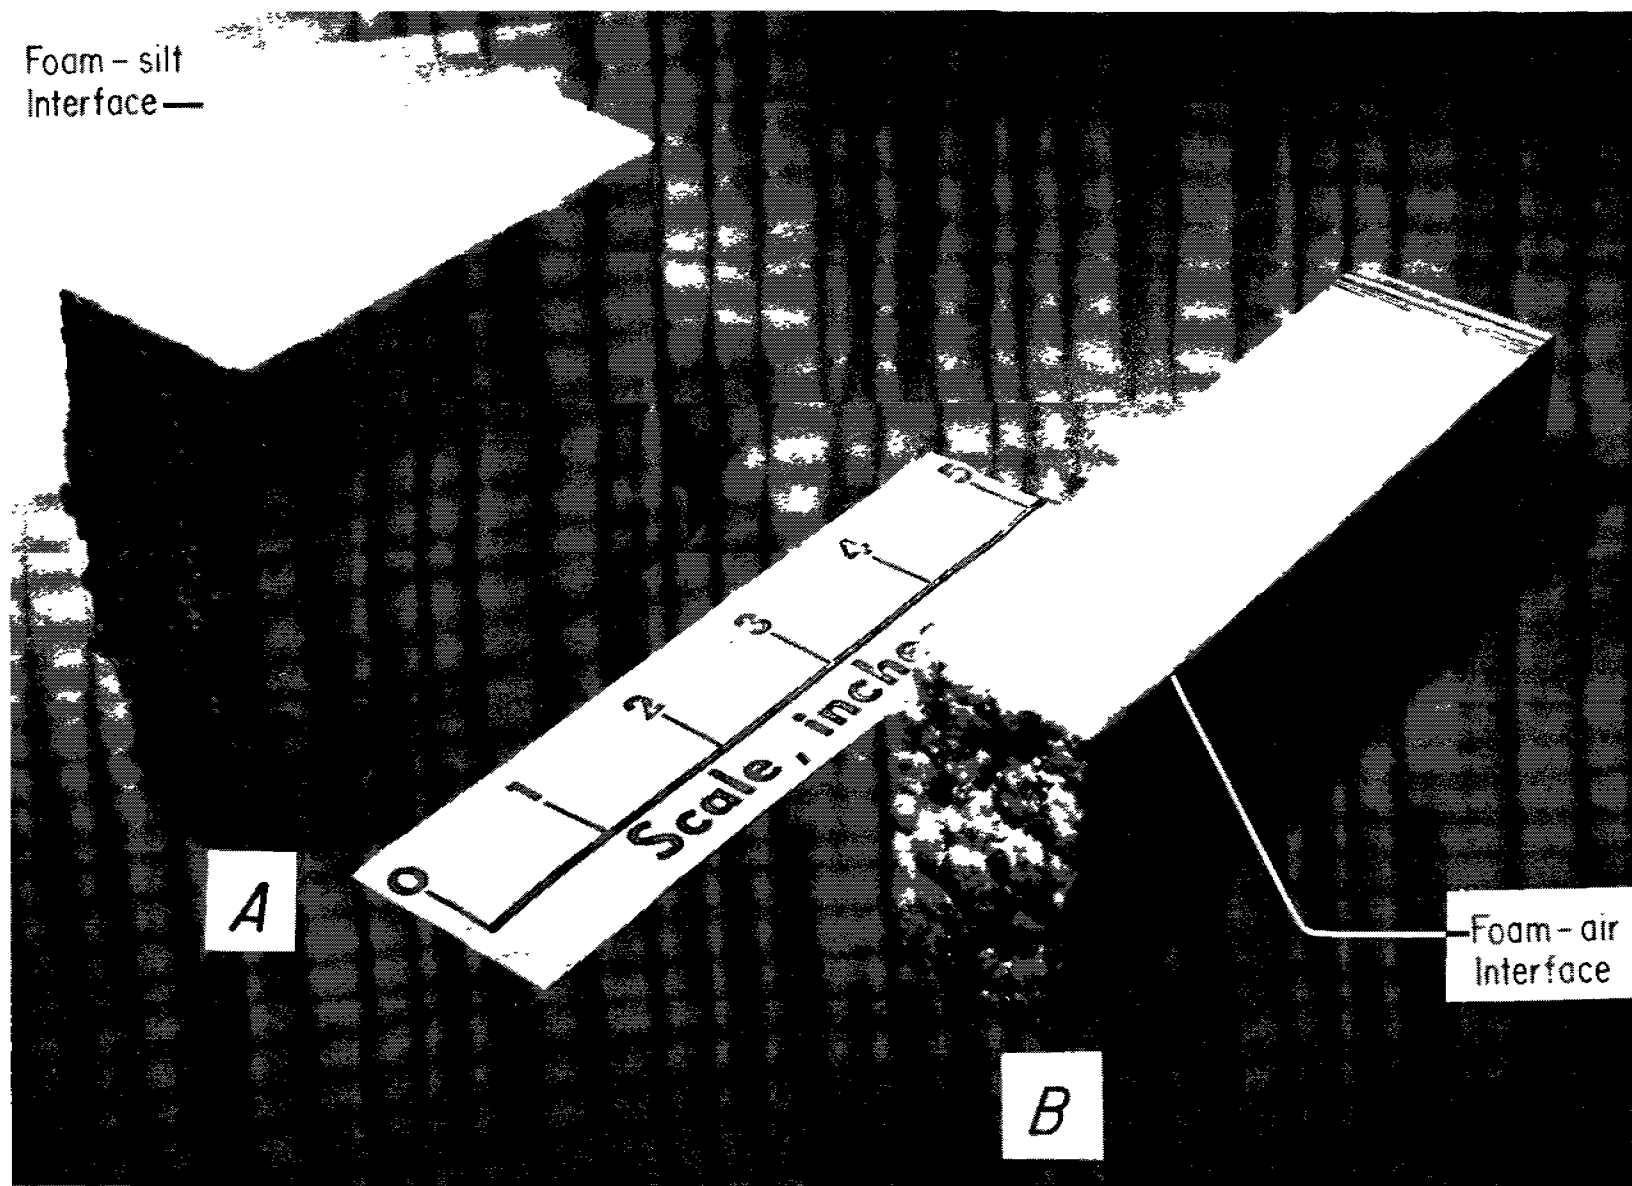
FIGURE 14. - Samples of Cured Foam. *A*, Sprayed on frozen silt; *B*, sprayed on bulkhead.

One observed property of the cured material could create difficulties with some types of applications. As the foam rises and hardens, considerable stresses evidently are produced within the material. When the material was being trimmed from around the door of the gravel room, a system of cracks, running to the extremities of the bulkhead, instantaneously developed radially from the point where the knife first penetrated the foam layer. The cracks later were filled with conventional rock-wool insulation. No cracking was observed, however, in the foam that was in contact with the frozen ground.

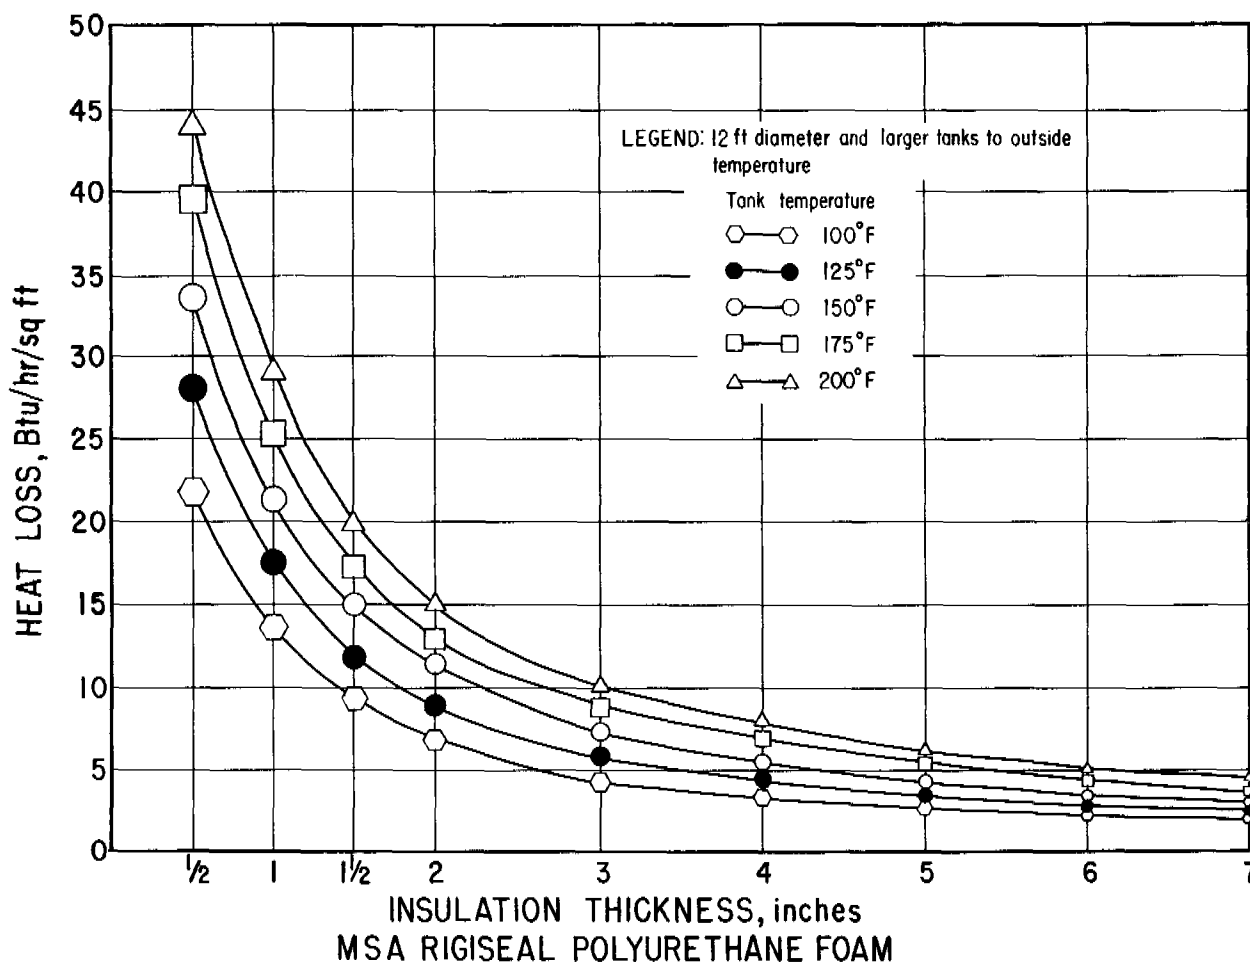
FIGURE 15. - Effect of Insulation Thickness on Heat Loss.

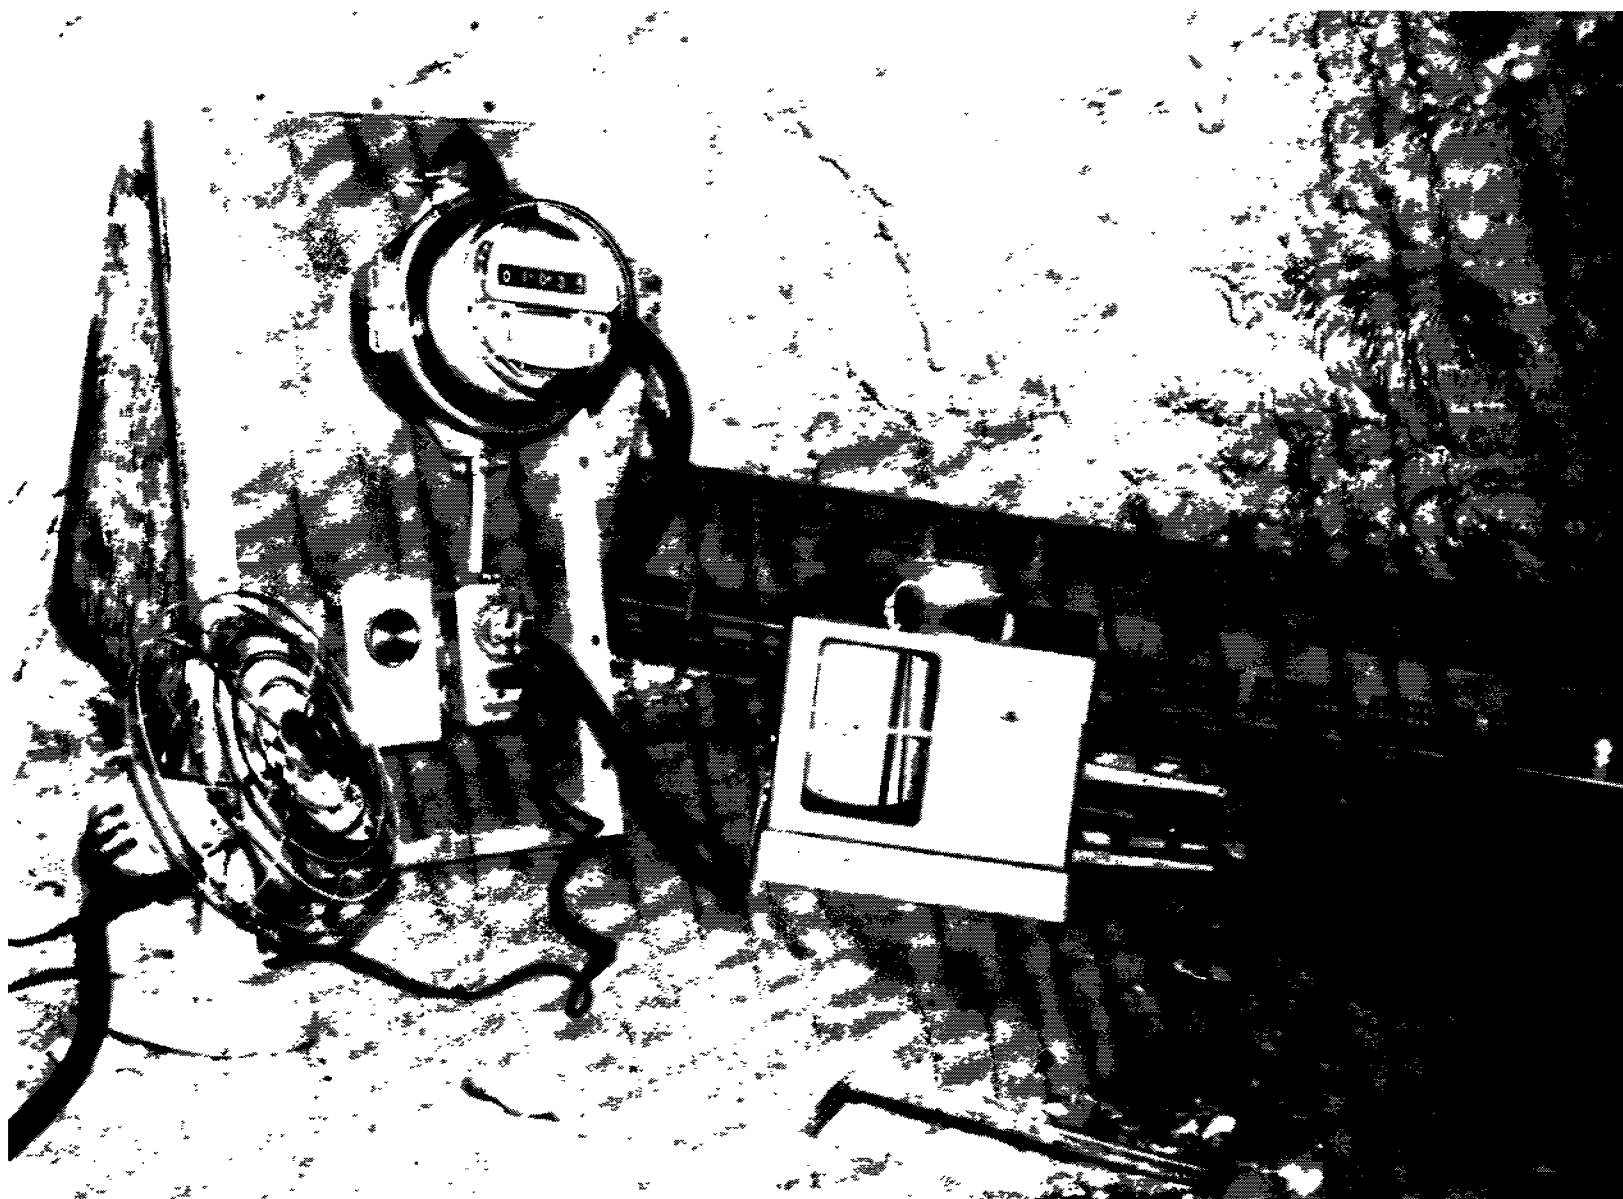
FIGURE 16. - Heating and Monitoring Equipment Inside Foamed Room.

The day following application, the foam was cut and trimmed from around the doors. A strip heater, fan, watt-hour meter, and thermograph (fig. 16) were installed in each room, and initial temperature and closure readings were made. Heat was introduced in the silt room on January 27, 1969, and in the gravel room on February 20, 1969.

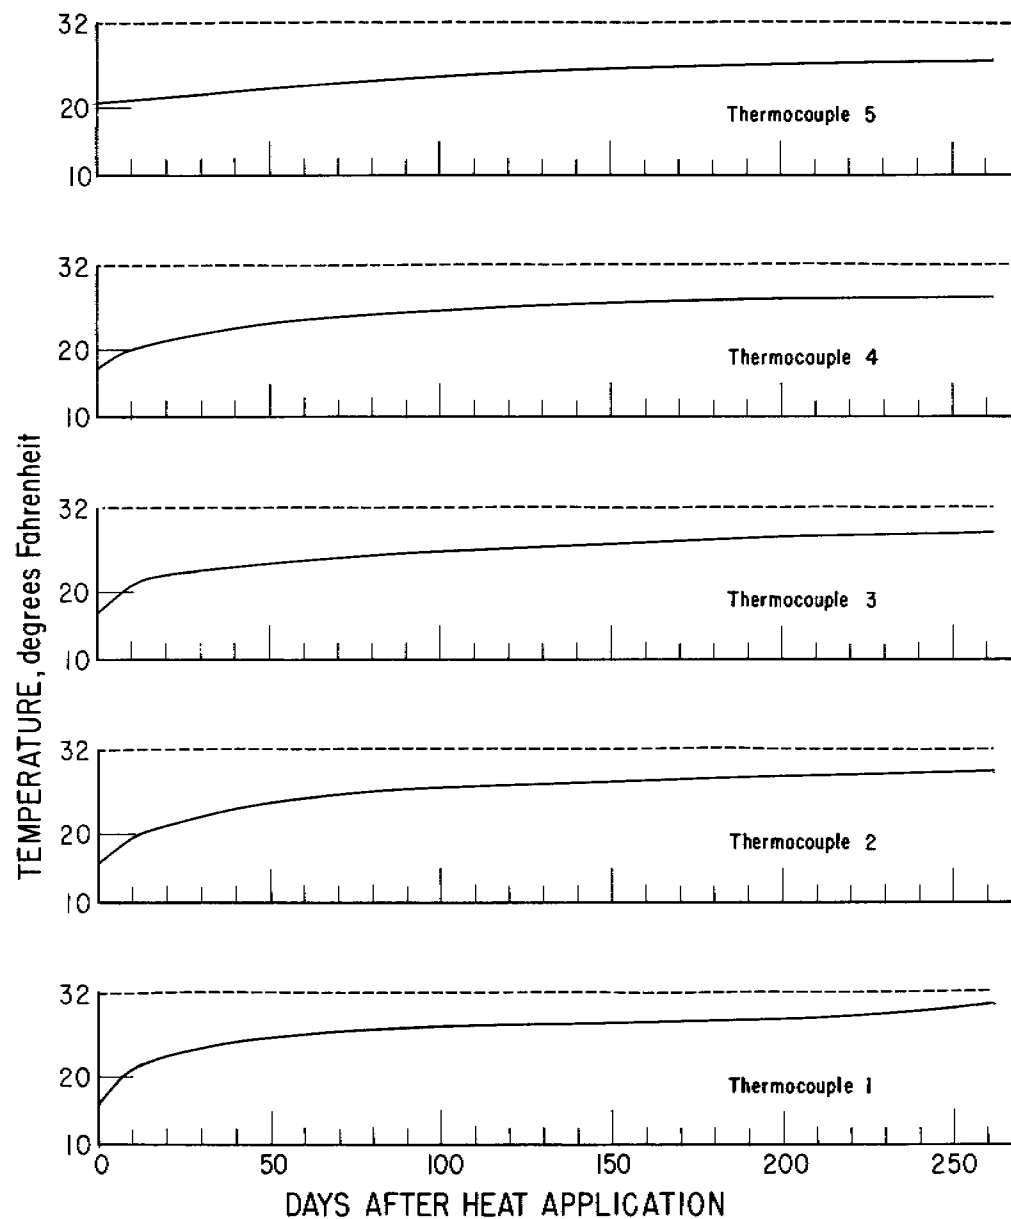
FIGURE 18. - Thermocouple Readings, Back of Silt Room.

Temperatures maintained in the silt and gravel rooms averaged  $57^{\circ}$  and  $51^{\circ}$  F, respectively. The transfer of heat across the insulating barrier and its migration into the frozen walls are shown by thermocouple readings in figures 18-27. A comparison of the graphs indicates that the walls of the silt room were colder than those of the gravel room at the time of insulation; the reason was that the silt room was excavated on December 4, 1968, the gravel room excavated on January 13, 1969, and the rooms were foamed on January 21, 1969. This difference in original temperatures is reflected in the greater rate of closure and total closure in the gravel room. Closures for the period between June 6, 1969 (the date the new invar measuring rod was first used), and September 23, 1969 (the day following discontinuation of heating in the gravel room), are presented in figure 28. The rate of horizontal closure increased in both rooms about the first of September. During the middle of August, vertical closure in the gravel room accelerated. It is not established whether vertical closure rate also increased in the silt room, for at this time vertical closure readings were discontinued in this room because the height had become too small to accommodate the measuring device.

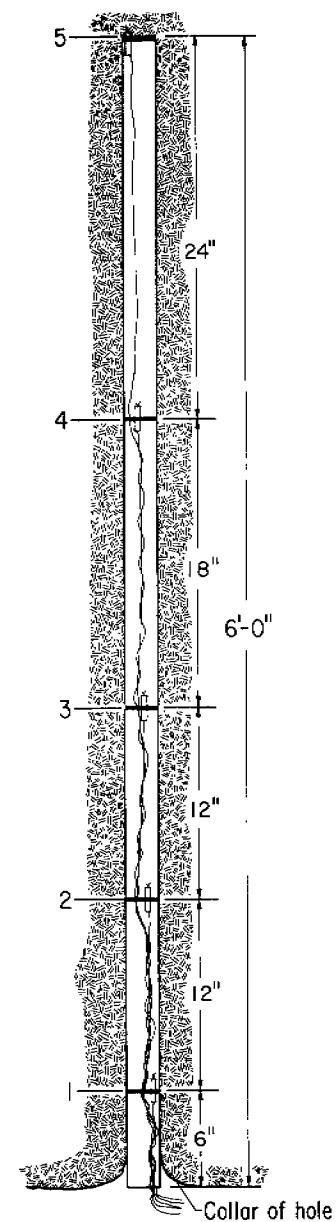
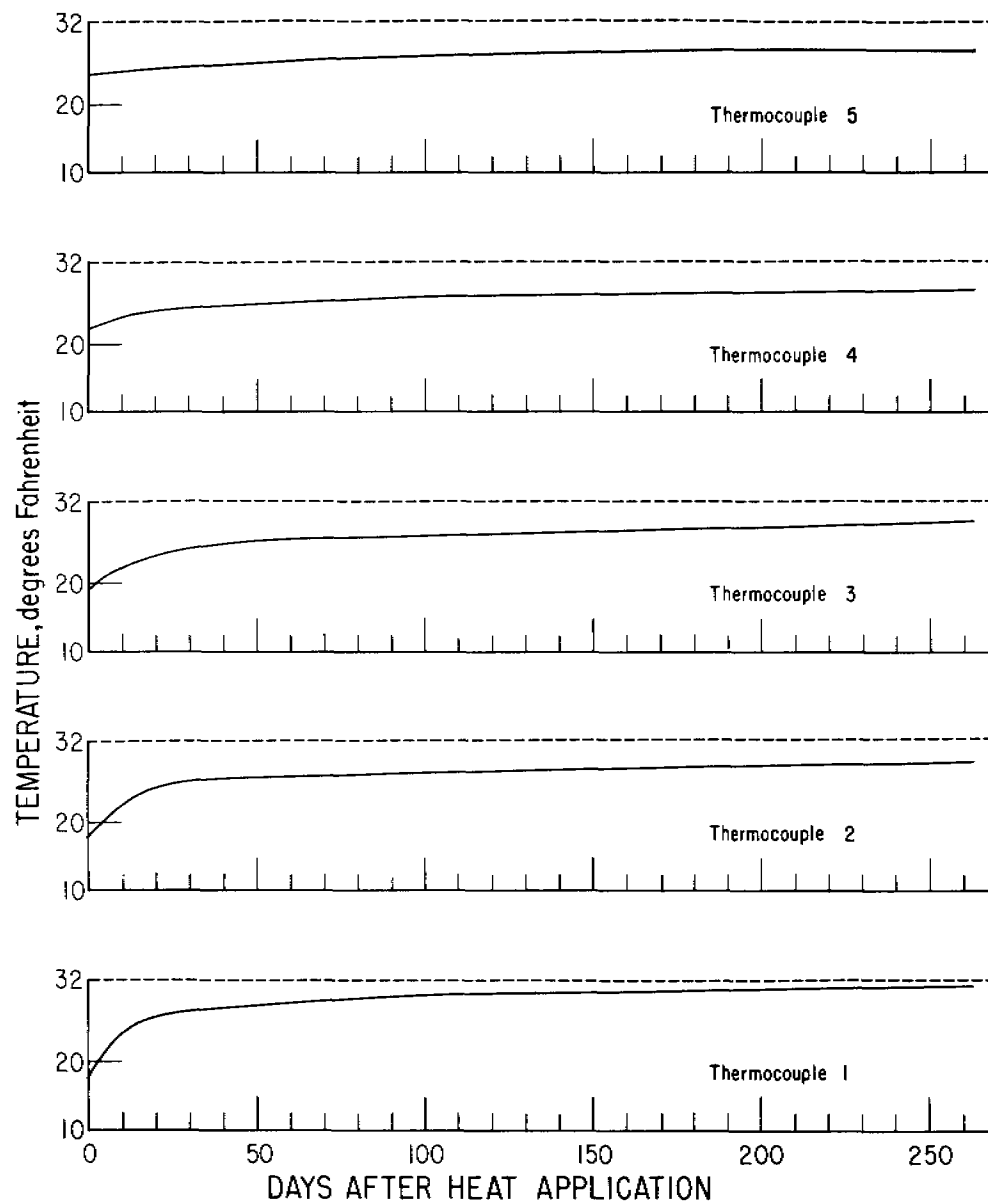
FIGURE 19. - Thermocouple Readings, End Wall of Silt Room.

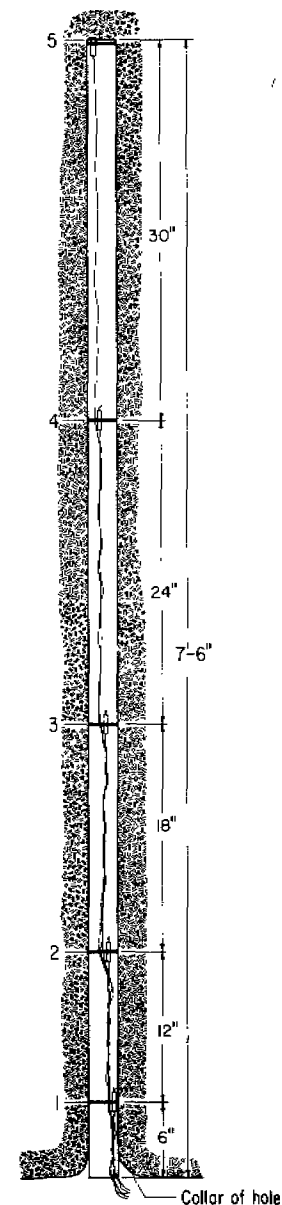
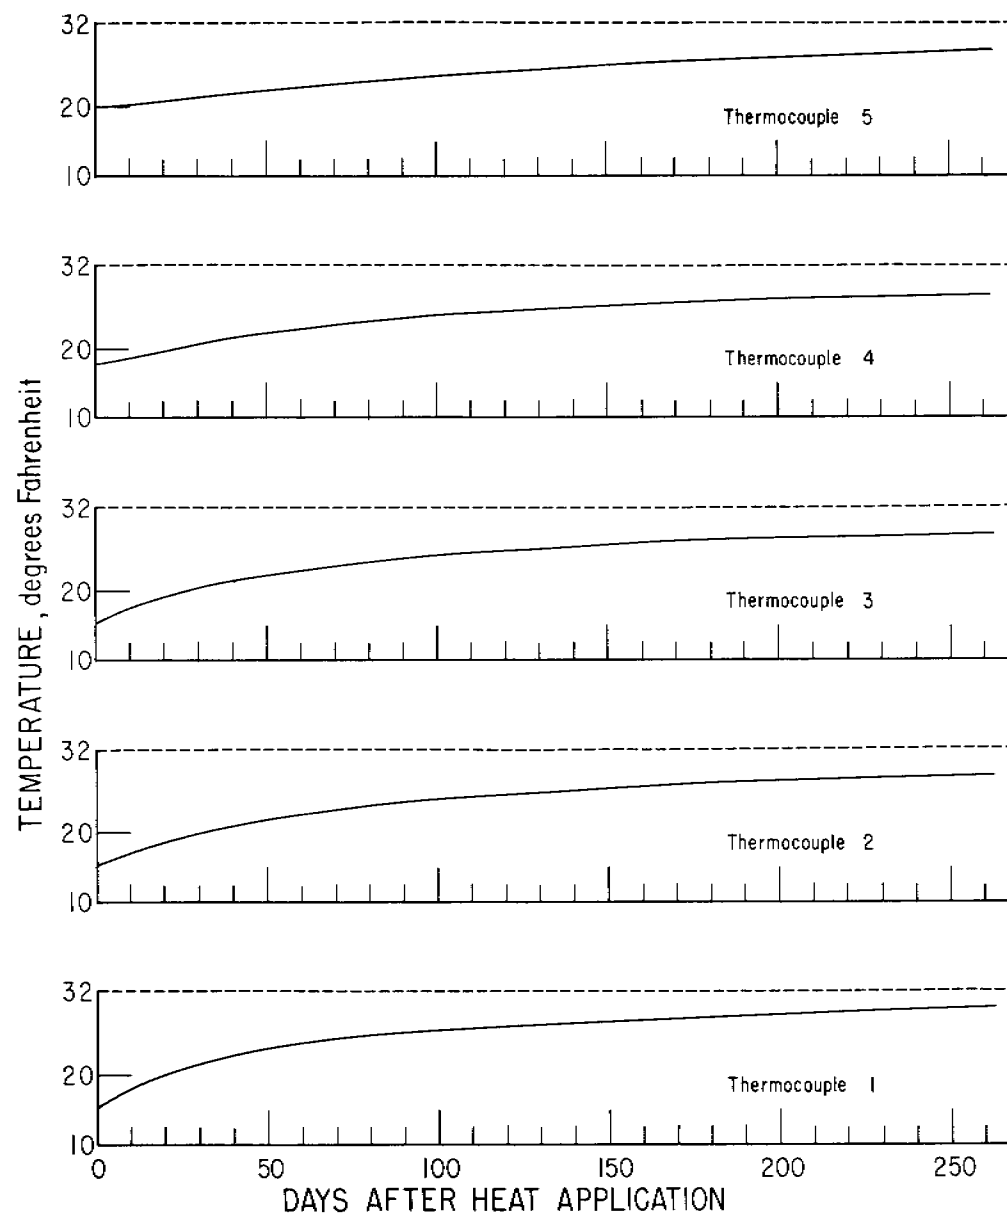
FIGURE 20. - Thermocouple Readings, Side Wall of Silt Room.

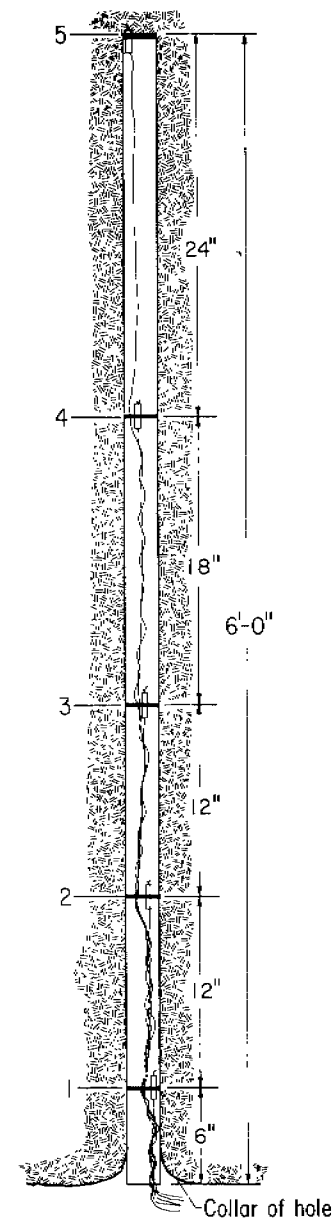
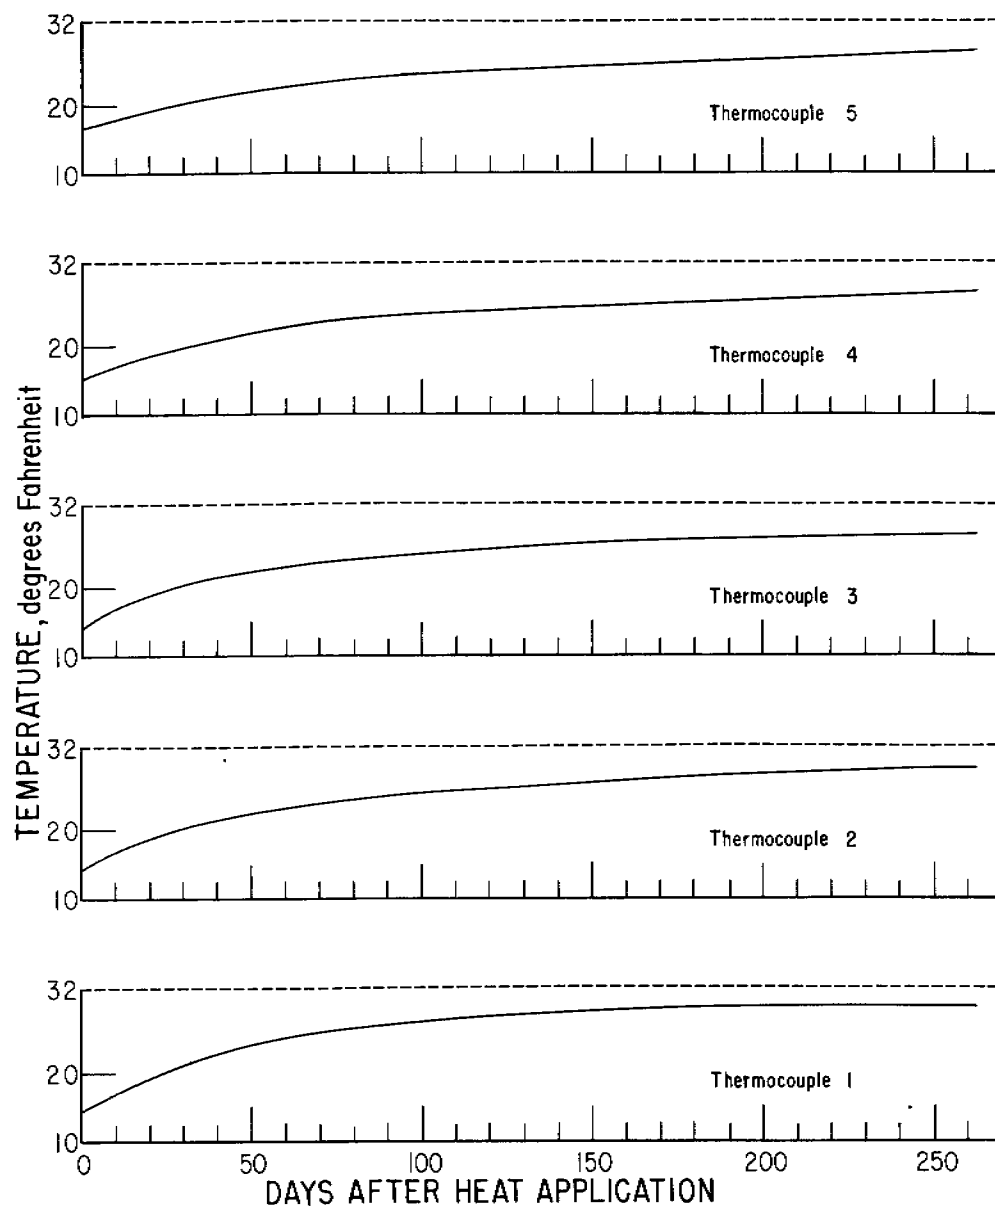
FIGURE 21. - Thermocouple Readings, Sill of Silt Room.

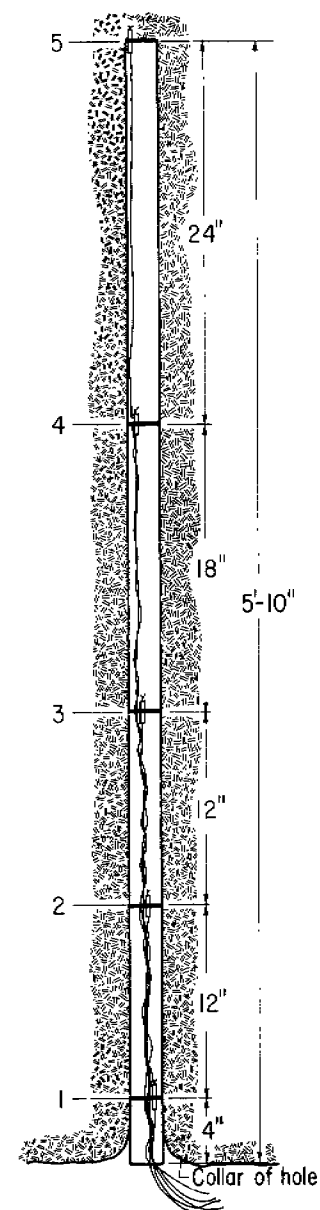
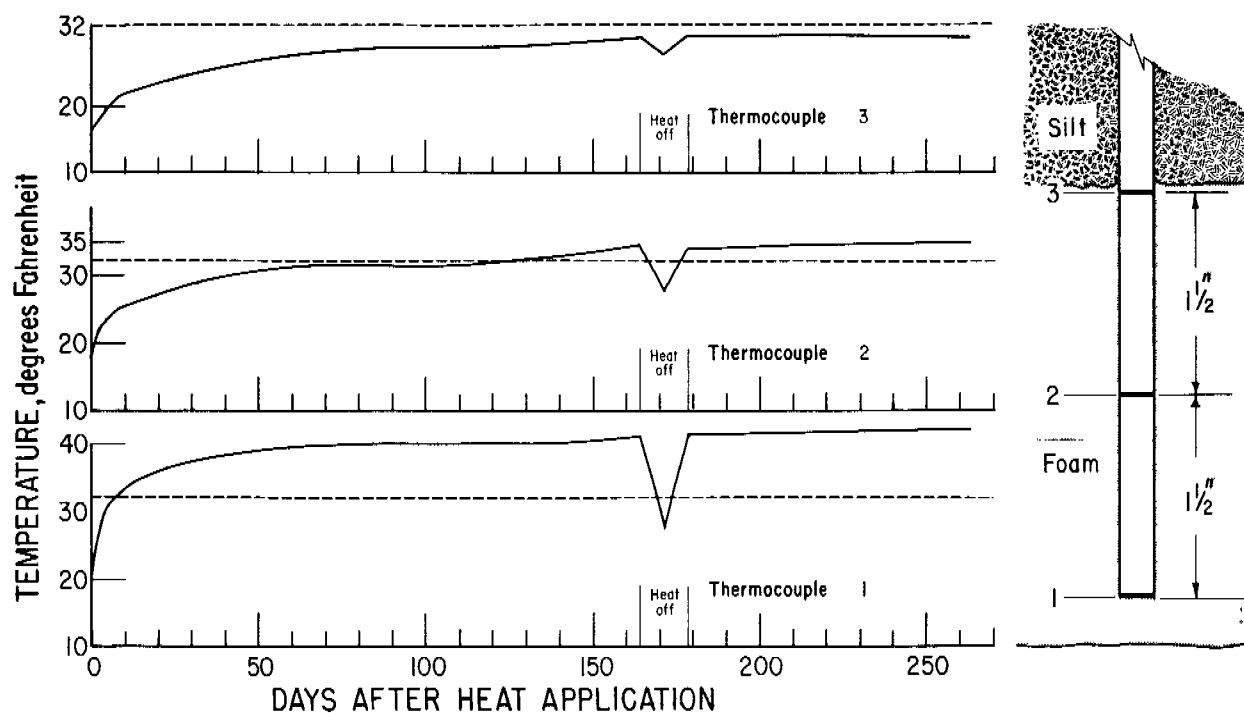
FIGURE 22. - Thermocouple Readings, Insulation in Silt Room.

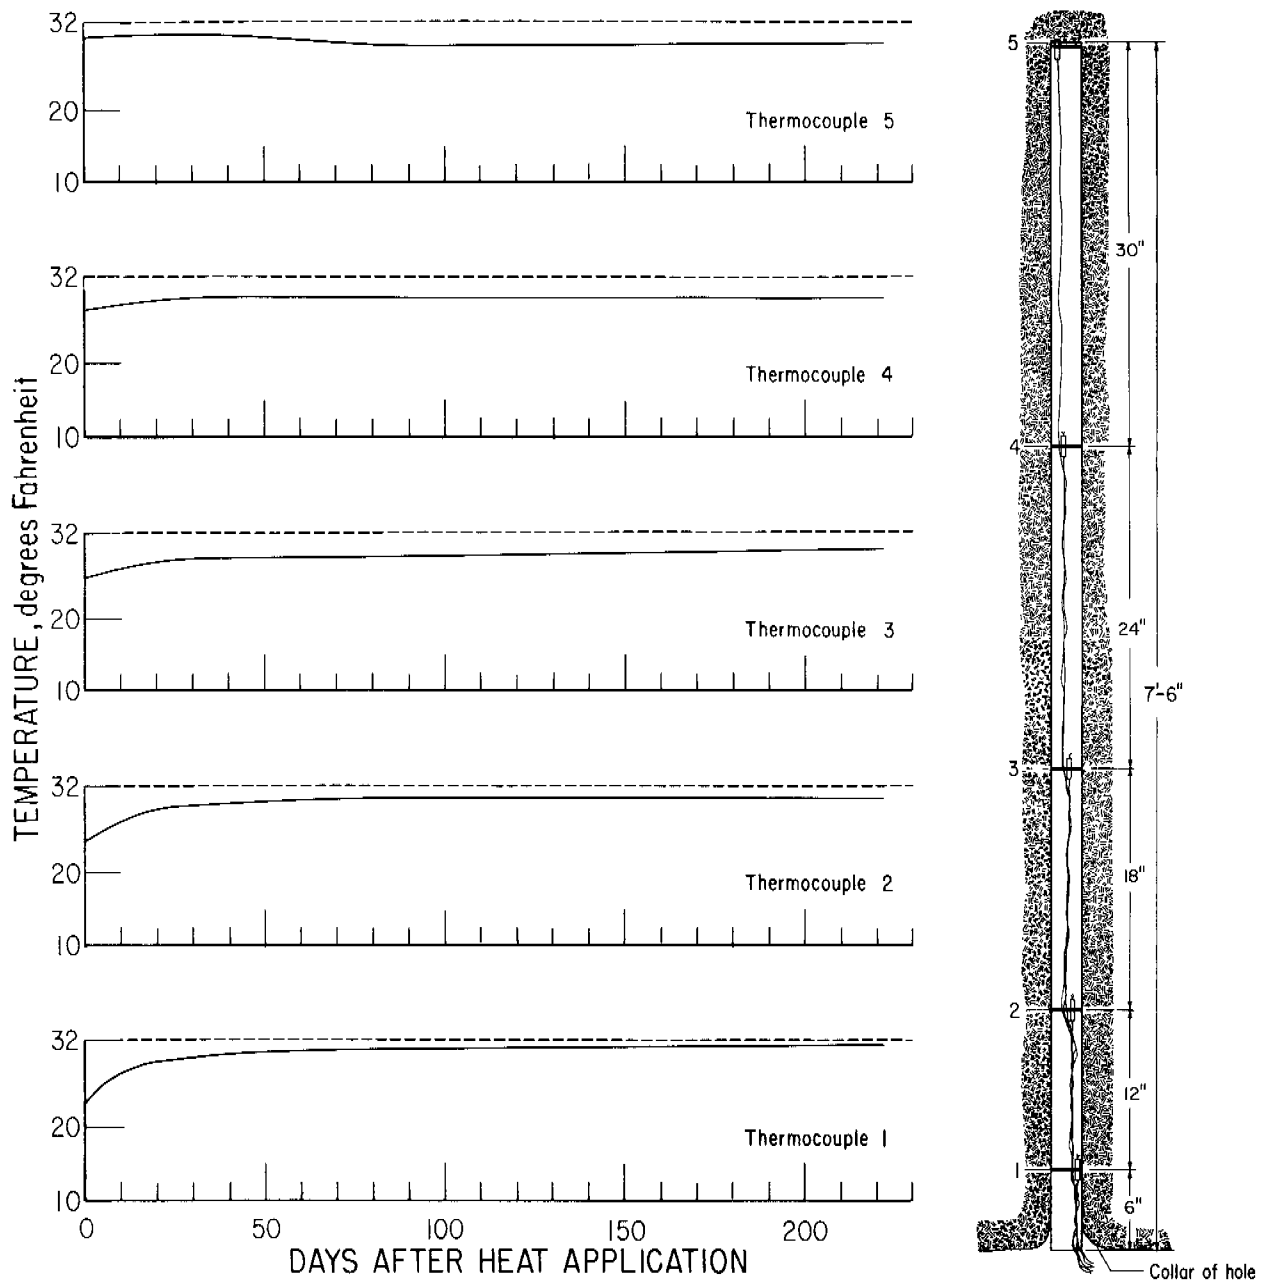
FIGURE 23. - Thermocouple Readings, Back of Gravel Room.

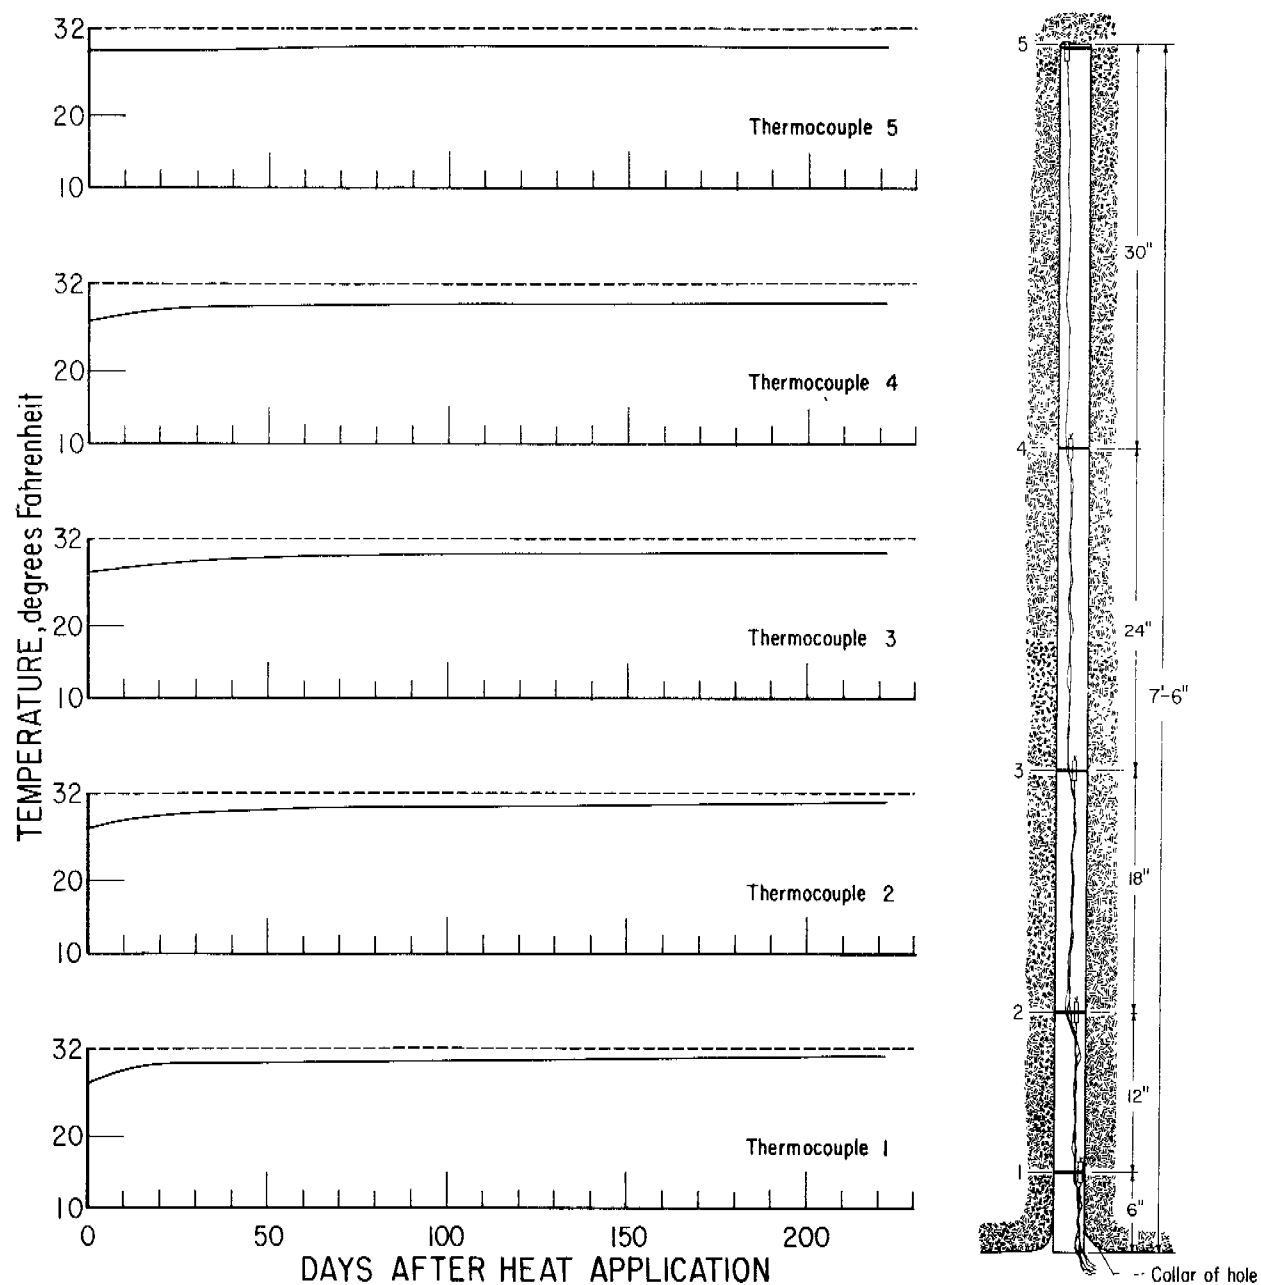
FIGURE 24. - Thermocouple Readings, End Wall of Gravel Room.

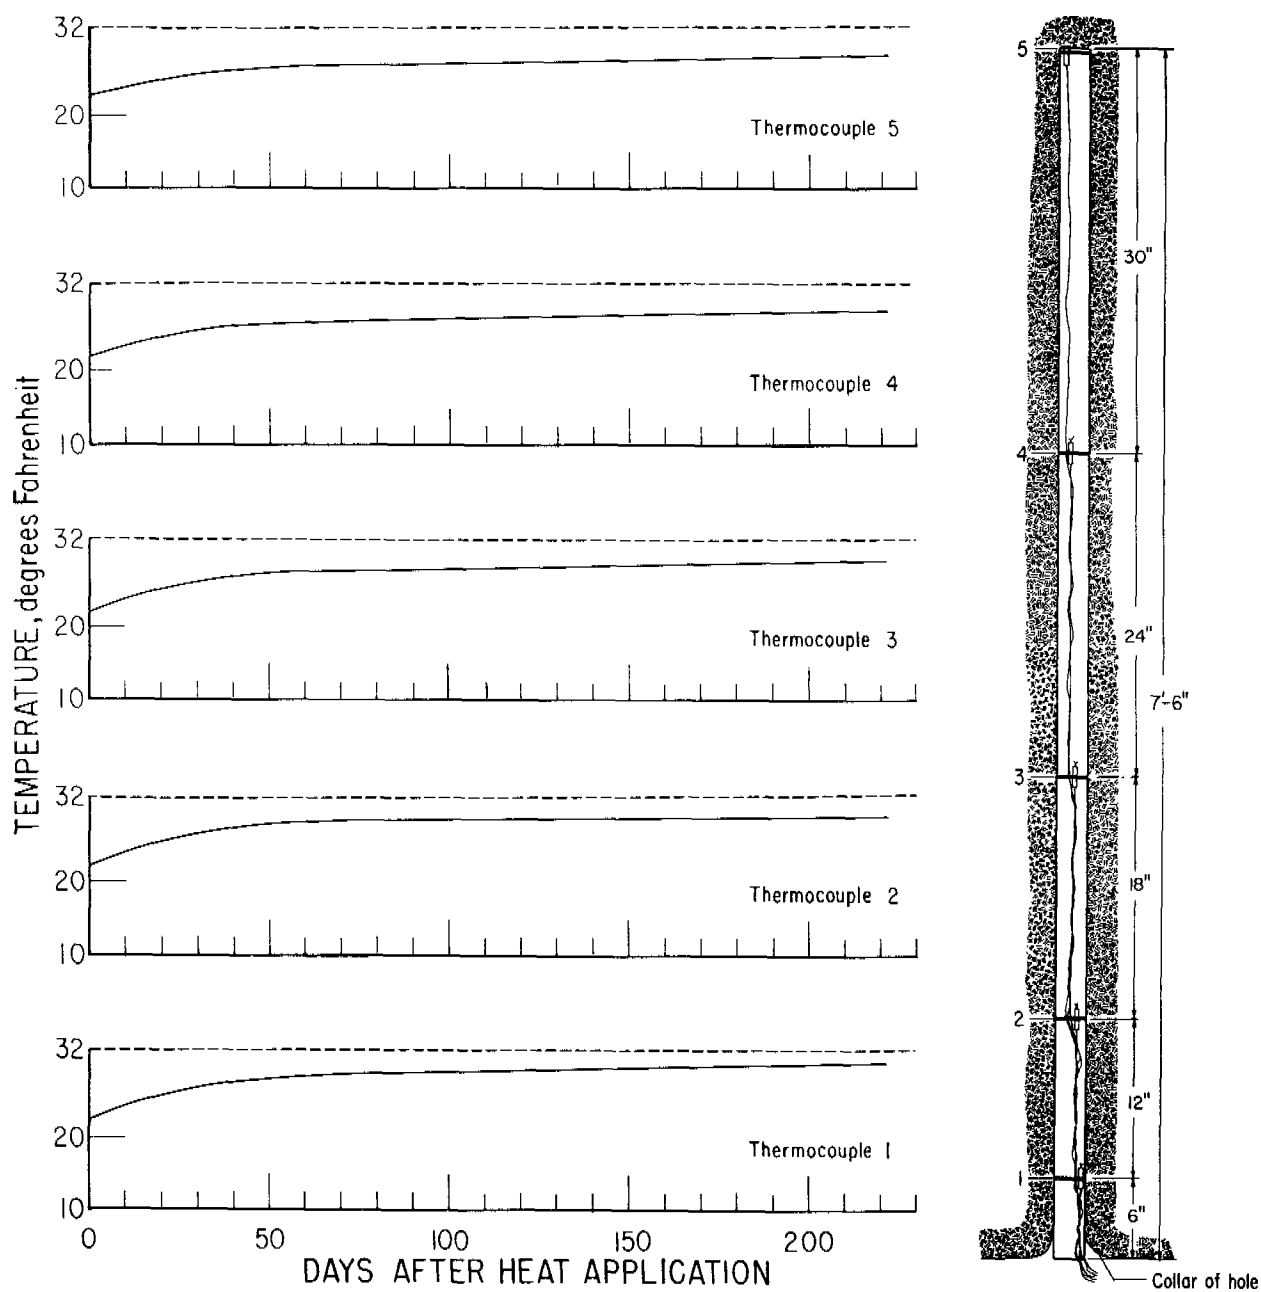
FIGURE 25. - Thermocouple Readings, Side Wall of Gravel Room.
