bureau of mines  
report of investigations 7392

SPRAY-APPLIED POLYURETHANE  
FOAM TO INSULATE HEATED ROOMS  
EXCAVATED IN PERMAFROST

June 1970

By K. Robert Dorman and Aldon E. Gooch

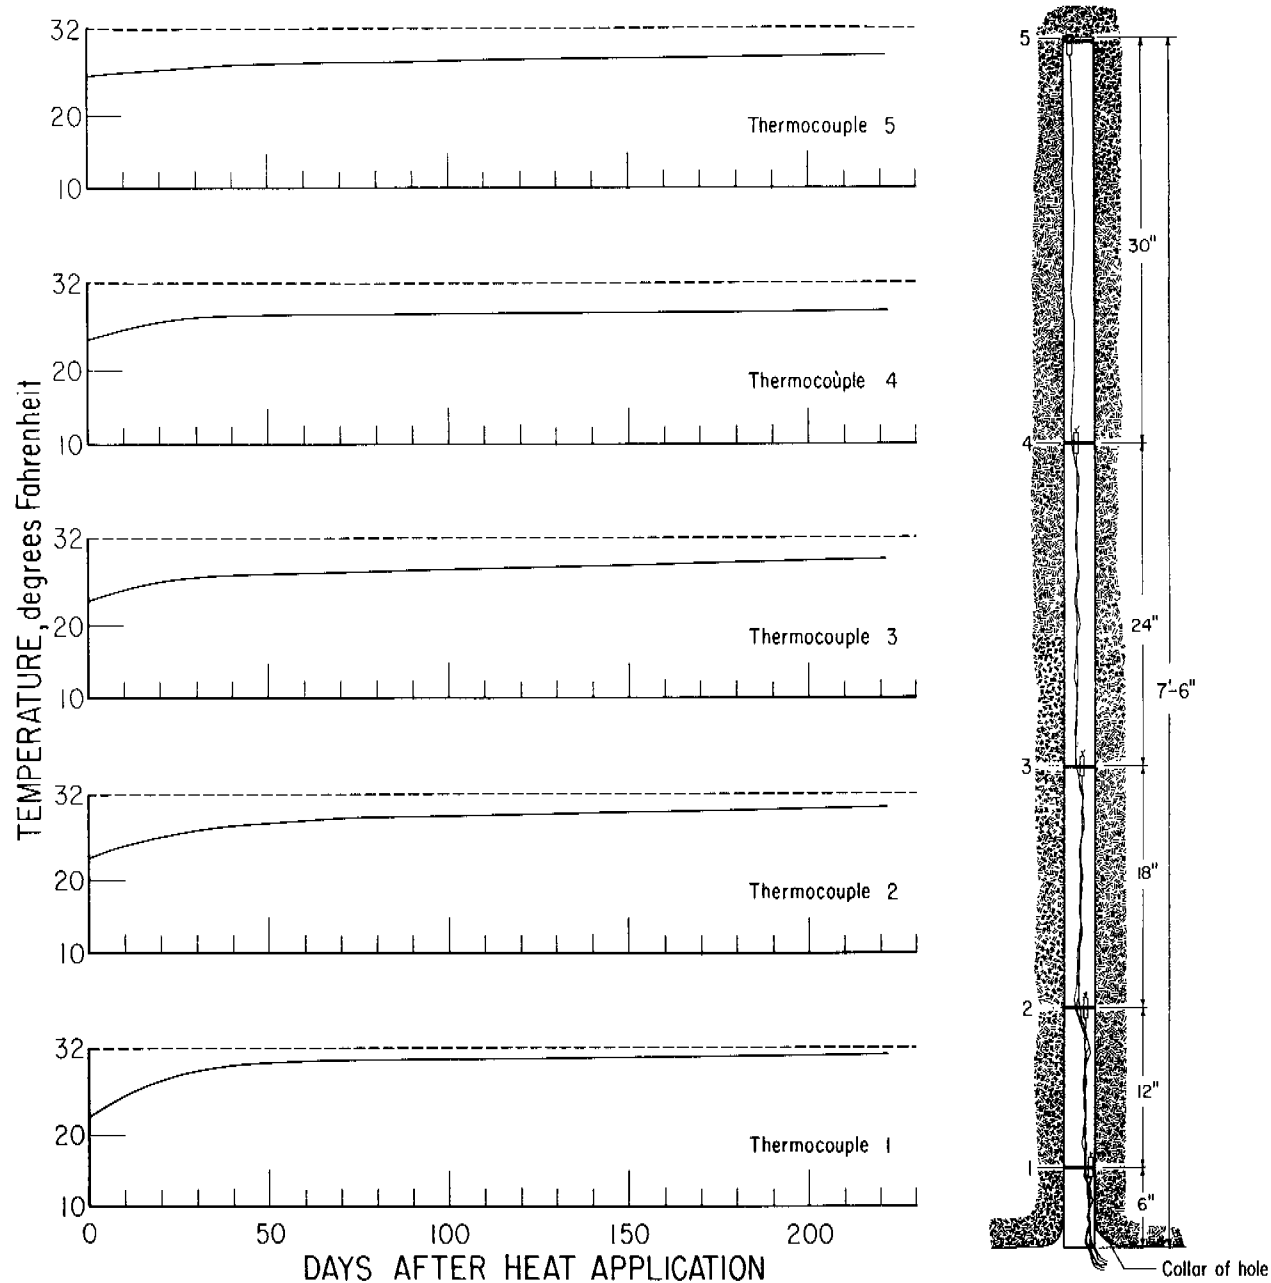
FIGURE 26. - Thermocouple Readings, Sill of Gravel Room.

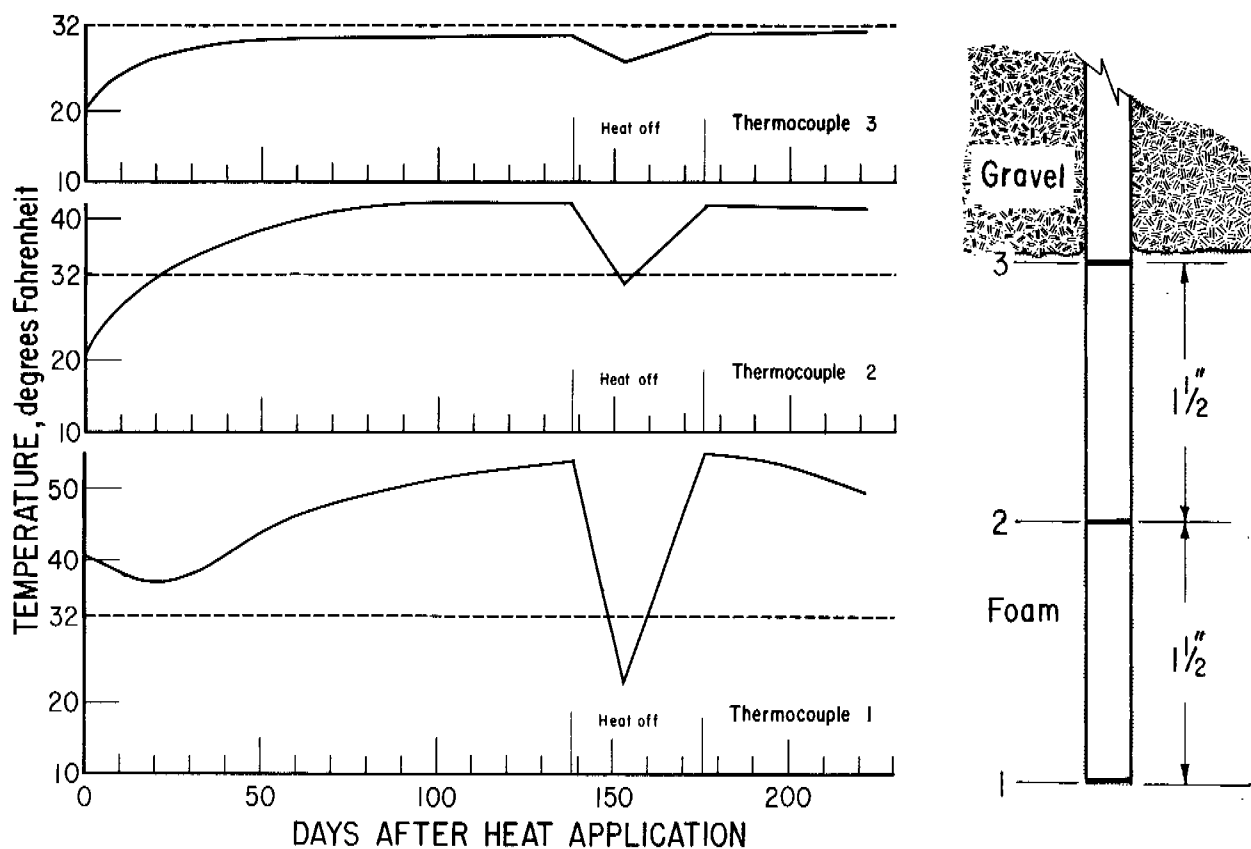
FIGURE 27. - Thermocouple Readings, Insulation in Gravel Room.

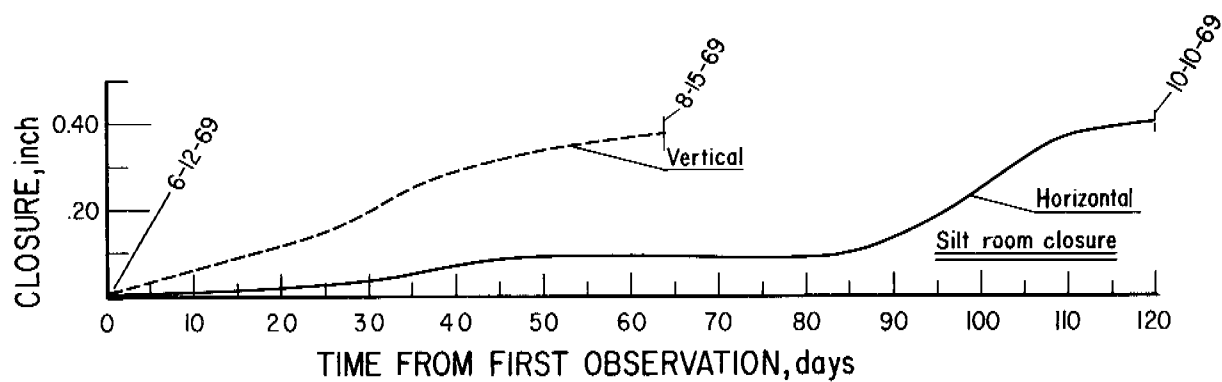
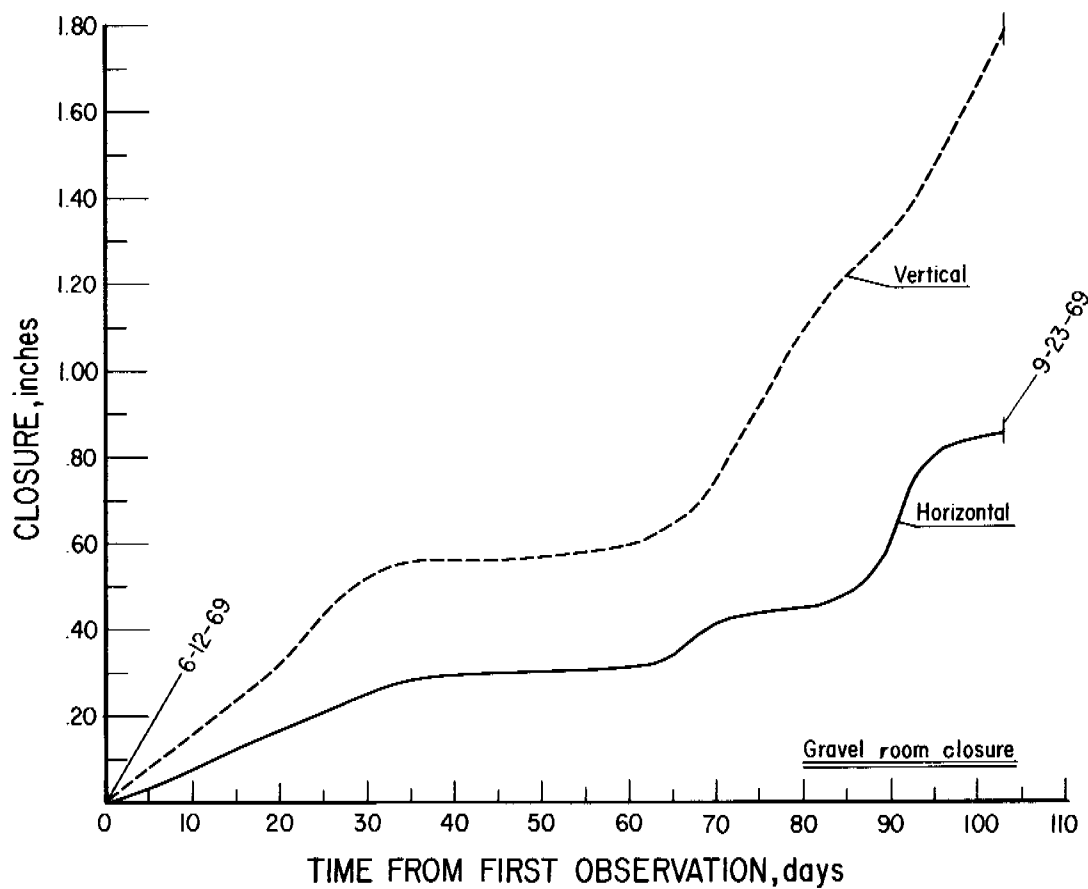
FIGURE 28. - Closure of Heated Insulated Rooms.

An analysis of temperature reading in the walls indicates no apparent reason for the increases in closure rates in either foamed room. On August 7, 1969, the room adjacent to the foamed gravel room (fig. 9) was bulkheaded to allow ambient-air temperature to rise from 25° (result of refrigeration) to 28° F. As a direct consequence of air-temperature rise, the larger room exhibited an increase in vertical closure rate beginning the middle of August. This acceleration of closure in the larger adjacent room undoubtedly affected the closure rate of the foamed gravel room. However, no explanation has been found for the increase in horizontal closure rates of both foamed rooms approximately 2 weeks later.

Total closures from February 12 to October 24, 1969, as measured by steel tape, are given in table 5. Vertical closure of the gravel room was 2.4 times that of the silt room. Horizontal closure was 5.9 times that of the silt room. At least part of this difference can be attributed to the fact that the walls of the silt room were colder than those of the gravel room at the time insulation was applied. This condition still existed when heating and monitoring were discontinued. Figure 29 shows the effect of temperature on the strain of a frozen Manchester fine sand which is under compressive loading. The graph was constructed mathematically, using data derived by Sayles (8). The values are based upon an assumed 200 feet of overburden, averaging 120 pcf, acting over a 6-month period. Though these strain values are based upon laboratory results of unconfined compression tests on sand, the effect of temperature upon roof or wall closure in the silt and gravel rooms would be similar. Other factors that probably contributed to the differences in closure were differences in insulation thickness and physical properties of the surrounding medium.

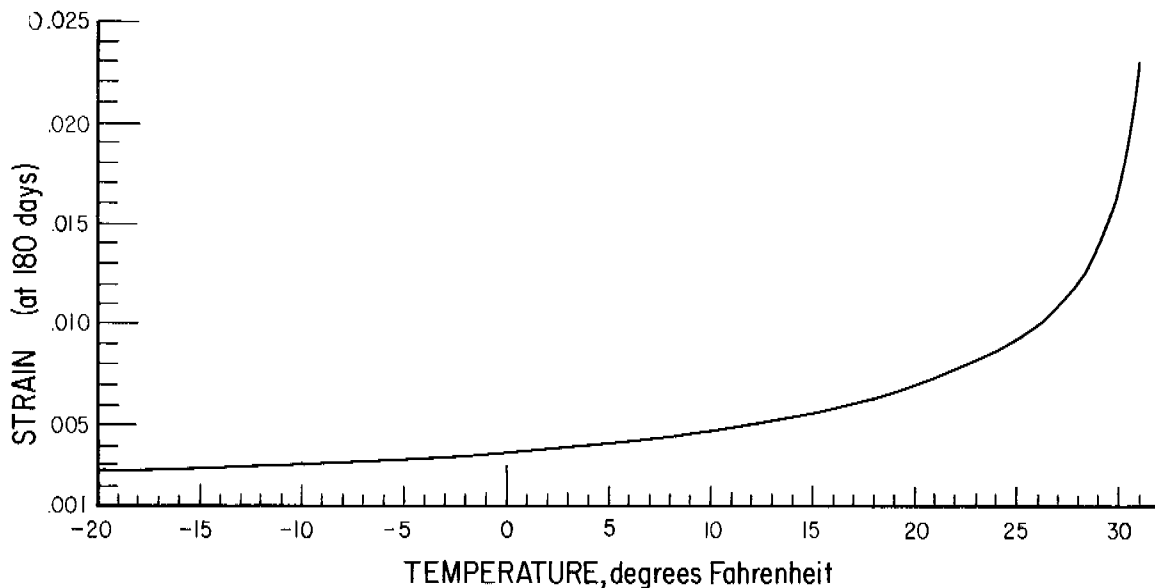
$$\epsilon = \left[ \frac{\sigma}{\sigma_{01} (\theta + 1)^a} \right]^{1/k} \frac{t^\psi}{\psi} + \epsilon_0$$

Formula and constants from  
"Creep of Frozen Sands" by Sayles(8)

FIGURE 29. - Effect of Temperature on Strain of Frozen Sand.

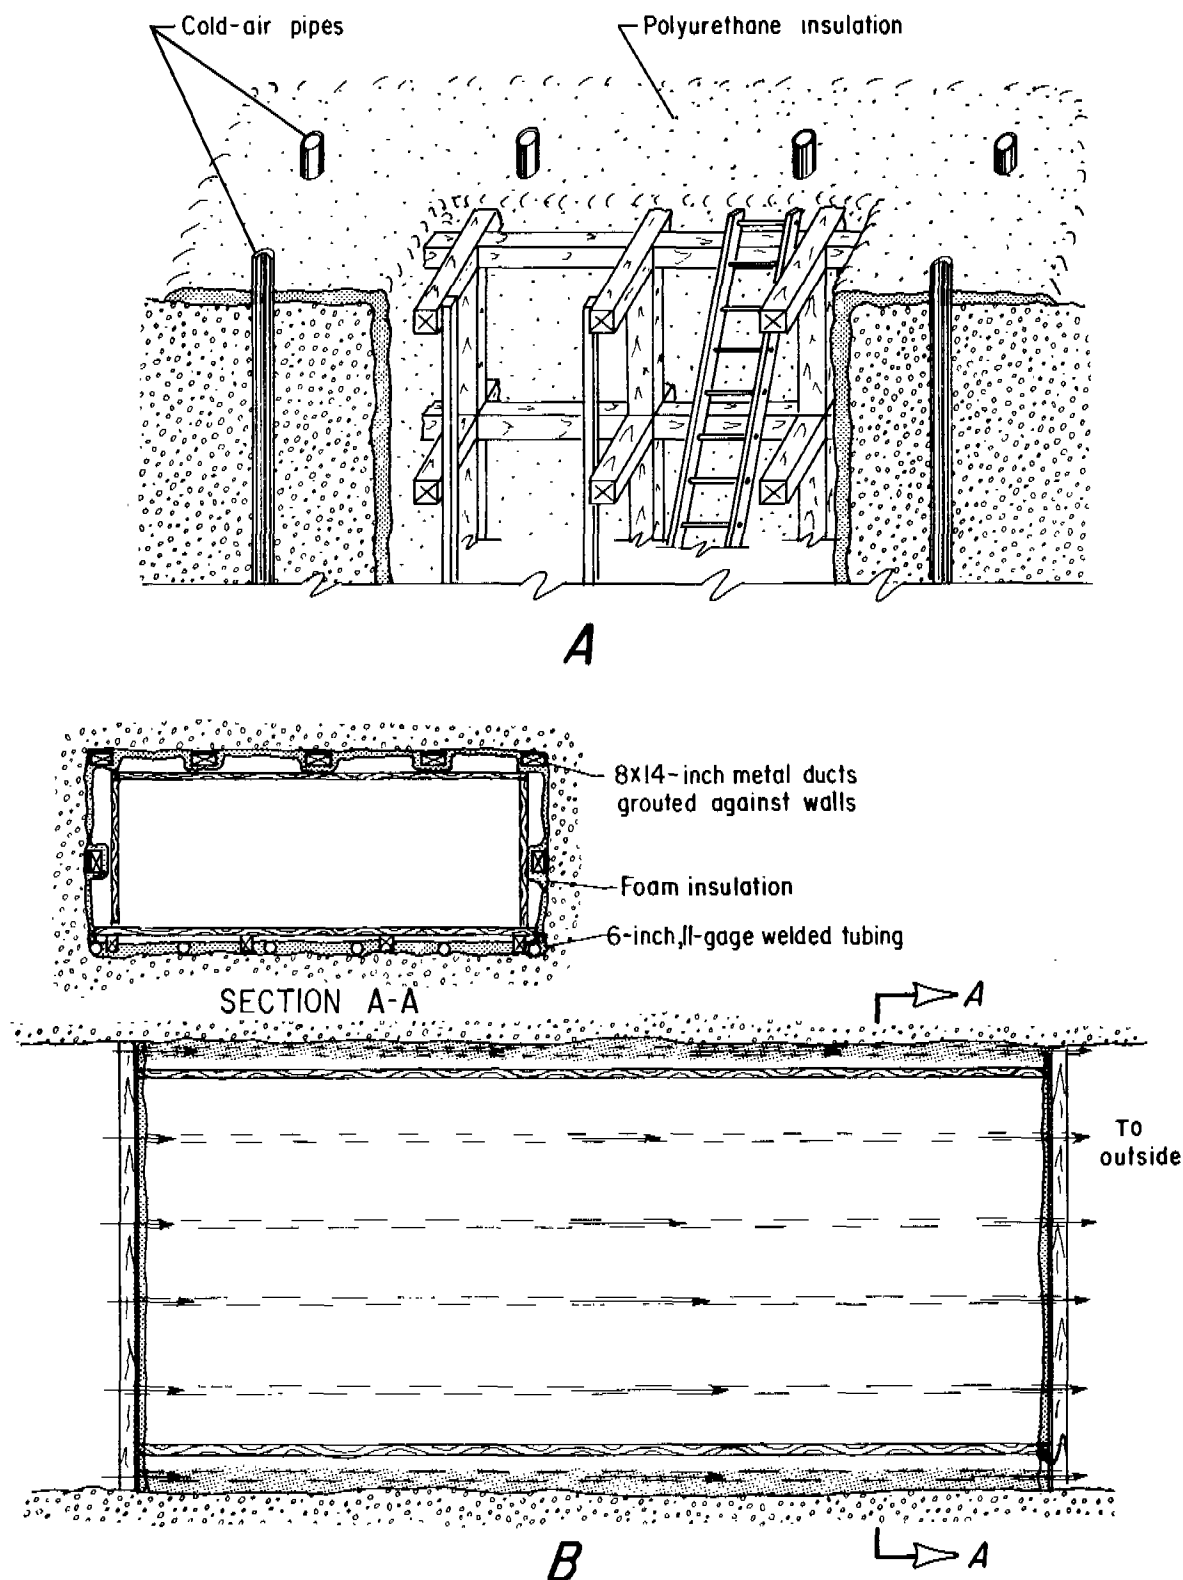
FIGURE 30. - Proposed Method of Maintaining Shaft or Heated Room in Permafrost.  
A, Shaft; B, heated room.

Obviously, it is desirable to exploit the extreme cold of winter whenever possible. A proposed method would utilize the winter cold to annually super-cool the zone surrounding an insulated opening in permafrost.

Rectangular ducts placed against the walls of the underground room afford passage for forced cold air during the winter months. The ducts are sealed during the summer.

In both schemes, the use of casing or ducts is necessary to prevent sublimation. Because creep cannot be entirely eliminated, soft squeeze blocking is required. With the scheme illustrated in figure 30, it should be possible to maintain a shaft or a heated room in permafrost for several years.
