# 25

## *Case Studies on Fall from Elevated Devices among Fire Fighters*

Timothy Merinar

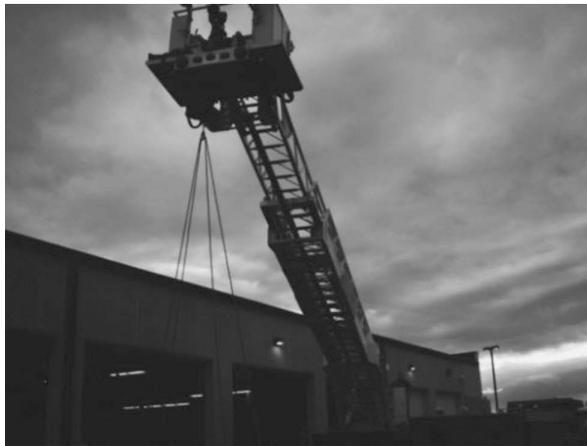
**FIGURE 25.1**  
Training site. (Photo courtesy of Fire Department.)

The victim was climbing up a rope, using a hand-over-hand technique that had been used to demonstrate rope haul systems, and attempted to grab another rope out of his reach. The victim likely lost his grip on the rope and fell to the asphalt pavement, striking his head. Emergency medical aid was administered by fellow fire fighters, and he was transported to a local hospital, where he died from his injuries. The medical examiner reported the cause of death as blunt force head trauma.

Key contributing factors identified in this investigation include lack of a safety officer, lack of proper personal protective equipment, and student to instructor ratio (NIOSH, 2011).

- Ensure that a qualified safety officer (meeting the qualifications defined in NFPA 1521) is appointed in practical skills training environments
- Ensure that minimum levels of personal protective equipment are established for practical skills training environments (as defined in NFPA 1500)
- Ensure that sufficient instructors or assistant instructors are available for the number of students expected to participate in practical skills training evolutions

- Take steps to ensure that ropes and equipment used in emergency services practical skills training are inspected and records are kept on the purchase, use, and inspection of the ropes and equipment (as defined in NFPA 1500 4.6.5)

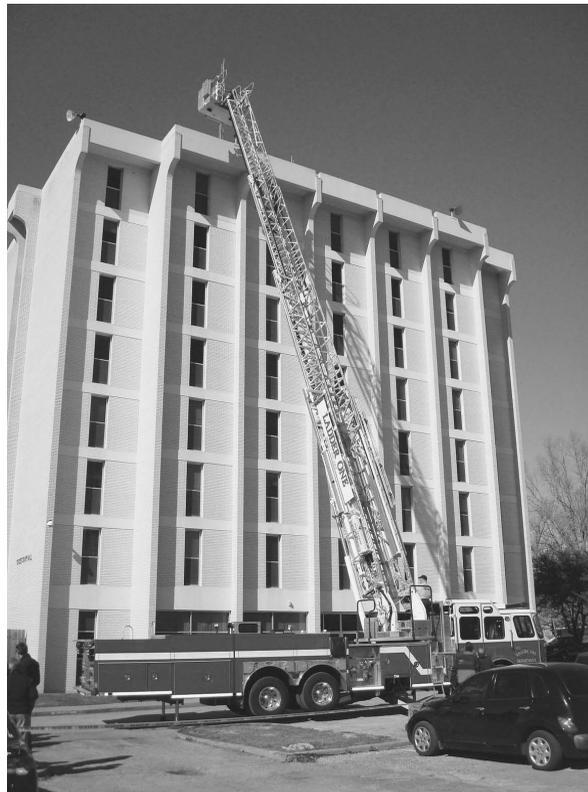
**FIGURE 25.2**

Aerial platform positioned at dormitory building to recreate incident scene. (Photo from NIOSH.)

building, then began to whip violently back and forth. Two of the four fire fighters standing in the platform were ejected from the platform by the motion. They fell approximately 83 ft to the ground and died from their injuries. None of the fire fighters in the elevated platform were wearing any type of fall restraint.

Key contributing factors identified in this investigation include the fire fighters being unfamiliar with the controls on the newly purchased aerial platform truck, training in a “high-risk” scenario before becoming familiar with new equipment, failure to use fall restraints, the design of the platform railing and integrated doors, and the location of the lifting eyes underneath the platform, which contributed to the platform snagging on the building’s parapet wall (NIOSH, 2009).

- Ensure that fire fighters are fully familiar with new equipment before training under “high-risk scenarios”
- Ensure that fall protection is used whenever fire fighters and other personnel are working in elevated aerial platforms
- Follow SOPs for training, including the designation of a safety officer
- Ensure that SOPs covering the operation and use of fire apparatus (including aerial platform apparatus) are developed and followed during training exercises as well as in fire suppression activities
- Provide fall protection belts with all aerial ladder and platform apparatus and ensure that fall protection is used in both training exercises and emergency response events

- Include the use of fall protection in both demonstration and training programs
- Ensure that aerial platforms and other aerial devices are designed to reduce or eliminate the potential for snagging on buildings or other elevated surfaces
- Ensure that aerial platform doors or gates are designed to prevent opening in the outward direction

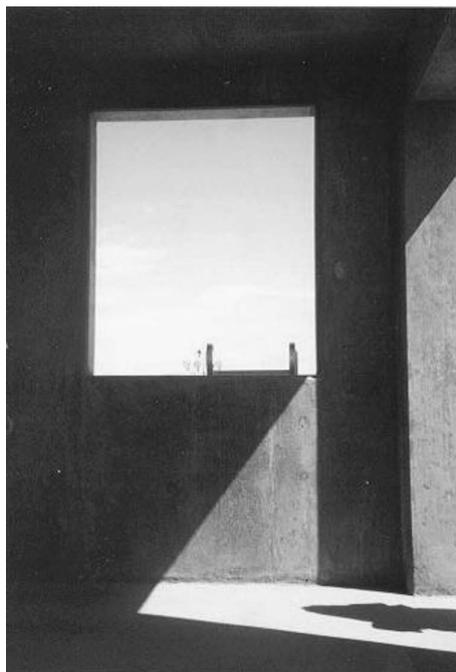
**FIGURE 25.3**  
Forty-two inch window sill and ladder tip. (Photo from NIOSH.)

Key contributing factors identified in this investigation include the lack of an incident safety officer and an unpracticed emergency bailout procedure (NIOSH, 1999).

- Ensure that all new training programs undergo a comprehensive review prior to the implementation of the program
- Collaborate with other fire-related organizations regarding the feasibility of all new training procedures before the programs are implemented
- Ensure that all aspects of safety are adhered to per established standards and recommendations while training is being conducted
- Designate individual safety officers at all significant training exercises to observe operations and ensure that safety rules and regulations are followed

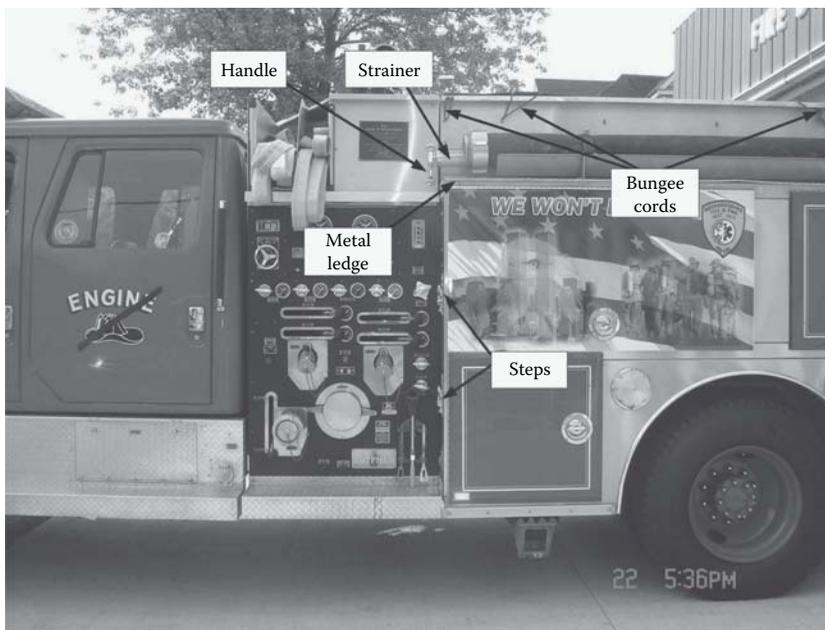
**FIGURE 25.4** Side of the engine where the victim ascended and the incident occurred. (Photo from NIOSH.)

Key contributing factors identified in this investigation include the design of the engine, which introduced numerous potential fall risks when loading the hose bed and securing the vinyl protective cover; fire department practices in loading the hose bed and securing the vinyl hose bed cover, which were unwritten and inadequately addressed fall hazards; and damage to the mounting system of snaps, which made securing the vinyl hose bed cover more cumbersome (NIOSH, 2007a).

- Develop and implement SOPs on the correct procedures/safe methods for reloading hose and securing hose bed covers
- Consider requiring the use of a ladder when servicing items that are out of reach from ground level on the fire apparatus
- Ensure that hose bed covers on fire apparatus are maintained in good physical condition or are replaced when needed
- Consider, when purchasing a new fire apparatus, that it be equipped with available safety features to assist with hose loading and covering the hose bed (e.g., a hose bed that hydraulically lowers, or hose bed covers that are hydraulic, roll-up, or hinged metal)

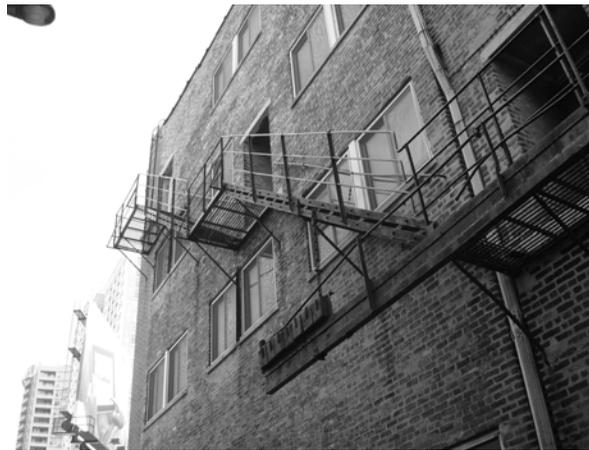
**FIGURE 25.5**

Key contributing factors identified in this investigation include using a fire escape to access the roof, rather than a safer means such as an aerial ladder or interior stairway, and the victim being unable to maintain a three-point contact with the vertical portion of the fire escape due to carrying the hand pump (NIOSH, 2010).

Fire escape post incident. The access ladder from which the victim fell can be seen at the upper left corner. (Photo from NIOSH.)

- Ensure that standard operating guidelines (SOGs) on the use of fire escapes are developed, implemented, and enforced
- Ensure that tactical-level accountability is implemented and enforced
- Ensure that companies are rigorously trained in safe procedures for roof operations and climbing ladders of any type
- Ensure that fire fighters are rigorously trained in safe procedures for carrying and/or hoisting equipment when ascending or descending elevations
- Evaluate the fire prevention inspection guidelines and process to ensure that they address high-hazard occupancies, such as restaurants, and incorporate operational crew participation

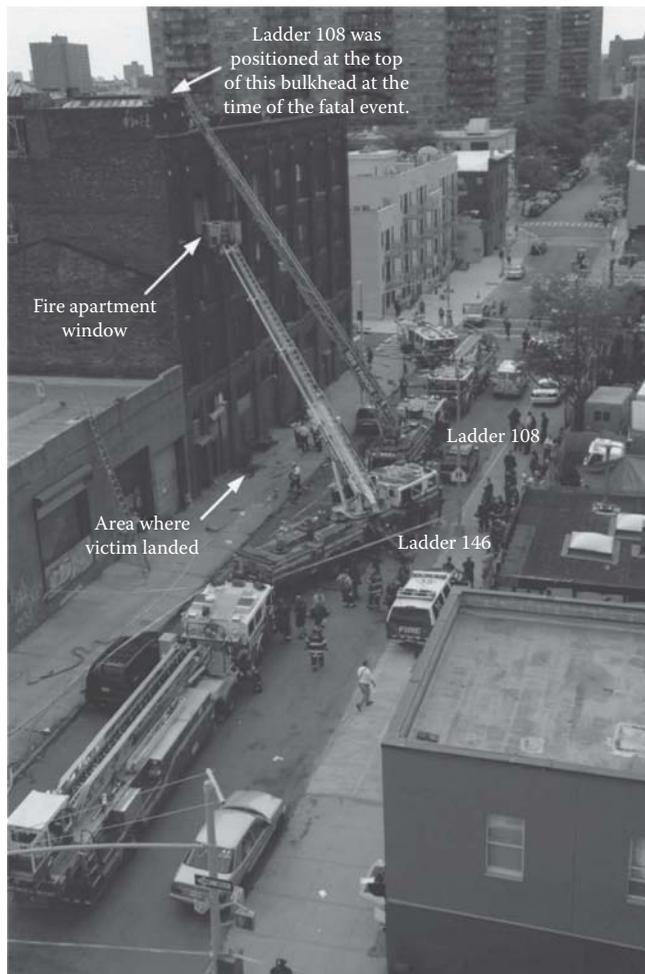
**FIGURE 25.6**  
Aerial view of incident scene. (Photo courtesy of Fire Department.)

Key contributing factors identified in this investigation include the judgment of the fire fighter in deciding on a riskier means of moving from the roof bulkhead to the main roof; the placement of the ladder against the roof bulkhead rather than the main roof, which introduced additional fall risks for fire fighters; the hazardous task of climbing a ladder while laden with tools and equipment; and the method by which the saw was carried, which allowed the shifting saw to put the fire fighter off balance (NIOSH, 2007b).

- Stress to fire fighters the importance of exercising caution when working at elevation
- Consider the location and placement of aerial ladders to prevent fire fighters from climbing from different elevations during fireground operations

- Consider the use of portable scissor ladders to facilitate access from an aerial ladder to the roof
- Ensure that fire fighters communicate any potential hazards to one another and ensure that team continuity is maintained during roof operations
- Evaluate the manner in which equipment is harnessed or carried by fire fighters to prevent loss of balance
- Consider reducing the amount of equipment that fire fighters must carry while climbing ladders

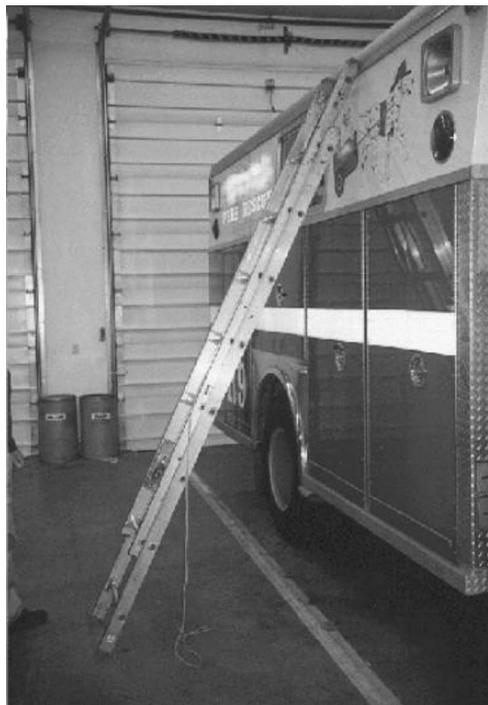
**FIGURE 25.7**  
Fire rescue truck with ladder. (Photo from NIOSH.)

Key contributing factors identified in this investigation include failure to properly position the ground ladder in a safe manner, use of the incorrect type of ladder, and failure to size up the work area to consider potential safety issues (NIOSH, 2000).

- Ensure that ladders are used in accordance with existing safety standards
- Designate an individual as the fire station safety officer for all in-house maintenance to identify potential hazards and ensure that those hazards are eliminated
- Consider the use of mobile scaffolding, personnel lifts, scissor lifts, or boom lifts, instead of the top surface of a fire truck
