Knowledge Gaps and Emerging Issues for Fall Control in Construction

G. Scott Earnest and Christine M. Branche

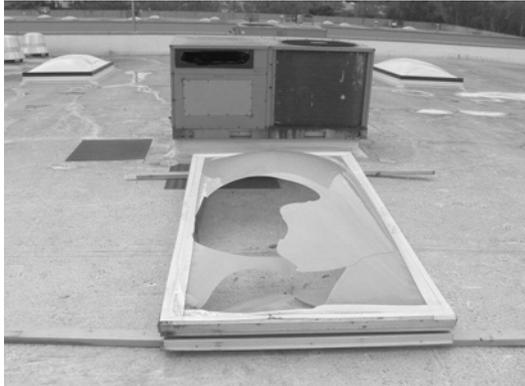
FIGURE 27.1
Skylight on a roof that had a fall through.

Openings on roofs can also lead to fatal falls. Sometimes, the openings are created during work on roofs. Secured and marked rigid objects may be used to cover roof openings or fragile walking and working surfaces. The covers should support at least twice the maximum load and have full edge bearing on all sides. Falls through fragile roofs are problematic in both roof and building maintenance work, and cause half of the fatal falls. Fragile roof surfaces are areas that are not designed to bear loads. Persons standing on fragile and brittle roof surfaces are at risk if the roof gives way. These roofs are often made from molded or fabricated synthetic materials. The following are likely to be fragile: skylights (Figure 27.1), glass, fiberglass, polycarbonate roofing, old ceramic tiles, corroded metal roof sheets, and rotting wood.

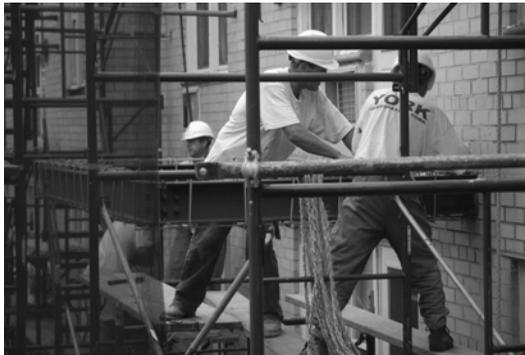
FIGURE 27.2
Construction workers using scaffolding on the side of a building.

Scaffolds are temporary structures used to support workers and material during building repairs and construction (Figure 27.2). Scaffolds are typically built from metal pipes or tubes, horizontal boards, and couplers. Falls from scaffolds accounted for 21% of fatal construction falls reported from 1974 to 1978 (OSHA, 1979). Similarly, falls from scaffolds during 1980–1985 accounted for 17% of all fatal falls from elevations, second only to falls

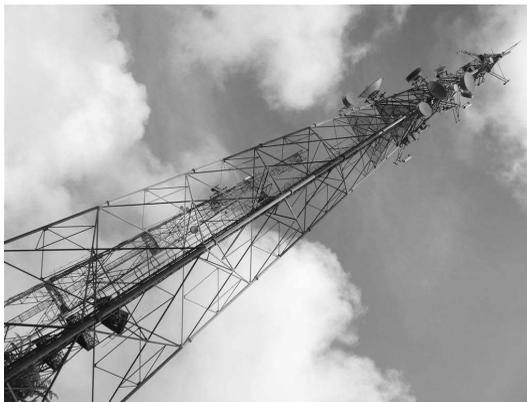
FIGURE 27.3
Construction worker using an aerial lifts near structural steel.

The number of telecommunication towers (Figure 27.3) in the United States has increased dramatically over the past 30 years. This increase has closely followed the greater use of cell phones, especially smartphones, and other wireless devices, and the demand they make, subsequently, for faster speeds and more data capacity. Similarly, more workers are needed to upgrade existing towers, which presents unique risks.

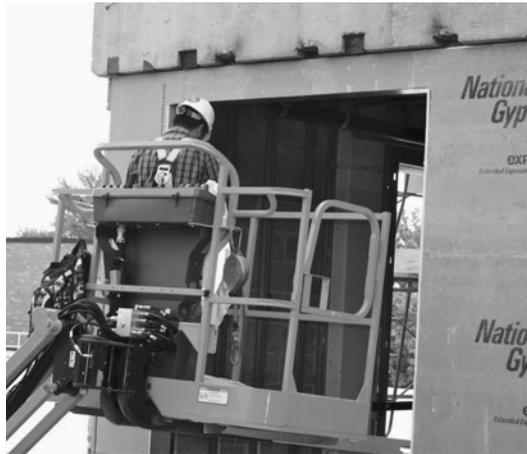
FIGURE 27.4
Construction workers using several aerial lifts near structural steel.

Ladder-related falls can be reduced through more frequent use of aerial lifts (Figure 27.4). Aerial lifts include vehicle-mounted “bucket trucks,” boom lifts, and scissor lifts. Scissor lifts are well suited for smooth finished floors in manufacturing. Rugged-terrain boom lifts are used on construction projects. When aerial lifts are extended, they can present stability issues, and they are complex systems that can fail because of mechanical issues or operator error.

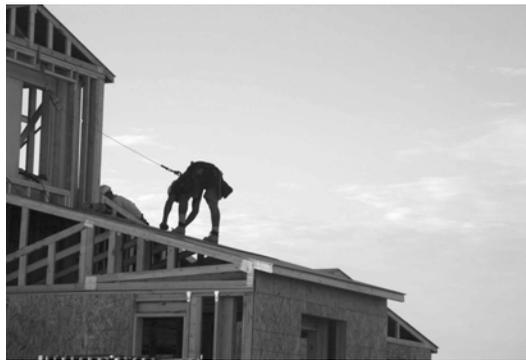
FIGURE 27.5
Roofer using a fall arrest system.

Personal fall arrest systems (PFAs) are designed to protect a worker in the event of a fall (Figure 27.5), and fall restraint systems are designed to prevent a fall (Figure 27.6). PFAs consist of an anchor, connectors, a deceleration device, and a body harness. These systems stop a fall (OSHA, 1998) by preventing the worker from contacting a surface below through deceleration. PFAs must be inspected for wear damage and deterioration before each use.

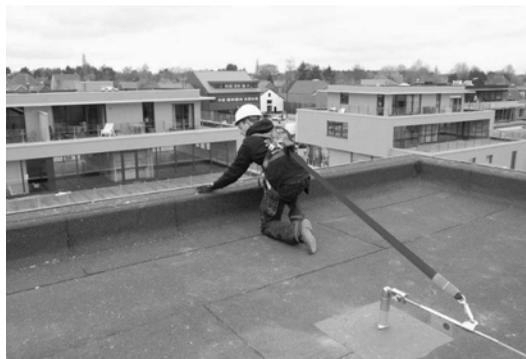
FIGURE 27.6
Worker using a fall restraint system.

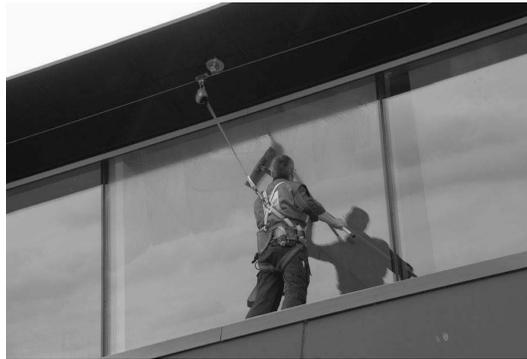
FIGURE 27.7
Worker wearing a body harness and fall arrest system.

Fall protection harnesses (Figure 27.7) are an integral part of PFAs; however, for many years, little was known about how well they fit workers. Early harnesses were designed based on parachute harnesses for men in the military rather than the more diverse construction populations, including women. At times, suspension trauma injuries after a fall have been attributed to poor harness fit. Hsiao et al. (2003) evaluated the fit of body harnesses for approximately 100 male and female construction workers. Their body sizes and shapes were measured with a laser scanner while they were suspended (with a harness) and standing (with and without a harness). Analysis determined that the current sizing selection scheme by height and weight was acceptable. However, redesign of harness components was needed for approximately 40% of those evaluated while standing or suspended. Fifteen body models for standard harnesses were identified.

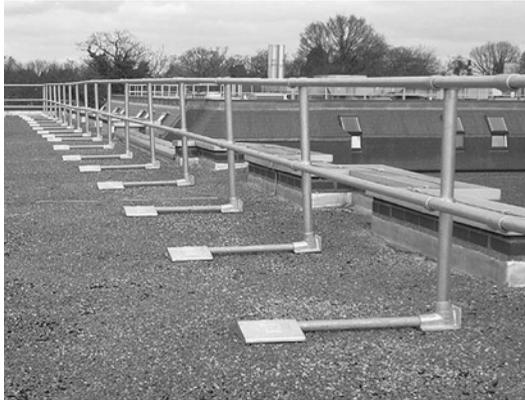
FIGURE 27.8
Guardrail system near the edge of a roof.

Guardrails (Figure 27.8) are barriers to prevent employees from falling to lower levels (OSHA, 1998). They should be used when work is expected to take place at elevations of 6 ft (1.8 m) or higher. OSHA requires that guardrails be constructed from 2×4 in. lumber ranging from 39 to 45 in above the working surface. They are often mounted on the roof as joists or attached to the wall or roof of the building.
