Information Circular 8947

Safety in the Use and Maintenance of Large Mobile Surface Mining Equipment

**Proceedings: Bureau of Mines Technology Transfer
Seminars, Tucson, AZ, August 16, 1983, Denver, CO,
August 18, 1983, and St. Louis, MO, August 23, 1983**

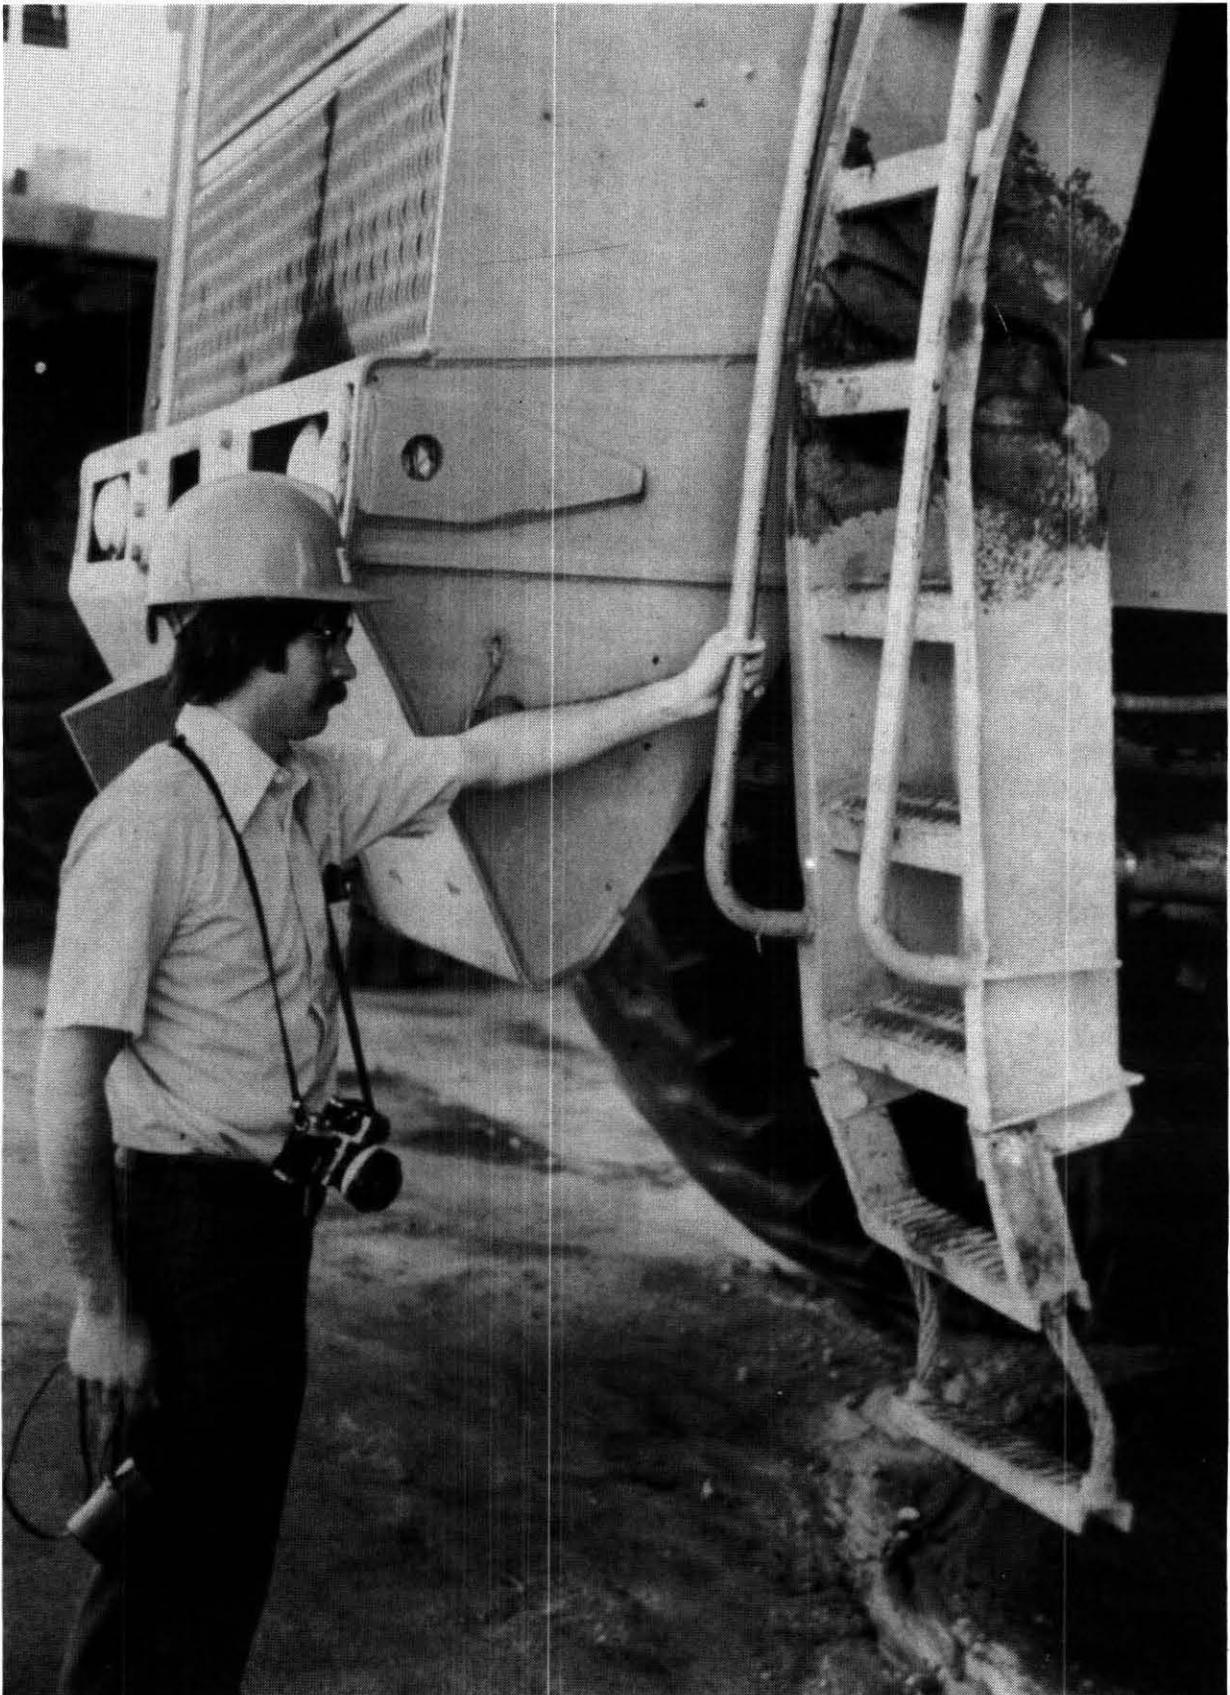
FIGURE 1. - Typical ladder on off-highway haulage truck.

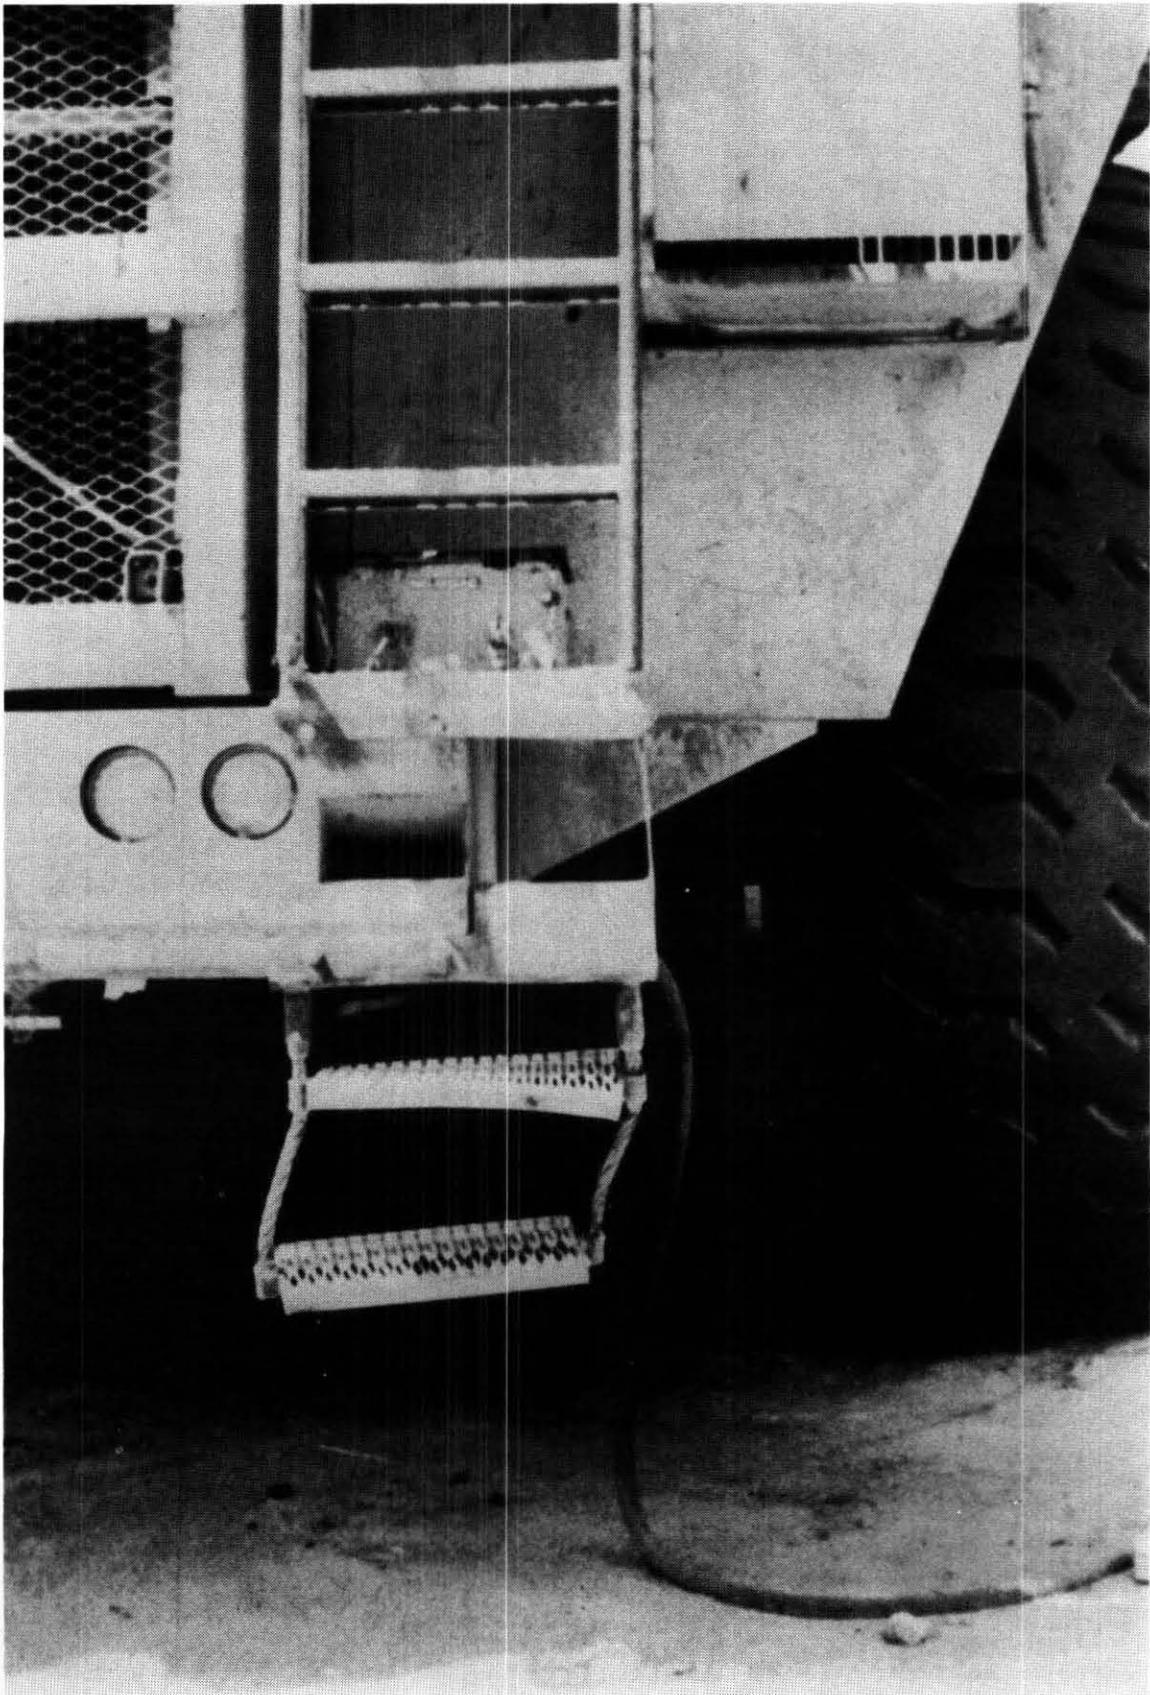
FIGURE 3. - Truck ladder using bumper as part of ladder system.

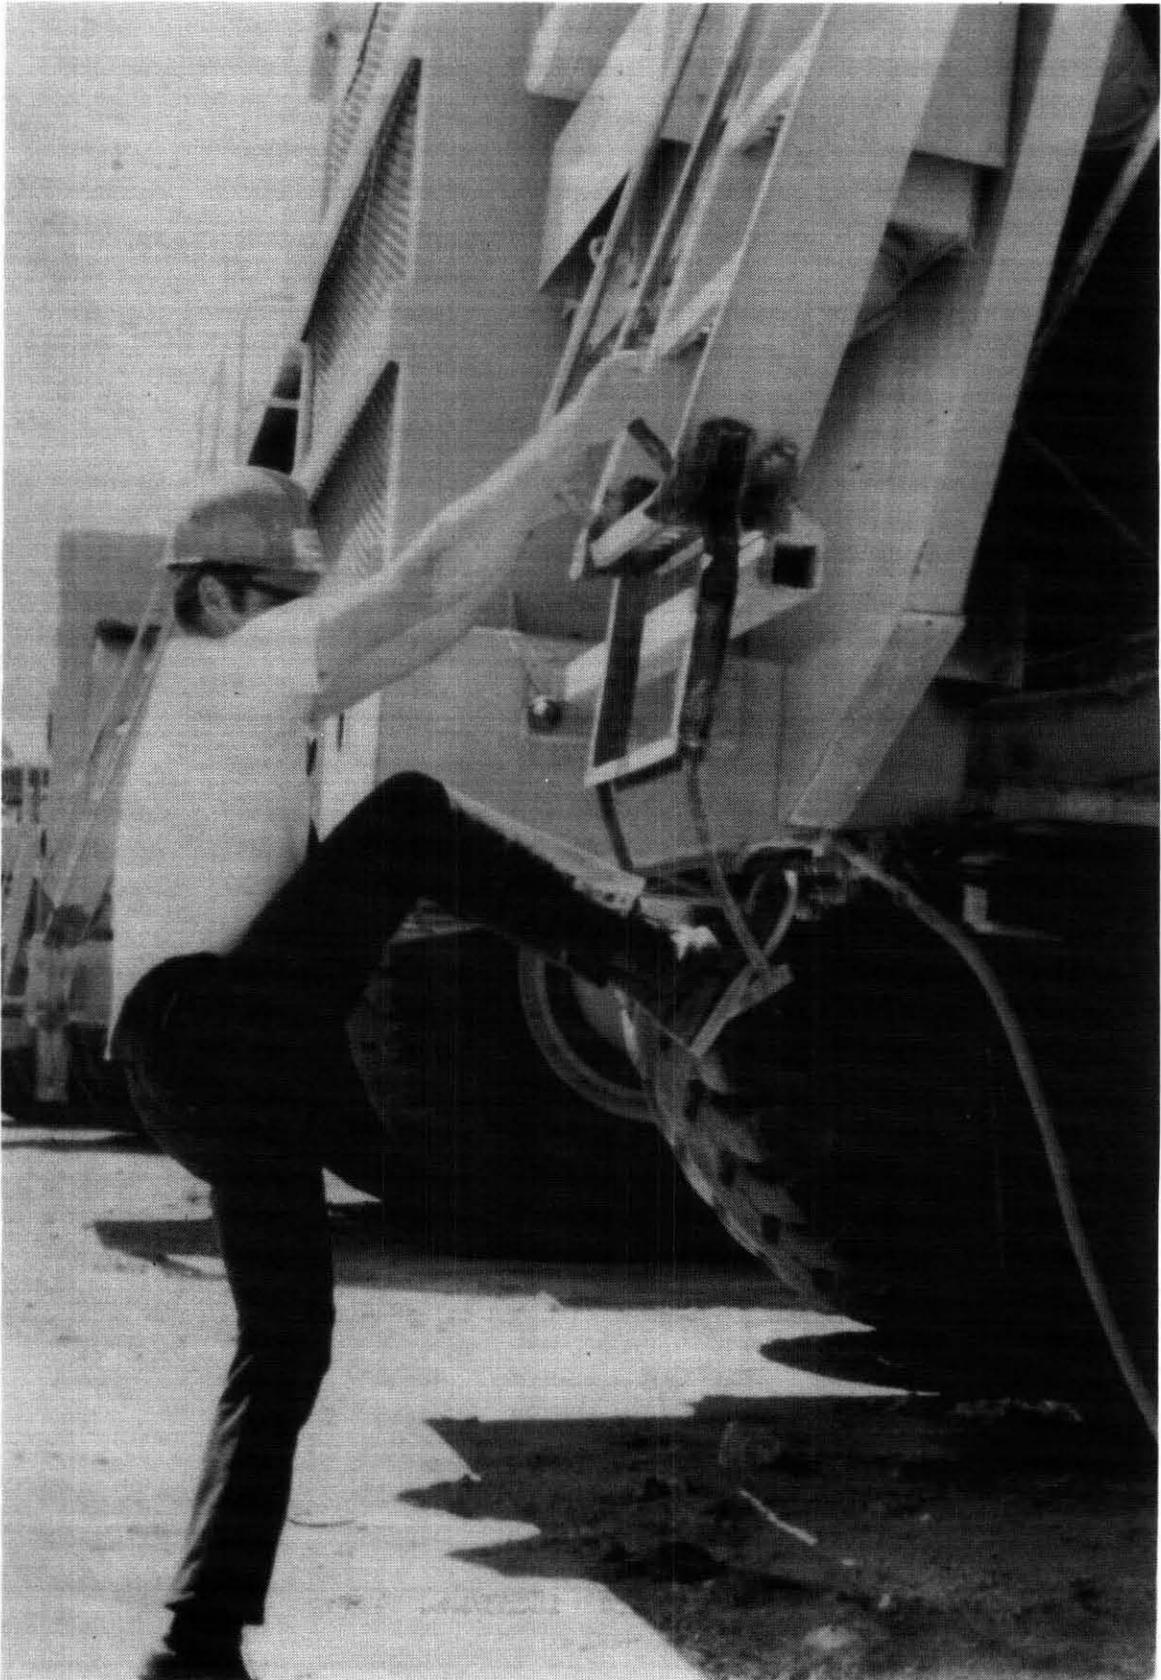
FIGURE 4. - Wire-rung lower truck ladder.

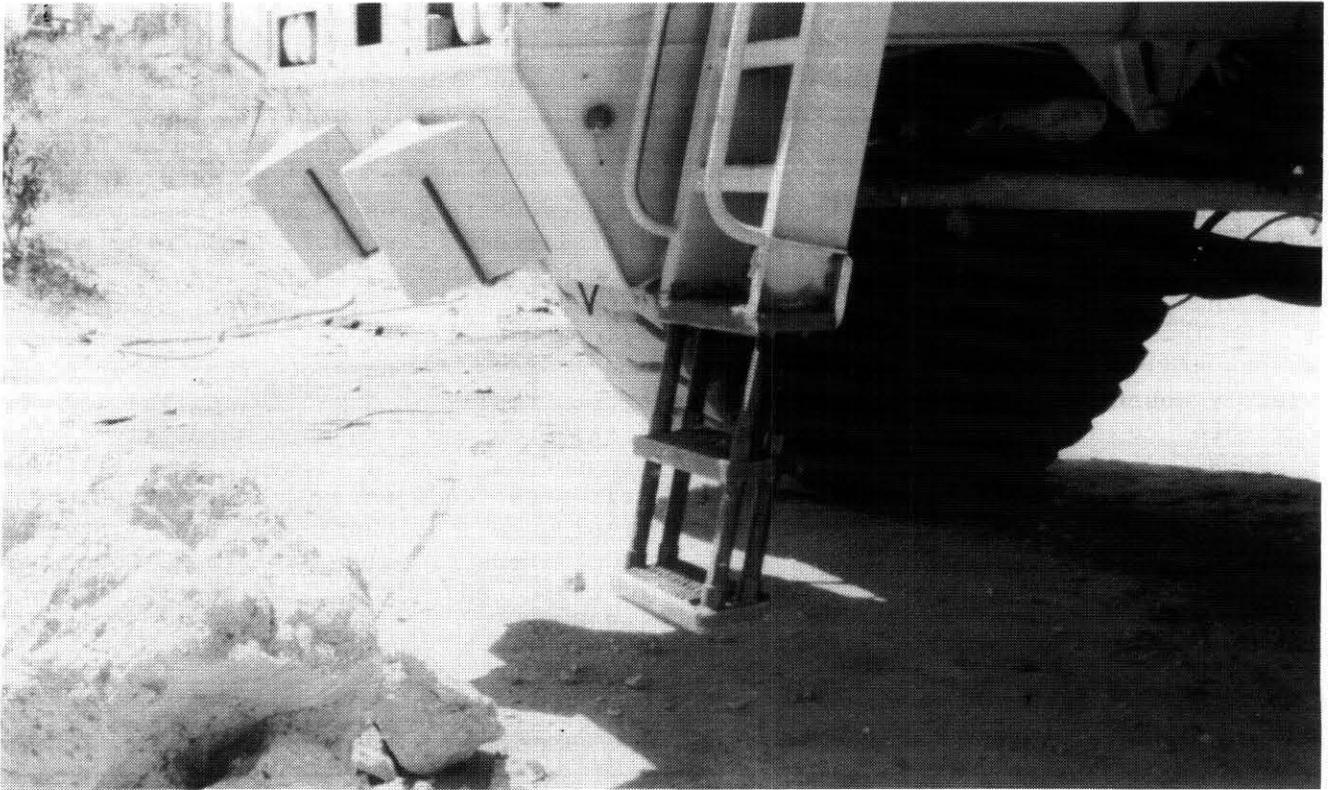
FIGURE 6. - Bureau of Mines spring step.

Since 1978 some 30 spring steps have been field-tested at 13 mines on 27 surface mine vehicles. The maintainability of the spring ladders varied widely from mine to mine. At some mines the ladders sustained damage after 3 or 4 weeks, while at other mines, ladders remained on the trucks with little or no damage for more than a year. Failure of the spring step occurred owing to a variety of reasons. The most common reasons included shear at the point where the step is welded to the ladder, spring failure resulting from low ground clearance, and lack of operator or supervisory acceptance.

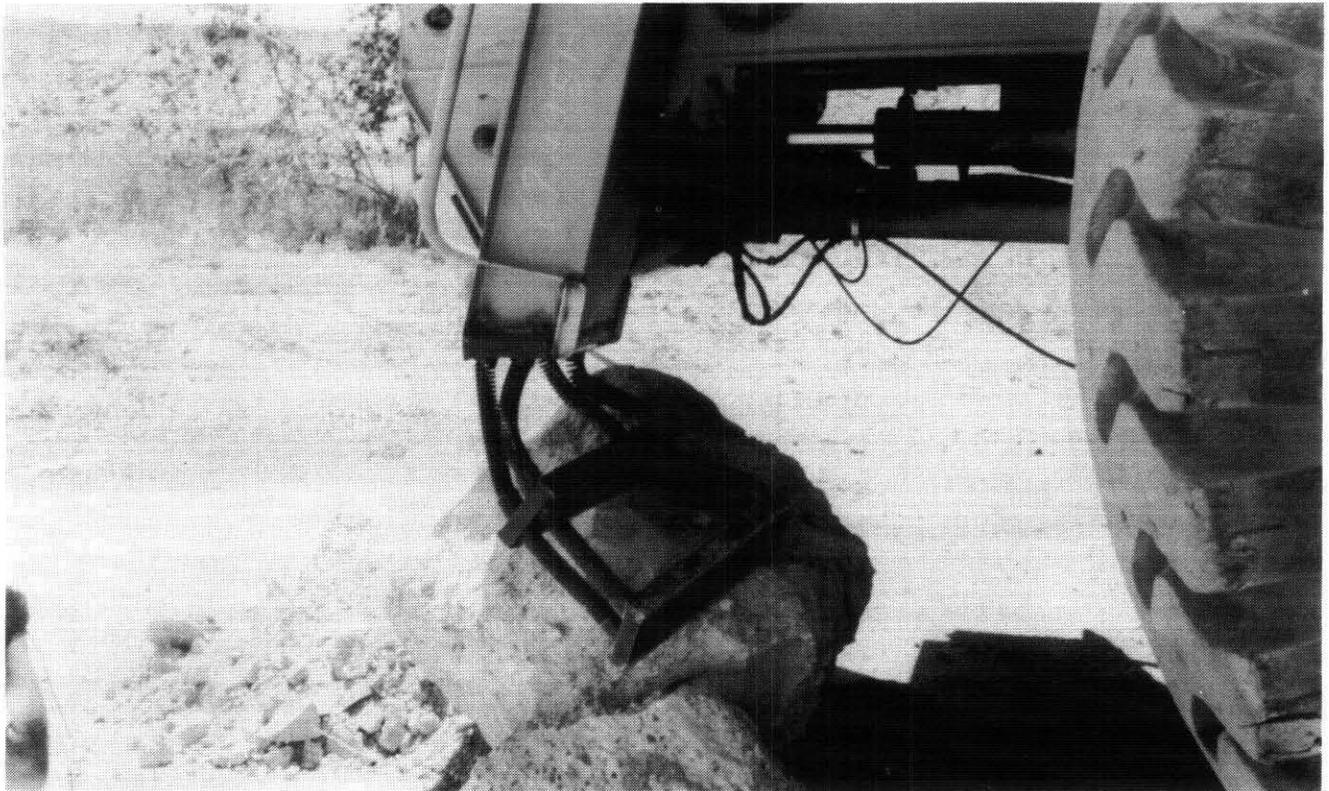
FIGURE 7. - Bureau of Mines spring step striking a boulder.

Proper supervision and management support is essential for long-term success. Some of the test units that might have realized longer life through simple maintenance and repair were quickly replaced with the traditional "home-made" steps at the slightest sign of failure. Operator acceptance is also important, because in several cases it seems that the vehicle operator was putting the step to the test. The spring step unit is not indestructible.

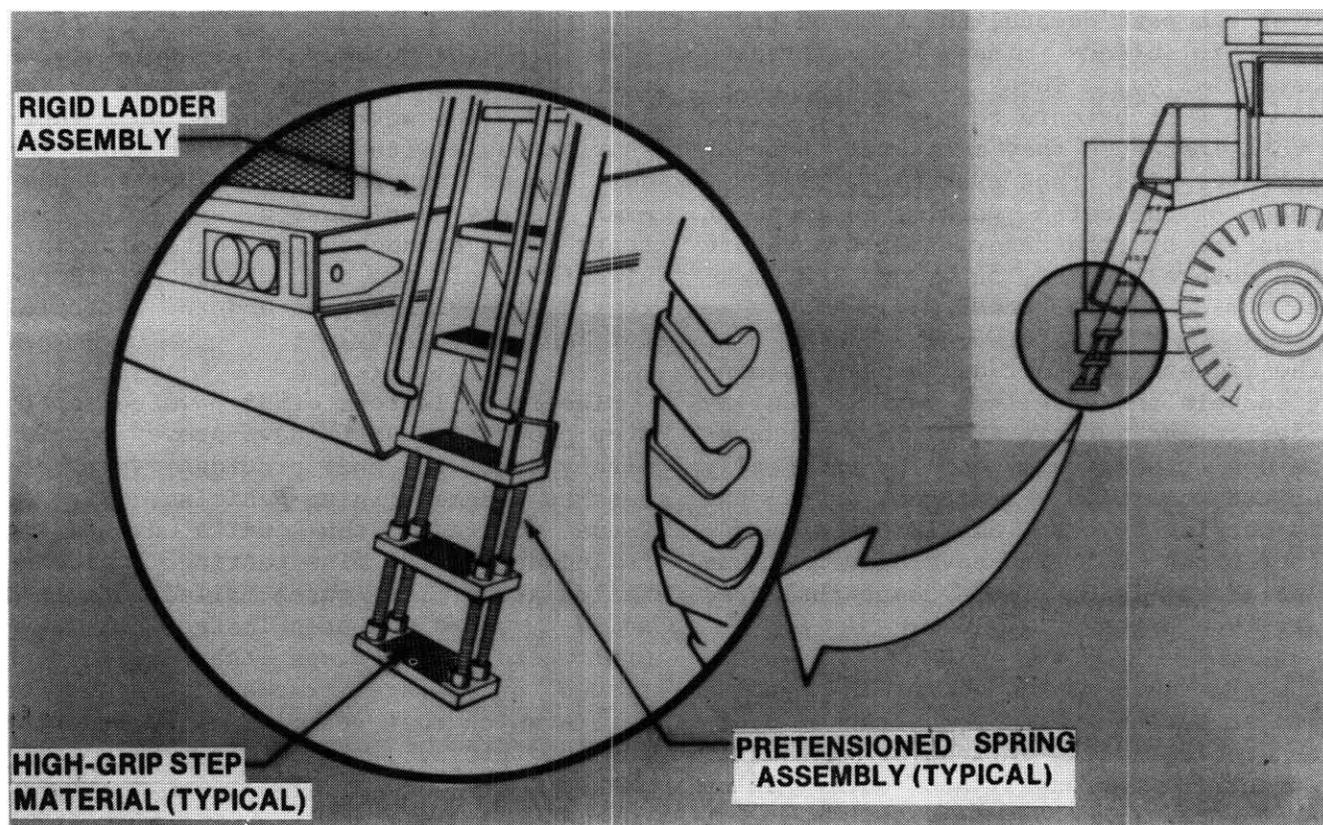
The spring ladder concept is shown in figure 8. The unit consists of two steps constructed from grip strut material to minimize the accumulation of debris and provide an antiskid surface for good footing. The steps are joined with two pairs of spring assemblies and mounting brackets. The mounting brackets consist of a flat plate and a collar to support the spring, which is welded to the

FIGURE 8. - Bureau of Mines pretensioned four-spring step.

flat plate. The springs are fabricated from stainless steel and pretensioned to 150 lb.

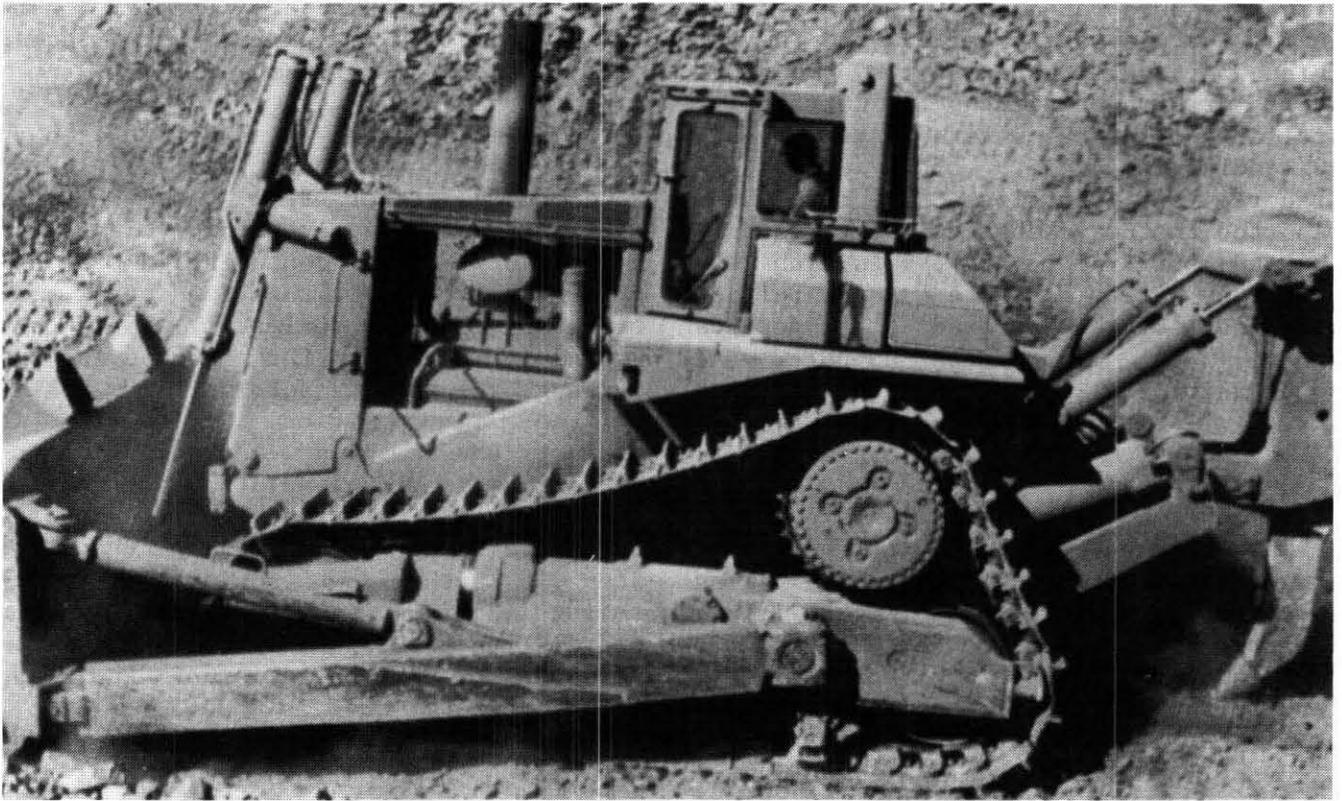
FIGURE 9. - Typical track dozer.

Over the past decade, the size of track dozers in surface mines has increased substantially. Today operators must climb up 4 ft or more to mount the dozer. In most instances they must step onto or climb over the track assembly (fig. 9). Because of the harsh working environment encountered by the dozer, the tracks are often covered by mud, snow, or ice, making them an unsafe access way.

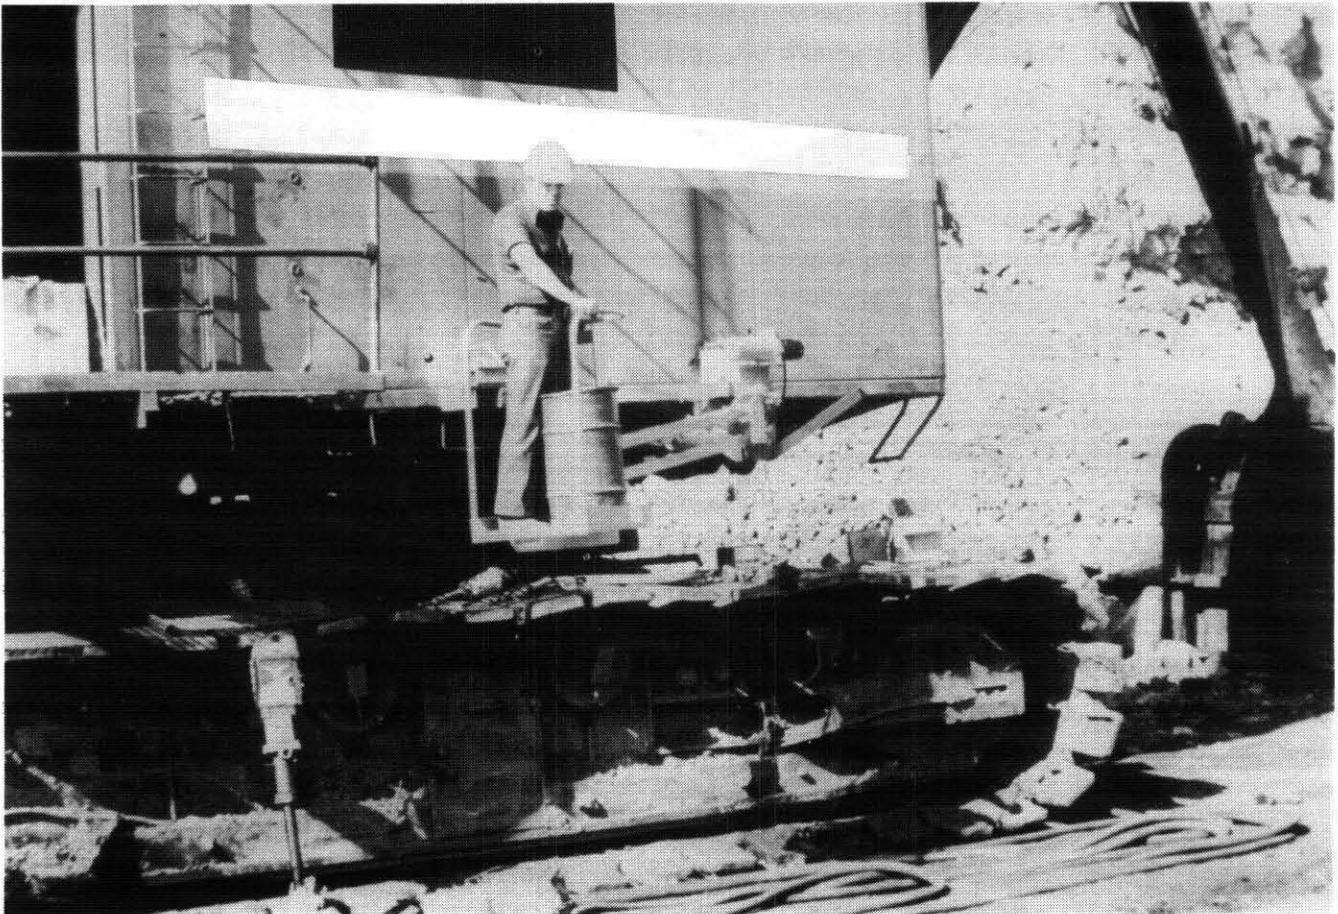
FIGURE 11. - Powered safety step on a loading shovel.

The powered safety step is a hydraulically powered device to lift personnel and materials from the ground to working levels on large equipment (figs. 11-12). The primary application of the powered step is on the large track dozers, shovels, and draglines. The powered unit eliminates hazardous blind steps and

The powered safety step is powered by a self-contained electric-hydraulic unit. Power comes either from the vehicle's auxiliary power supply or from the step's own battery source, depending on the application. When in the "down" position, the step rests approximately 15 in from ground level. When the machine is operating, the step is automatically locked in the "up" position, protecting it against any damaging contact with obstructions. Visual alarms and machine interlocks are provided where necessary to prevent machine operation when the step is in the "down" position. On rotating machines, such as draglines and shovels, an electrical interlock is provided to prevent operation of the swing motors when the step is down.

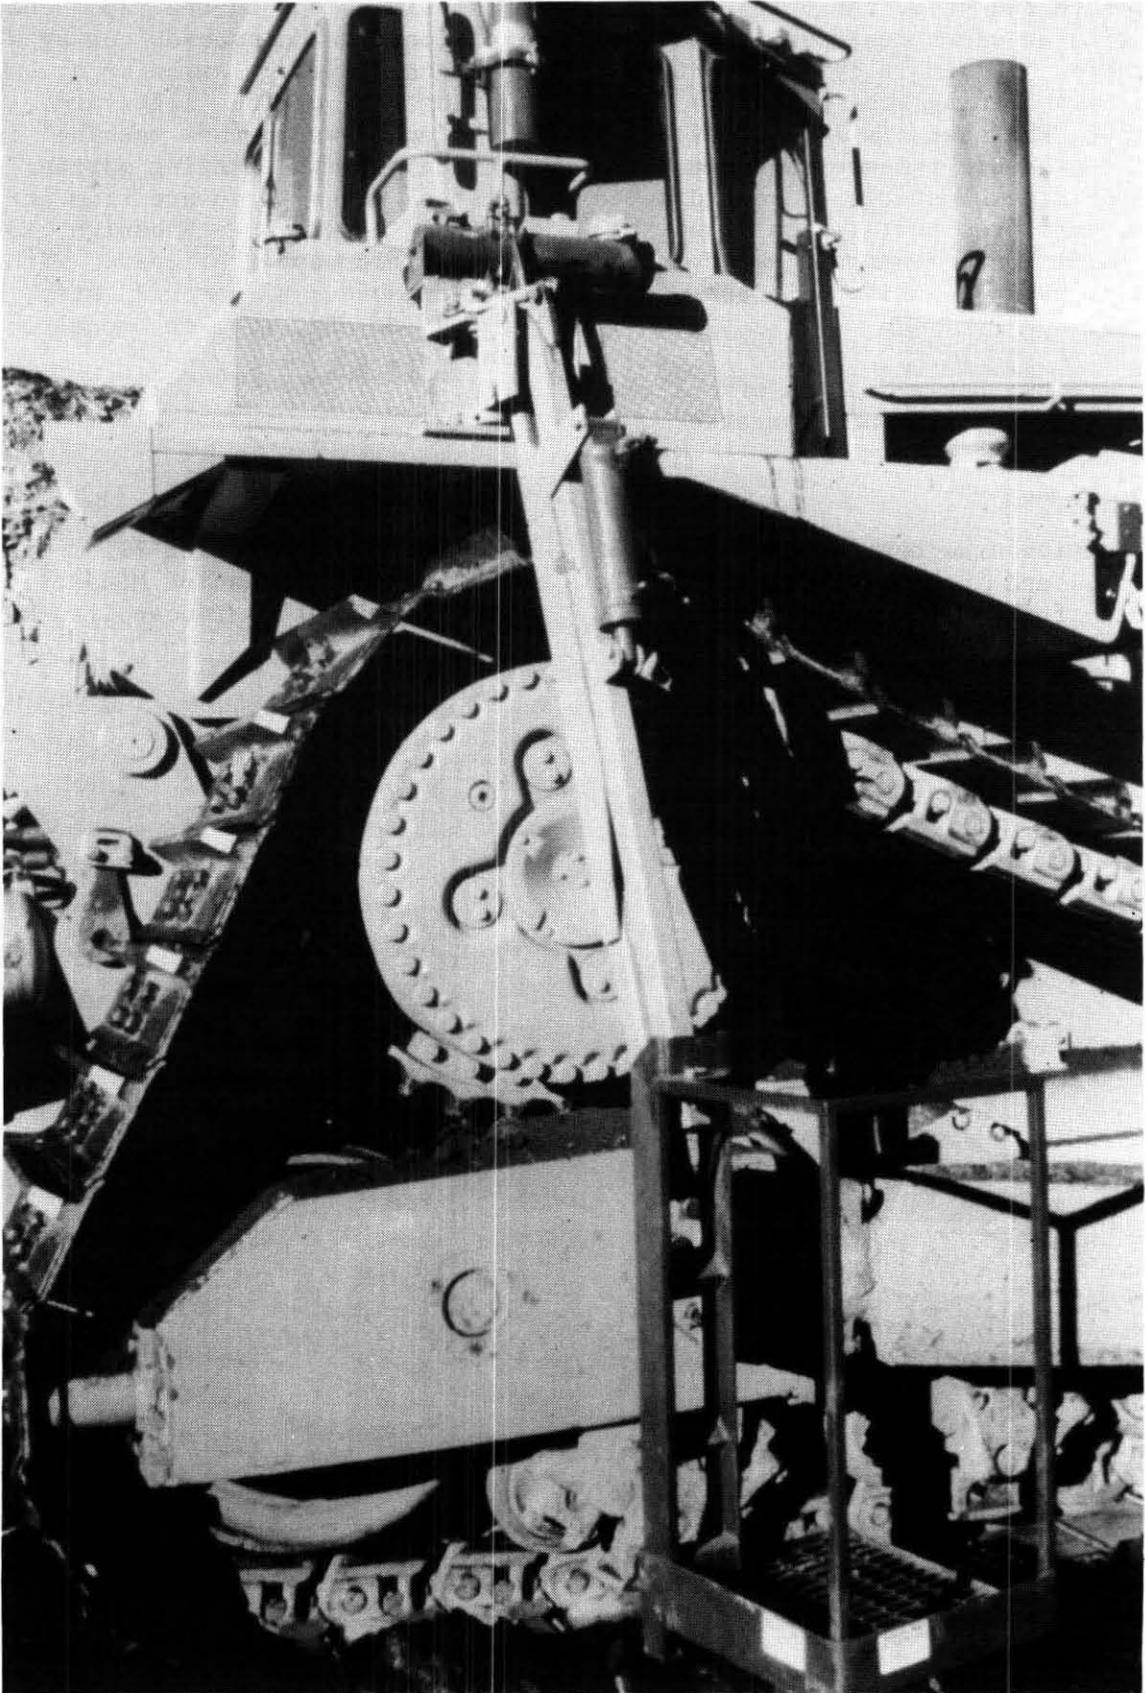
FIGURE 12. - Powered safety step on a track dozer.

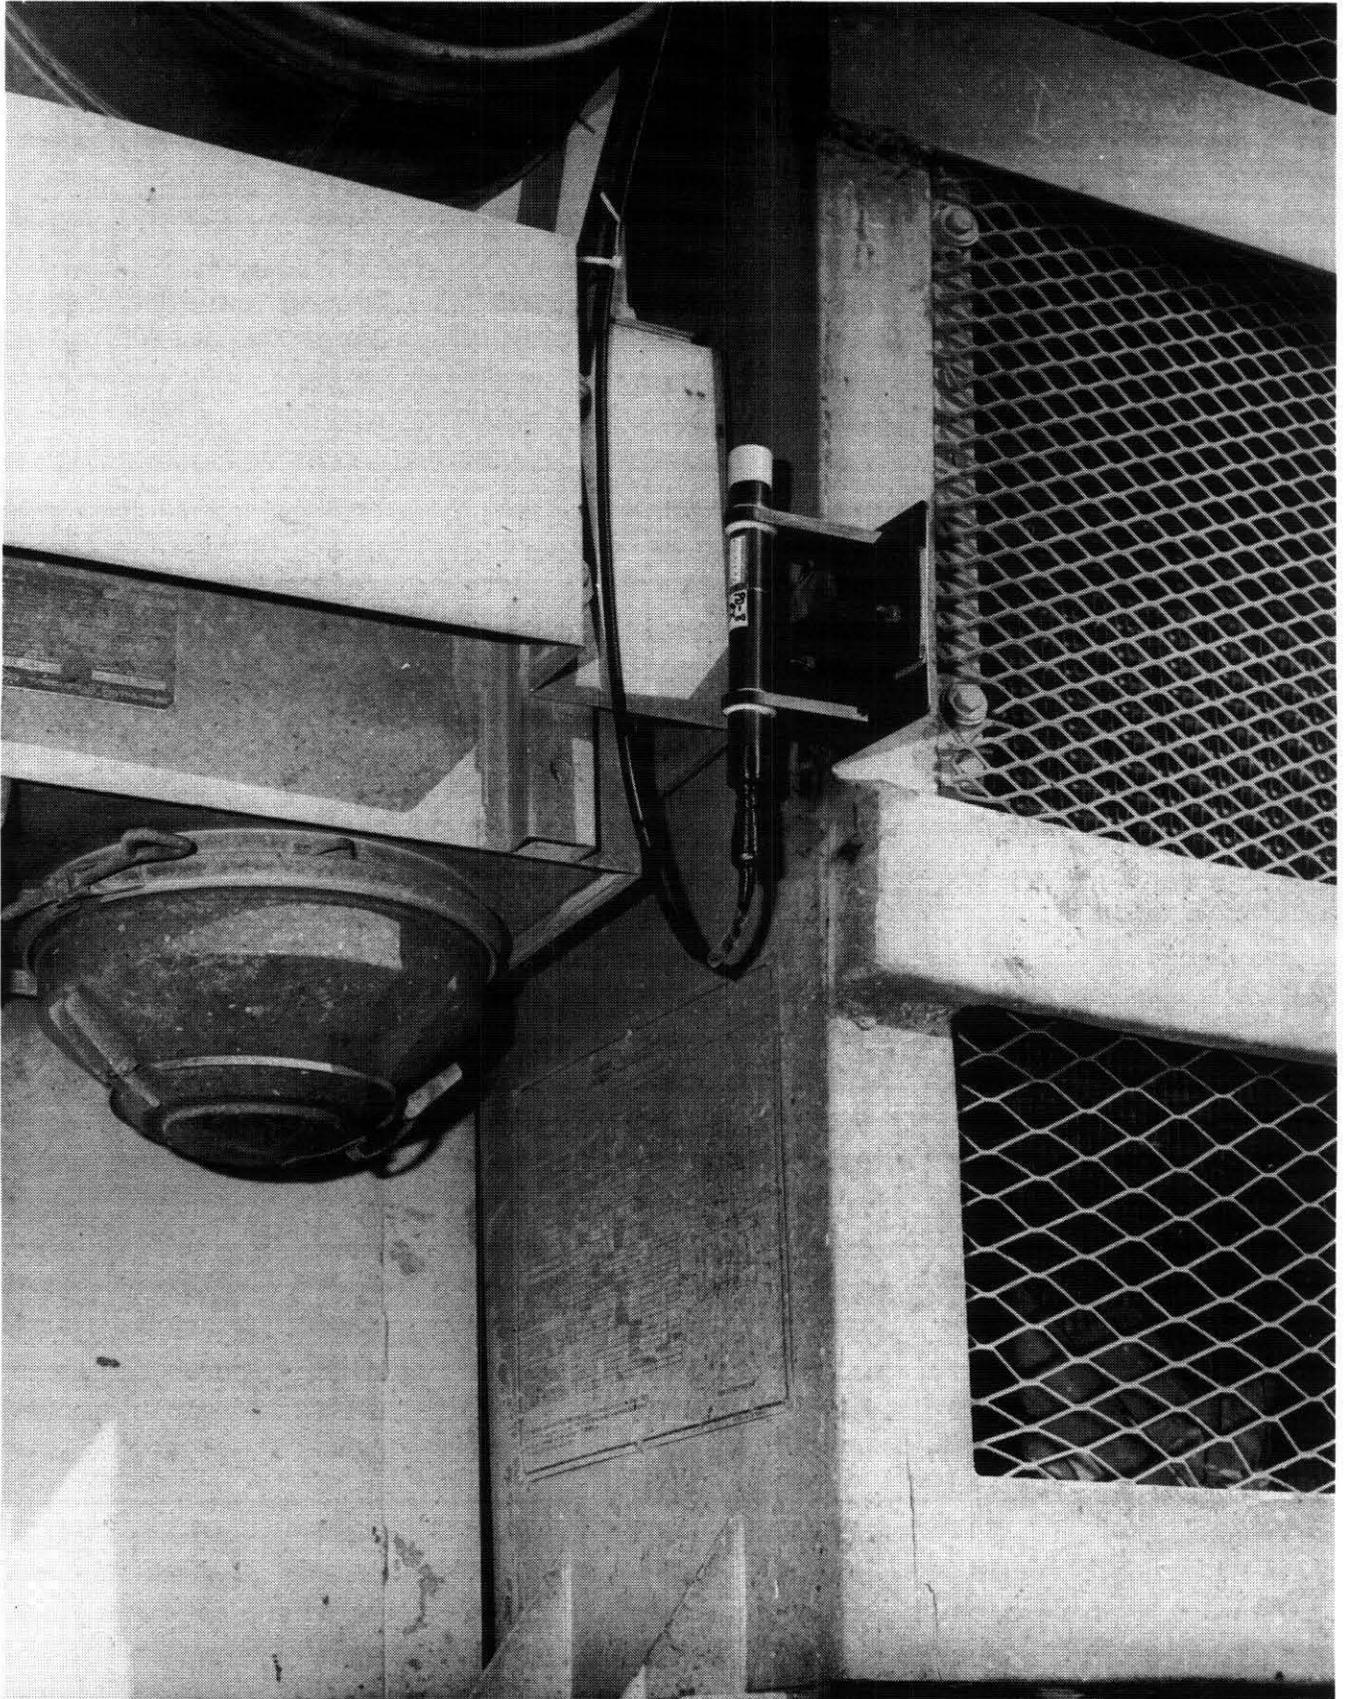
FIGURE 2. - Front antenna, unit 51.

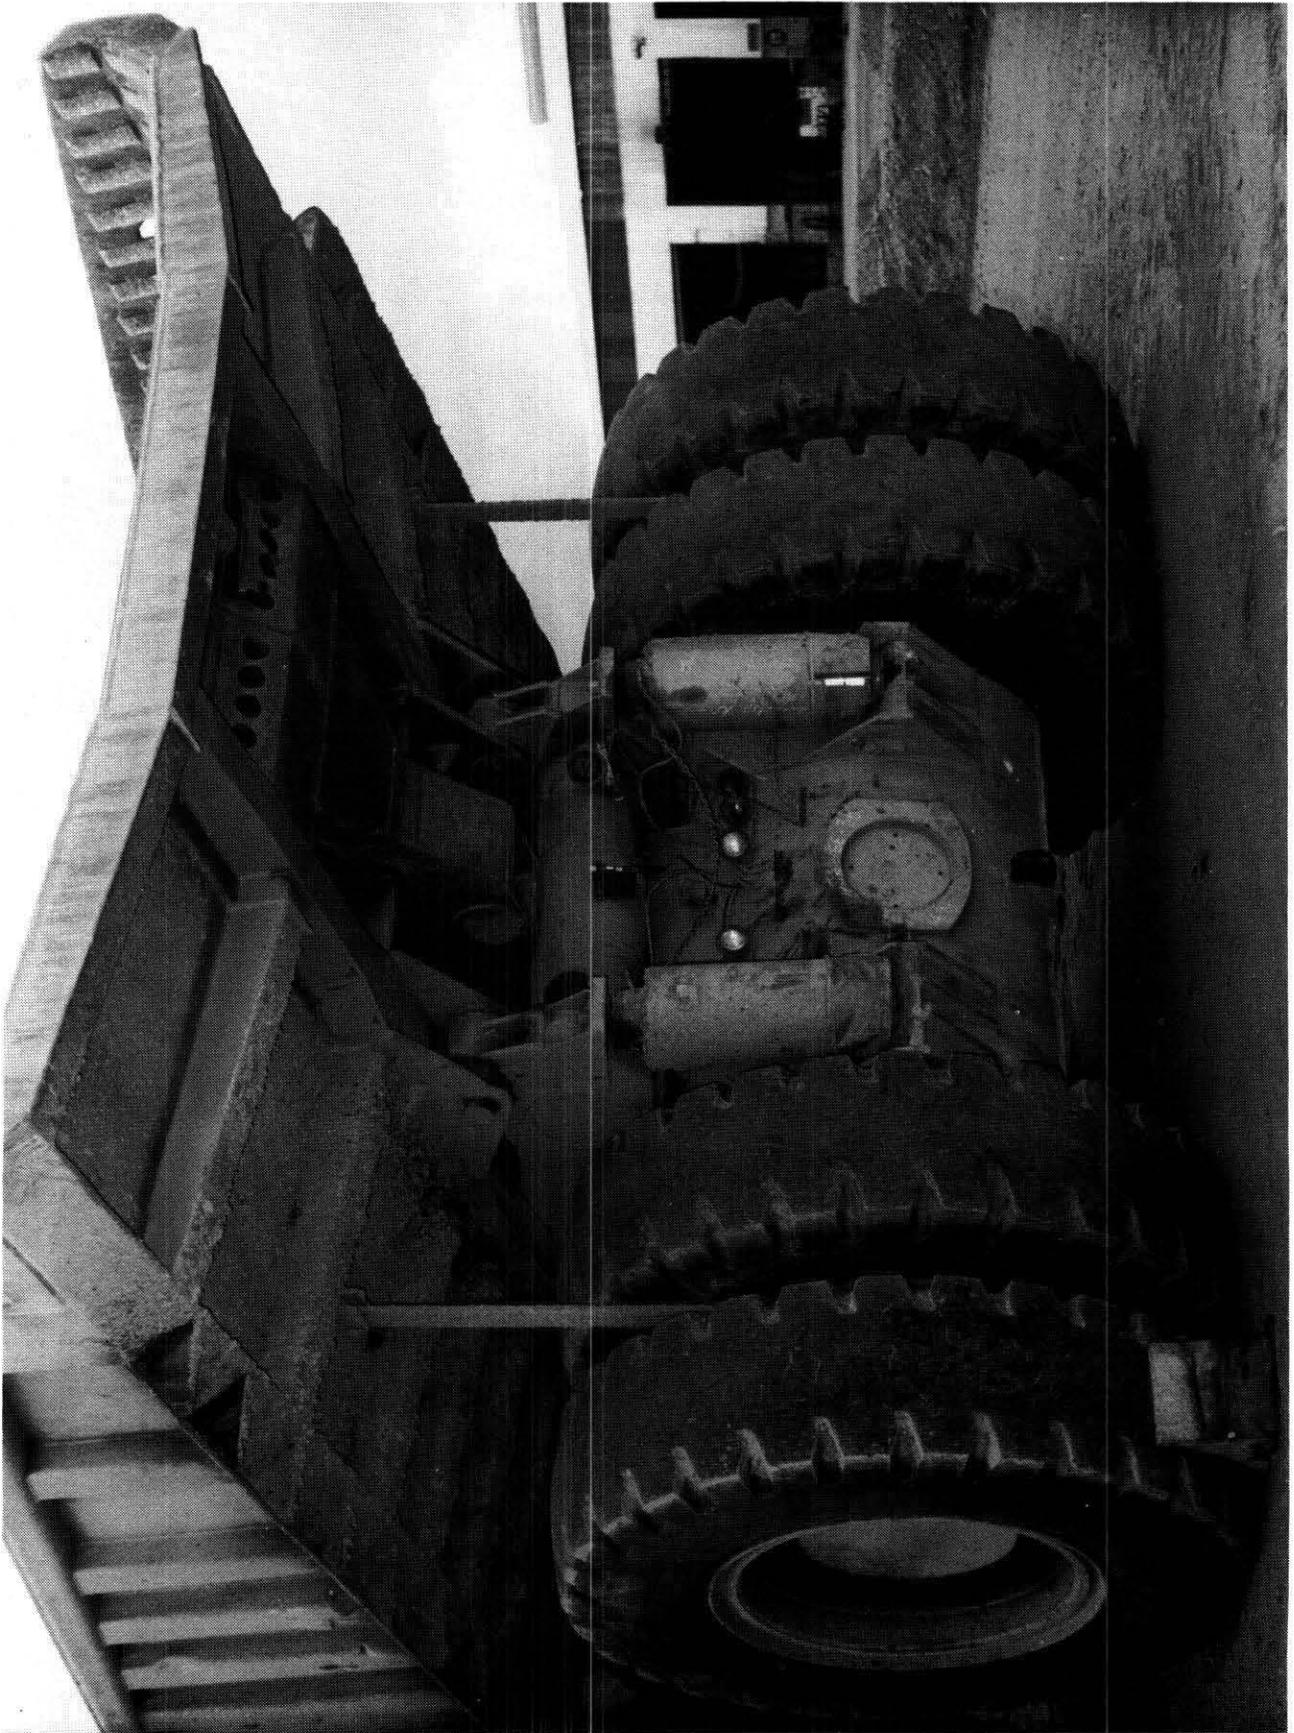
FIGURE 3. - Rear view, unit 51.

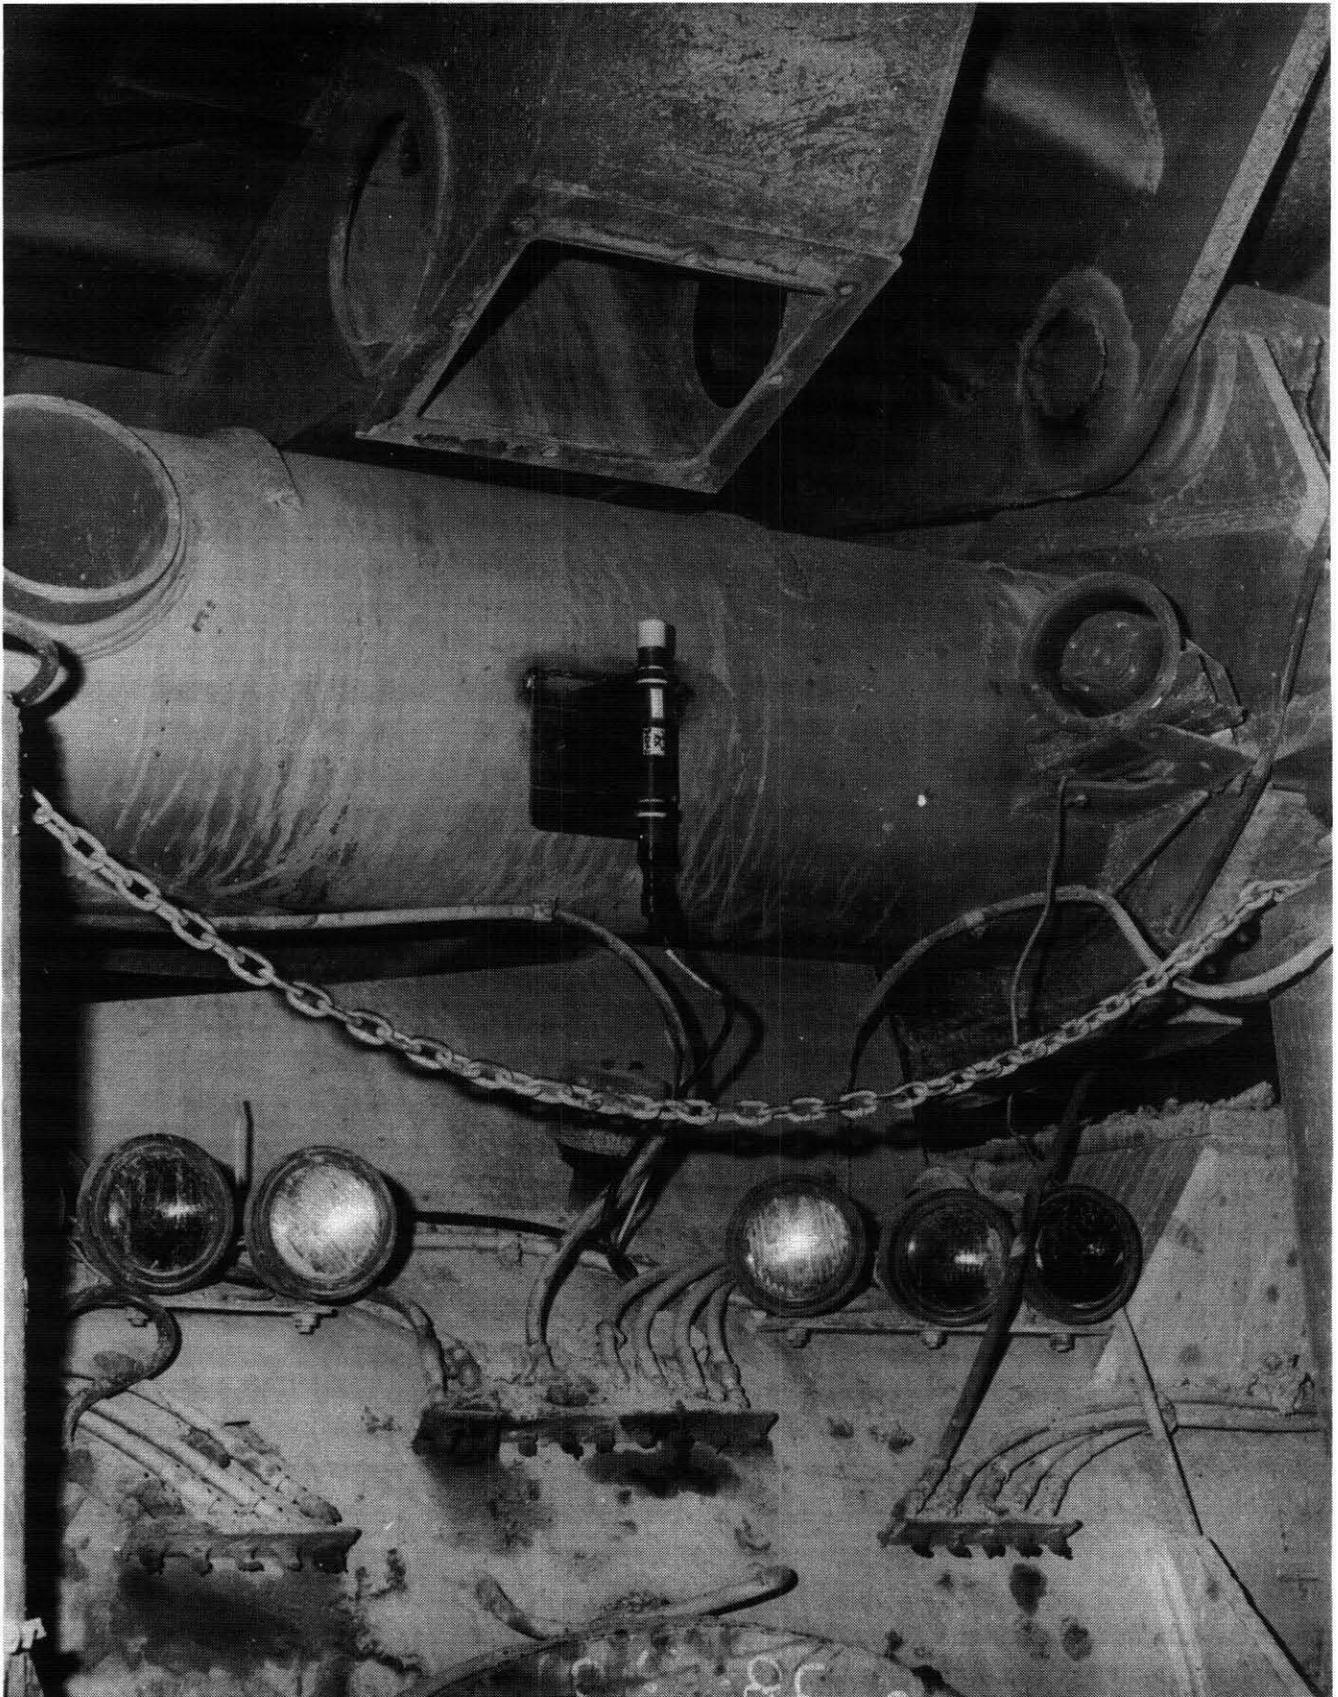
FIGURE 4. - Rear antenna, unit 43.

The rear antenna separation was initially adjusted to 25 ft, the maximum for the original receiver configuration. Later in the test program, the distance was increased to about 36 ft by modifying a jumper on the range detector board.
