Information Circular 8947

Safety in the Use and Maintenance of Large Mobile Surface Mining Equipment

**Proceedings: Bureau of Mines Technology Transfer
Seminars, Tucson, AZ, August 16, 1983, Denver, CO,
August 18, 1983, and St. Louis, MO, August 23, 1983**

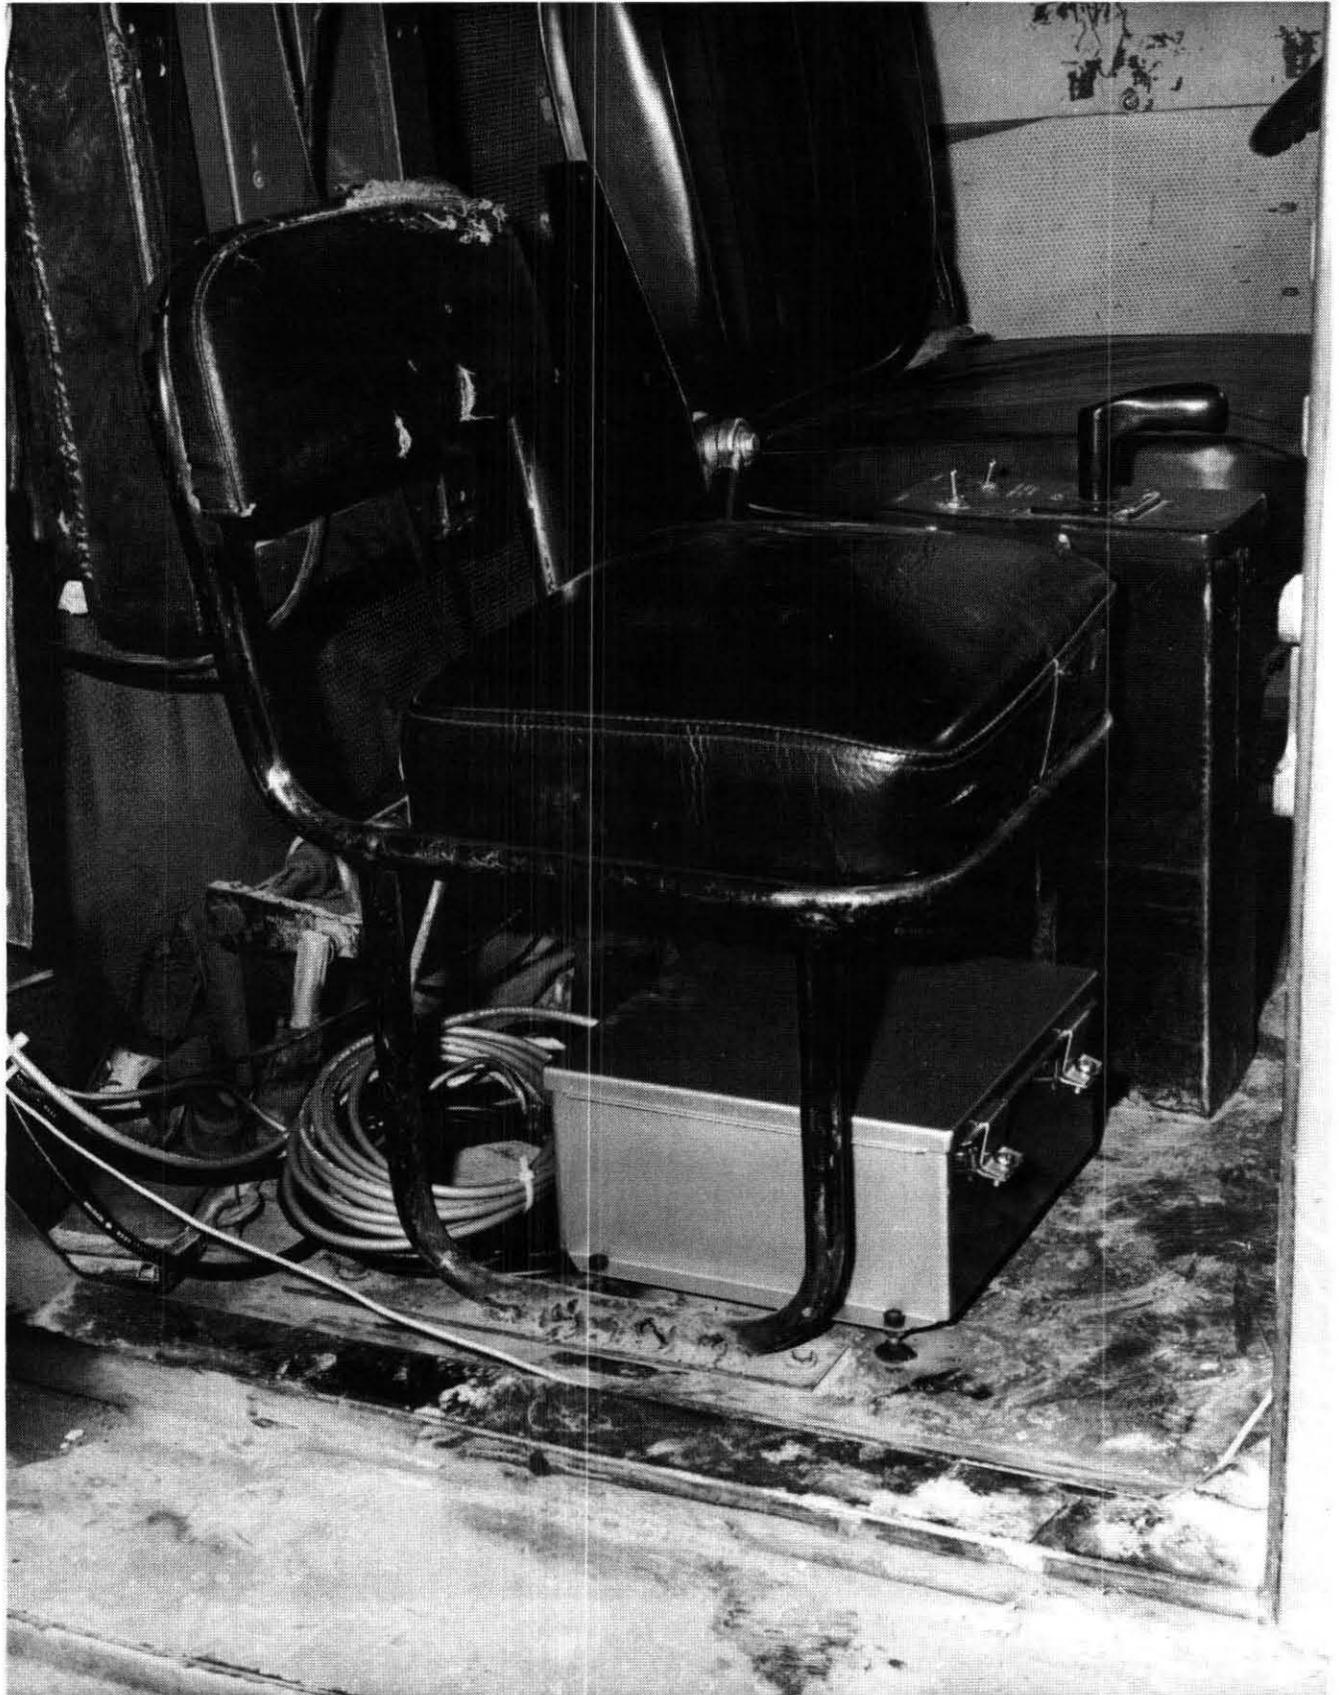
FIGURE 5. - Floor-mounted receiver.

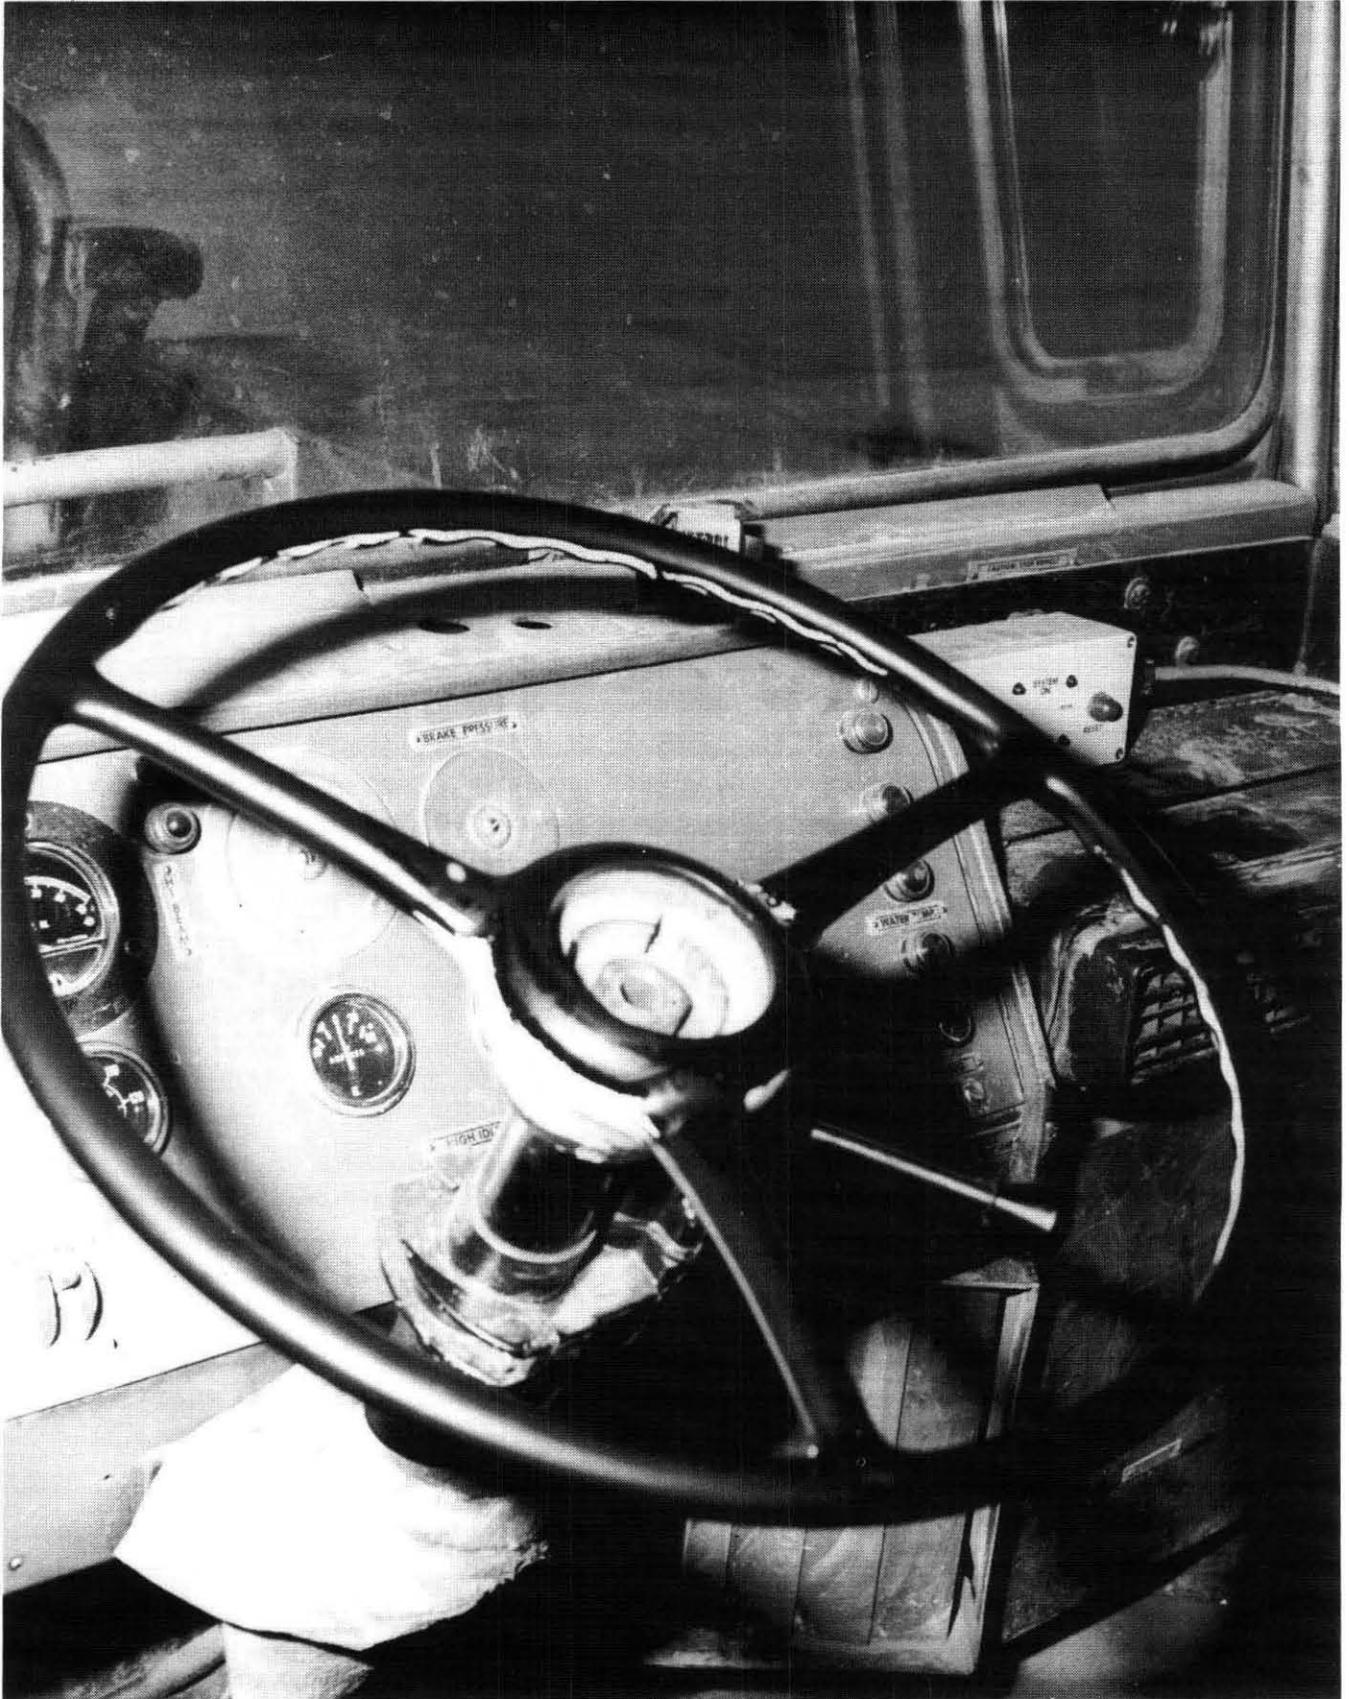
FIGURE 6. - Display panel, unit 51.

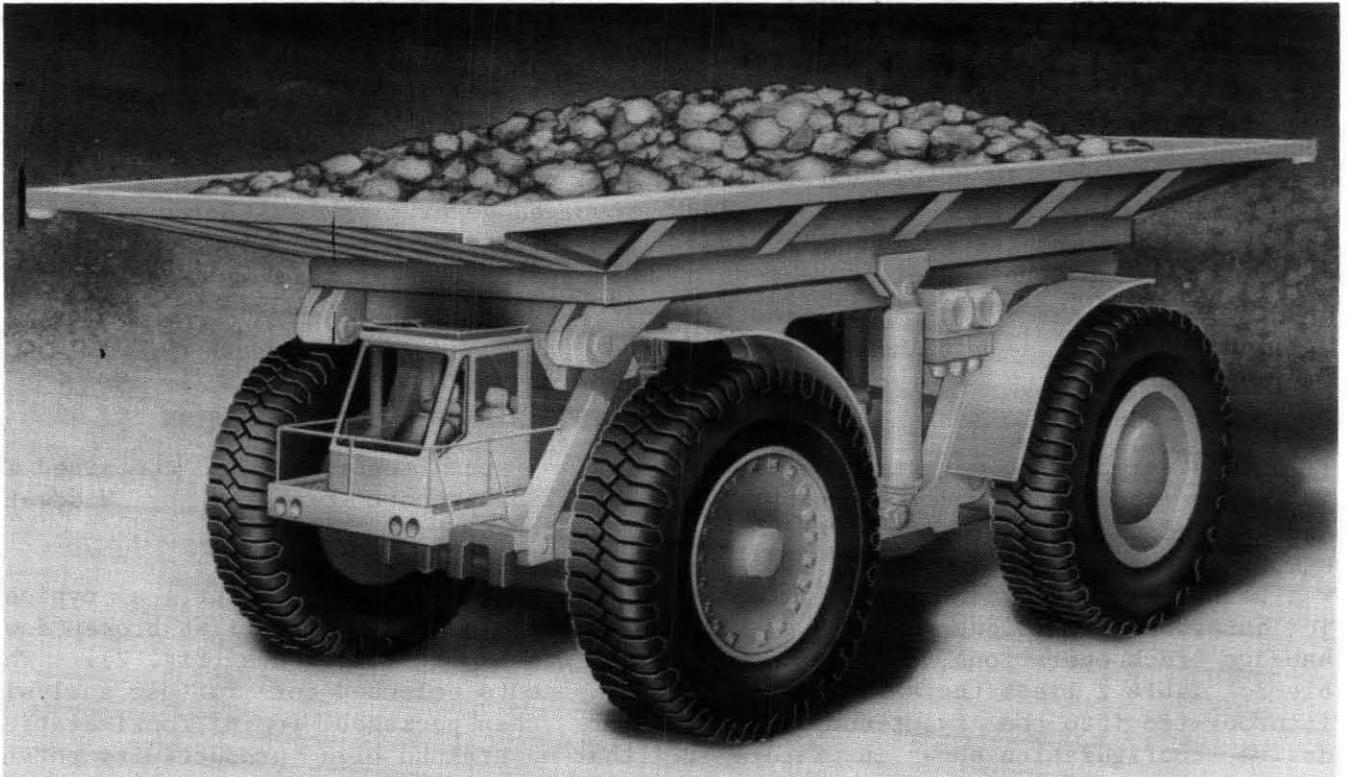
FIGURE 1. - Front-dumping, midengine, 170-ton-capacity truck concept.

Body capacity, cu yd:	
Struck.....	73
2:1 heap.....	142
Body capacity, tons....	170
Dimensions, ft:	
Height.....	17
Width.....	22
Length.....	42
Wheelbase.....	20
Turning circle, ft.....	83.5
Weight, tons:	
Empty.....	170
Loaded.....	340
Engine:	
Type.....	KTA-3067-C
Gross horsepower.....	1,600
Transmission.....	GTA-15, W/GE776C
Tires.....	40:00-57

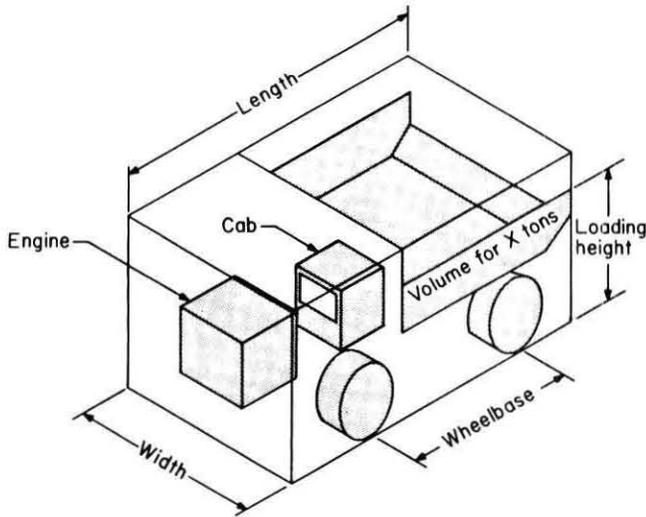
FIGURE 2. - Major components of a typical large haulage truck.

To generate the concept, a typical large haulage truck was first broken down to its major components (fig. 2). The components selected for further analysis were then packaged in a configuration that maintained high productivity potential while also providing improved safety features (fig. 3). This design concept

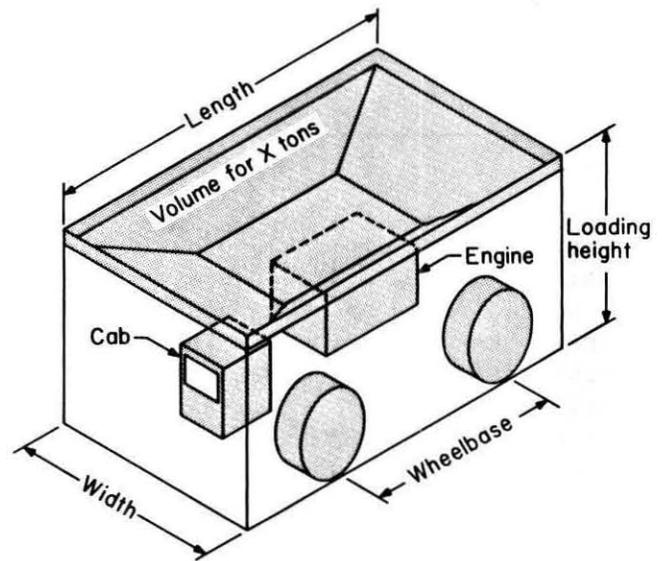
FIGURE 3. - Components of a safer, more productive novel haulage truck design concept.

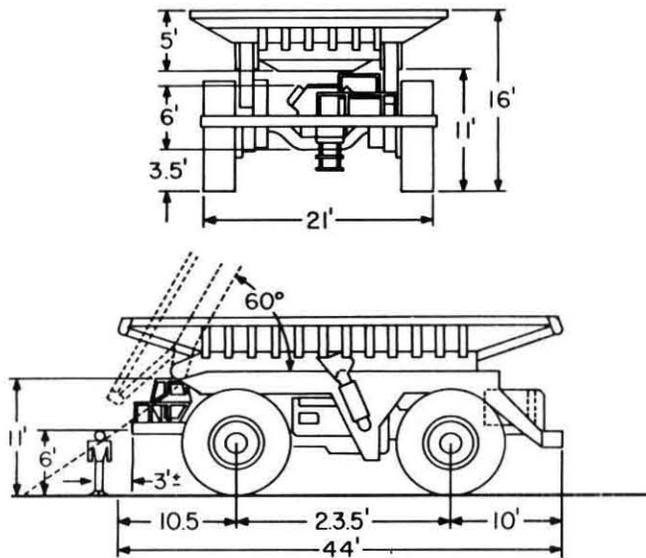
FIGURE 4. - Dimensions of the novel concept.

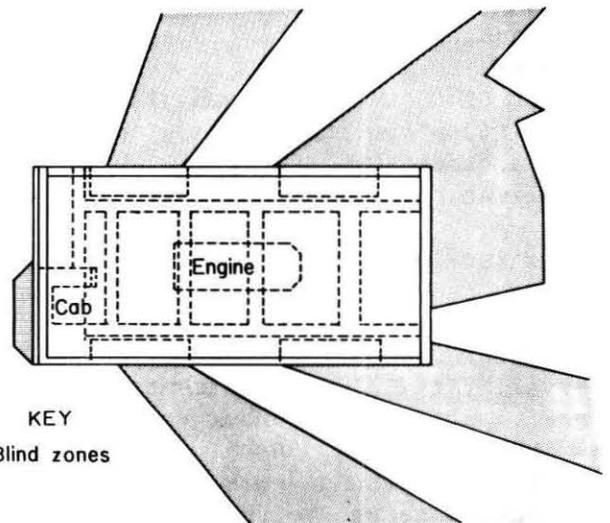
FIGURE 5. - Anticipated direct field of view of the novel concept.

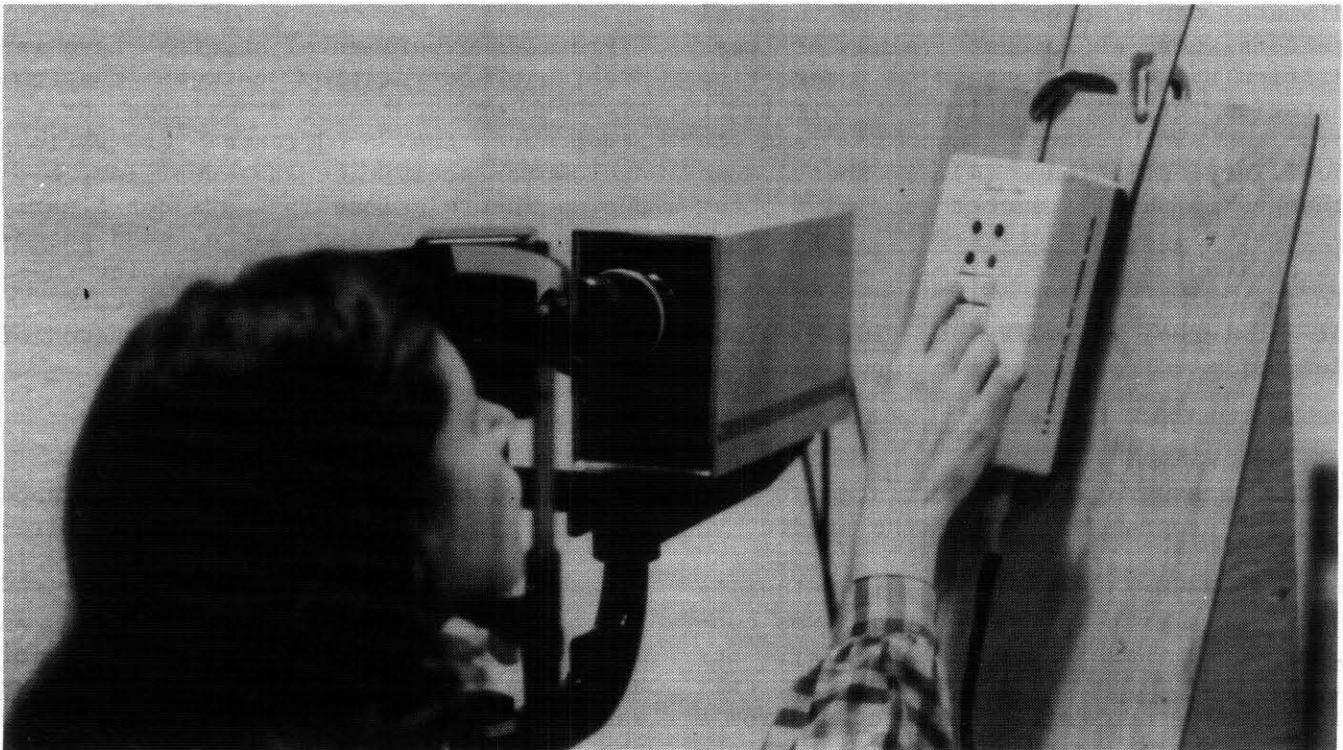
FIGURE 1. - Wilkinson stimulus-response unit.

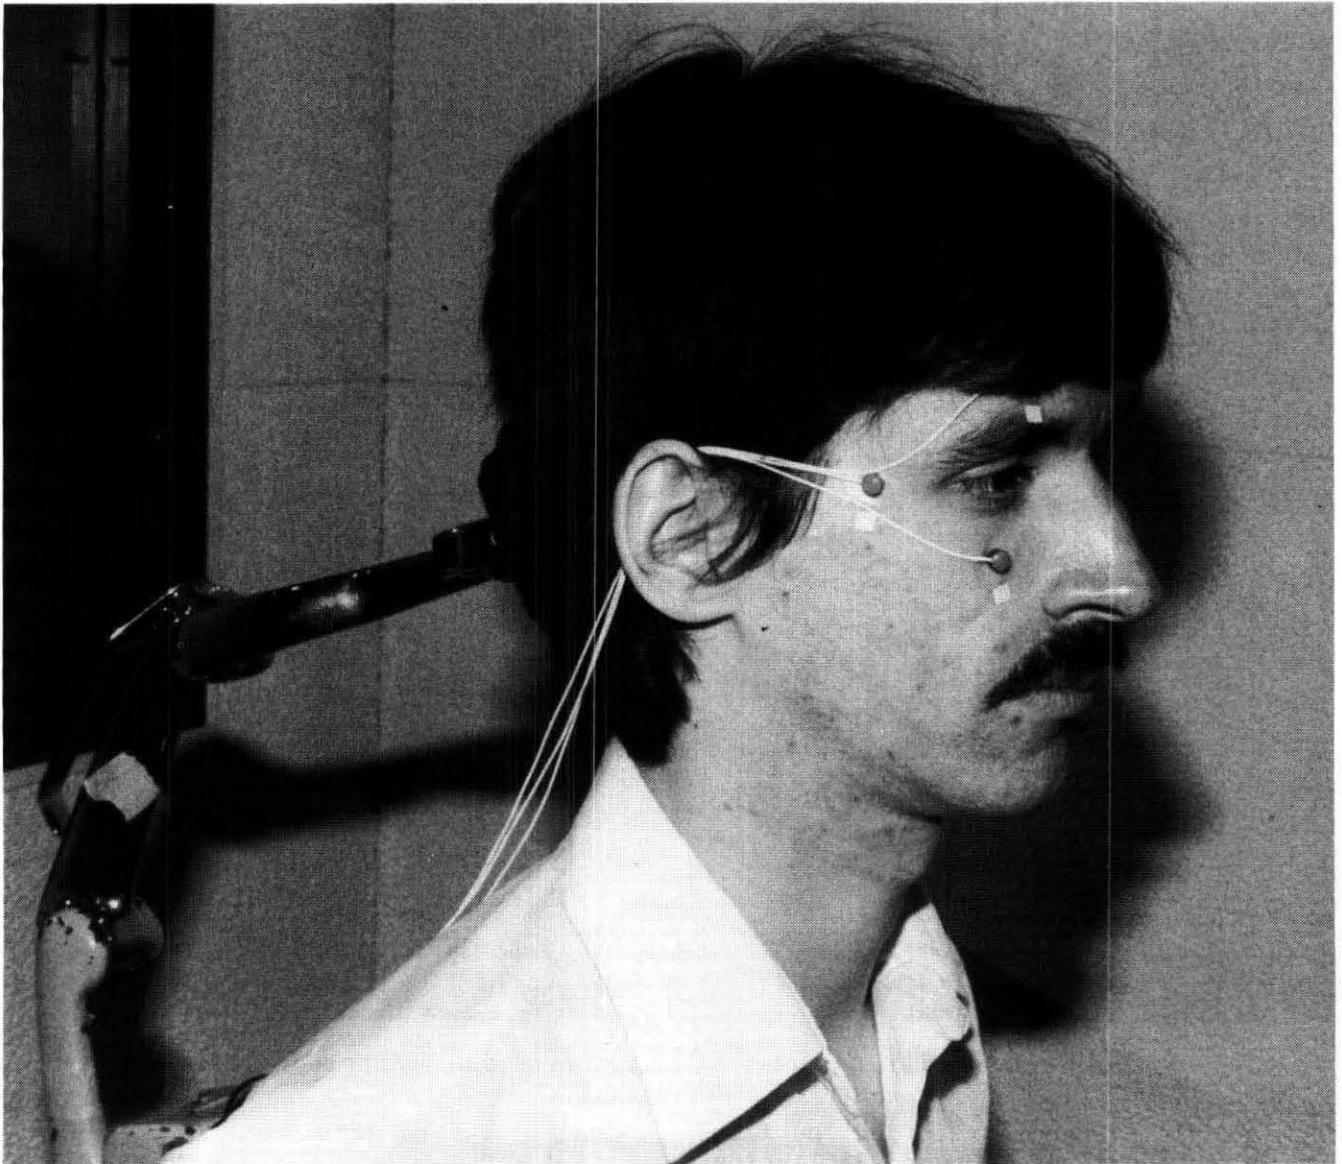
FIGURE 2. - Ag-AgCl electrodes used to monitor vertical eye movements.

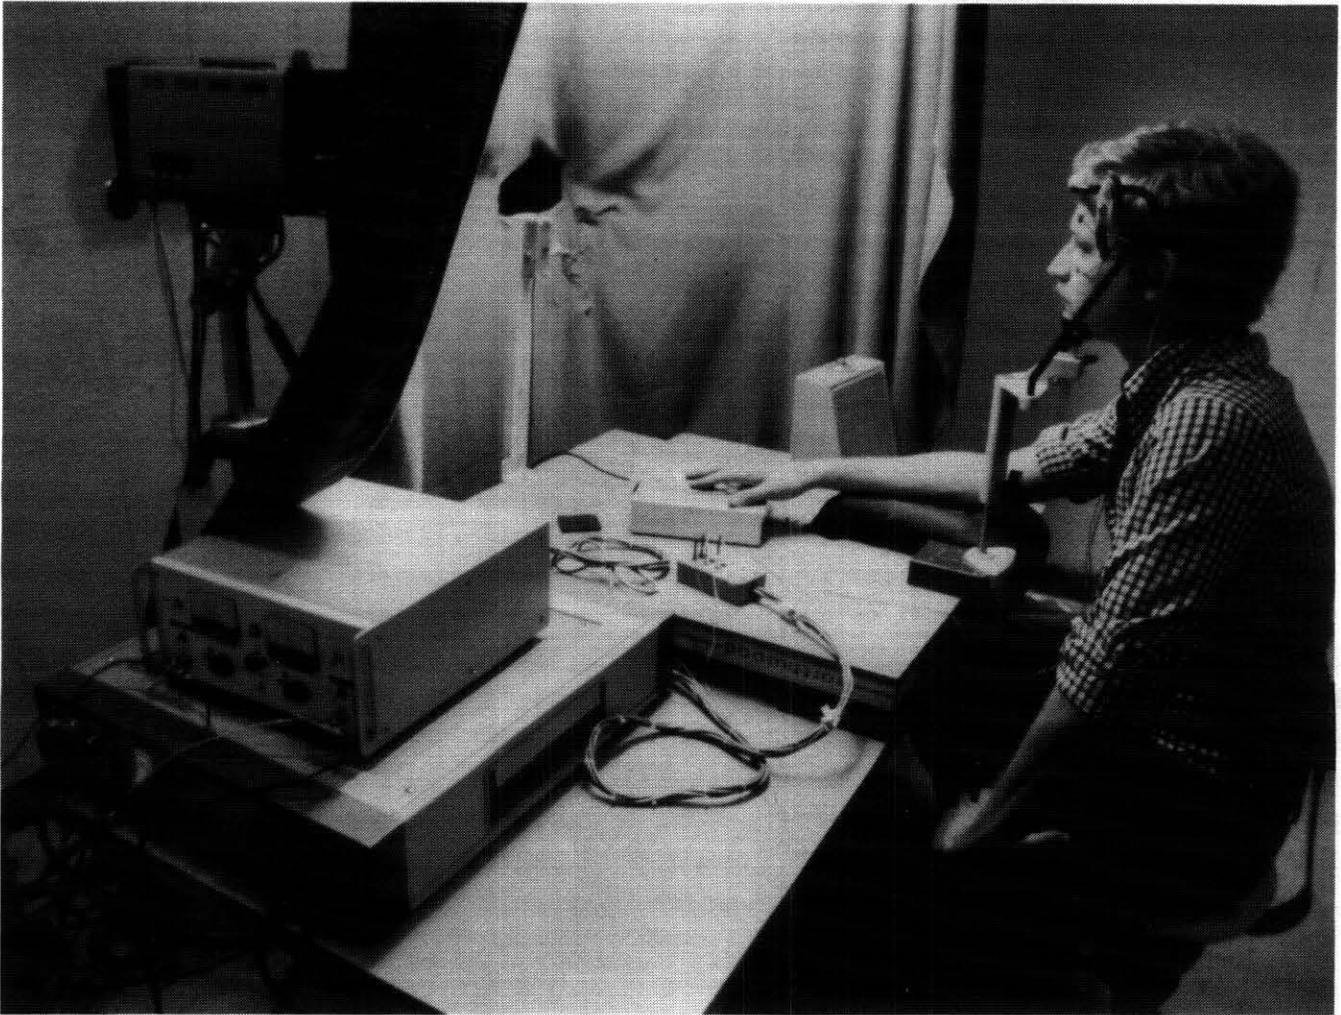
FIGURE 3. - Head restraint and CCTV camera used to monitor pupil size.

Pupillary information was monitored by means of a closed-circuit television (CCTV) camera. During the vigilance testing, the subject was seated with his

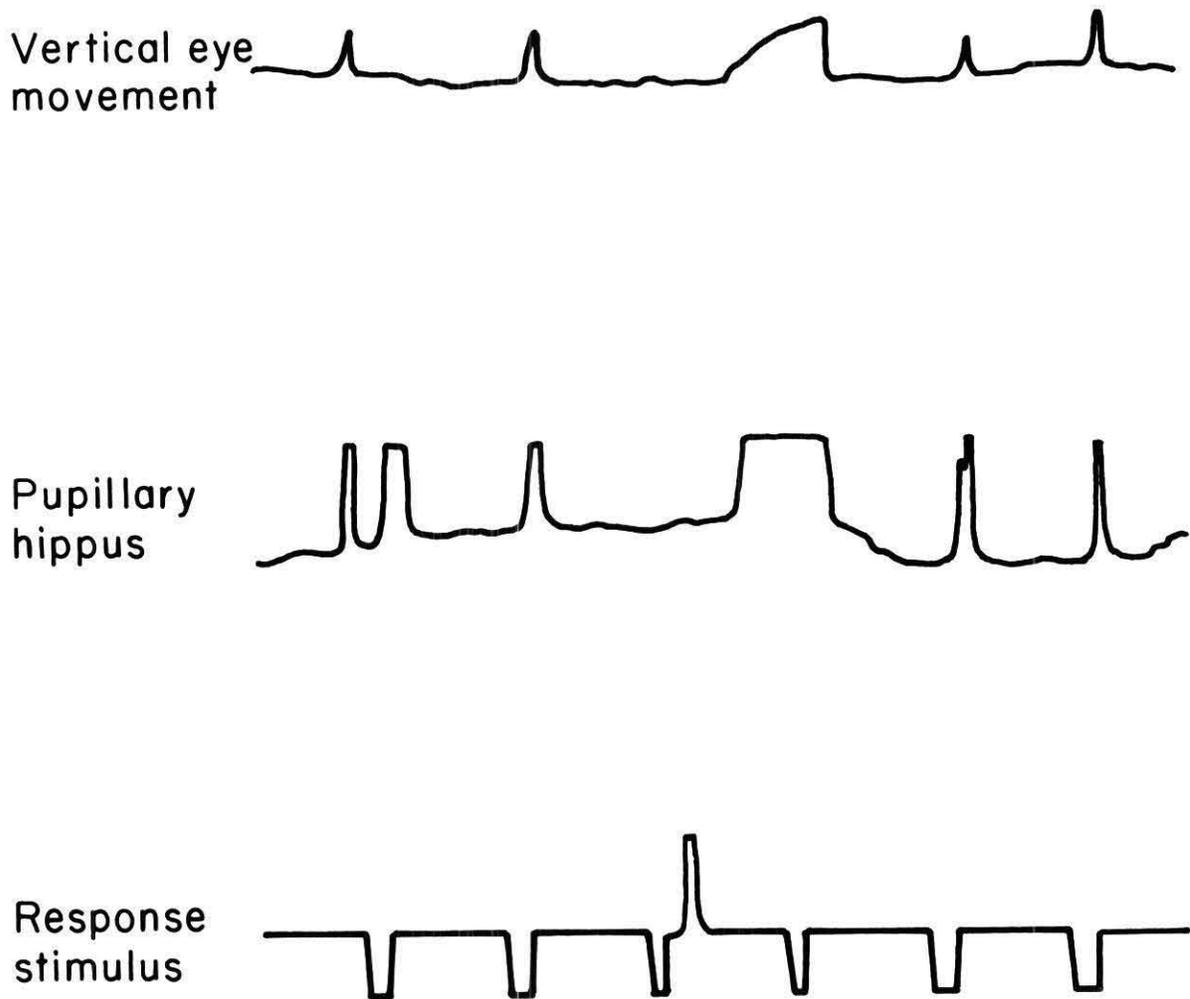
FIGURE 4. - Sample strip chart from auditory vigilance testing.

is shown in figure 4. The lower channel depicts both the stimuli presentation and subject's response. As indicated on the figure, a downward deflection of the pen represents the presentation of the tone with the width of the square wave corresponding to the duration of the signal. The subject's response is displayed as an upward deflection of the pen. As can be seen in this example, the subject correctly discerns the third signal as being 200 ms in duration and responds appropriately. However, no response is recorded for the next signal, which is also 200 ms in duration.

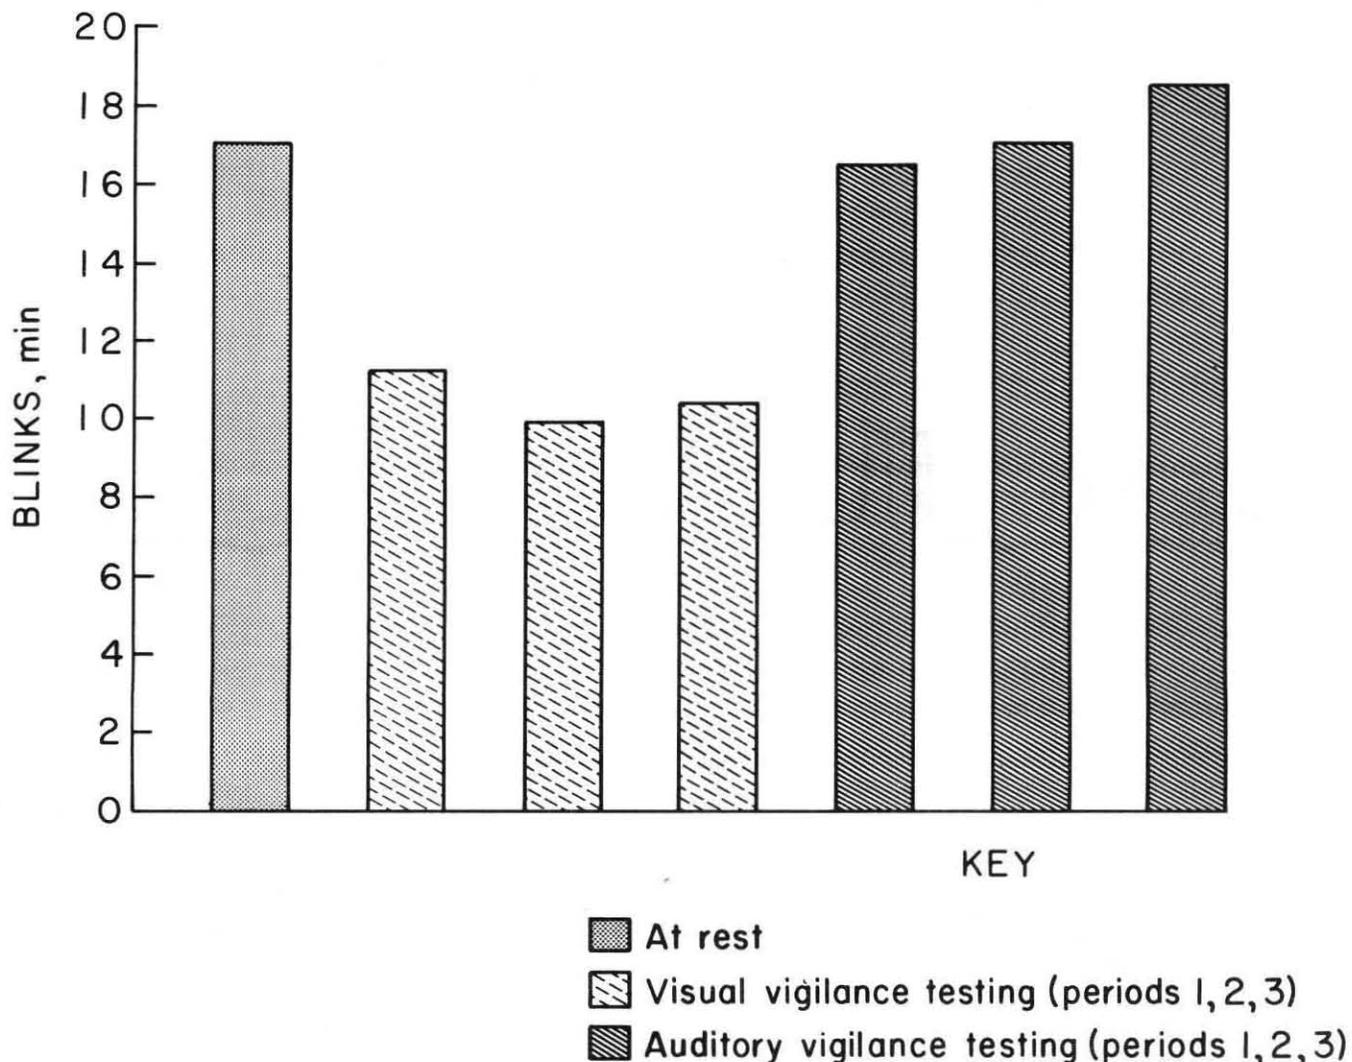
FIGURE 5. - Eyeblink frequency data.

The most apparent result from the study was that there was significant inhibition of blinking during the visual vigilance testing. Figure 5 shows the blink rates exhibited during both visual and auditory vigilance testing and during a period of rest. It can be seen that the test subjects blinked more frequently during the rest period (17.0 blinks/min) and auditory test (17.3 blinks/min) than

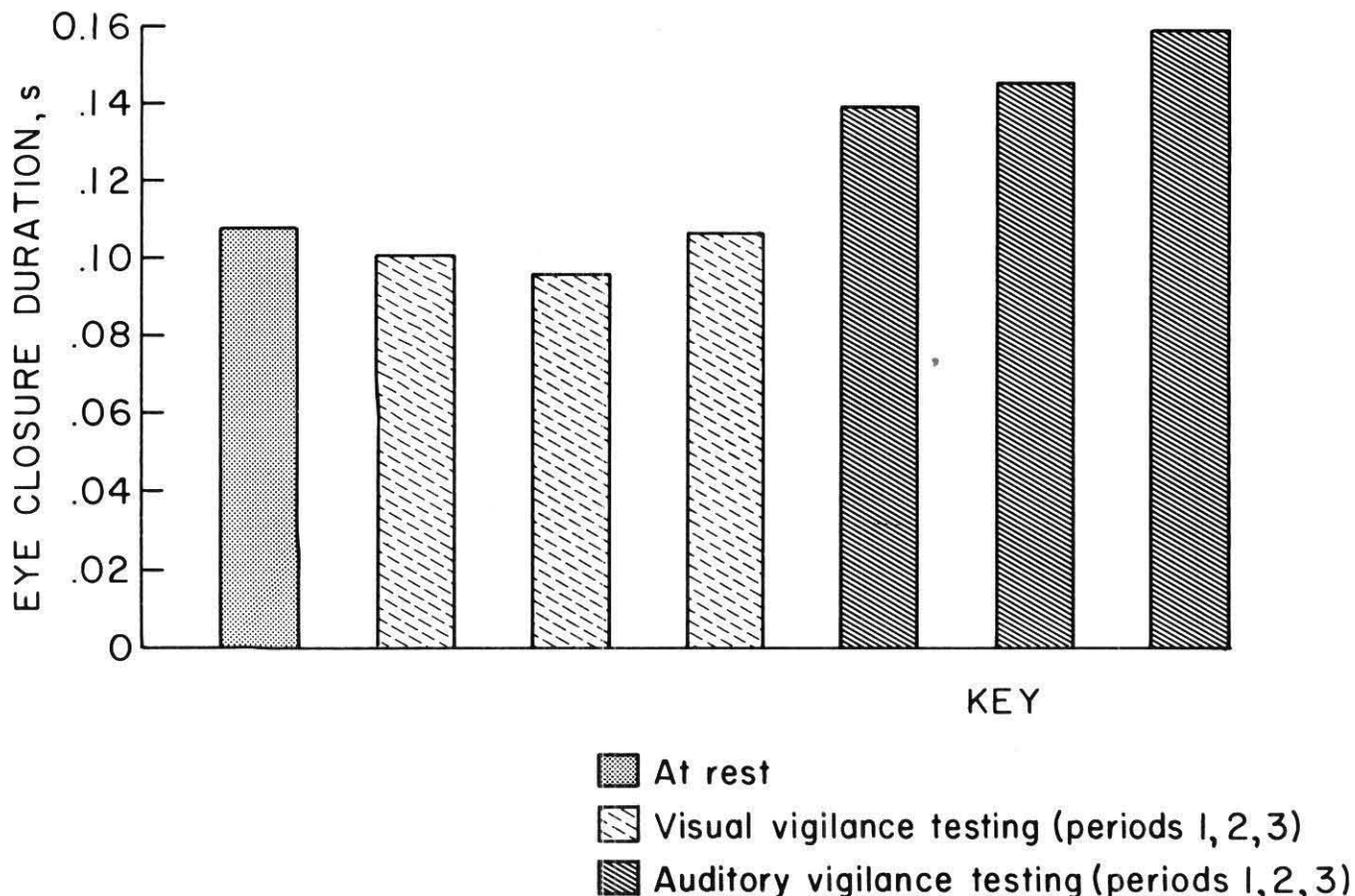
FIGURE 6. - Eye closure duration data.

significant. Figure 6 shows that closure duration, as expected, was longer during the auditory task than during either the visual testing or the rest period when measured at 50 pct of full blink amplitude. There was no statistically significant difference between closure duration for the visual testing and the rest period. Thus, it can be concluded that blink closure duration is significantly affected by the type of task subjects are called upon to perform. A visually demanding task leads to a reduction in closure duration, while a task with no demands for visual processing leads to a significant increase in closure duration.

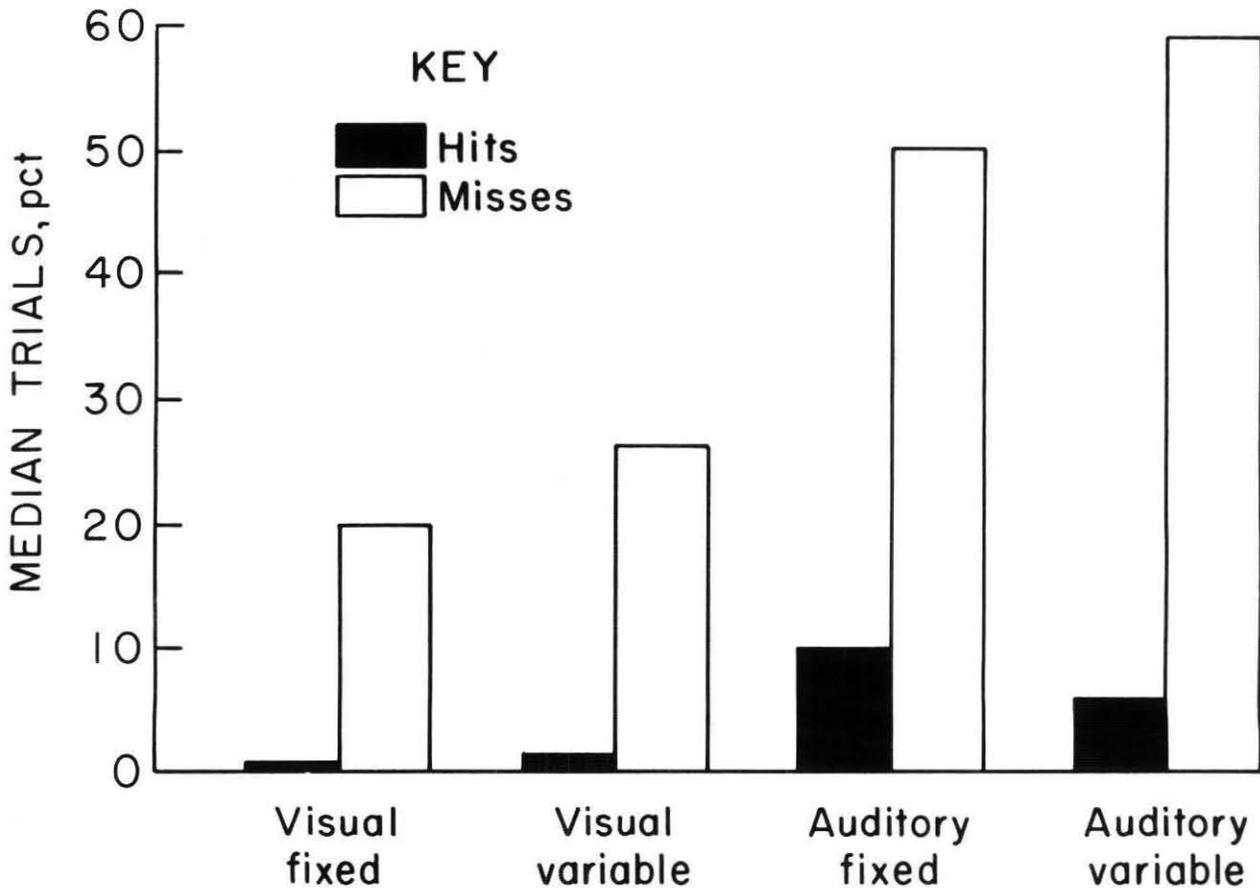
FIGURE 7. - Percent of trials on which blinks and/or closures occurred during stimulus presentation.

A graphical representation of the results is shown in figure 7. The plot presents the percentage of trials on which eyeblinks or closures occurred in association with either a correct response (hit) or a missed signal (miss). The results are discriminating in that, for both auditory and visual stimuli, the incidence of blinks or closures associated with correct responses is markedly less than that associated with missed signals. These limited data indicate that when an eyeblink or closure was observed to have occurred during

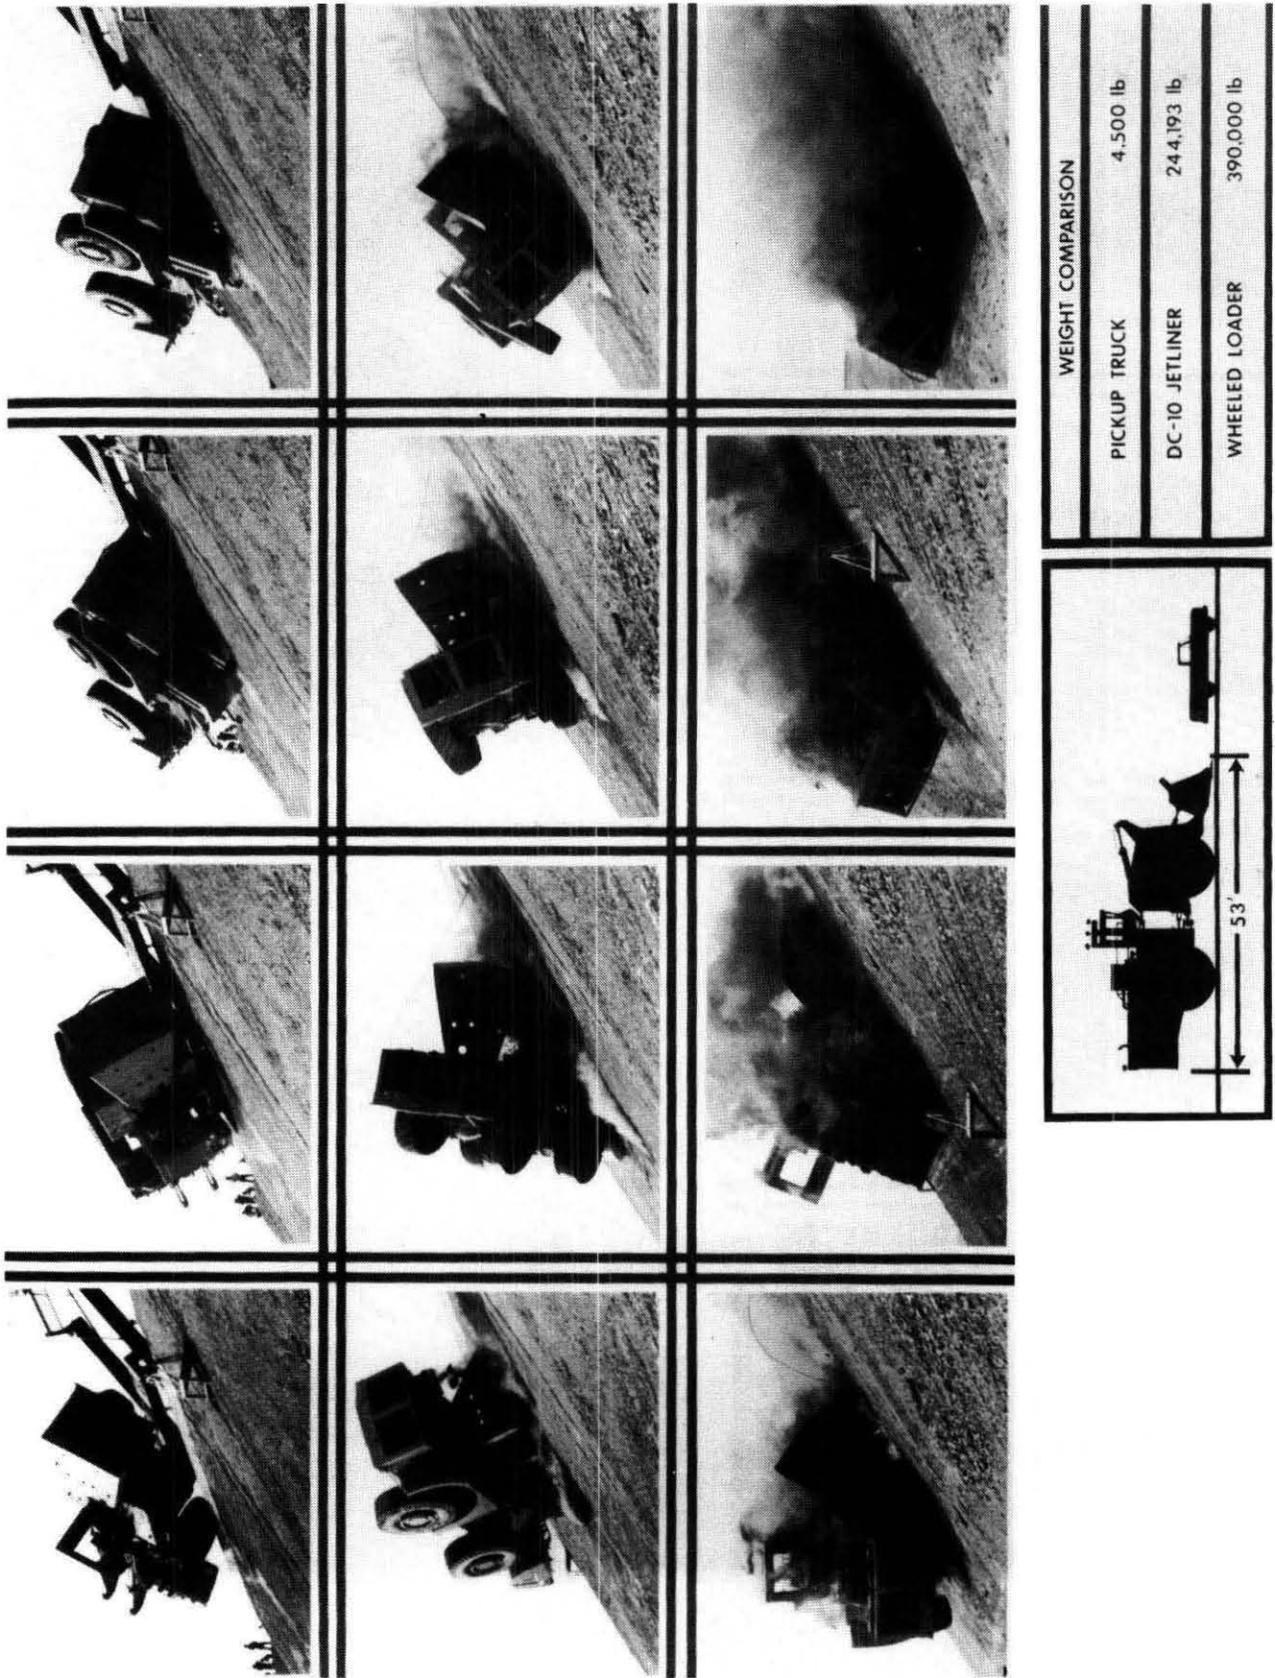
FIGURE 1. - First roll test of a 390,000-lb wheeled loader (720°).

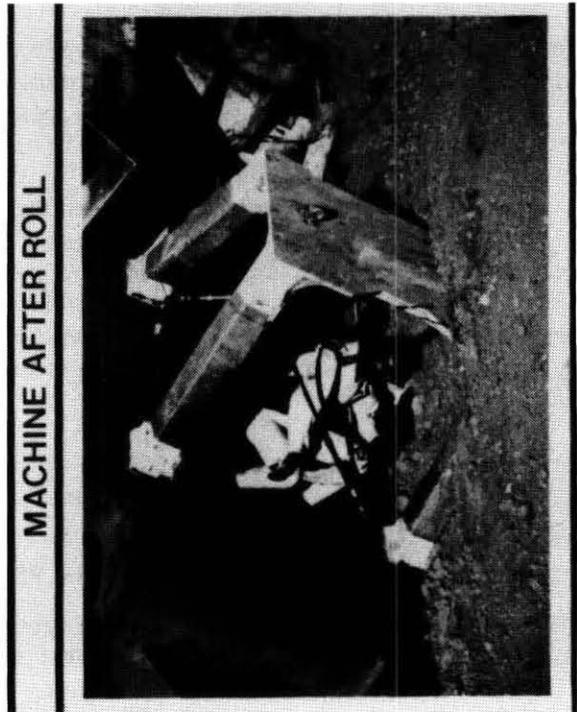
FIGURE 3. - Roll test of a 286,000-lb front-end loader (720°).

To evaluate this design, a seatbelt rollover test was conducted in conjunction with the ROPS rollover program, utilizing a 50th percentile anthropomorphic male dummy weighing 160 lb. Seatbelt loads were obtained for both the left and right sides of the belt. With the exception of the longitudinal head acceleration, these values were obtained during the first impact of the ROPS. The vertical acceleration of the dummy's head exceeded the limitation of the accelerometer, which was approximately 20 g. The maximum longitudinal head acceleration occurred after the first impact.

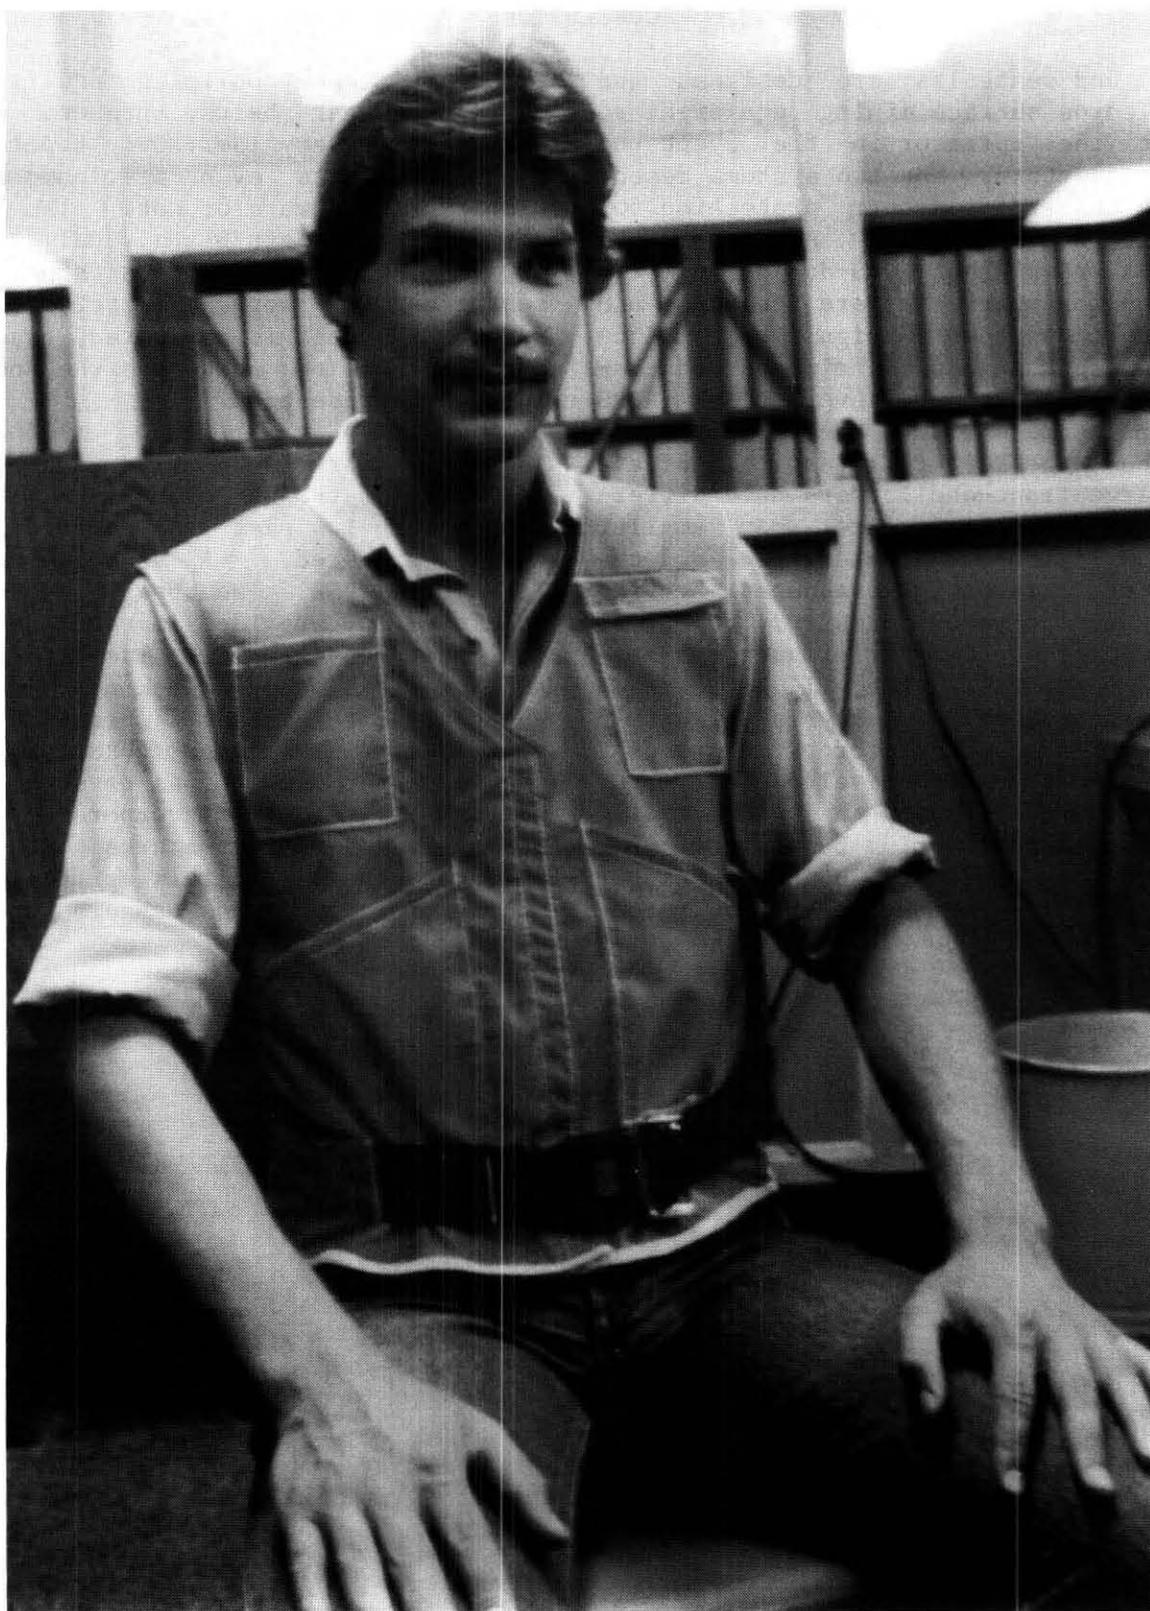
FIGURE 4. - Vest restraint system.

A preliminary analysis of the VRS indicates that the prototype vest can be comfortably and easily adjusted for proper fit. Because of snaphooks and other attachment devices for tools and lunch buckets on the VRS, the operator's hands can be free during ingress and egress from the equipment. This improved way of carrying items aboard the vehicle will reduce slip and fall accidents.

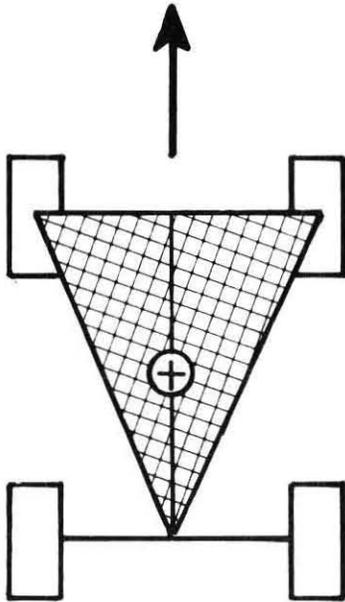
FIGURE 1. - Front-end loader suspension points under normal conditions.

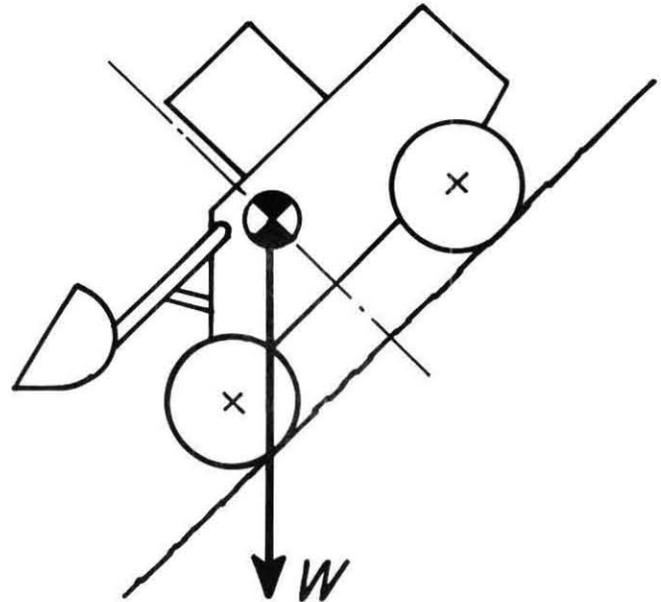
FIGURE 2. - Projection of center of gravity near overturn.

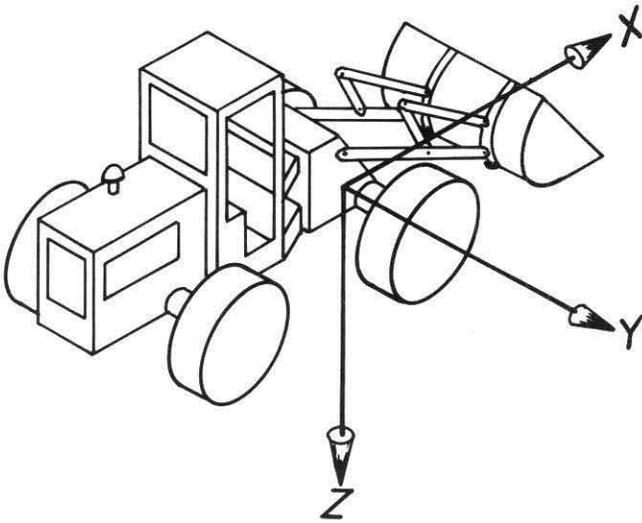
FIGURE 4. - Coordinate system used in analysis.

The CG is located with respect to a vehicle coordinate system whose origin is at the center of the front axle, with the x-axis pointing forward, the y-axis to the right, and the z-axis down (fig. 4). The mathematical procedure used is to locate the vehicle on a horizontal ground plane with a selected bucket load, lift arm position, and articulation angle. The ground plane is then inclined to a combined front and side slope, and the vertical projection of the vehicle CG is determined. If this projection falls
