Information Circular 8947

Safety in the Use and Maintenance of Large Mobile Surface Mining Equipment

**Proceedings: Bureau of Mines Technology Transfer
Seminars, Tucson, AZ, August 16, 1983, Denver, CO,
August 18, 1983, and St. Louis, MO, August 23, 1983**

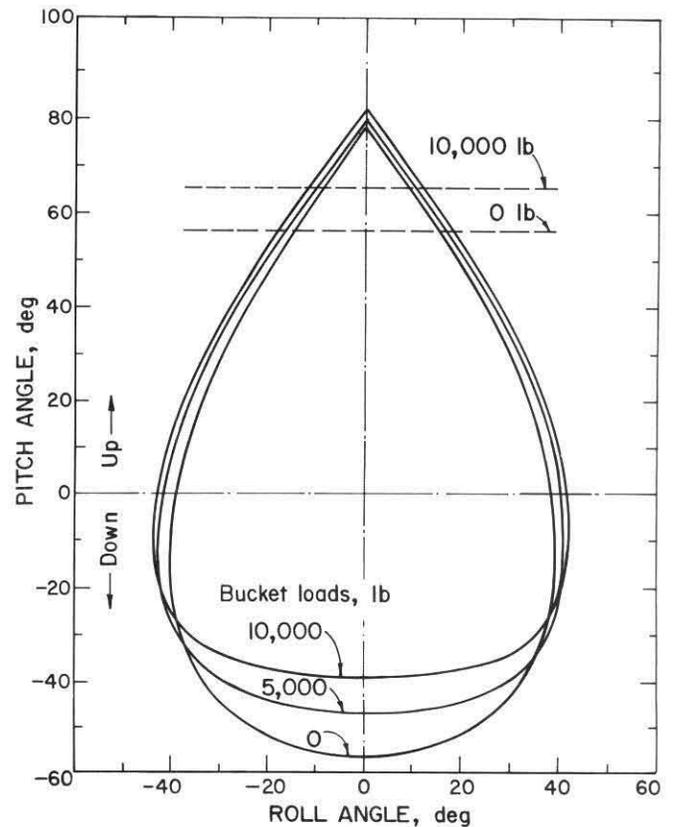
FIGURE 5. - Stability envelope for arm at carry and articulation = 0° .

Using the above procedure, the static stability limits as functions of pitch and roll angles were generated with the bucket load, articulation angle, and lift arm position as independent parameters. Figure 5 is a plot of the pitch angle versus the roll angle with the bucket load as a parameter for 0° articulation angle and with the lift arm at the "carry" position. The FEL is stable for any combination of roll and pitch angle within the stability "triangle." Figure 6 is a similar plot except that the lift arm is in the "full-up" position. As is expected, the operating envelope is

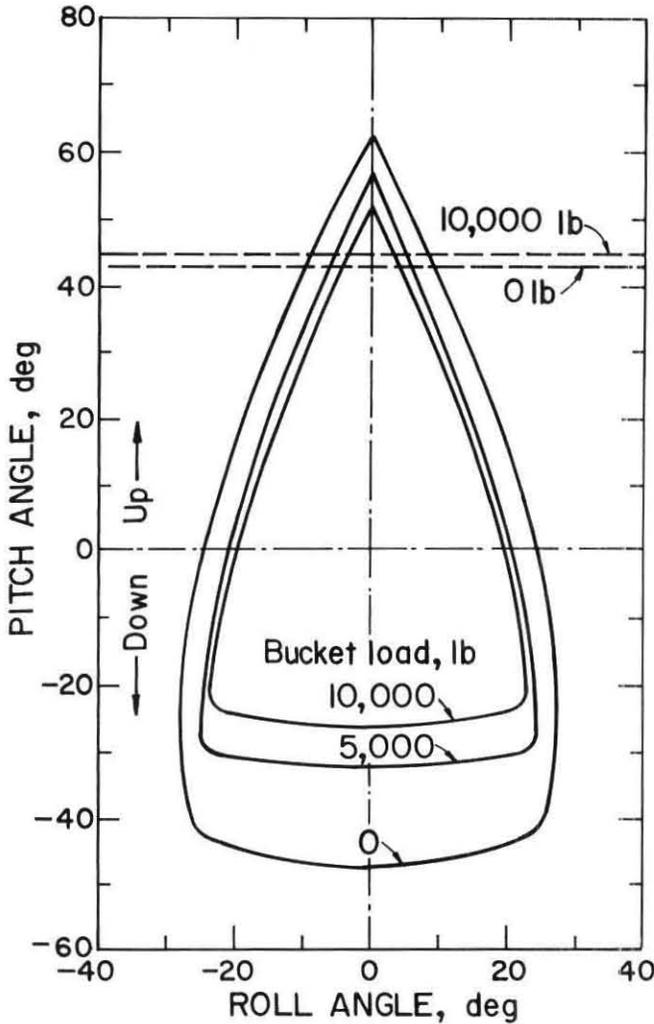
FIGURE 6. - Stability envelope for arm full-up and articulation = 0°.

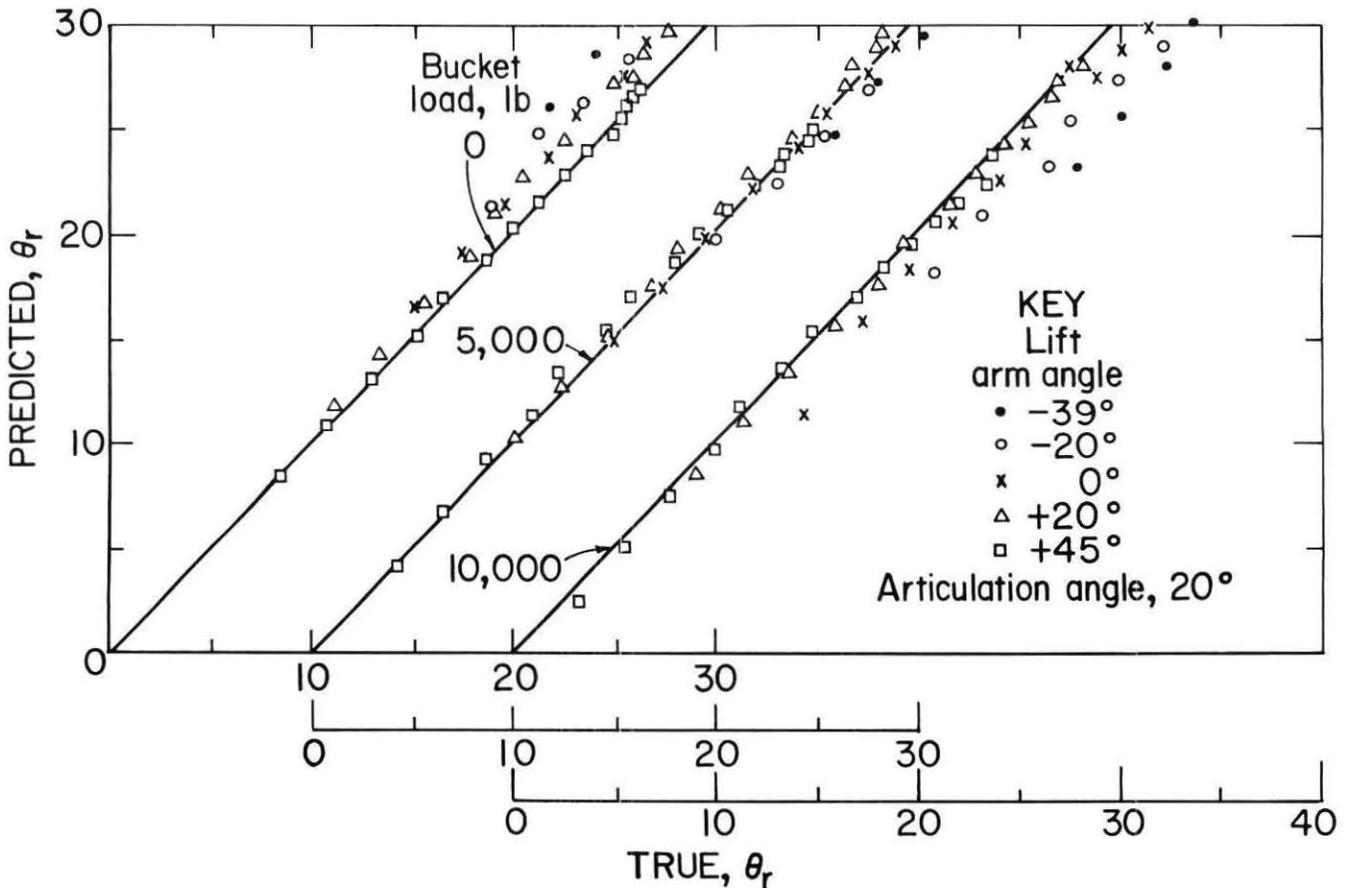
FIGURE 9. - Correlation of data between predicted and actual cases.

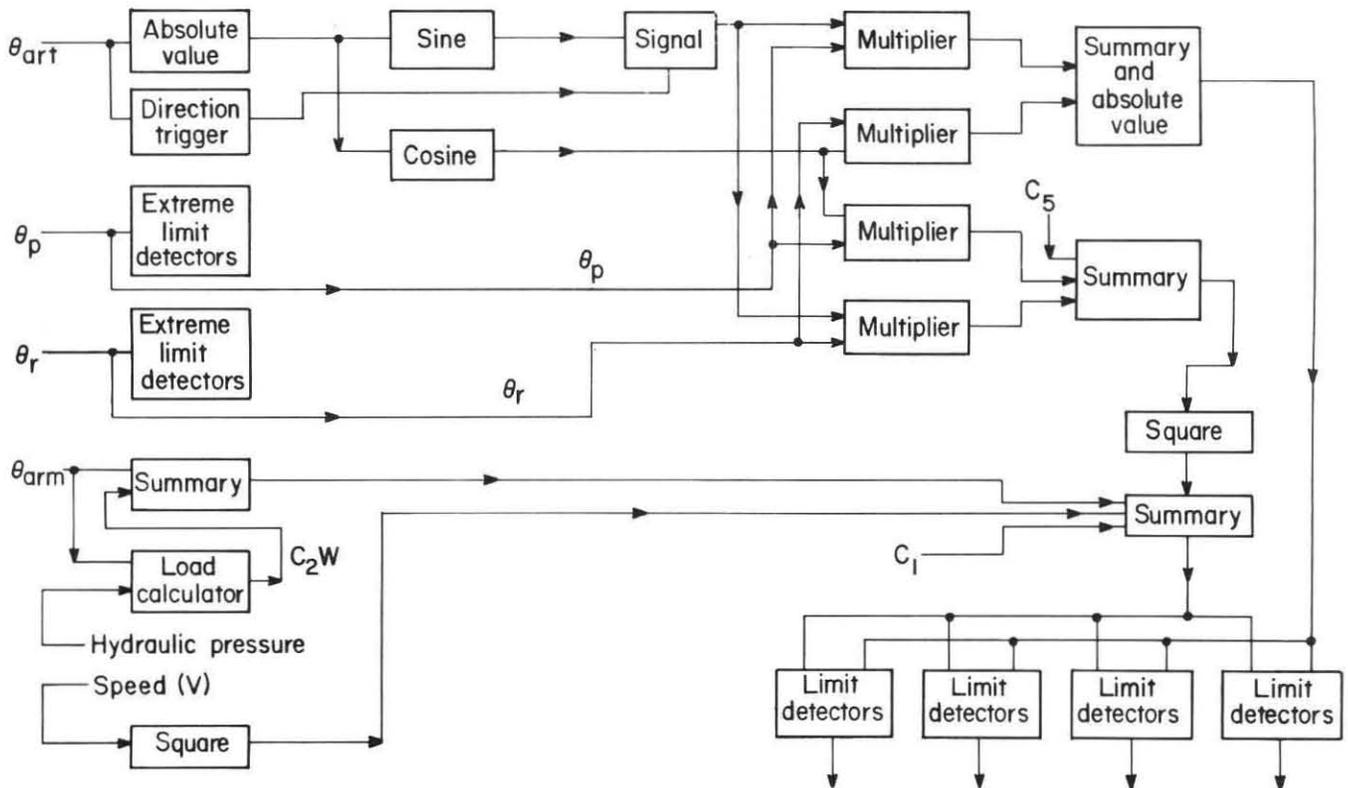
FIGURE 10. - Block diagram of signal processor.

The driver's warning device consisted of four indicator lights. One was green, two were amber, and one was red. The analog circuitry accepted the five sensor inputs, calculated the angle at which the machine would roll over, and compared

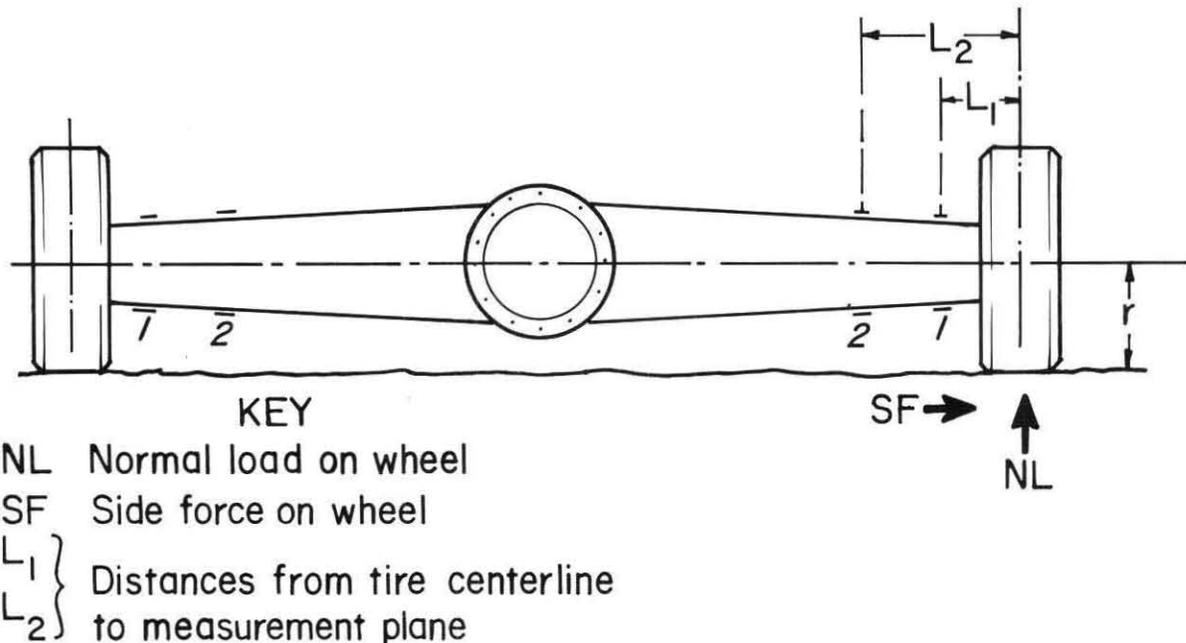
FIGURE 12. - Forces acting on wheel of front-end loader.

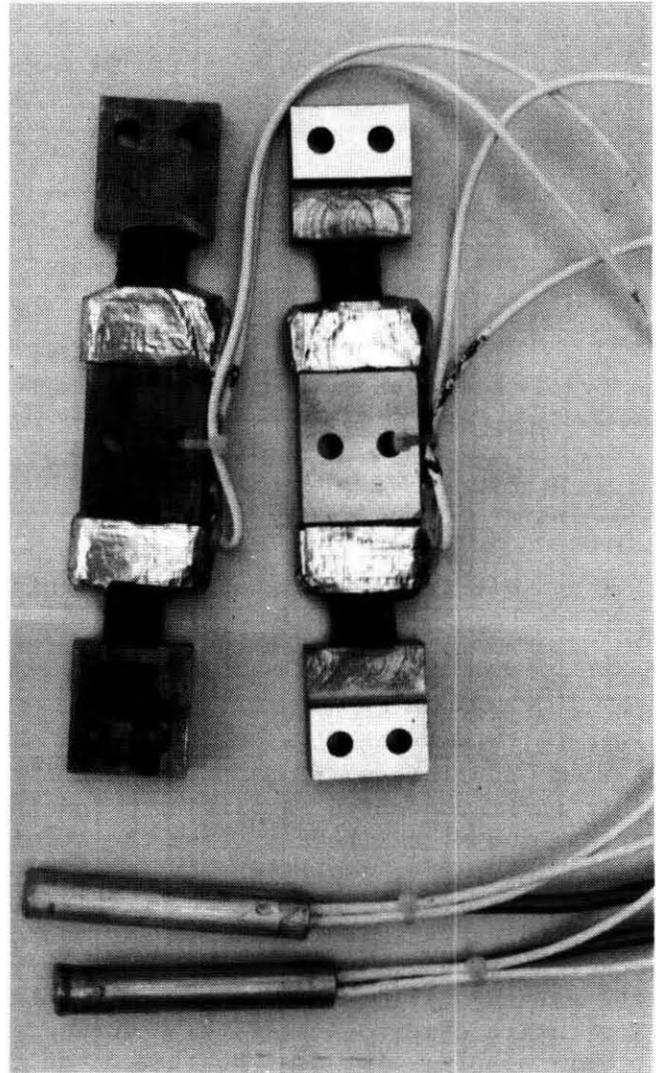
FIGURE 13. - View of strain links.

At the present time, two fastening methods are being tested. The strain links on one side of the FEL axle are bolted to the mounting blocks using 3/8-in socket-head cap screws. The strain links on the other side of the axle are bonded to the mounting blocks. The bonding method is quite simple, using pre-packaged epoxy, and requires little skill. In addition, the strain link does not experience any zero shift, due to bolting torque, when it is bonded, thus reducing the electronic adjustments required.

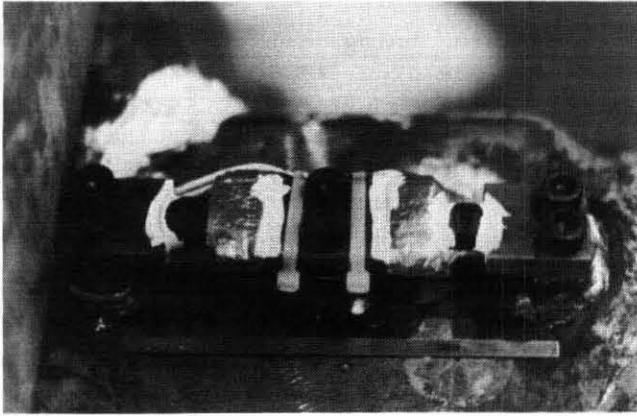
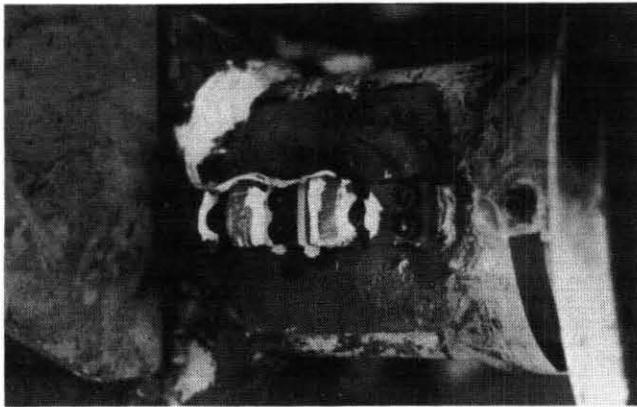
FIGURE 14. - Strain links installed on front-end loader axle.

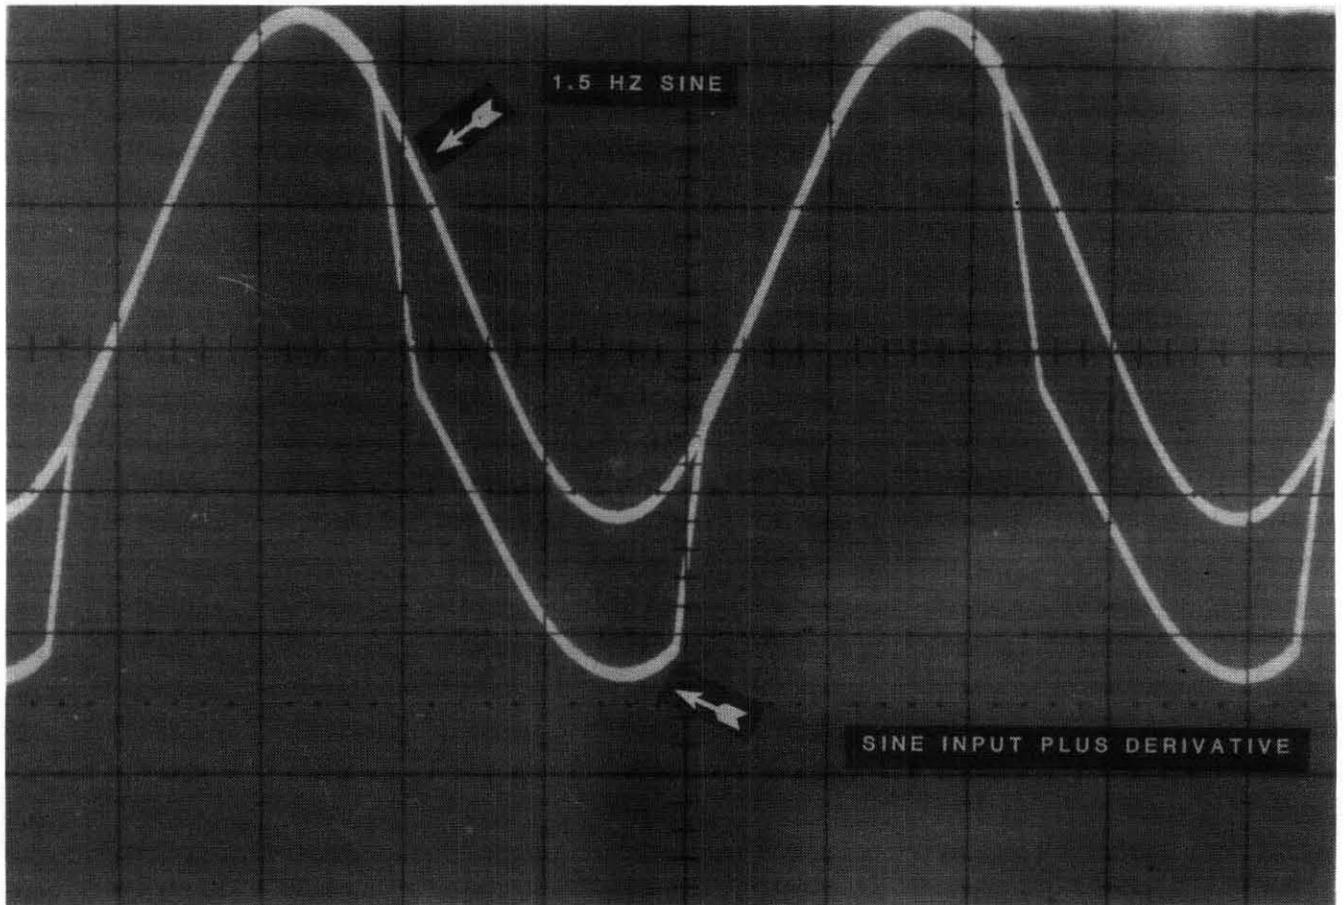
FIGURE 17. - Oscilloscope trace of normal load signal and normal load signal summed with its derivative.

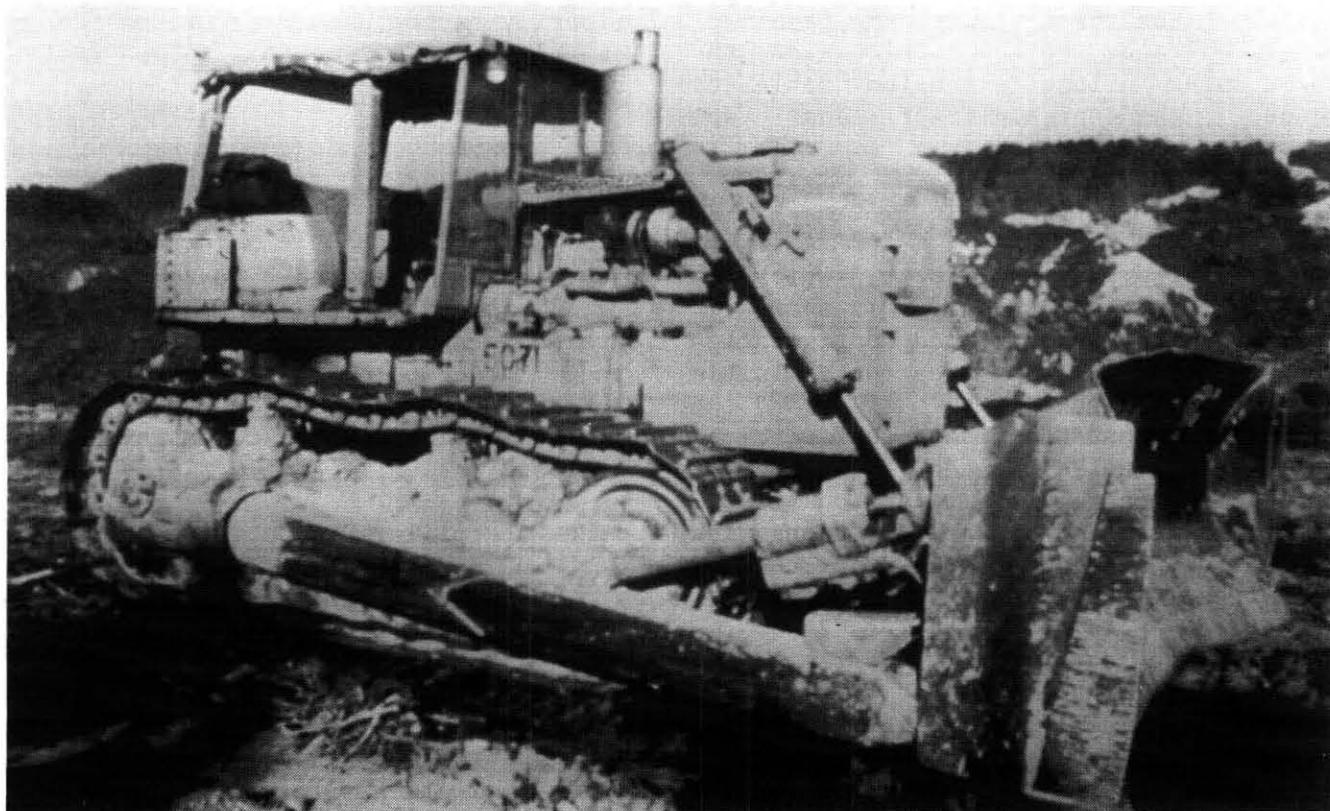
FIGURE 1. - Noise-controlled ROPS-only-equipped Caterpillar D9G.

No.	Treatment	Sound level, dBA	Noise reduction from baseline, dBA
1	None (baseline).....	105.5	0
2	Lexan windshield.....	101.5	4
3	Absorption under FOPS.....	102.5	3
4	Exhaust muffler.....	104	1.5
5	Windshield and absorption.....	100	5.5
6	Treatment 5, plus muffler.....	99.5	6
7	Treatment 6, plus dash seals and isolation.....	96.5	9
8	Treatment 7, plus floor seals.....	95.5	10
9	Treatment 8, plus seat seals.....	95	10.5
10	Treatment 9, plus tank seals and hydraulic valve cover.....	94	11.5

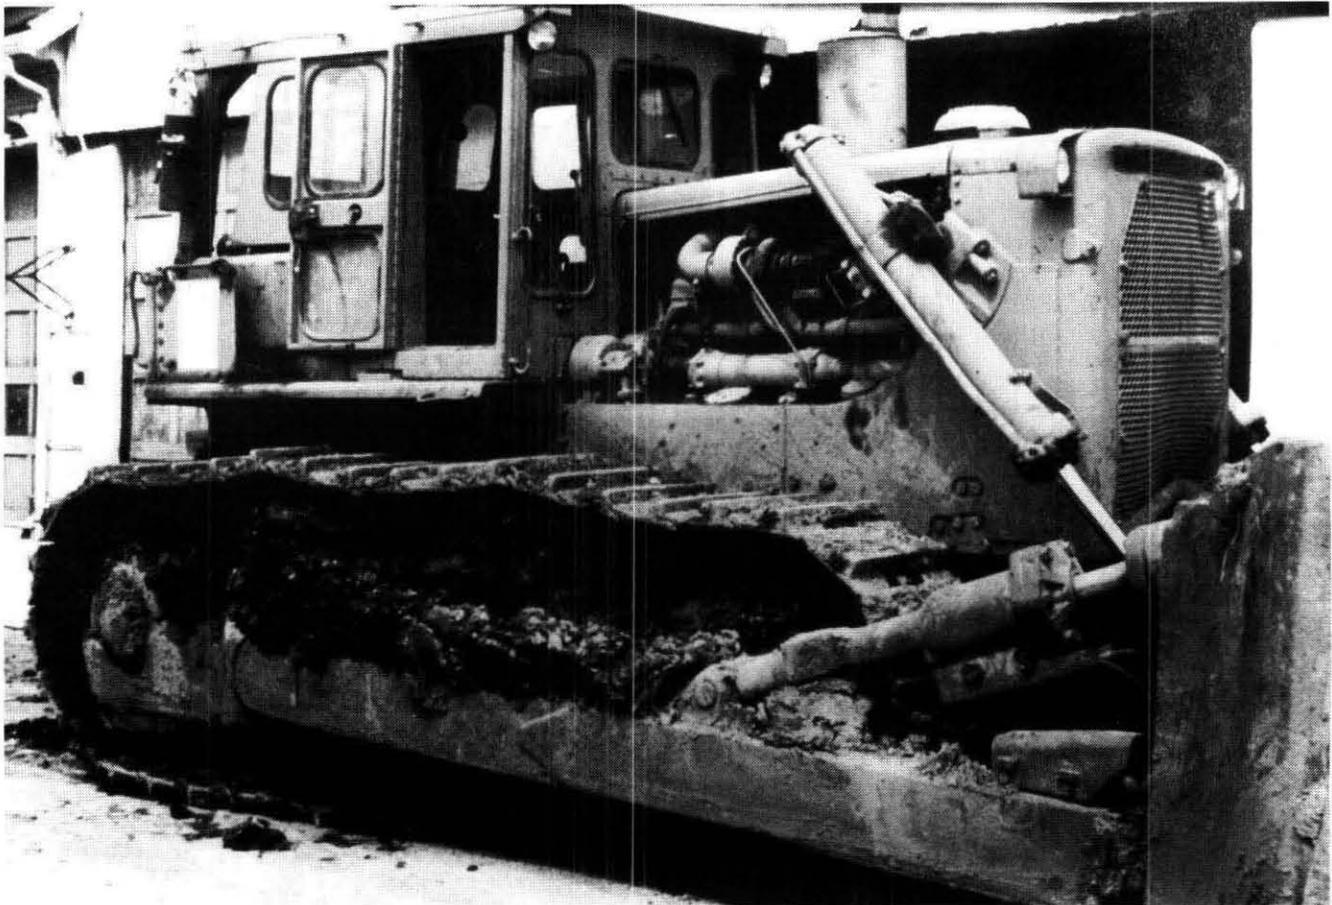
FIGURE 2. - Noise-controlled cab-equipped Caterpillar D9G.

No.	Treatment	Sound level, dBA	Noise reduction from baseline, dBA
1	None (baseline).....	100	0
2	Absorption under FOPS.....	98	2
3	Absorption and cab wall seals..	97.5	2.5
4	Treatment 3, plus floormats and pedal seals.....	95.5	4.5
5	Treatment 4, plus seat seals, hydraulic tank cover seals, and blade control seal.....	93.5	6.5
6	Treatment 5, plus dashboard treatment.....	89	11

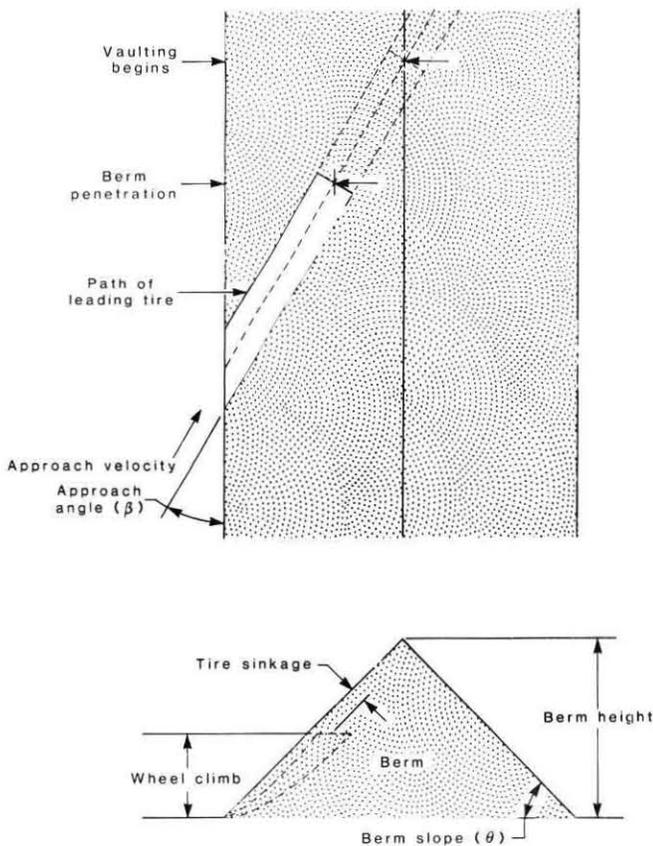
FIGURE 1. - Configuration of edge-of-road berm.

Collision with a deformable berm is usually a combination of penetration and climb; as the leading vehicle tire penetrates the berm, the tire sinks, increasing rolling resistance, while climbing the berm. To prevent a vehicle from leaving an elevated roadway, a properly designed berm must be constructed with its onboard face at an angle that will cause a vehicle to roll over onto the roadway if the vehicle exceeds the

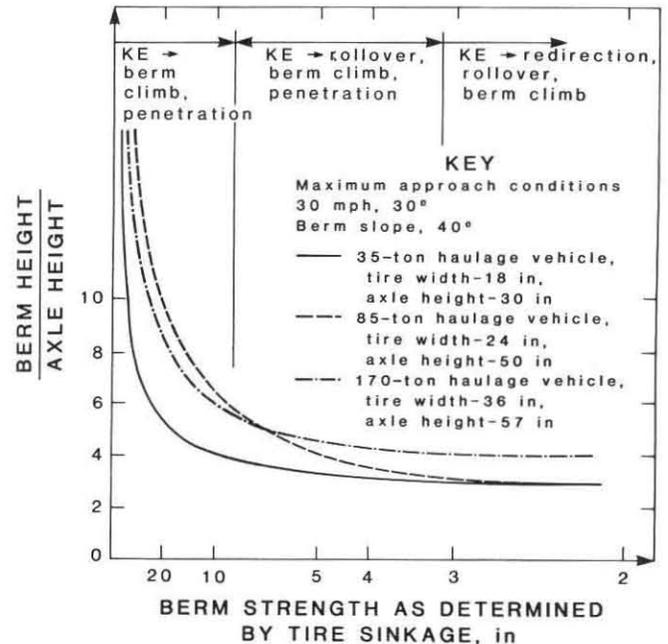
FIGURE 2. - Berm size requirement as a function of berm strength for 35-, 85-, and 170-ton haulage vehicles. (KE = kinetic energy)

Berms can be constructed and compacted in layers to meet these recommendations. The face of the berm should then be cut at a steep angle (40°) to minimize the

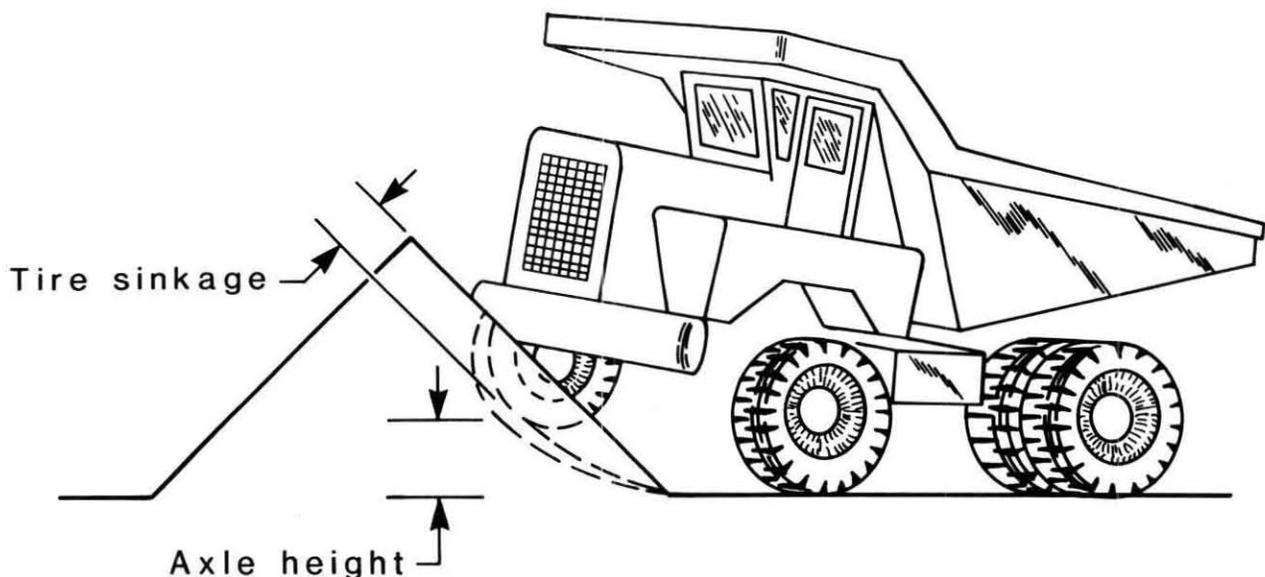
FIGURE 3. - Berm qualification test at a 45° vehicle approach angle.

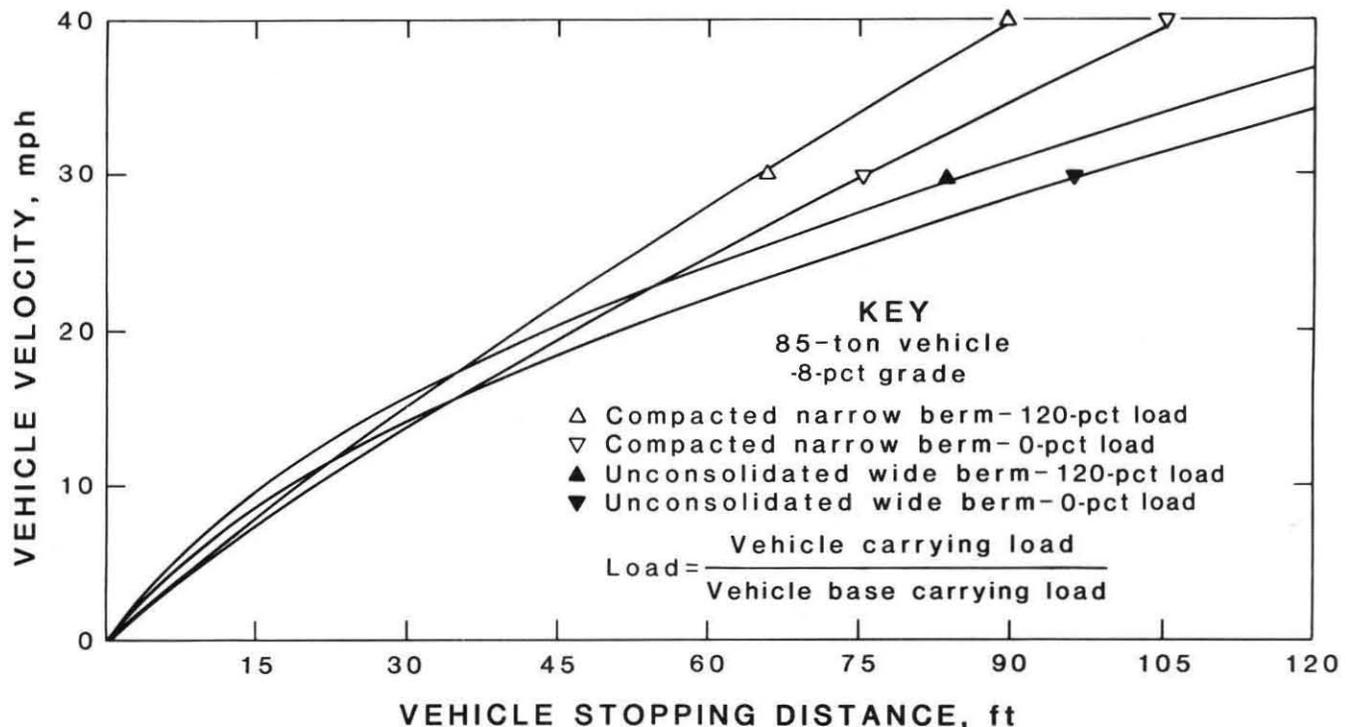
FIGURE 4. - Comparison of stopping distances on median berms for an 85-ton haulage vehicle on an 8-pct downgrade.

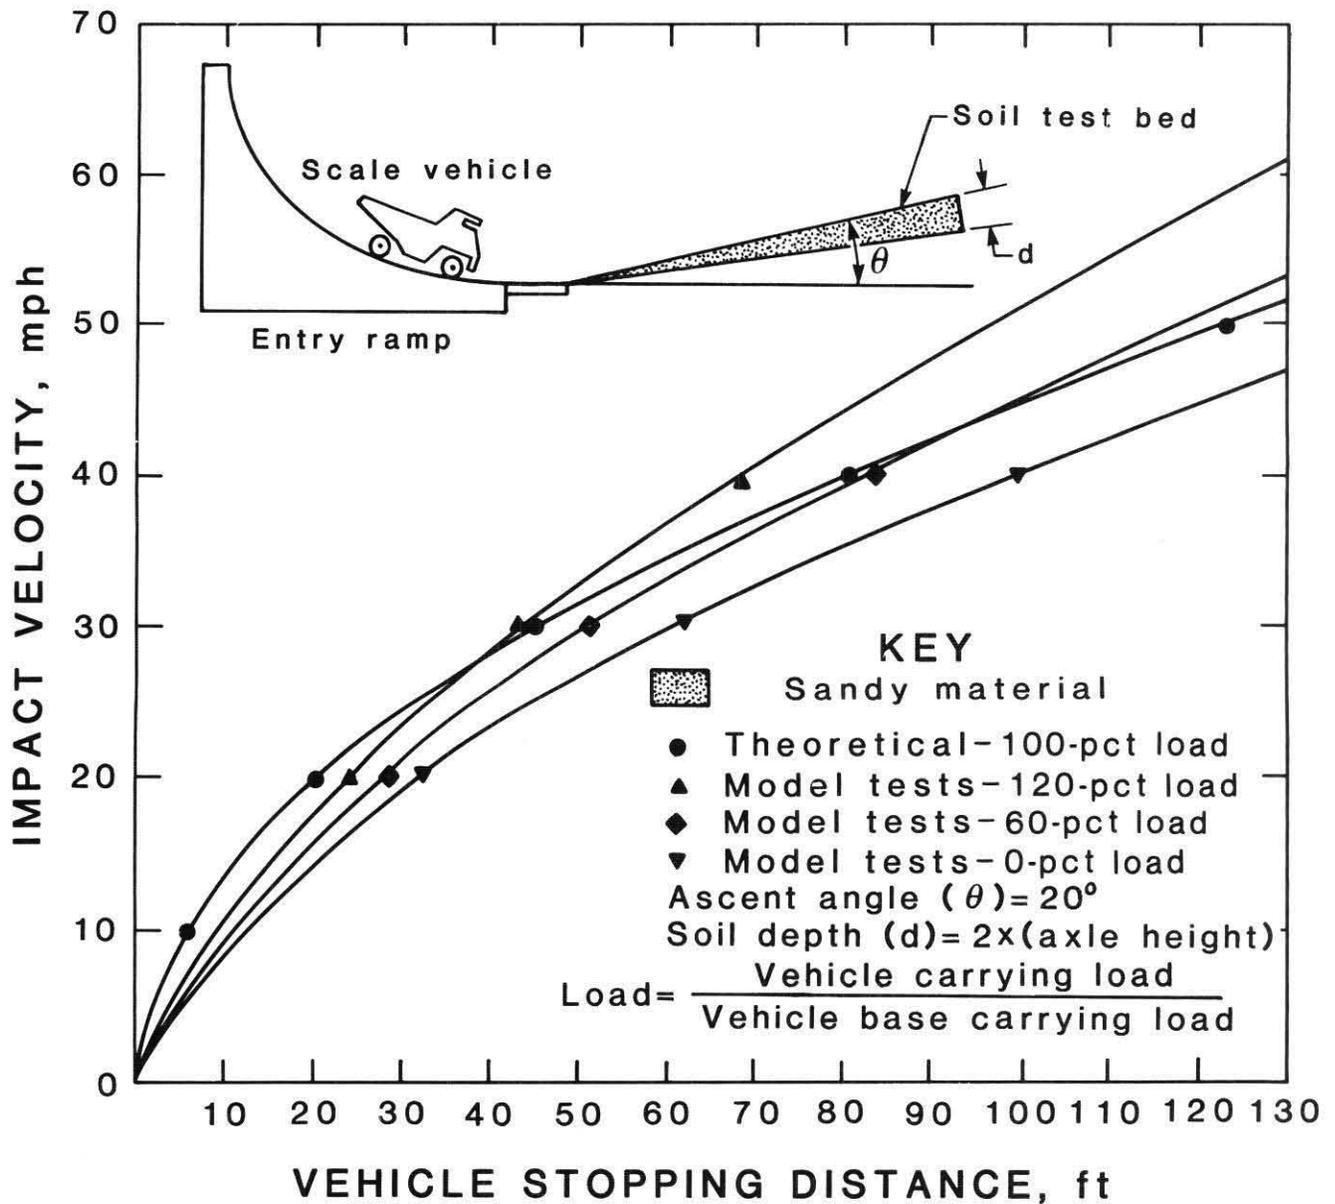
FIGURE 5. - Stopping distances for an 85-ton haulage vehicle on an escape lane impacting at various velocities on a 20-pct positive grade.
