Information Circular 9209

Rollover Protective Structure (ROPS) Performance Criteria for Large Mobile Mining Equipment

By Stephen A. Swan

**BUREAU OF MINES
T S Ary, Director**

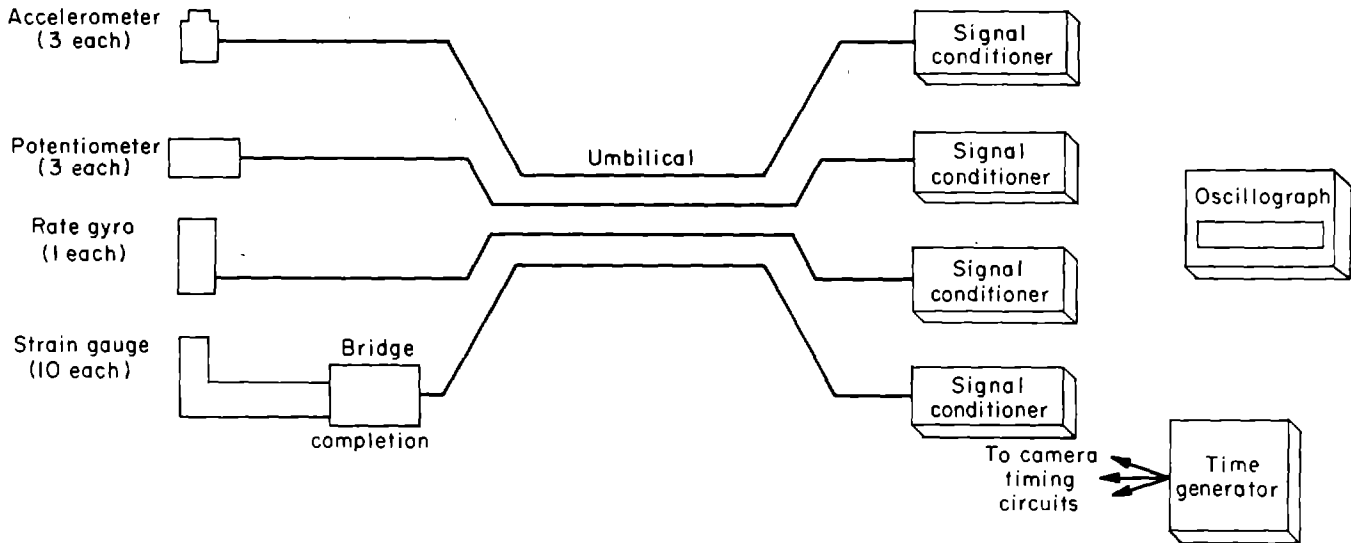
Figure 3. — Instrumentation schematic.
