Information Circular 9228

Surface Testing and Evaluation of the Multiple-Unit Continuous Haulage System

By Jasinder S. Jaspal, Lee A. Erhard,
and William D. Mayercheck

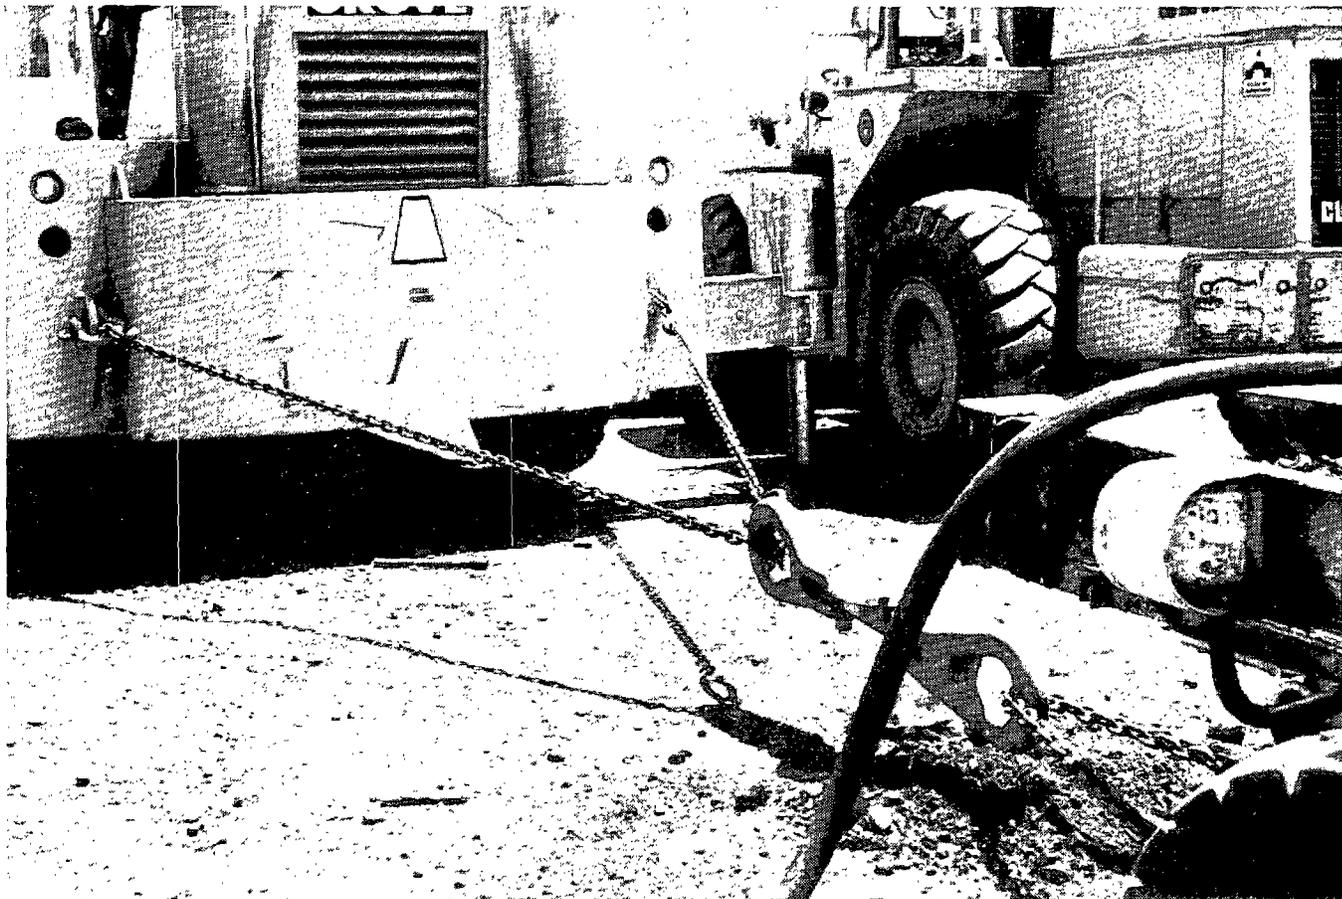
Figure 32.—Crane and dynamometer used during drawbar pull test.
