SKIN FAILURE OF ROOF AND RIB AND SUPPORT TECHNIQUES IN UNDERGROUND COAL MINES

By Eric R. Bauer¹ and Dennis R. Dolinar¹

Information Circular 9453

**Proceedings: New Technology For Coal Mine
Roof Support**

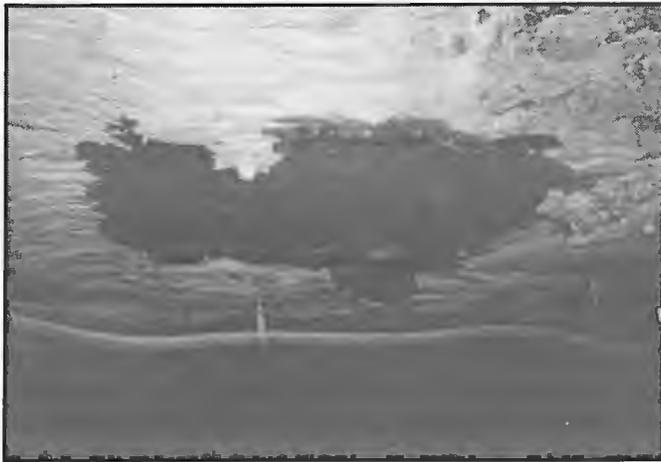
Figure 2.—Skin failure in supported roof.

figure 2 is an example of skin failure of supported (bolted) mine roof where the failure occurs between the supports. In general, skin failure of the roof in by permanent support must be controlled by the ATRS or canopies of the roof bolting machine. The skin failure under permanent support can usually be handled by removal or by surface control systems. Rib skin failures are shown in figure 3 (unsupported rib) and figure 4 (supported rib).

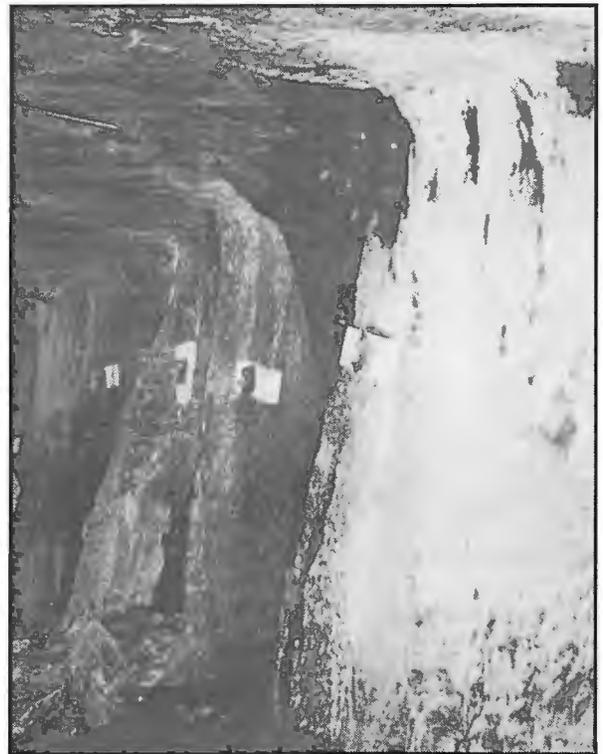
Figure 4.—Skin failure of supported rib.

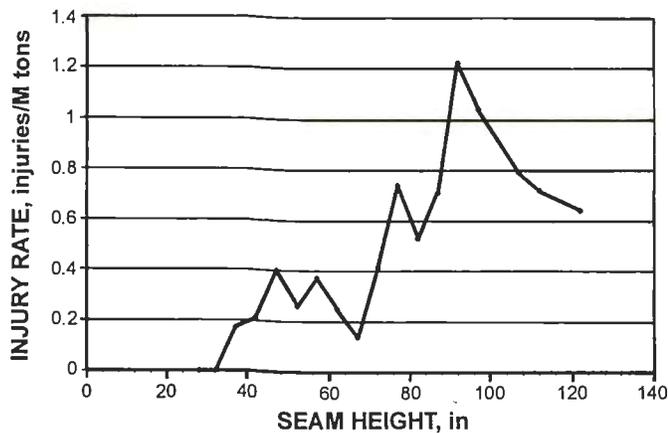
Figure 5.—Seam height versus injury rate for rib skin failures, 1997 (after Bauer et al. [1999]).

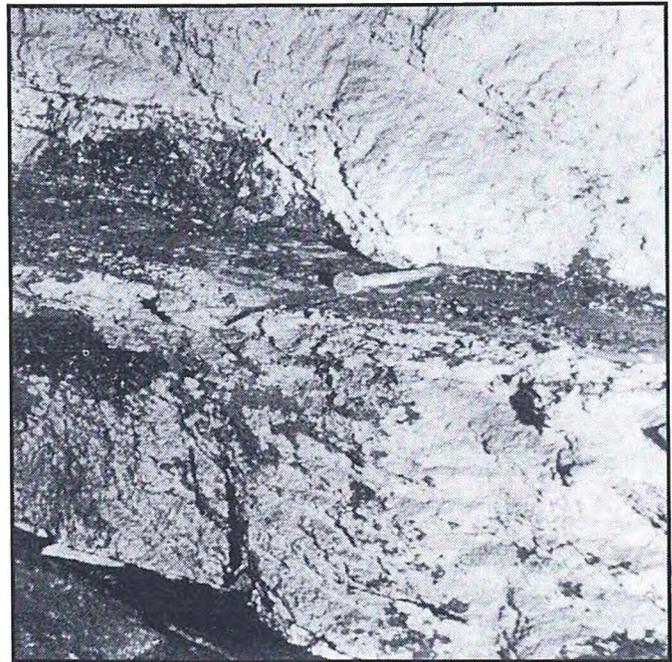
Figure 6.—Example of differential movement along a parting in a coal rib.

the coal pillar or with draw rock located at the roof-rib interface. Rock partings or bands within the pillar create planes of weakness where differential movement (figure 6) and failure can occur, leading to spalling (skin failure). When weak draw rock that is subject to failure during coal extraction is present and is mined with the coal, the draw rock exposed in the coal pillars creates a zone of potential rib skin failure. This inherent weakness makes the draw rock susceptible to spalling from the rib as the coal pillars experience load.

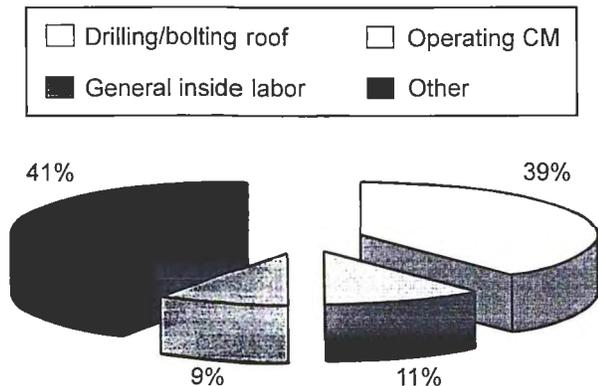
Figure 7.—Mine worker activities during roof skin injuries, 1995-98.

Finally, the mine worker activities during roof and rib skin injuries were extracted from the MSHA database for 1995-98. The most common activities of workers injured by roof skin failures were drilling or bolting of the roof (39%), operating the continuous mining machine (11%), and general inside labor (9%) (figure 7). These three activities accounted for 59% of the injuries. No other worker activity was involved in more than 7% of the injuries. For injuries resulting from rib skin failures, the most common worker activities were operating the continuous mining machine (18%), drilling or bolting the roof (16%), general inside labor (12%), walking (9%), and maintenance and repair (8%). The total of these accounted for 63% of the injuries (figure 8). All other activities were involved in 5% or less of the rib skin injuries. Surprisingly, scaling of the roof or rib, which deals directly with skin failure and is thought to be a dangerous activity, comprised only 1% of the roof and rib skin failure injuries. This low level of scaling injuries compared with the high number of skin failure injuries

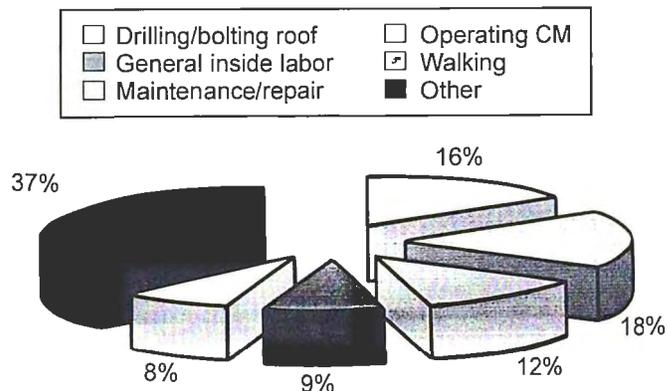
Figure 8.—Mine worker activities during rib skin injuries, 1995-98.

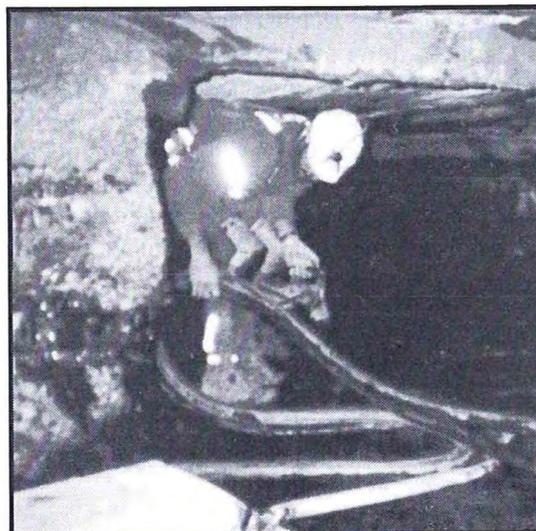
Figure 9.—Mine worker moving mining machine power cables.

may indicate that not enough scaling is done. In addition, cable handling was involved in 3% of the total roof and rib skin failures (figure 9).

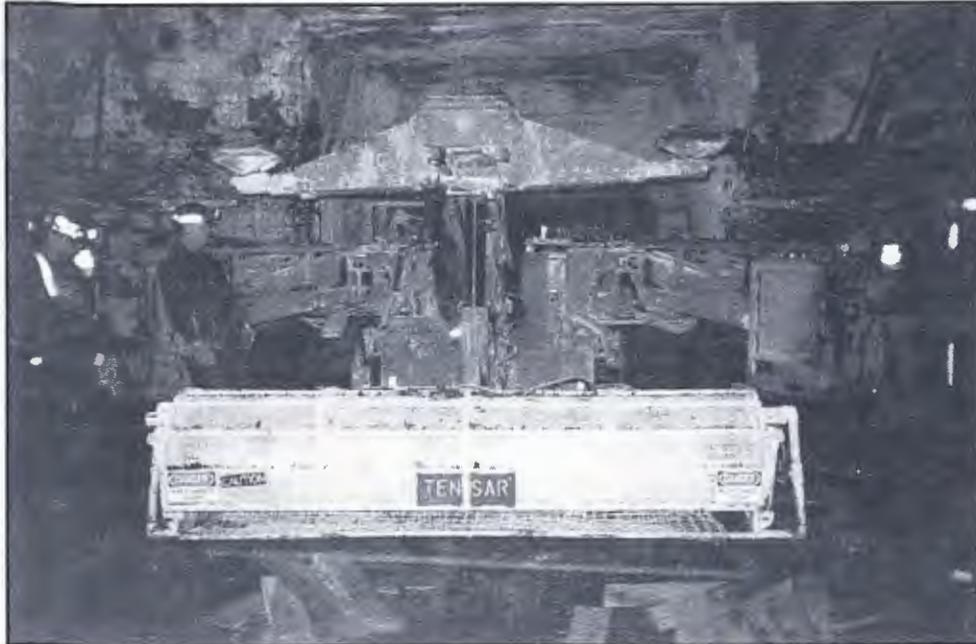
Figure 10.—Automatic grid dispenser. (Photo courtesy of Tensar Earth Technologies.)

Improved skin control and elimination of skin failure injuries, especially those resulting from roof skin failures, are contingent on providing increased surface control. To this end, safer, faster, and more efficient installation of mesh is the surface control method receiving the most attention. For instance, the walk-through bolter allows sheets of mesh to be installed with minimal worker exposure to the unsupported roof. The mesh can be placed on top of the protective canopy, then slid forward into place without the workers ever leaving the supported roof area. The method of installing synthetic mesh material is also being improved. An automatic grid dispenser has been developed that mounts on the inby side of the ATRS and dispenses the mesh up and over the ATRS (figure 10). As the mesh leaves the dispenser, the folded edges fan out from 9 to 15 ft in width to provide almost complete rib-to-rib coverage. In addition, the mesh has been strengthened to >13,000 psf to provide a material with similar strength and protection as those of conventional mesh materials. Figure 11 shows the use of synthetic mesh to support roof and rib.

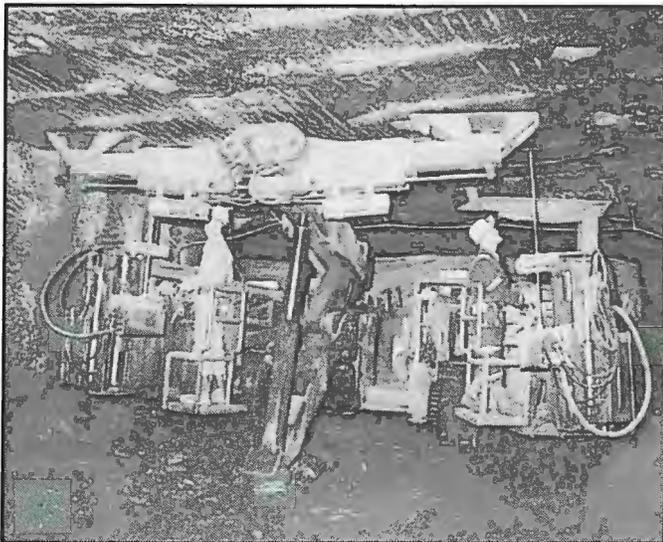
Figure 12.—Walk-through chassis roof bolting machine. (Photo courtesy of J. H. Fletcher and Co.)

To remove the operator from the hazardous area, roof bolters with walk-through chassis, with or without automated drill functions, have been developed (figure 12). The major advantage of the walk-through chassis is to reduce mine worker exposure to rib hazards. Another manufacturer's RBM, currently available for higher coal seams only, uses four automated booms for drilling the bolt holes. The Multibolter is also a walk-through design (figure 13). It allows the operators to remain under a canopy equipped with side slide extensions that provide substantial work area coverage from roof hazards. This machine also uses side shields or chain curtain on the walkway platform to prevent rib failure injuries.

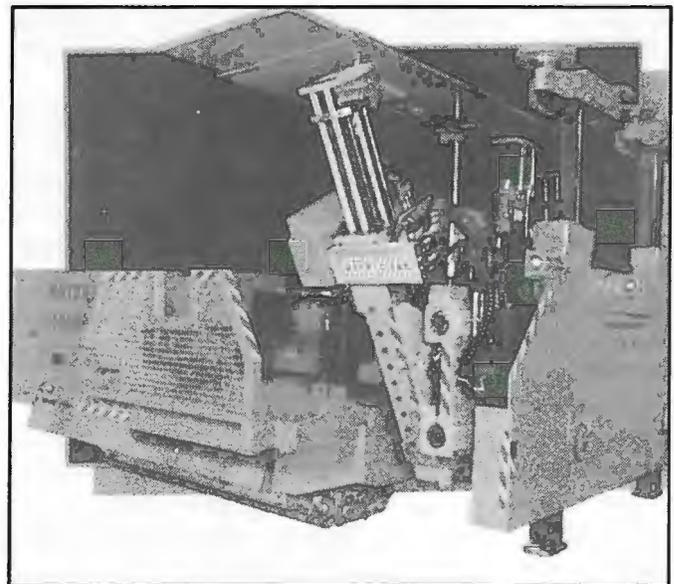
Figure 13.—Joy Multibolter. (Photo courtesy of Joy Mining Machinery.)

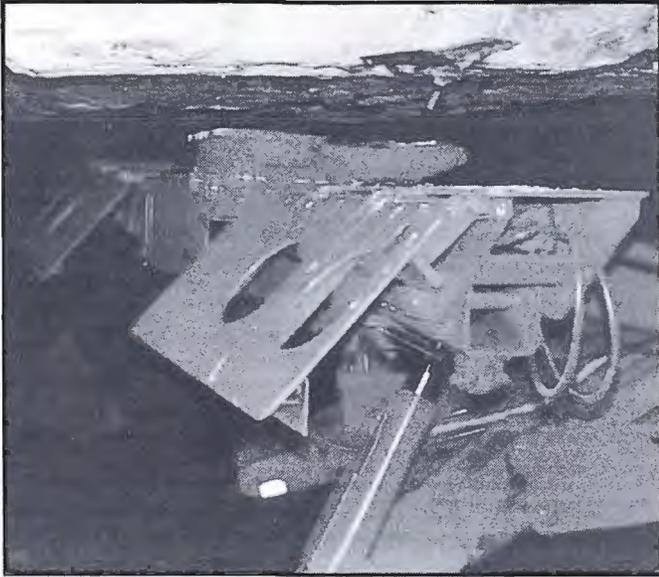
Figure 14.—Inby rocker pads to deflect falling rocks. (Photo courtesy of J. H. Fletcher and Co.)

operator when the ATRS is lowered. The deflector forces the loose rocks to slide toward the face, falling flat against the mine floor, rather than landing on edge and falling over onto the operator's feet and legs. Rock deflector plates are also provided on the ATRS boom that can help deflect falling rocks away from the RBM operators. Another safety improvement is a sliding extension of the drilling canopy to provide additional surface coverage (figure 15).

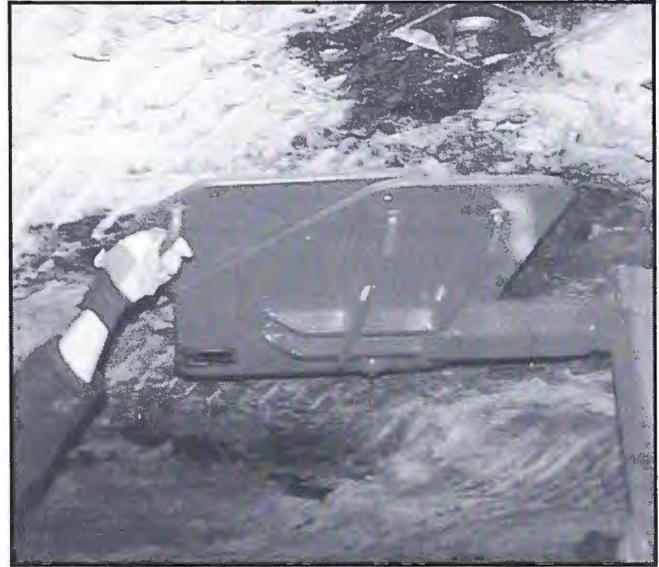
Figure 15.—Pullout canopy extension. (Photo courtesy of J. H. Fletcher and Co.)
