CABLE SUPPORT IN LONGWALL GATE ROADS

By Dennis R. Dolinar¹ and Lewis A. Martin²

This paper will discuss cable bolts and trusses and the design of cable systems for the support of longwall gate road entries.

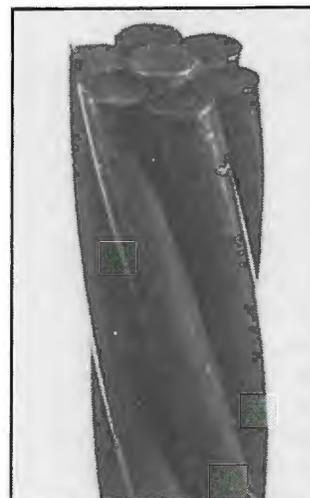
Figure 1.—Seven strand steel cable used to make cable bolts.

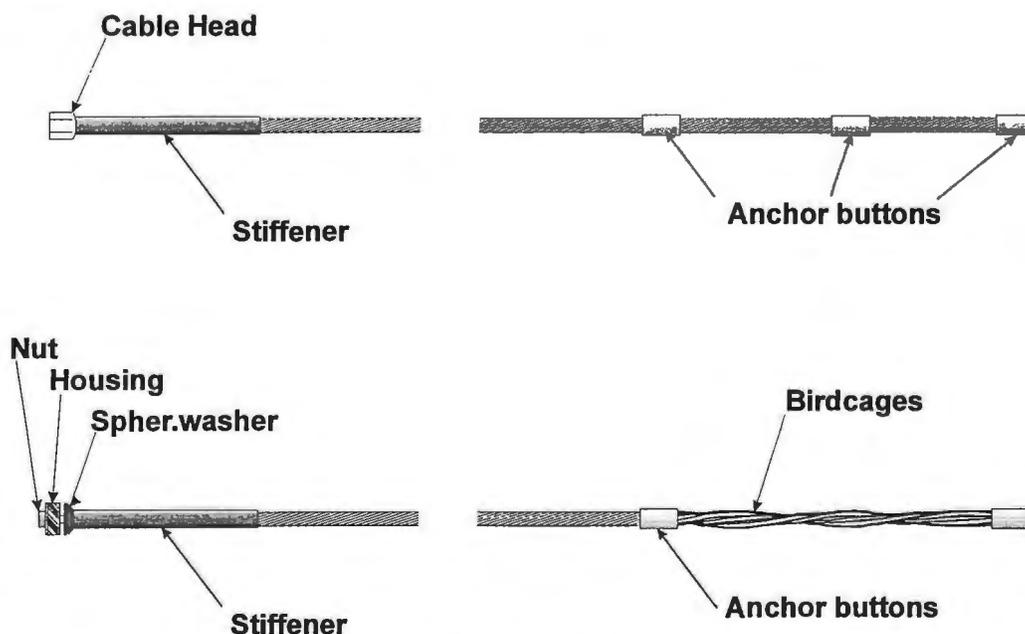
Figure 2.—Cable bolt and cable bolt components.

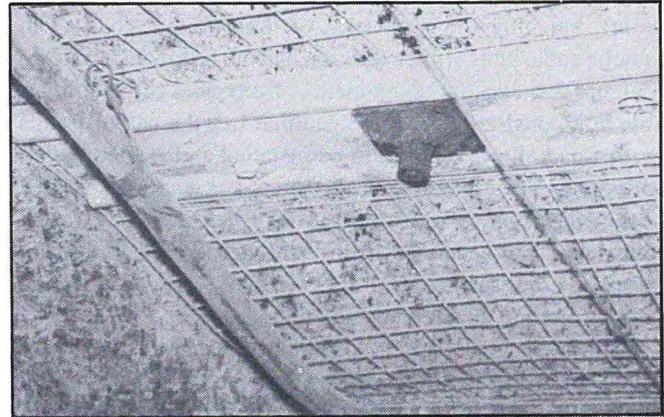
Figure 3.—Cable bolt system installed in a tailgate.

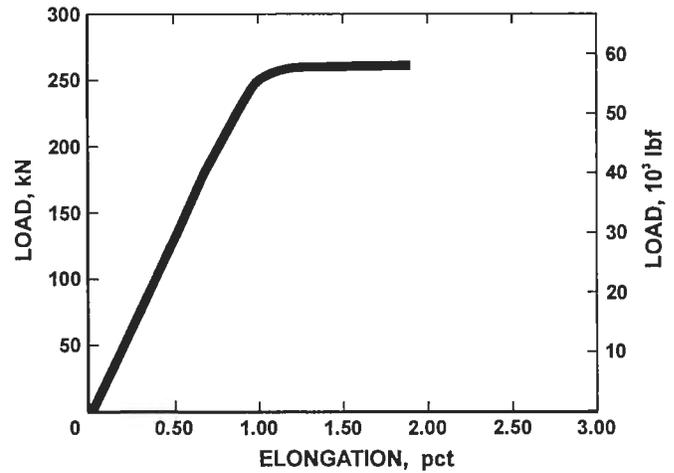
Figure 4.—Load-deformation curve from a laboratory tensile test of a cable.

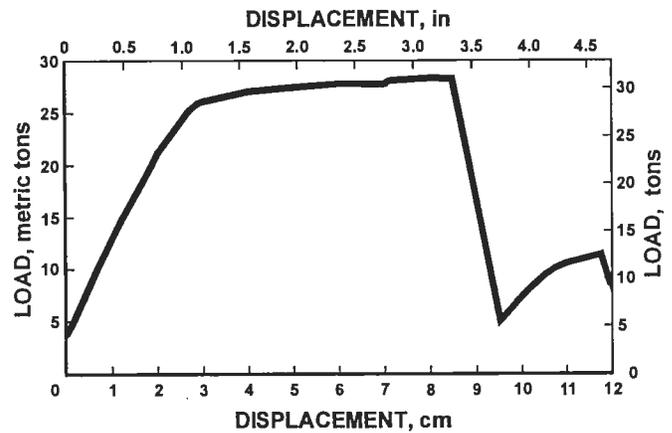
Figure 5.—Load-deformation curve from a pull test of a cable bolt underground.

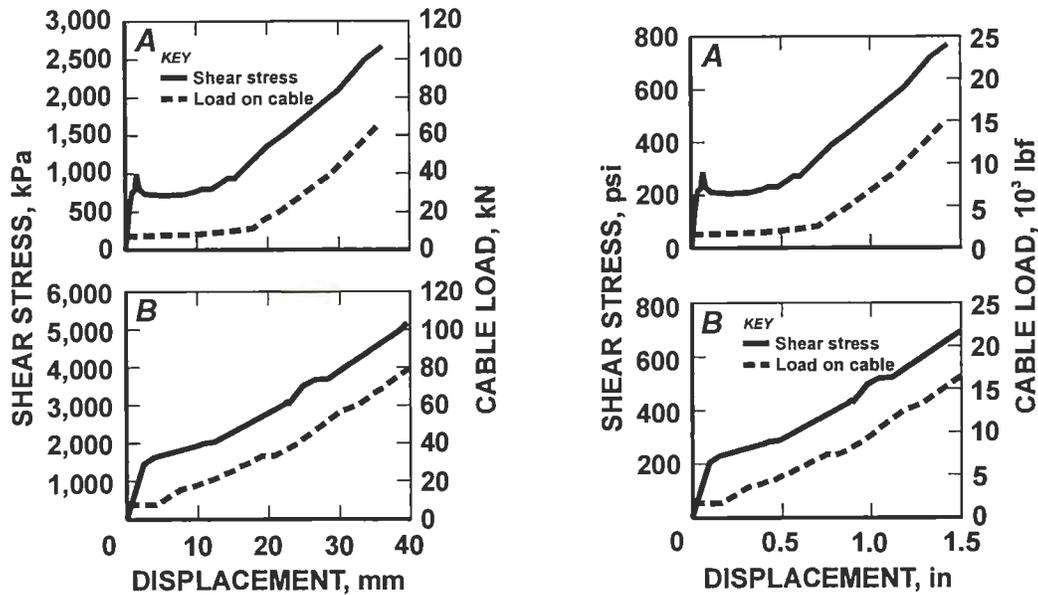
Figure 6.—Typical cable load and shear stress versus shear displacement A, smooth joint with cable bolt reinforcement and B, rough joint with cable bolt reinforcement.

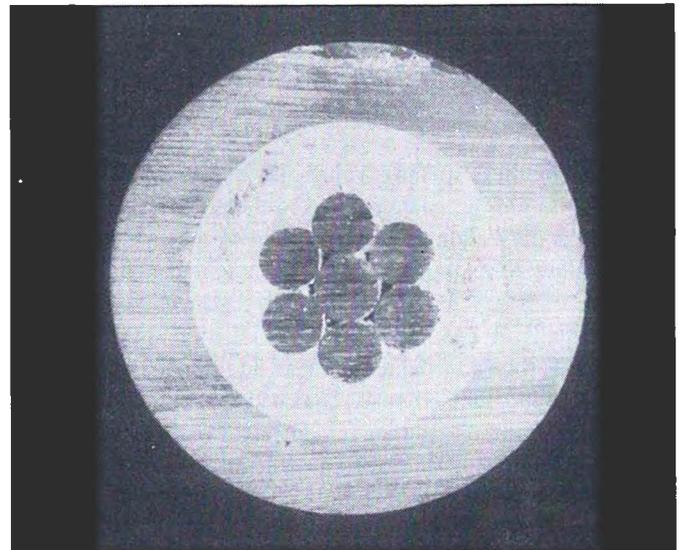
Figure 7.—Cross section of 1.52 cm (0.6 in) cable set in resin, installed in a 2.5 cm (1 in) diameter hole.

Several factors influence the effectiveness of the resin anchor, including anchor length, type of resin, and hole diameter [Zelanko et al. 1995]. Figure 7 shows a cross section of a cable installed in resin. The cables will transfer the load through the anchor to the rock with all the load transfer taking place within the anchor length. However, if the anchor is too short, the anchor could slip (rock-grout interface failure), especially in weak rock. With a longer anchor, the anchor

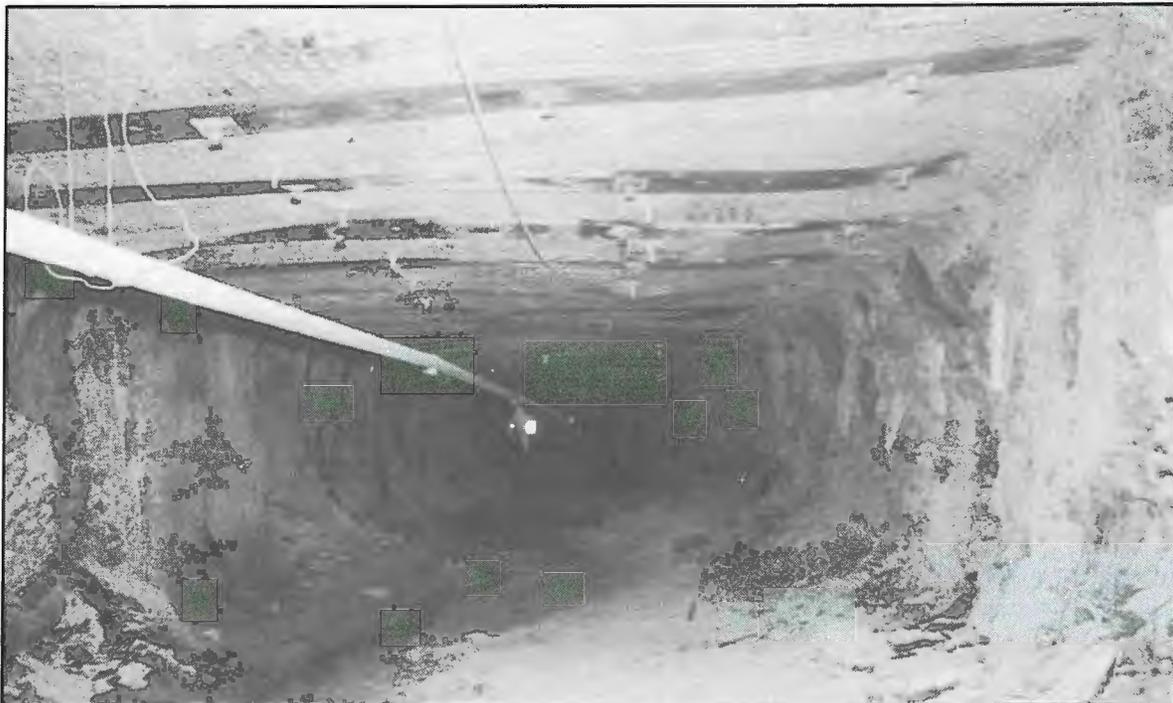
Figure 8.—Surface control in the form of a "Monster Mat" installed with cable bolts.

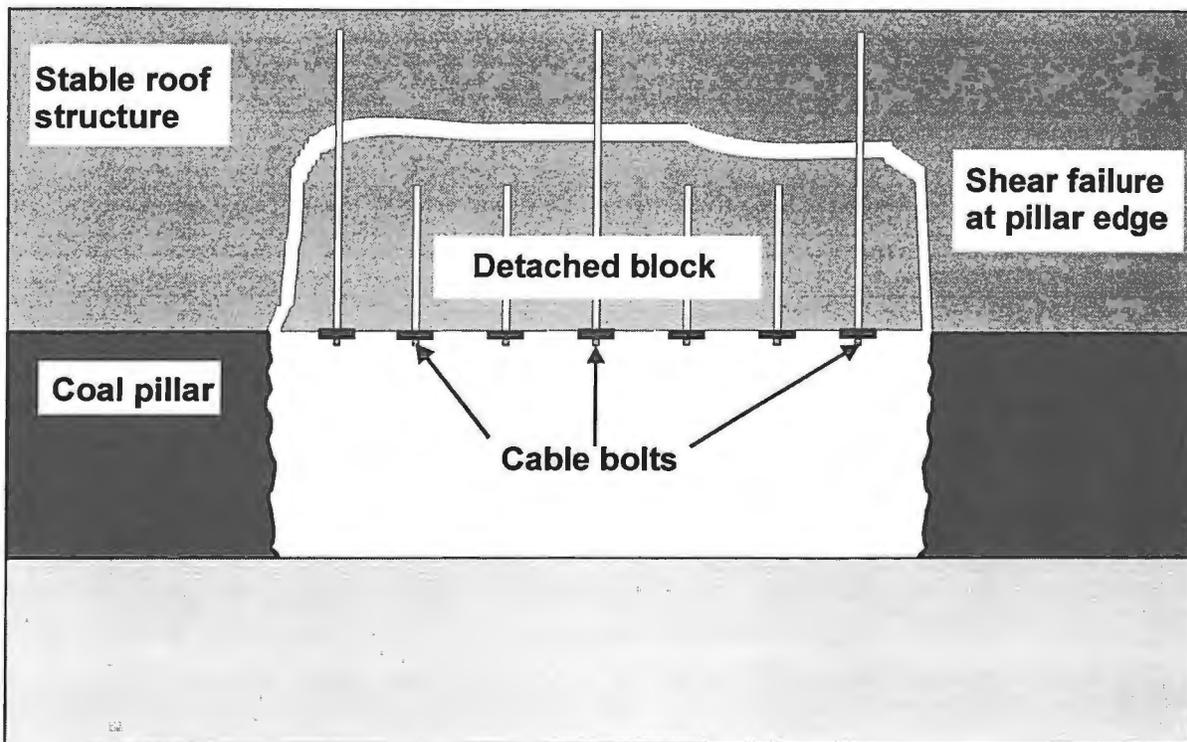
Figure 9.—Detached block of failed roof supported by cables.

For suspension, the simplest approach is to identify a parting plane or a flat-lying, potential failure plane above the bolted roof horizon where the roof will shear at the pillar edge of the opening and the entire weight of the rock must be supported as a detached block (figure 9). The weight of the material can be determined from the following equations.

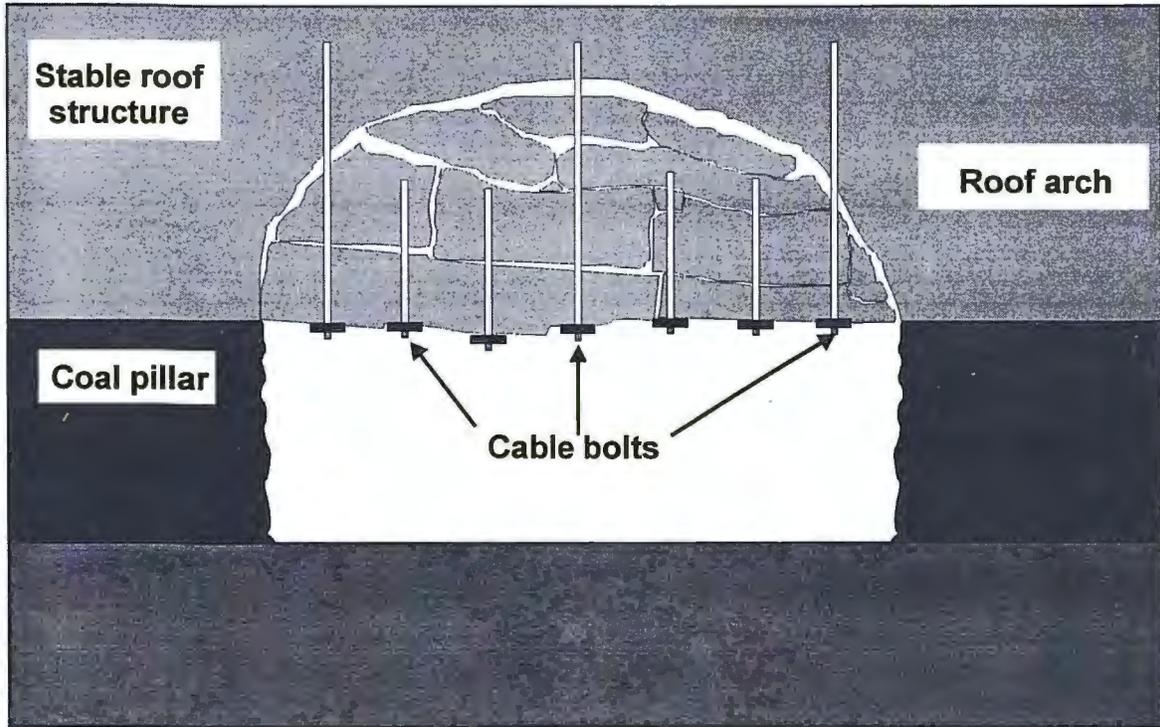
Figure 10.-Formation of pressure arch of failed mine roof material.

If an arched roof failure is formed with the pillars carrying some of the weight, the cables need only support the weight of the rock under the arch (figure 10). The height of the arch will be determined by a combination of the geology, as well as by the vertical and horizontal stresses acting on the roof and the induced mining stresses. Obviously, the length and the number of cables

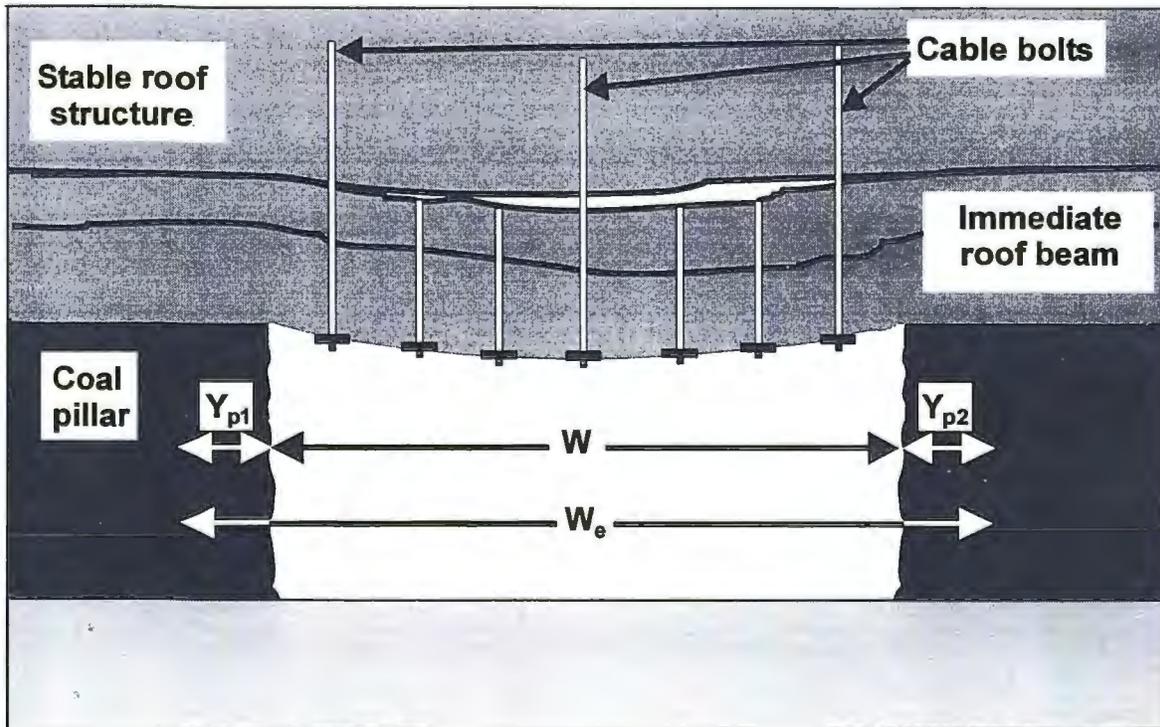
Figure 11.-Formation of yield zone in coal pillar, (W_e = effective width of opening; y_{p1} = yield zone of pillar 1; y_{p2} = yield zone of pillar 2)

The behavior of the pillar under different loading conditions will affect the width of the opening and therefore the weight of the rock that must be supported (figure 11). The depth of the yield zone can be determined from equations developed by Wilson and depend on the strength of the coal pillar [Wilson 1972]. The following equations can be used to estimate the depth of the yield zone. w = pillar width in meters (feet).

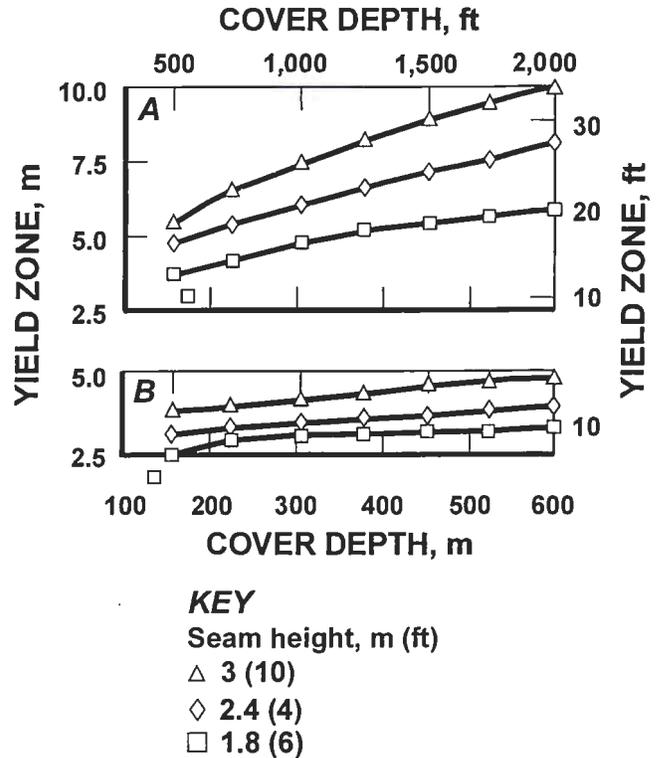
Figure 12. -Design chart to determine yield zone width in coal pillars. A, yielding roof; B, rigid floor.

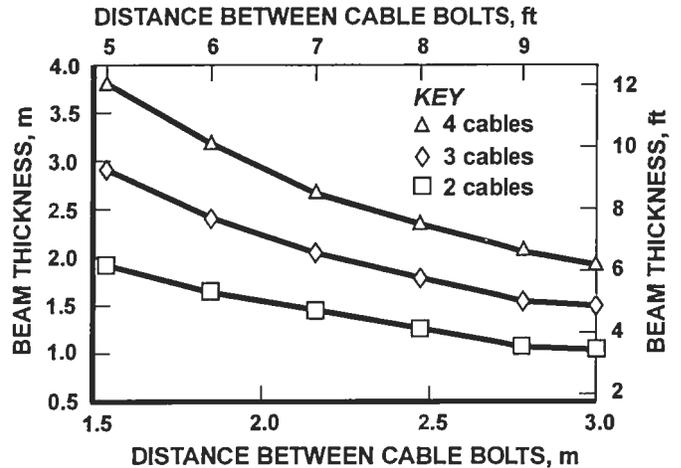
Figure 13.-Cable support design chart, where the effective width of opening (W_e) = 7.6 m (25 ft) and rock density (γ) = 2,403 kg/m³ 150 lb/ft³ [McDonnell et al. 1995].

Based on the weight of material that must be supported, the spacing of cable bolts across the opening, as well as row spacing, can be calculated. Using a cable with a capacity of 260 kN (58,600 lbf) and varying the number of cables across the opening and row spacing, a design can be determined for different thicknesses of rock that must be supported. Figure 13 shows this design chart for an effective width of 7.6 m (25 ft) and a rock density of 2,403 kg/m³ (150 lb/ft³). This chart is based on a flat failure surface developing at the given horizon with the additional weight of material for the yield zone. A separation at 2.4 m (8 ft) would require four cables per row with 2.4-m (8-ft) row spacing. However, there are no safety factors calculated into these charts.

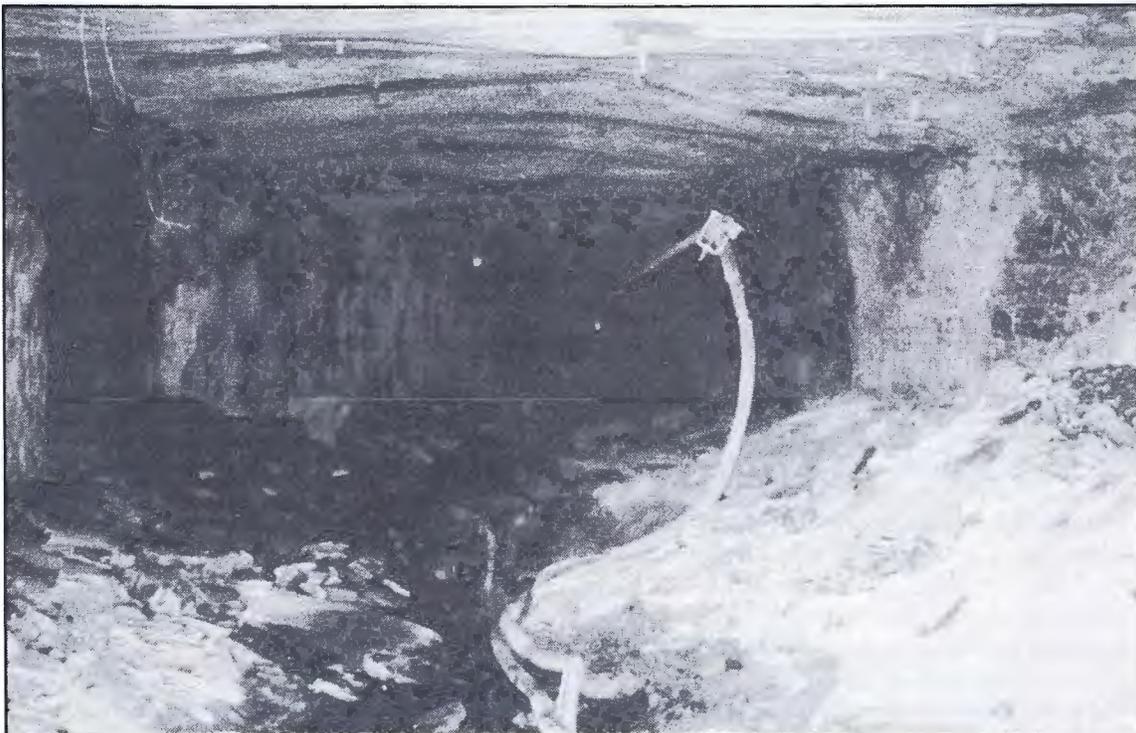
Figure 14.—Tailgate abutment zone outby the face supported with cable bolts.

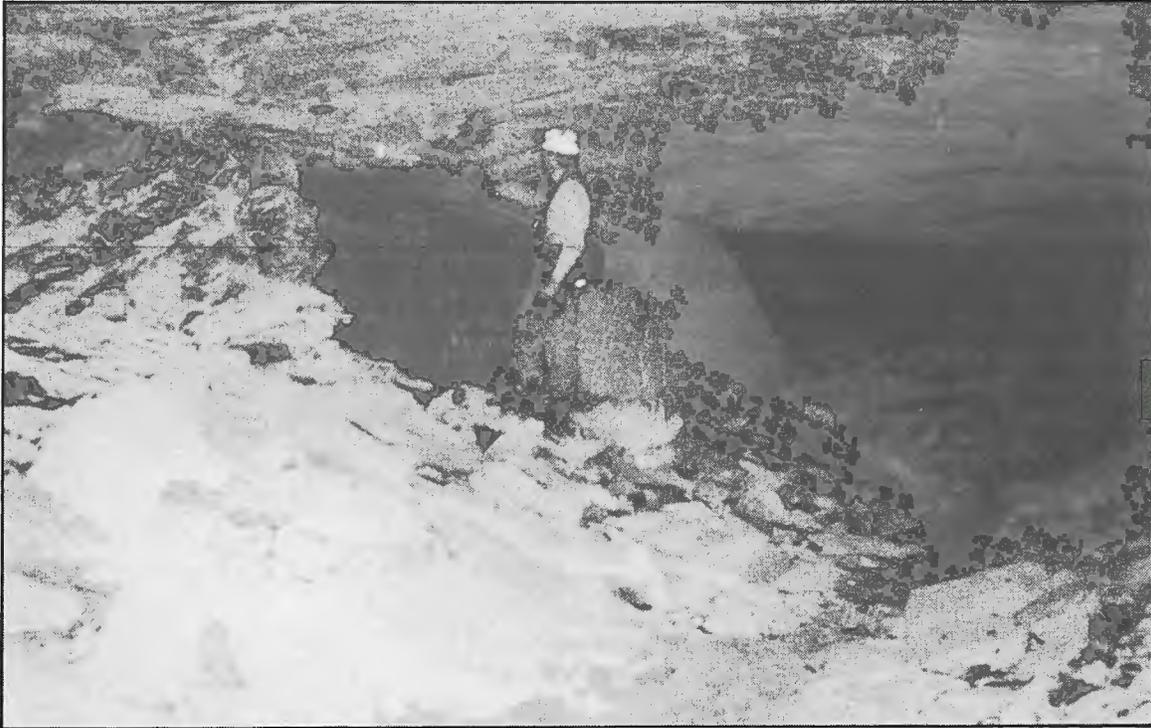
Figure 15.—Tailgate shield zone supported by cable bolts.

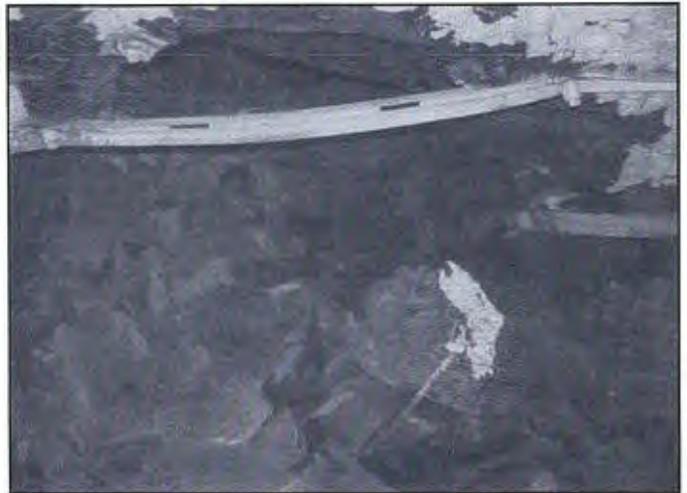
Figure 16.—Tailgate behind the shields has caved though supported with cable bolts.

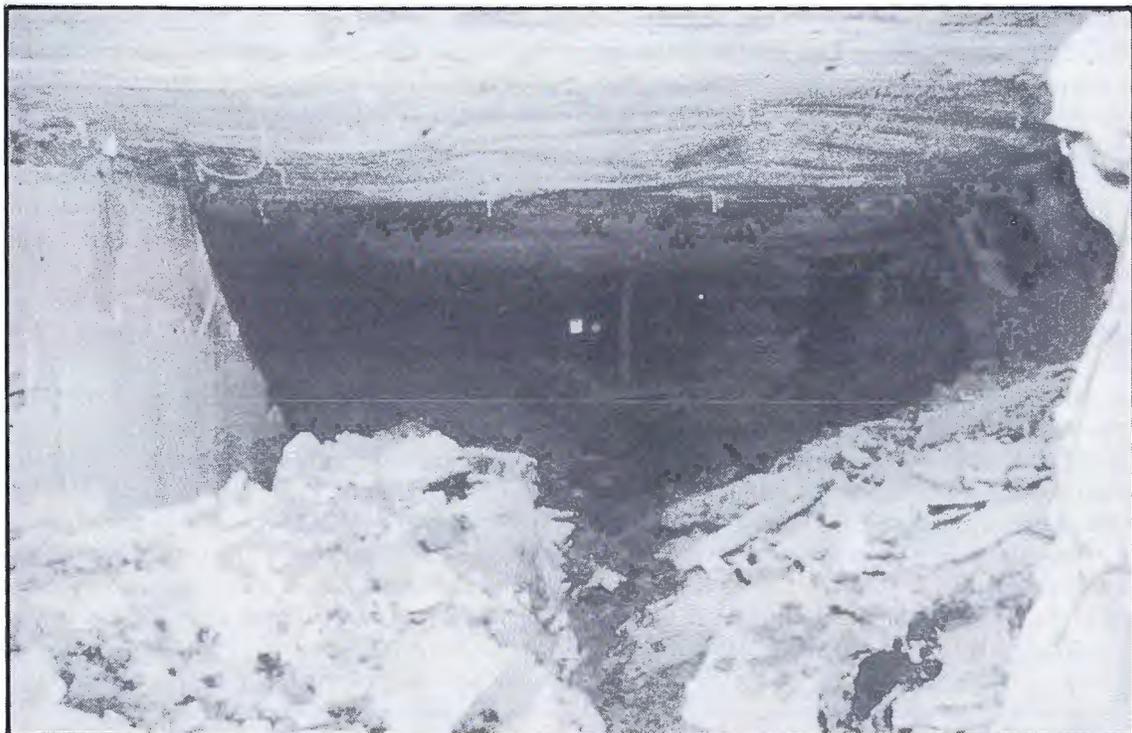
Figure 17.—Tailgate behind the shields kept open with cable bolts.

area is not a factor. However, in some mines, ventilation requirements necessitate that the gateroad be kept at least partially open to the nearest crosscut behind the face, a distance of usually 30 to 45 m (100 to 150 ft). The maintenance of this section of the tailgate by the cables is dependent to a large degree on the geology and the cave and only to a limited degree on cable system design. In the tailgate adjacent to the cave, the roof develops into a cantilever that must be supported. If the roof is not strong enough and the cave goes above the cables then the cantilever could fail and close most of the entry (figure 16). If the roof is strong enough to maintain the cantilever, then the cables will help to maintain any lower weaker roof. The critical factors are whether the cave develops above the cables and if the zone is strong enough to maintain the cantilever. The cables probably add little overall strength to the cantilever. However, there are cases where the entry has stayed open more than 45 m (100 ft) behind the face [Koehler et al. 1996; Martin et al. 1996; Mucho et al. 1996] (figure 17).

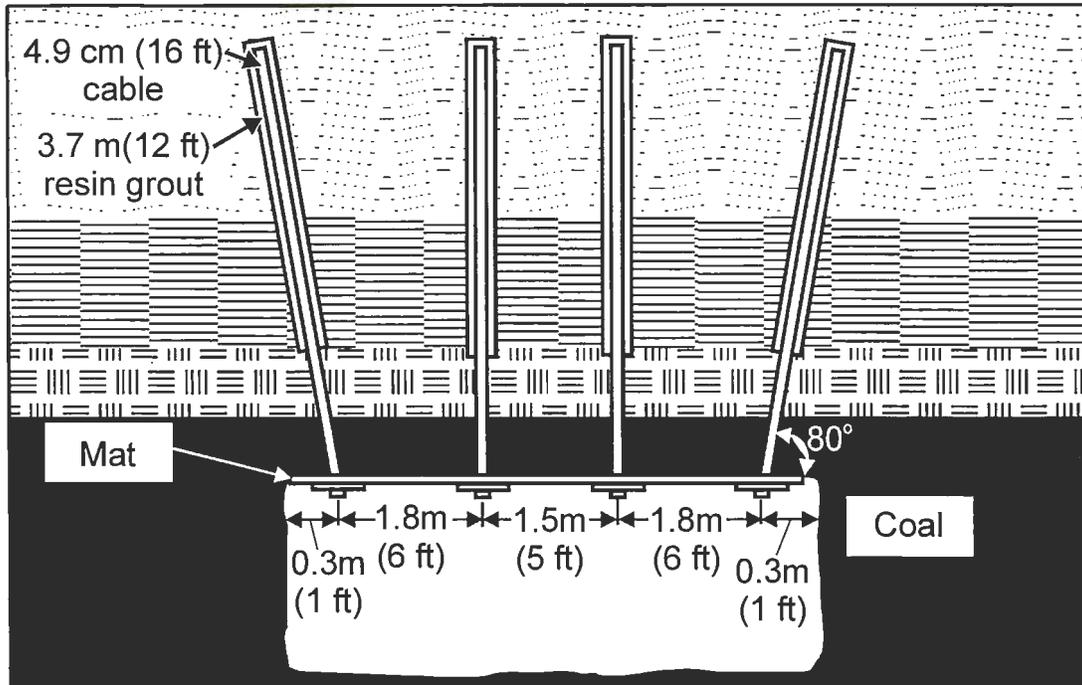
Figure 18.—Cross section of tailgate entry showing cable bolt design for case history 1.

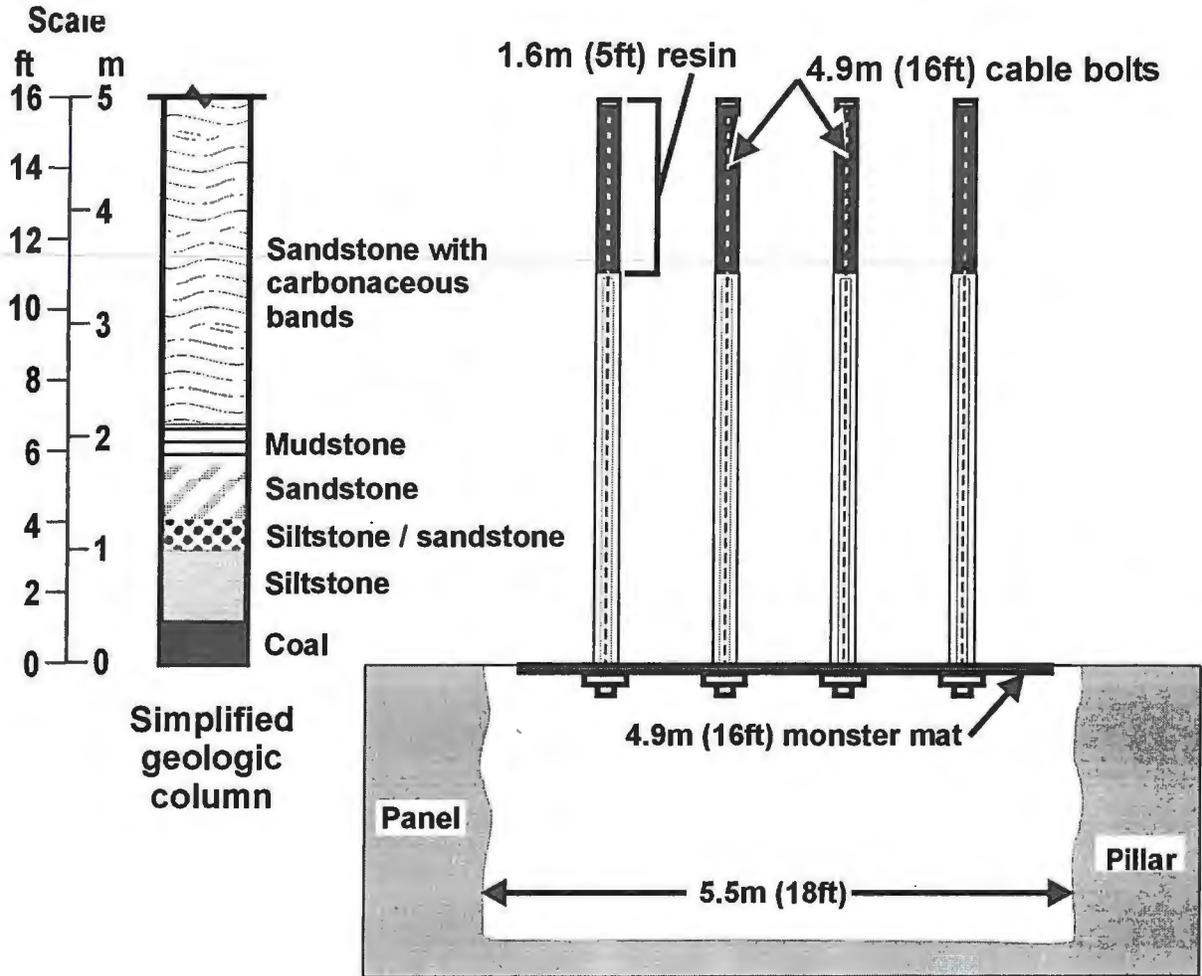
Figure 19.—Cross section of tailgate entry showing cable bolt design for case history 2.

Figure 19 shows the geology as well as a cross section of the entry with the cable system design. The cable bolts were 4.9 m (16 ft) long with four bolts per row and a row spacing of 1.5 m (5 ft). The resin anchor length was 1.5 m (5 ft), resulting in a free cable length of 3.4 m (11 ft). This free cable length allowed for greater cable elongation in the high-stress and deformation environment caused by crushing of the yield pillar. This cable system design would support a roof thickness of up to 3.3 m (10.9 ft) based on a dead weight load.

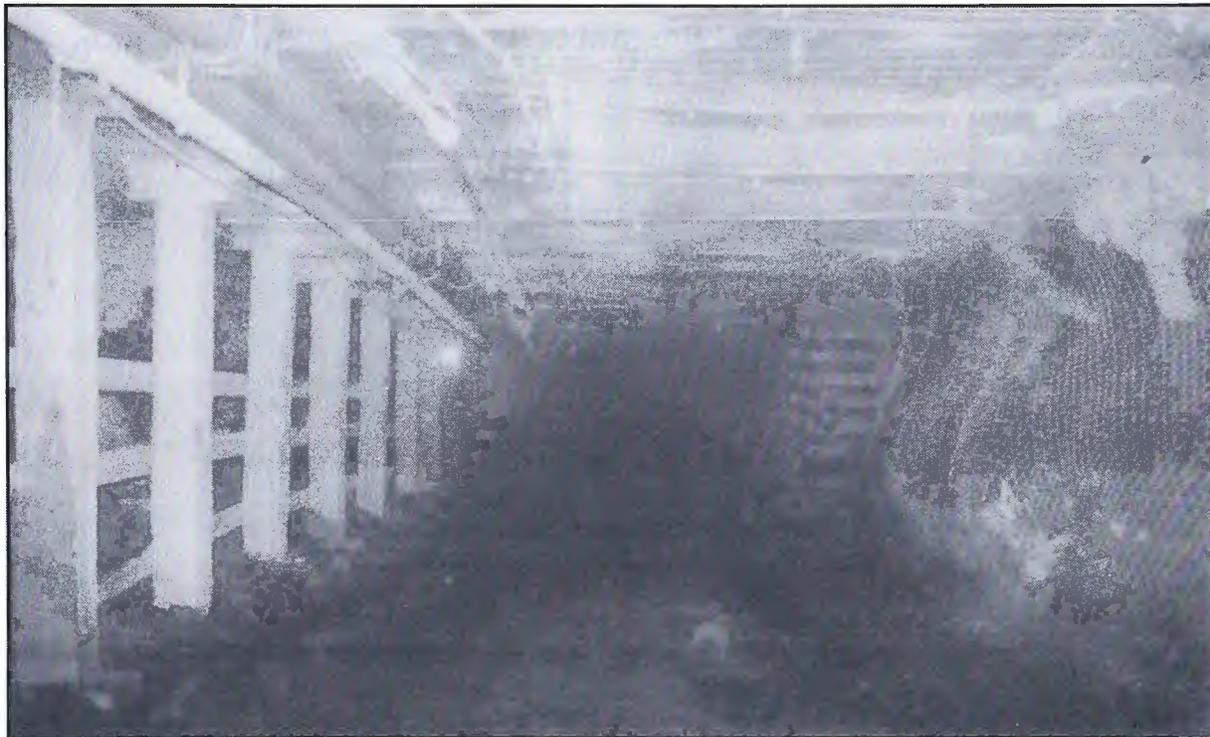
Figure 20.—Two entry yield pillar tailgate showing the abutment zone outby the face, supported with cable bolts

this differential movement, and some standing support was added. Separations were observed in the mine roof, but never above the anchor horizon. Up to 10 cm (4 in) of overall roof separation was seen, most of which occurred between the mudstone-sandstone layers within the lower 1.2 to 1.8 m (4 to 6 ft) of the roof. This was within the elongation capacity of the cables. However, cable loads up to 275 kN (40,000 lbf) and cable failures indicated that this level of elongation was approaching the limit of the cable system especially as it was developed by shear. Despite this high-deformation environment, the tailgate was kept open and functional with the cable support even under the sandstone channels (figure 20).

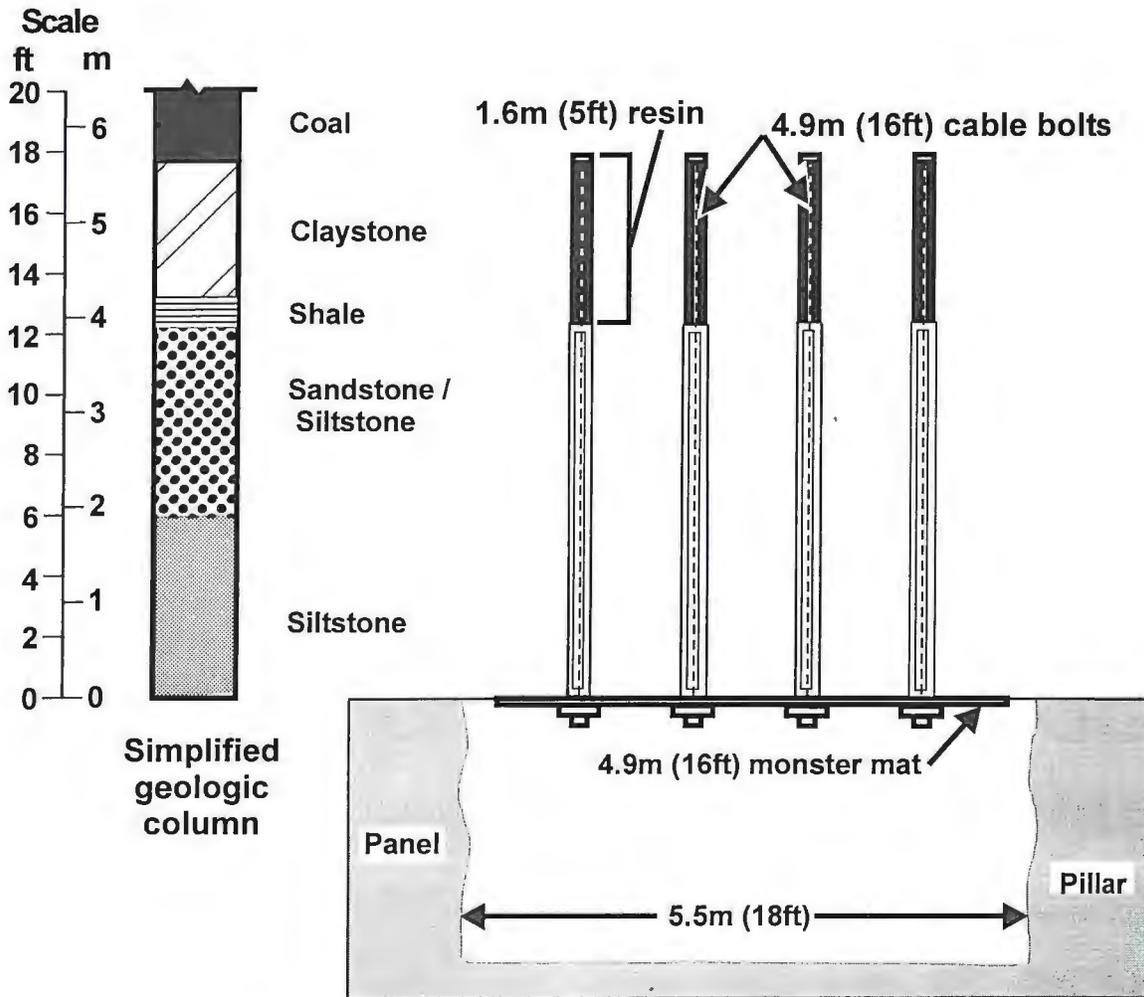
Figure 21.-Cross section of tailgate entry showing cable bolt design for case history 3.

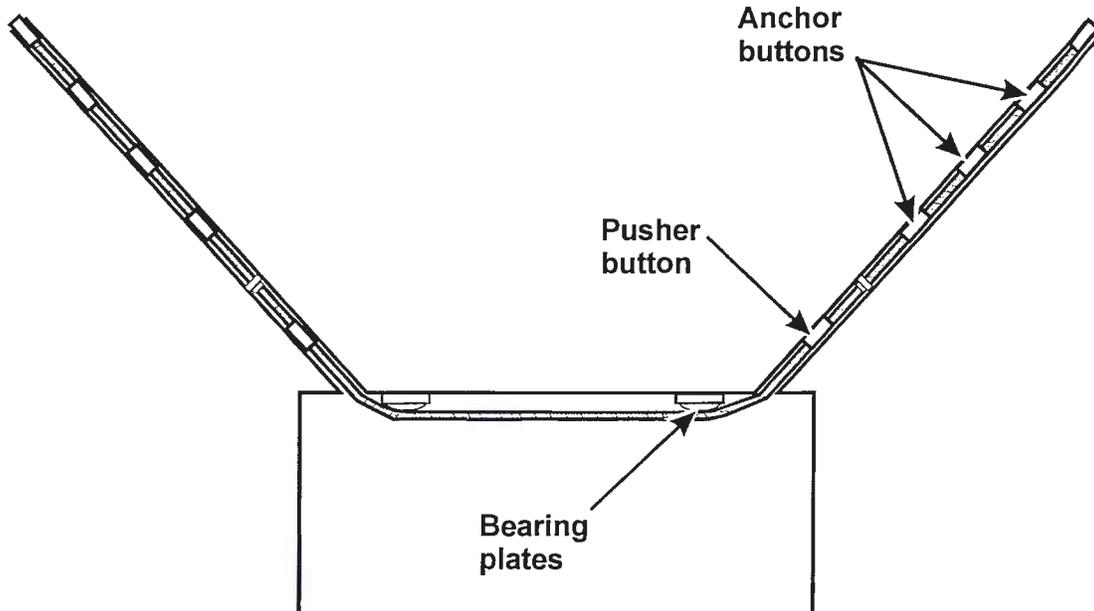
Figure 22.- Single piece cable truss.

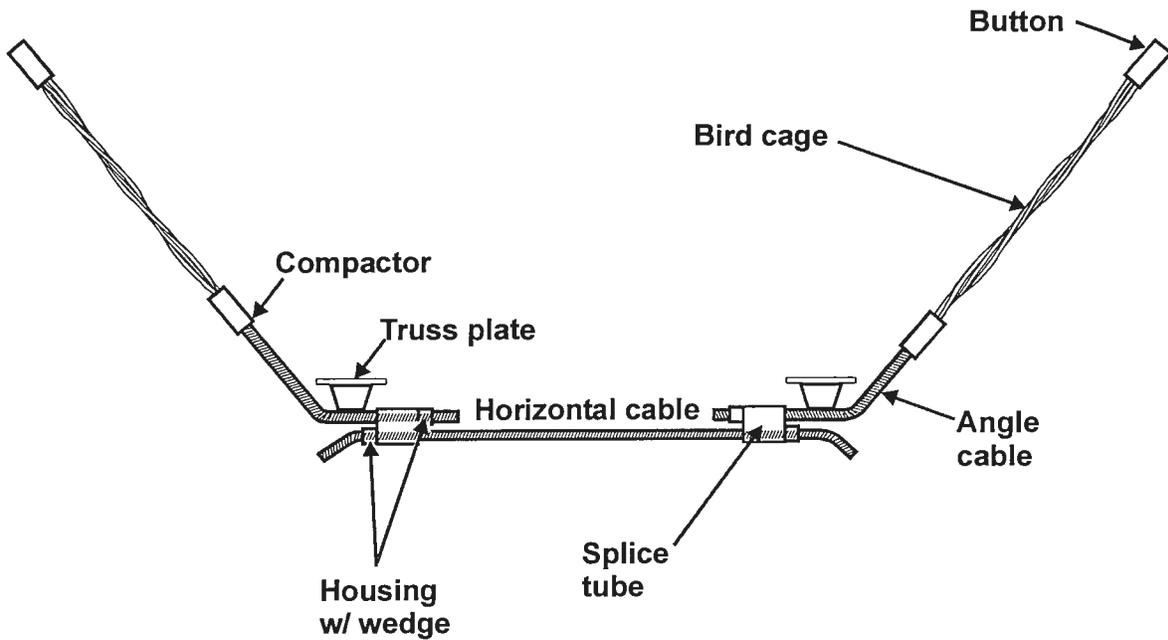
Figure 23.-Three piece cable truss.

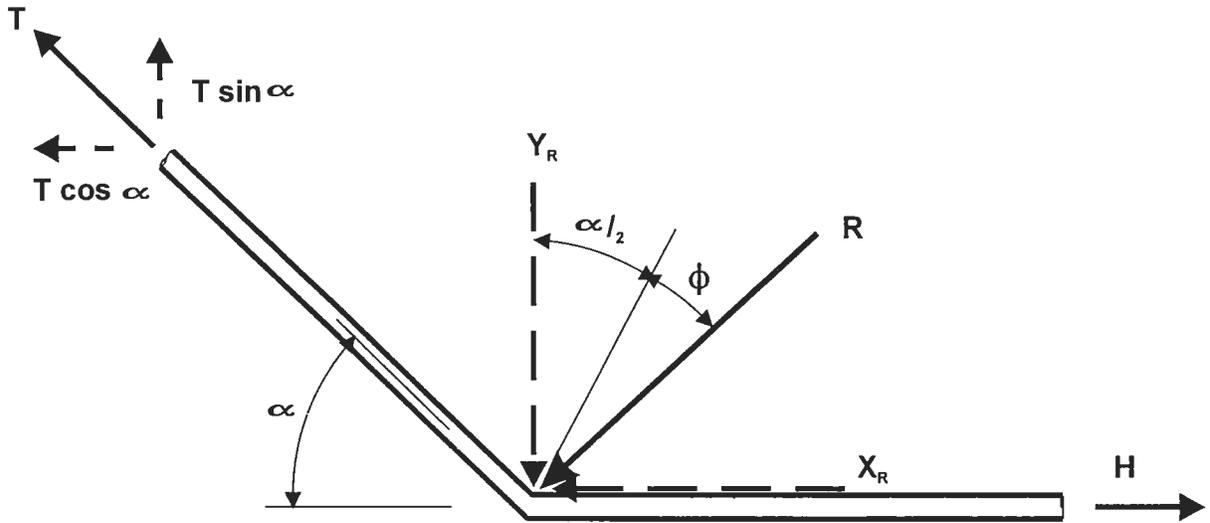
Figure 24.-Free body diagram of half truss showing the truss loads.

The loads developed in a truss can be evaluated by simple statics. Figure 24 shows a simple free-body diagram of the loads for a half of a truss. The following equations can be used to describe the relationship between the reaction force R broken into horizontal and vertical components and the cord tensions.

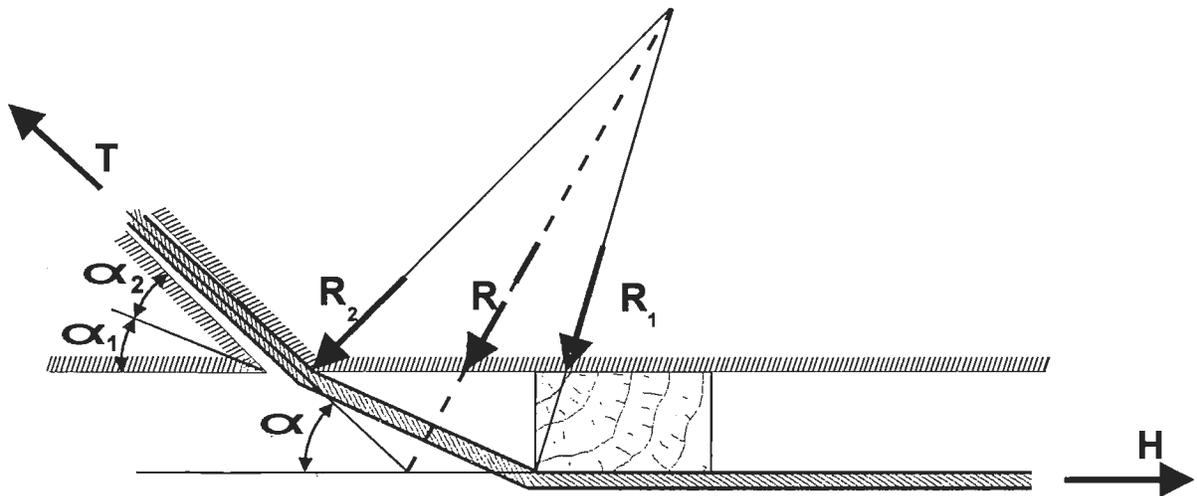
Figure 25.-Free body diagram of half cable truss, showing static loads that develop.

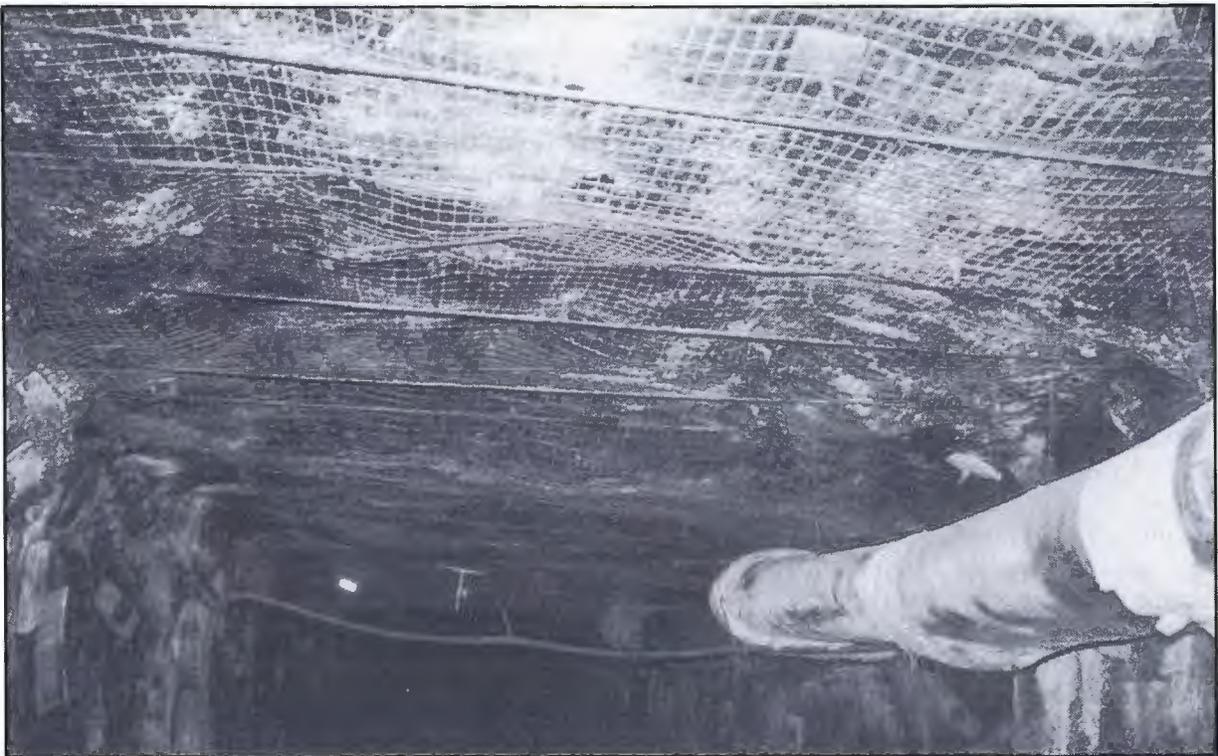
Figure 26.-Cable trusses installed in the headgate entry.

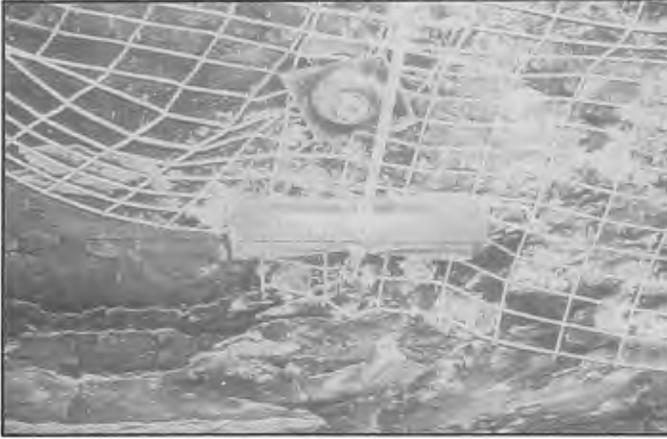
Figure 27.—Roof damage from horizontal stress around cable truss in headgate just outby the face.

A mine located in western Colorado had roof damage in the headgate ahead of the face as the panel was mined [Dolinar et al. 1996]. This was the result of horizontal stress concentration ahead of the face and geologic features susceptible to stress damage. (See case 1 for a more detailed description of the geology.) A single-piece cable truss with a diameter of 1.52 cm (0.6 in) was installed on 1.2-m (4-ft) centers in the headgate entry (figure 26). To evaluate loading during installation and as the panel was mined, special cable strain gages were installed on the horizontal section of some of the trusses. The installed load on the trusses ranged from 15.1 to 36.9 kN (3,400 to 8,200 lbf). From mining, the maximum load was 74.7 kN (16,800 lbf) for a truss just in by the face, an increase of 55.2 kN (12,400 lbf). This shows that the cable trusses were loading and resisting the roof movement. The cable trusses were able to control the roof conditions that developed in the headgate successfully despite the lateral movement and roof damage (figure 27).

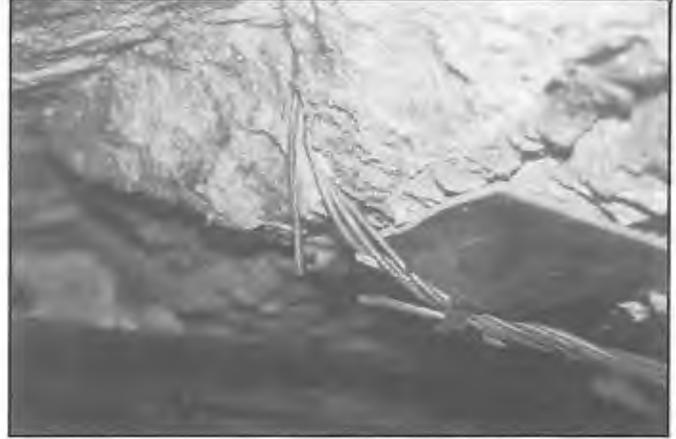
Figure 28.—Shear failure of cable truss near bearing plate.
