EXAMINING LONGWALL SHIELD FAILURES FROM AN ENGINEERING DESIGN AND OPERATIONAL PERSPECTIVE

By Thomas M. Barczak¹

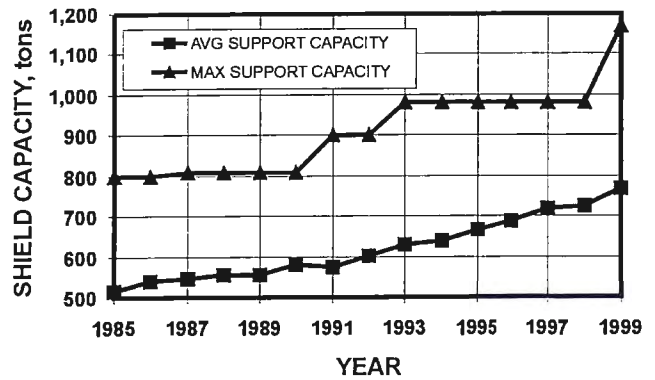
Figure 2.—Trend showing increase in support capacity.

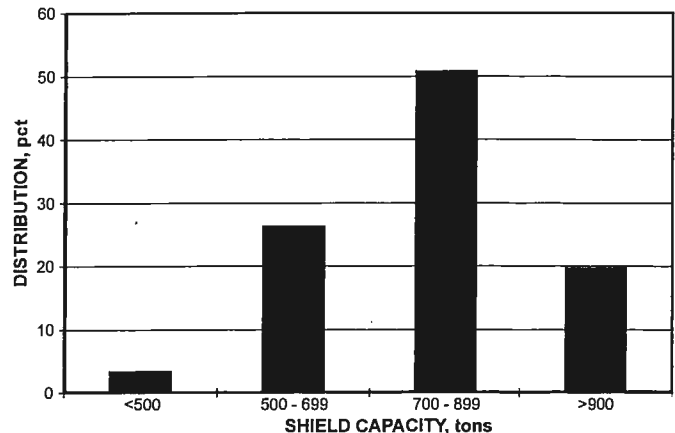
Figure 3.—Distribution of capacity for shields operating in 1999.

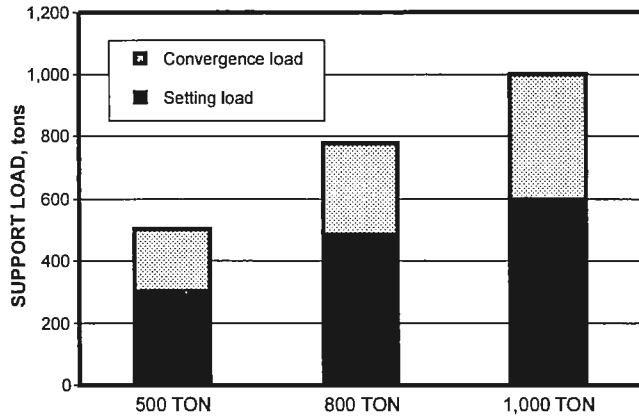
Figure 4.—Setting load and load developed due to 0.5 in of roof movement for shields of various capacities.

The increase in capacity has significantly impacted shield design and ground control capability. In order to provide the increased support capacity, larger diameter leg cylinders had to be utilized. One consequence of the larger diameter leg cylinders has been a proportional increase in shield stiffness. This increase means that the load developed in the support structure will occur at less displacement or face convergence. Although the increased stiffness may provide superior control of the immediate roof, main roof weighting that causes irresistible (in terms of the shield capacity) convergence on the longwall face will result in greater shield loading with the stiffer shield design. As a result, it is not uncommon for the high-capacity shields to be fully loaded to yield capacity just as often as the lower capacity designs that they replaced. An example is illustrated in figure 4, where a 500-ton, 800-ton, and 1,000-ton shield are all fully loaded when 0.5 in of convergence occurs.

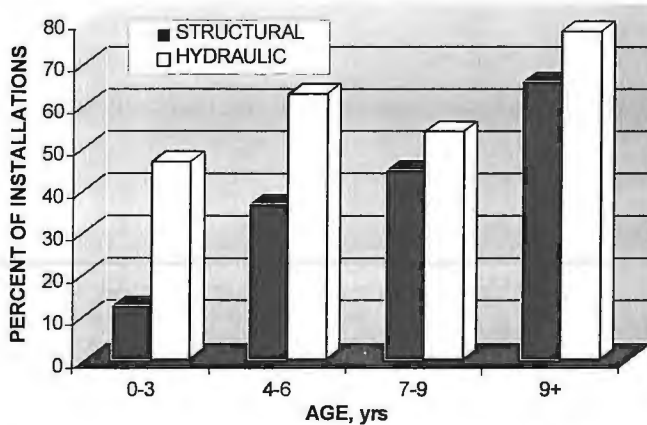
Figure 6.—Distribution of structural and hydraulic failures on shields as a function of age.

Figure 6 shows a near-linear increase in structural failures with age. Failure is defined as structural damage to any support component. It does not necessarily mean catastrophic failure that renders the support inoperable. The linear relationship suggests that *more than just fatigue failures are occurring*, since

There were *more hydraulic problems reported than structural problems* (figure 6), particularly in shields that have been in operation less than 6 years. There were nearly four times the number of hydraulic failures in shields operating 3 years or less and nearly twice as many for shields in the 4- to 6-year range than there were structural failures for the same age group. Obviously, the weak link in shield design is the hydraulic system. Numerous hydraulic failures or problems were reported. The high frequency of failures in the first 3 years of operation is distorted by failure of a component called a hydrafuse. The hydrafuse is a safety device incorporated by Joy as part of the leg cylinder design on its recent generation of shield supports in response to a fatality that occurred recently in Australia. An Australian mine worker was killed when the hydraulic fluid in the retract annulus of the leg cylinders was inadvertently pressurized while setting the support. Normally, the retract port is open through the return line back to the hydraulic reservoir whenever the leg cylinder is being pressurized. This is necessary since the pressure would be highly intensified (by a factor 30 or more) if the port was blocked, as in the case of the Australian fatality. The resultant pressure intensification caused the cylinder end cap to rupture, striking and causing a fatal injury to the mine worker.

Most hydraulic problems are related to internal leakage due to seal wear and/or corrosion of the cylinders. These problems typically begin when shields have been in service 4 to 6 yrs. As figure 6 shows, 60% of the shields had some sort of hydraulic problems during this timeframe. Many problems go undetected for extended periods of time, resulting in degraded support capacity that can contribute to ground control problems in heavy loading conditions. Methods to detect the onset of internal hydraulic leakages are discussed later in this paper. As previously described, there is a trend toward the use of low-

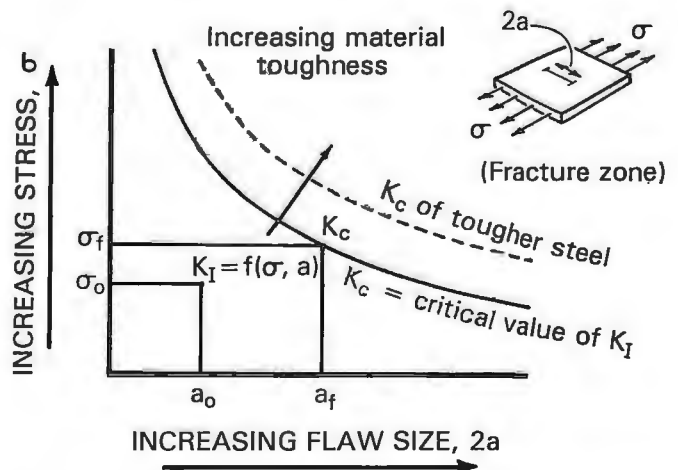
Figure 9.—Fracture mechanics principles regarding material toughness, stress, and flaw size.

The goal in fracture mechanics design is to keep the stress intensity level below the critical value that promotes crack propagation (figure 9), much like the goal of strength of materials design is to keep the design stress within the material's elastic range. To ensure that a structure does not fail by fracture, the number of cycles to grow a small (often microscopic) crack to a critical crack length must be greater than the life of the structure. Thus, the key idea to consider in a fracture mechanics design is the ability of the steel to absorb strain energy. If the material has a high absorption capability, such as mild steel, crack growth will be limited to plastic flow of the material, and general yielding will typically prevent brittle fractures from occurring. Conversely, the probability of fatigue-related failures increases with low-energy absorption materials. Unfortunately, from a fracture mechanics perspective, state-of-the-art shields are now constructed from high-strength steels (100,000- to 120,000-psi yield strength), which are much *more susceptible to brittle fracture* than the early generation of shield supports, which were constructed from

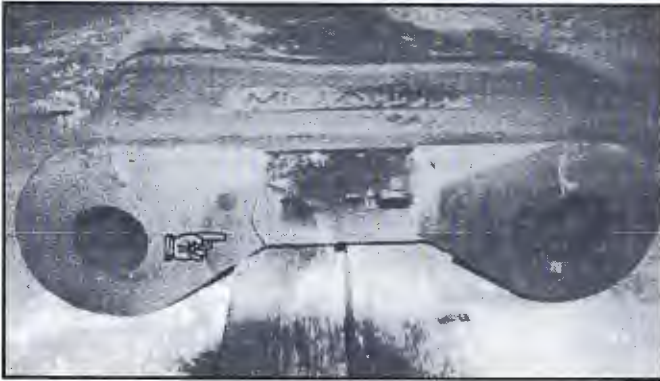
Figure 13.—Failure of bottom lemniscate link.

One example of a sharp change in geometry is a lemniscate link design with offset pinholes, as shown in figure 13. This link design is typically employed on a shield with a low profile designed for operation in low-coal seams. The bend is necessary to provide clearance with the caving shield in the collapsed or low operating height. Lemniscate links are primarily axially loaded members, but the offset pinhole geometry induces additional stresses due to bending and thereby significantly reduces the margin of safety for this component. Figure 13 depicts failure of a bottom lemniscate link on a 620-ton Westfalia shield that occurred during performance testing at NIOSH's Safety Structures Testing Laboratory. Although the shield had 45,000 load cycles from underground service before

testing, a new link was installed on the shield that was performance tested in the laboratory. This was a new link design that was fabricated for the mine by an outside vendor (not the support manufacturer). Failure occurred after only 14,000 loading cycles. This failure illustrates two problems. First, the design (allowable stress) was too high. Test results revealed that the nominal stress in the link exceeded 90% of the material yield strength. In addition, it appeared that the link side plates had been torch cut, adding an additional stress riser to the already sharp change in geometry at the bend in the link in the area where the failure occurred. These two factors resulted in an unacceptable time to failure. Figure 14 illustrates another problem where the fabrication process left large flaws that led to premature fatigue failure of the base rib. This problem may have been alleviated if the surface had been smoothed to remove most of the surface flaws.

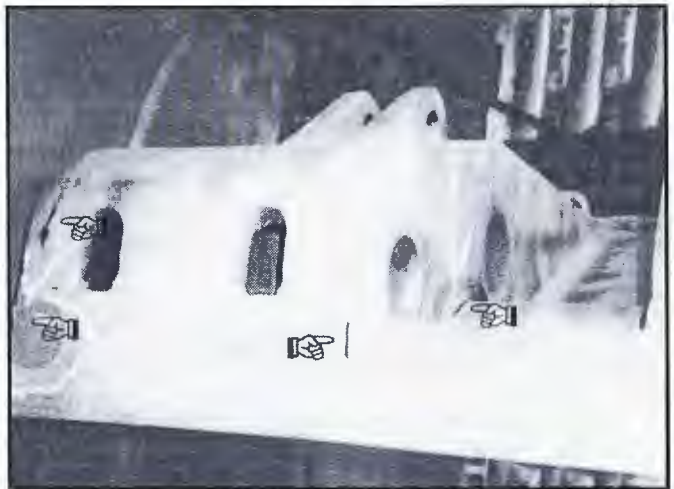
Figure 17.—Failures of caving shield due to stress concentration in sharp corners where lemniscate links connect.

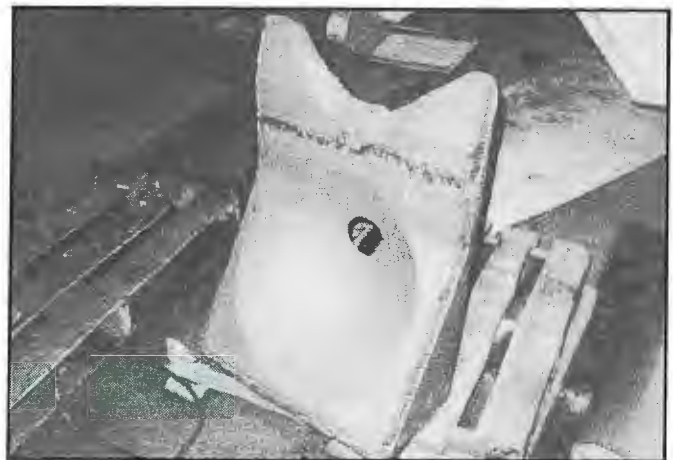
Figure 19.—"Zipper-shaped" leg cylinder casting to avoid stress concentration caused by orientation of casting to principal stress field.

position it at right angles to the principal tensile stress caused by the bending of the base structure. This orientation creates a stress intensity factor, which helps to promote fatigue-induced fracturing of the weldment. Some shields are now being designed with an elliptical or zipper-shaped casting (figure 19) so that the front and/or rear edge is not perpendicular to the principal tensile stress, thereby resulting in a reduction of the stress intensity factor.

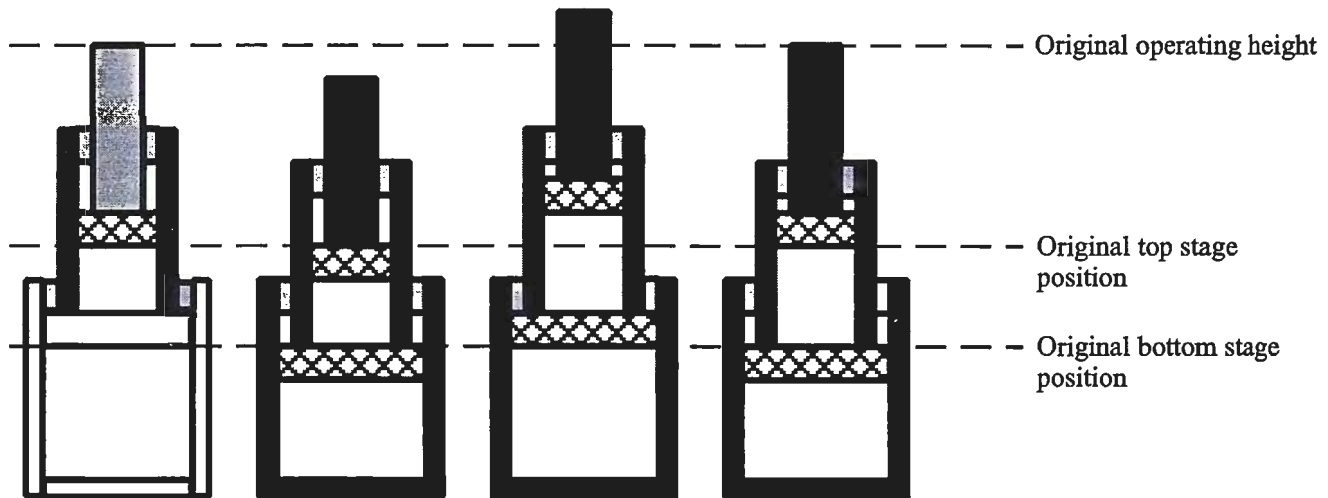
Figure 23.—Example of stage extension for changes in mining height.

An example is used to illustrate these concepts. As shown in figure 23, the initial setting of the support causes the bottom stage to be fully extended 24 in (stroke) and a 12-in (partial) extension of the top stage. If the roof-to-floor mining height is reduced on the second operating cycle by 3 in, the bottom-stage extension now will be 21 in, while the top-stage extension will remain at 12 in. If the mining height is increased by 6 in from that of the second cycle, the bottom stage will again be fully extended (24-in stroke) and the second-stage extension will increase to 15 in on the third cycle. This exercise can continue as shown in figure 23. As shown in this exercise, the top-stage extension on any cycle will equal the initial extension plus the incremental increase in mining height beyond the initial mining height. The top-stage extension will never be less than the initial extension unless the support is lowered to the point where the bottom stage is fully retracted. The bottom-stage extension will fluctuate with changes in mining height on each cycle and will be fully stroked whenever a new maximum operating height is attained.

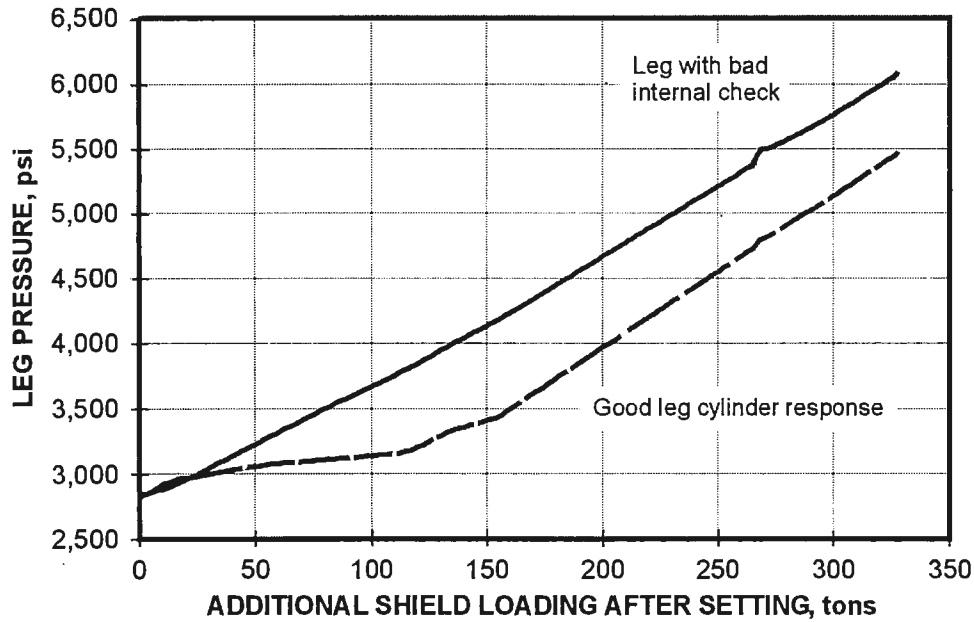
Figure 25.—Identification of defective leg cylinder staging valve.

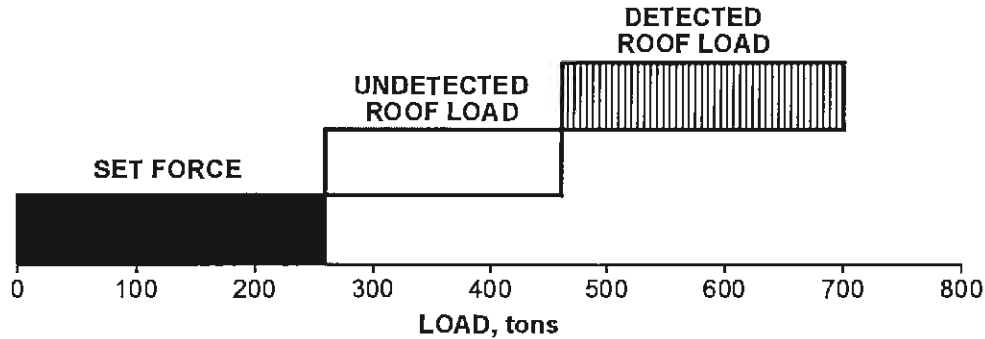
Figure 26.—Undetected roof loaded by bottom-stage pressure measurements when bottom stage is fully extended during setting of the shield.

Figure 26 depicts undetected roof loading for a 700-ton (two-stage) longwall shield set at full pump pressure. It is seen

from this figure that the unrecorded roof loading is quite large. For example, approximately 200 tons of undetected roof loading, which represents 84% of the remaining shield
