AUTOMATIC FIRE SENSING
AND SUPPRESSION SYSTEMS
FOR MOBILE MINING EQUIPMENT

FINAL REPORT

Prepared for
UNITED STATES
DEPARTMENT OF THE INTERIOR
BUREAU OF MINES

Contract HO262052
Automatic Fire Sensing and Suppression Systems
for Mobile Mining Equipment

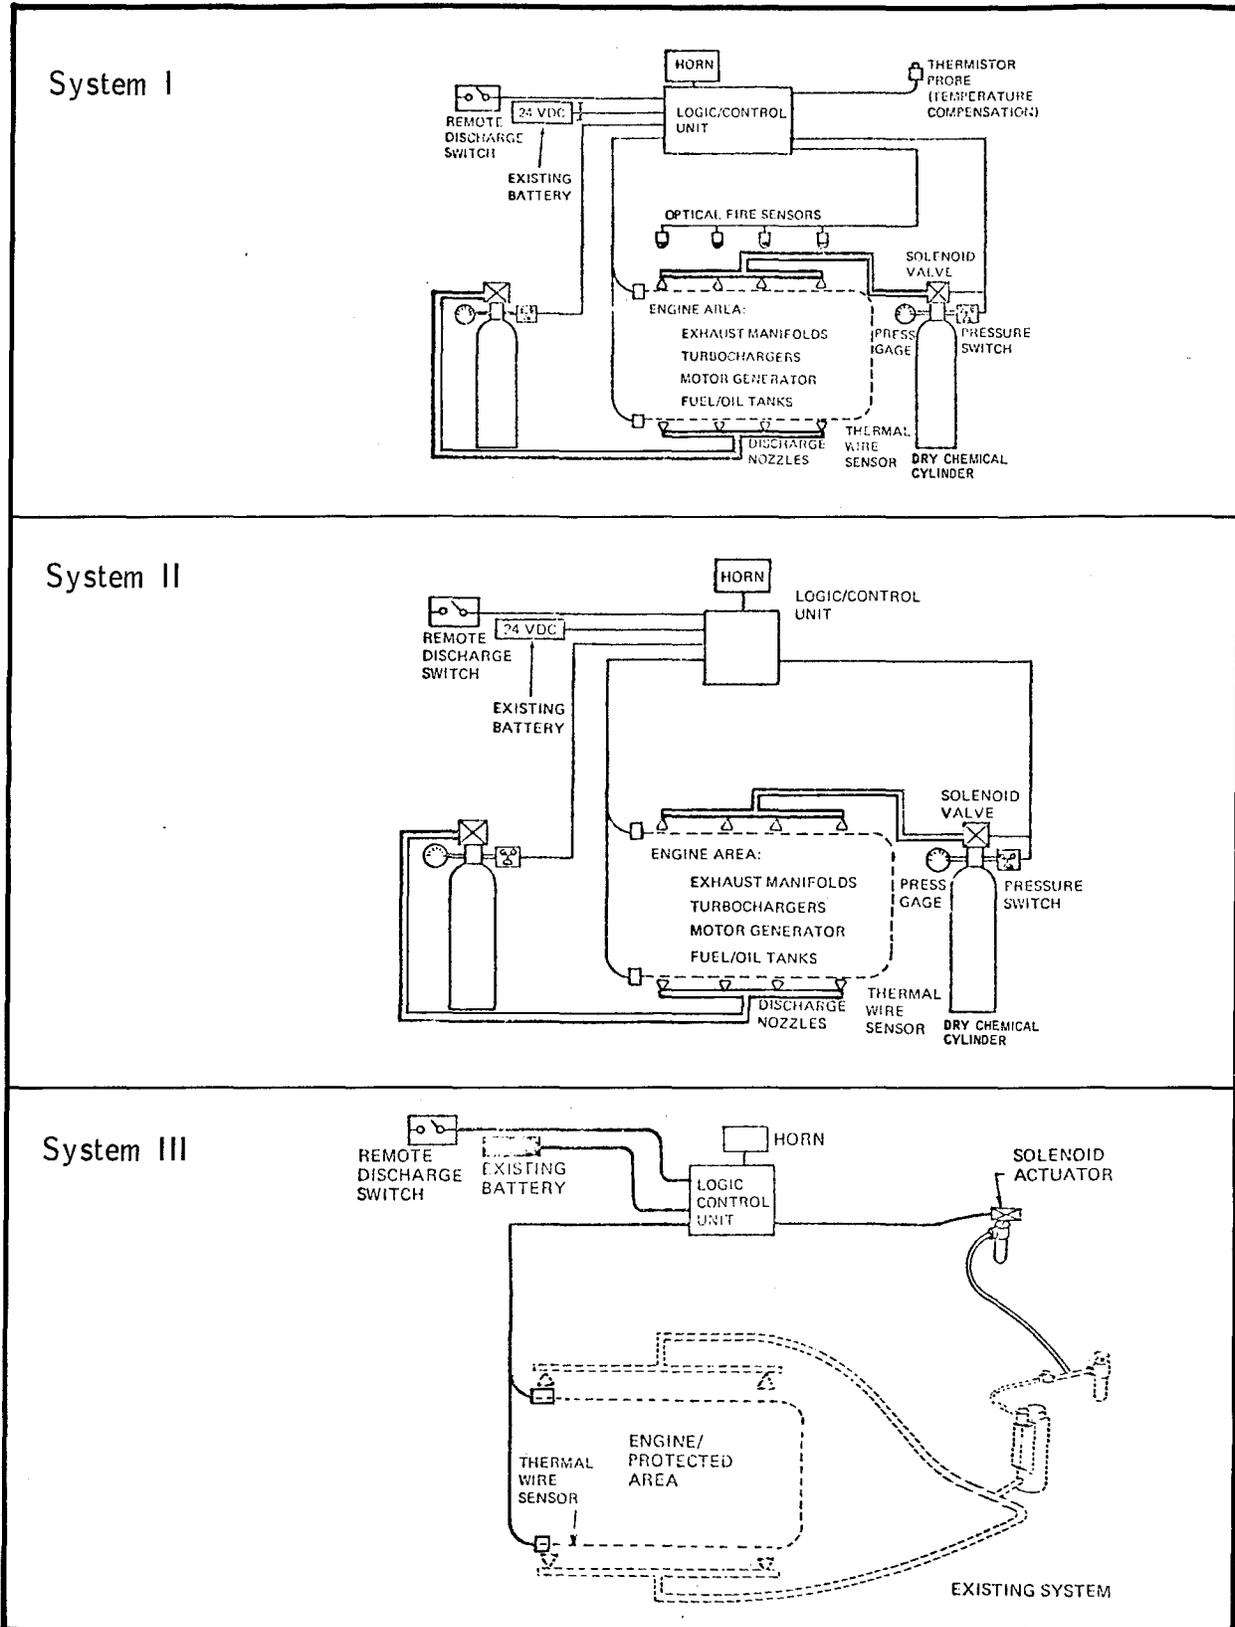
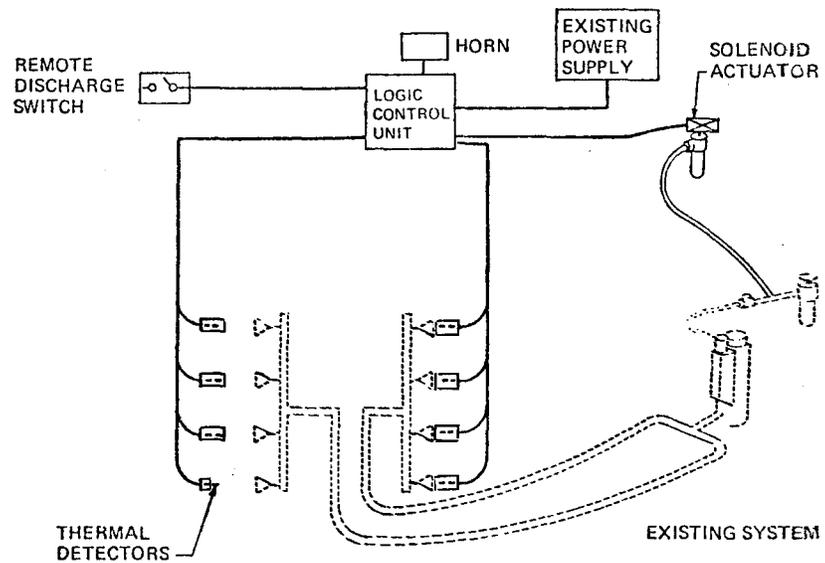
Figure A SCHEMATICS OF FIRE PROTECTION SYSTEMS (Sheet 1 of 2)

- System I, the existing FMC/Bureau of Mines system, including thermal and optical detectors, stored-pressure dry-chemical cylinders, logic control, and ambient temperature compensation.

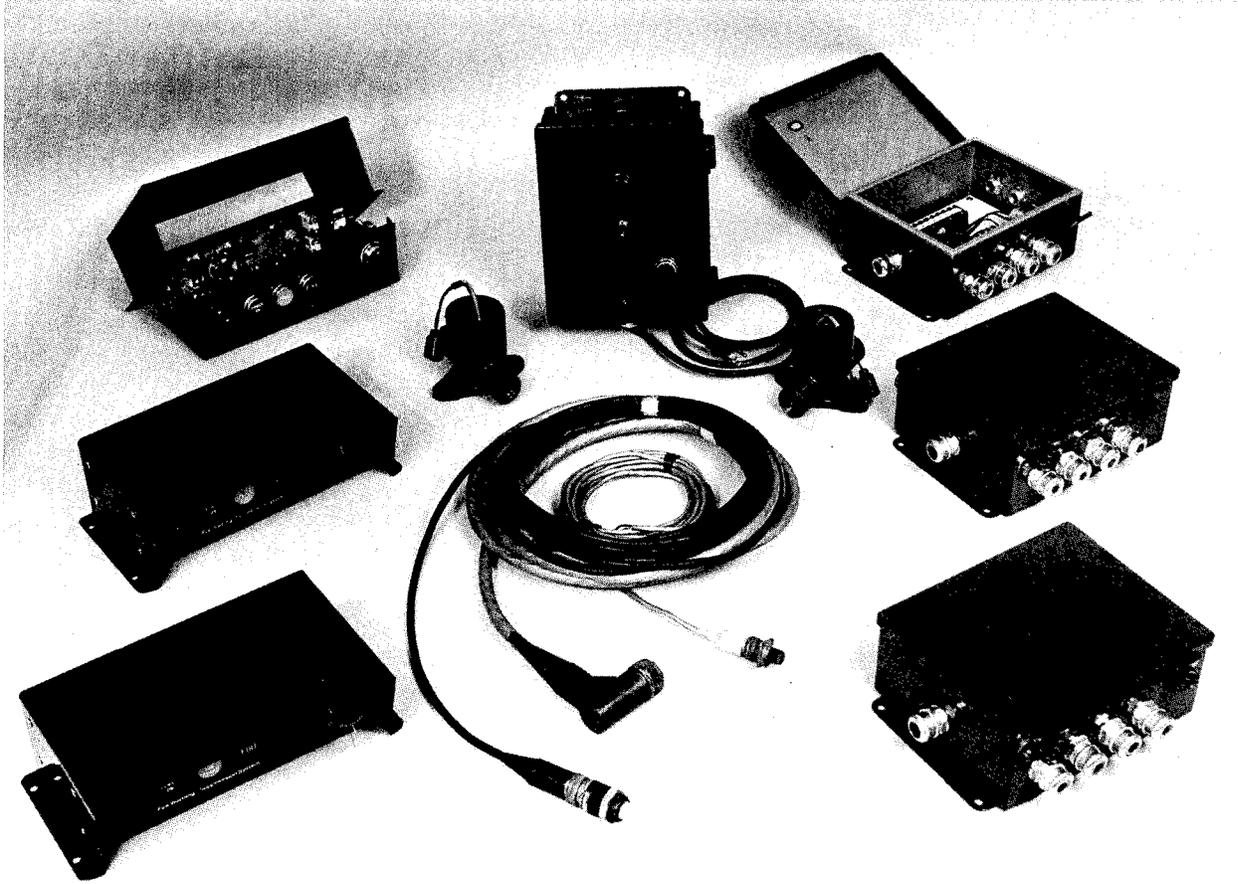
Figure 1 COMPONENTS OF FMC FIRE PROTECTION SYSTEMS

Major components of each system are pictured in Figure 1.

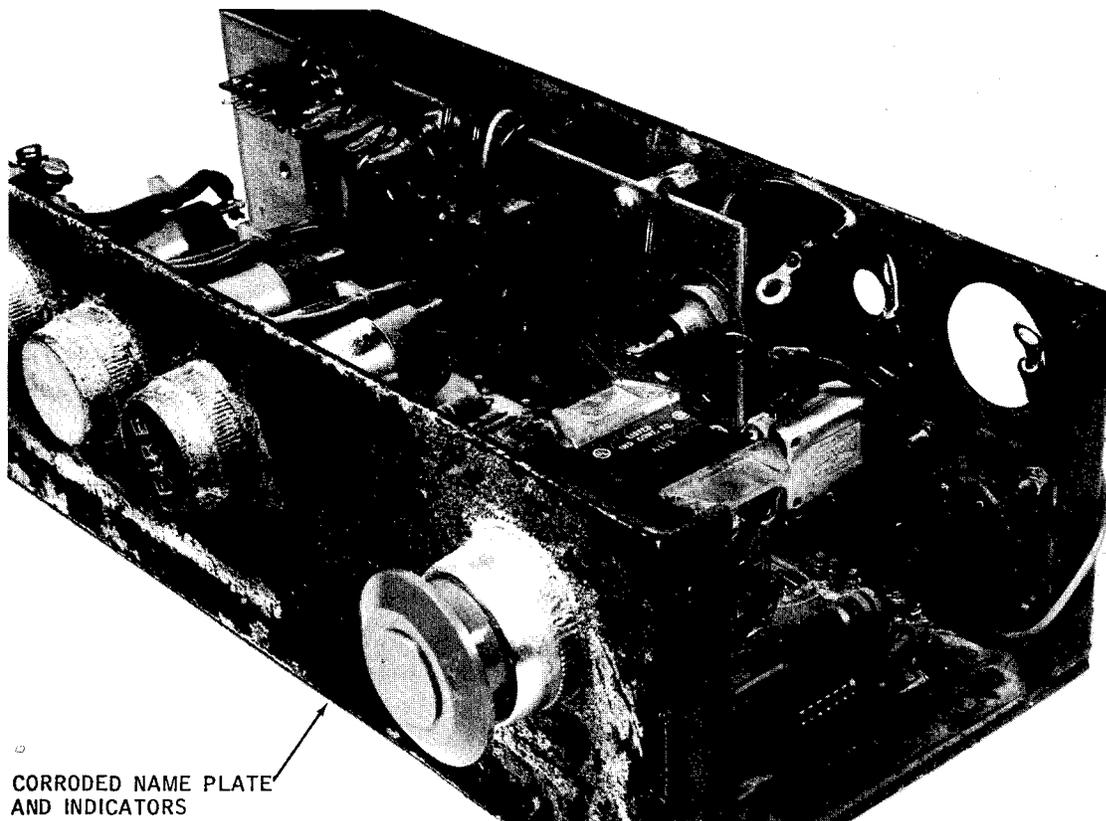
Figure 3 DAMAGE SUSTAINED BY ELECTRICAL CIRCUITS

Additional seals around the main control panel and the junction box proved effective after initial problems in each. Contrary to occasional practice, openings for "breathing" of electrical boxes proved fatal to electrical circuits at least three times. Three control panels had to be replaced after short duration in the harsh mine environment.

Visual indicators and other items on the control panel were also seriously affected by corrosion. Audible alarms, lights, switches, pushbuttons, and circuit breakers required protection, especially on the three vehicles subjected to routine steam cleaning (see Figure 3). No problems occurred on the automatic fire protection system installed on the cutter in the dry working area of the mine, even though salt dust accumulations were occasionally several inches thick on the components.

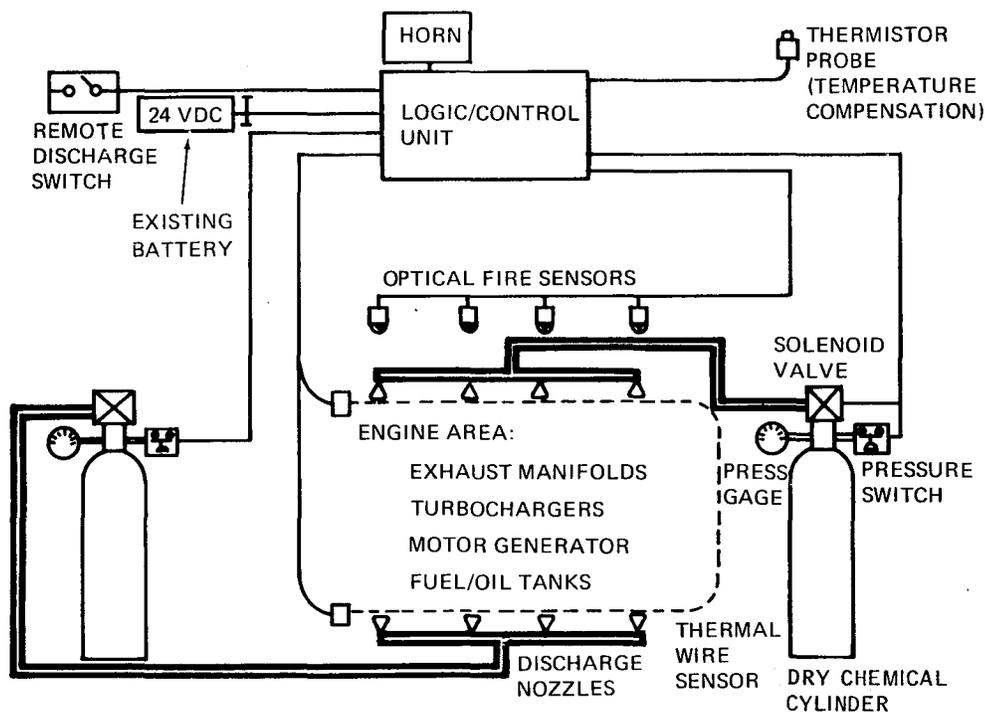
Figure 11 SYSTEM I MAJOR COMPONENTS

- Optical Sensing Element — Instant detection of flash fire in area protected; provides quicker response than thermal wire alone.
- Thermal Wire Sensing Element — High reliability; highly resistant to actuation by false stimuli.
- Thermistor Probe — Compensates for rapid changes in ambient temperature, improves system performance (cold weather environment only).
- Environmental Housings — Protect cylinders, valves from damage.
- Logic/Control Unit — Warns operator, both visually and audibly, of danger; utilizes output signals from both sensors to determine if flash fire or slower growing fire occurred; determines if system malfunction is present.
- Cylinder and Solenoid Valve Combined — Stores pressure and powder together, eliminating powder caking problems.
- Remote Discharge Switch — Allows manual discharge of system at ground level.

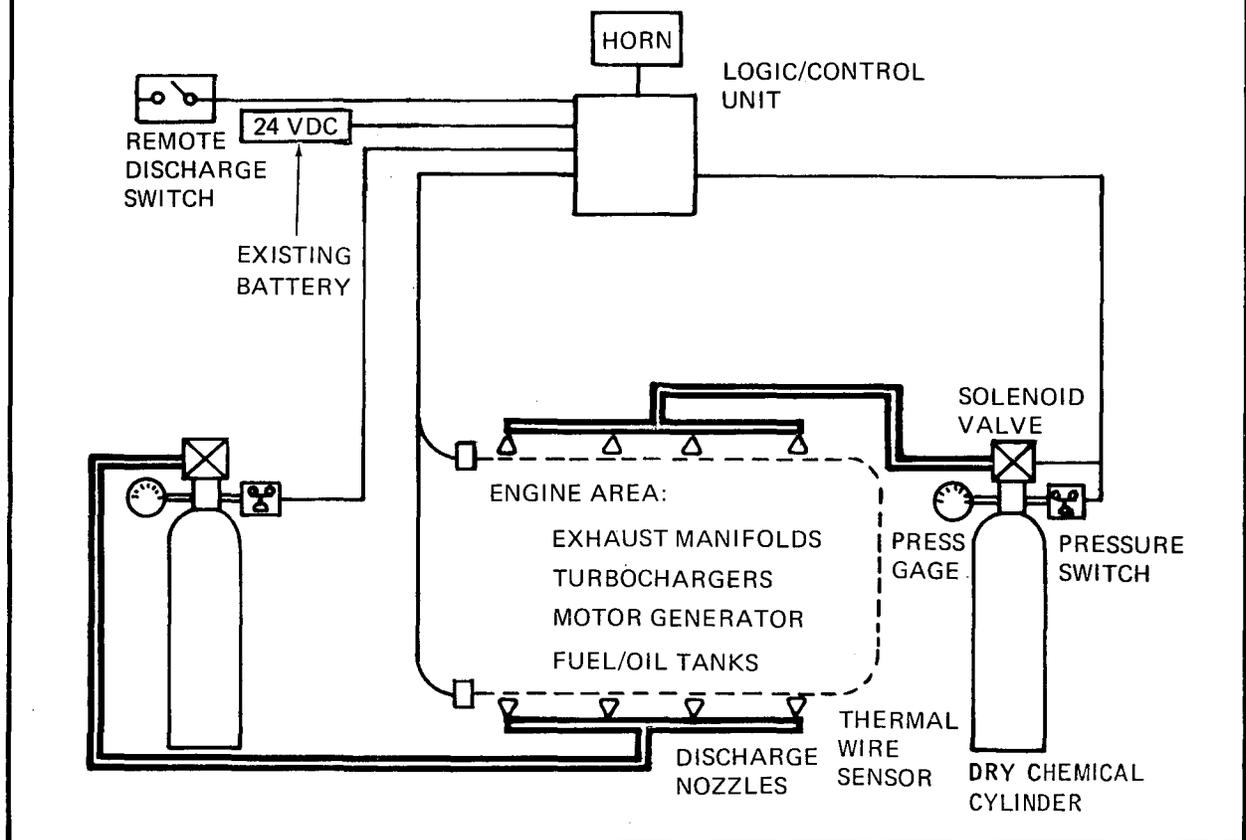
Figure 12 SYSTEM II MAJOR COMPONENTS

- Thermal Wire Sensing Element — High reliability; highly resistant to actuation by false stimuli.
- Logic/Control Unit — Warns operator, both visually and audibly, of danger; utilizes output signals from sensor; determines if system malfunction is present.
- Environmental Housings — Protects cylinders and valves from damage.
- Cylinder and Solenoid Valve Combined — Stores pressure and powder together, eliminating powder caking problem.
- Remote Discharge Switch — Allows manual discharge of system at ground level.

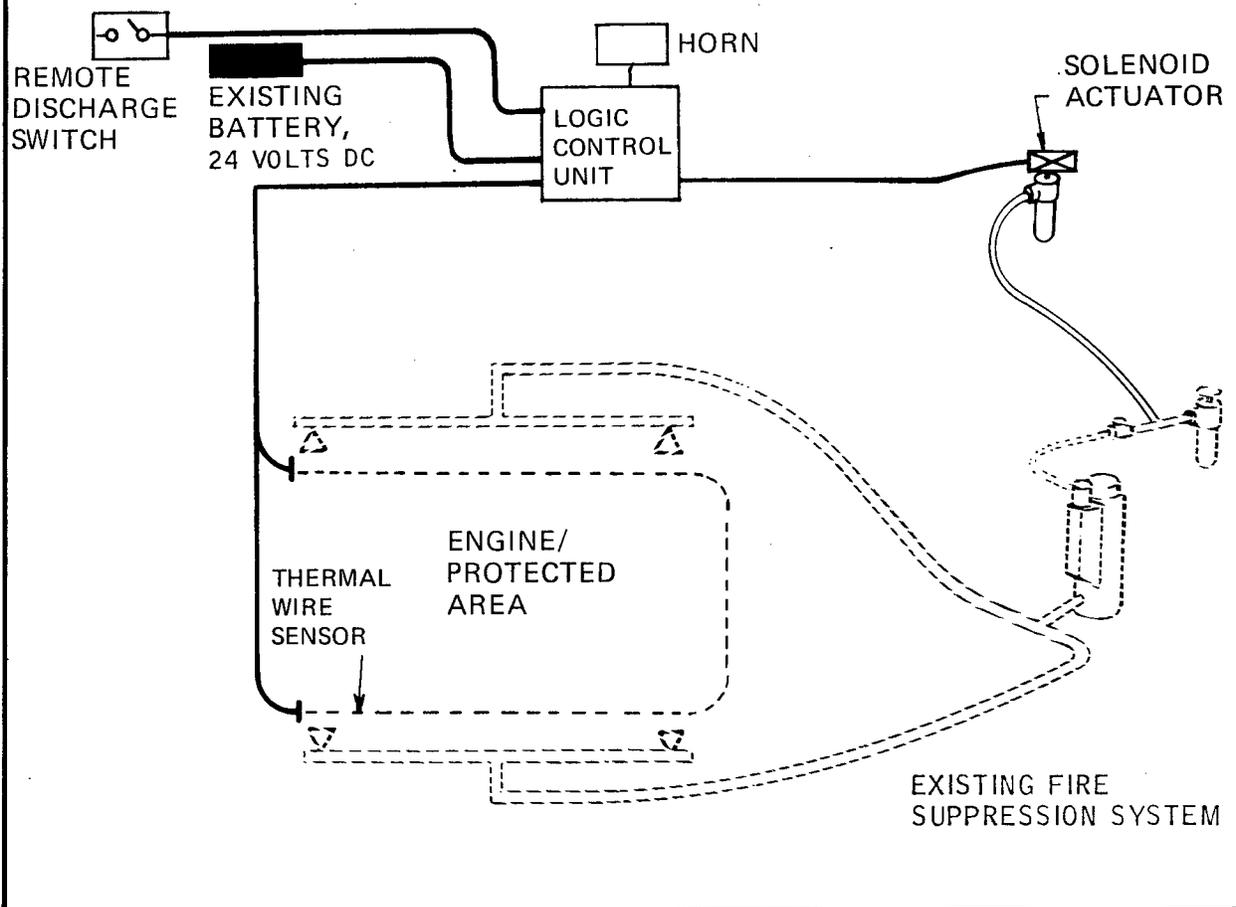
Figure 13 SYSTEM III MAJOR COMPONENTS

- Thermal Wire Sensor or Point Thermal Sensors — High reliability, highly resistant to actuation by false stimuli.
- Remote Discharge Switch — Allows manual discharge of system at ground level.
- Logic/Control Unit — Warns operator, both visually and audibly, of danger; utilizes output signals from sensor; determines if system malfunction is present.
- Solenoid Actuator — Discharges automatically and activates existing manual system.

The automatic fire sensing system for this vehicle was System III which is described in Subsection 3.5.3 and illustrated in Figure 13. Installation of System III on a Wabco 120-ton truck is depicted in Figure 66.

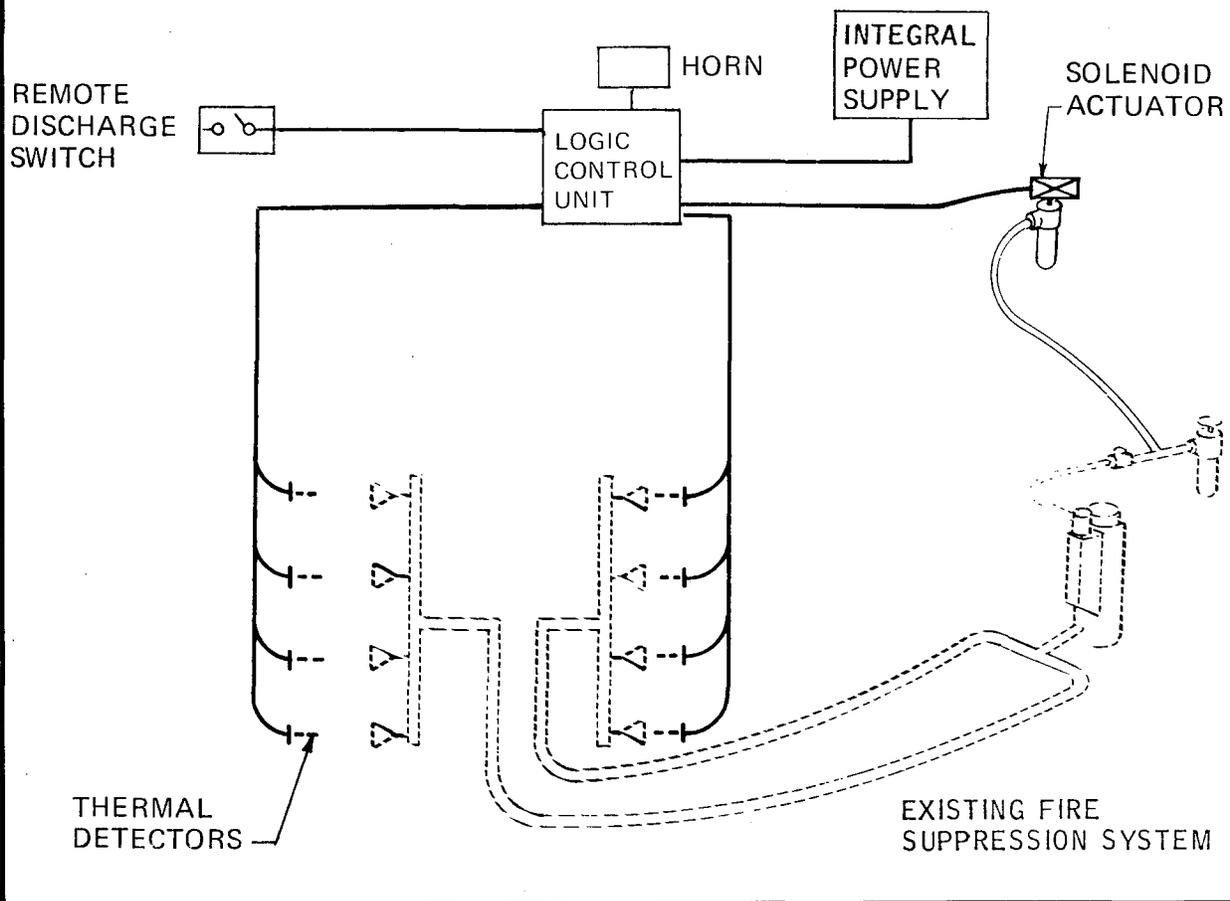
Figure 15 SYSTEM V MAJOR COMPONENTS

- Thermal Detector — High reliability; highly resistant to actuation by false stimuli.
- Remote Discharge Switch — Allows manual discharge of system.
- Logic/Control Unit — Warns operator, both visually and audibly, of danger; utilizes output signals from sensors, determines if system malfunction is present.
- Solenoid Actuator — Discharges automatically and activates existing manual system.
- Self-Contained Battery.

Automatic fire sensing System V was selected for the mobile crane. This system is described in Subsection 3.5.5 and is shown in Figure 15. System V is essentially identical to System III, but with an integral electrical power supply. The power supply was necessary on the 12-volt crane to make it compatible with the inherent 24-volt DC fire protection system voltage.

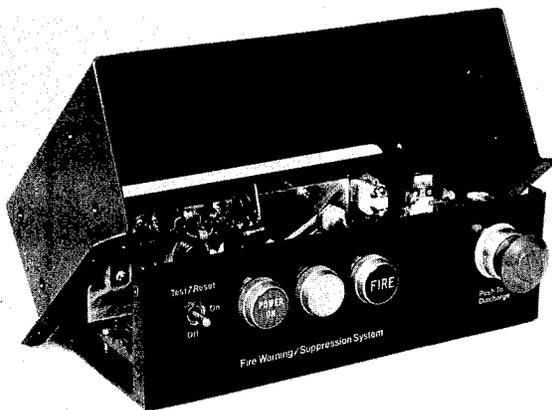
Figure 16 CONTROL PANEL ASSEMBLY (FMC Photo 66542)

FMC then fabricated a housing that would overcome the deficiencies in the 16-gage unit. A simple, two-part box assembly was designed using 14-gage steel and #10 screws for assembly. The design allowed for reasonable sealing and easy servicing. Figure 16 depicts the housing assembly.

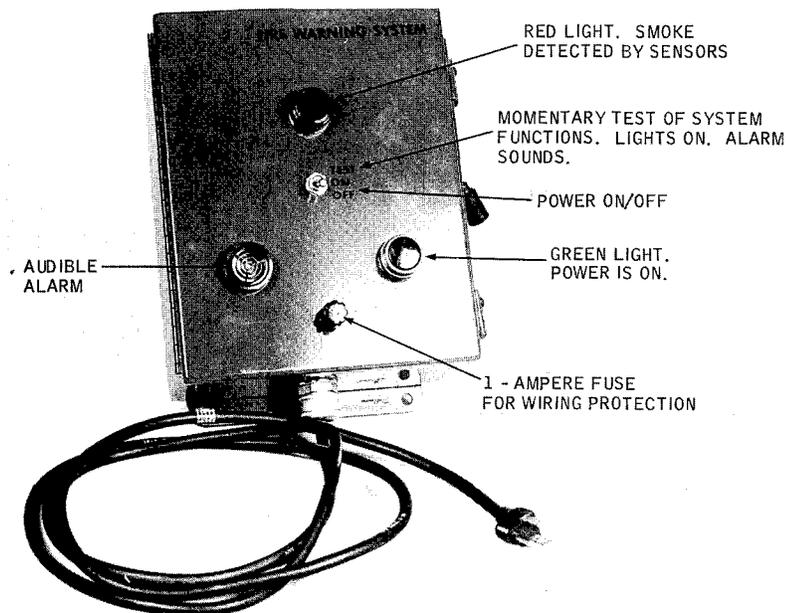
Figure 18 CONTROL PANEL DISPLAY, SYSTEM IV (FMC Photo 66533)

The control panel assembly for System IV (Figure 18) consists of one alarm monitoring unit and as many as 10 remotely mounted smoke detectors. When any smoke detector senses smoke, a red FIRE indicator illuminates and an audible alarm sounds. The system requires 110-volt AC power for operation.

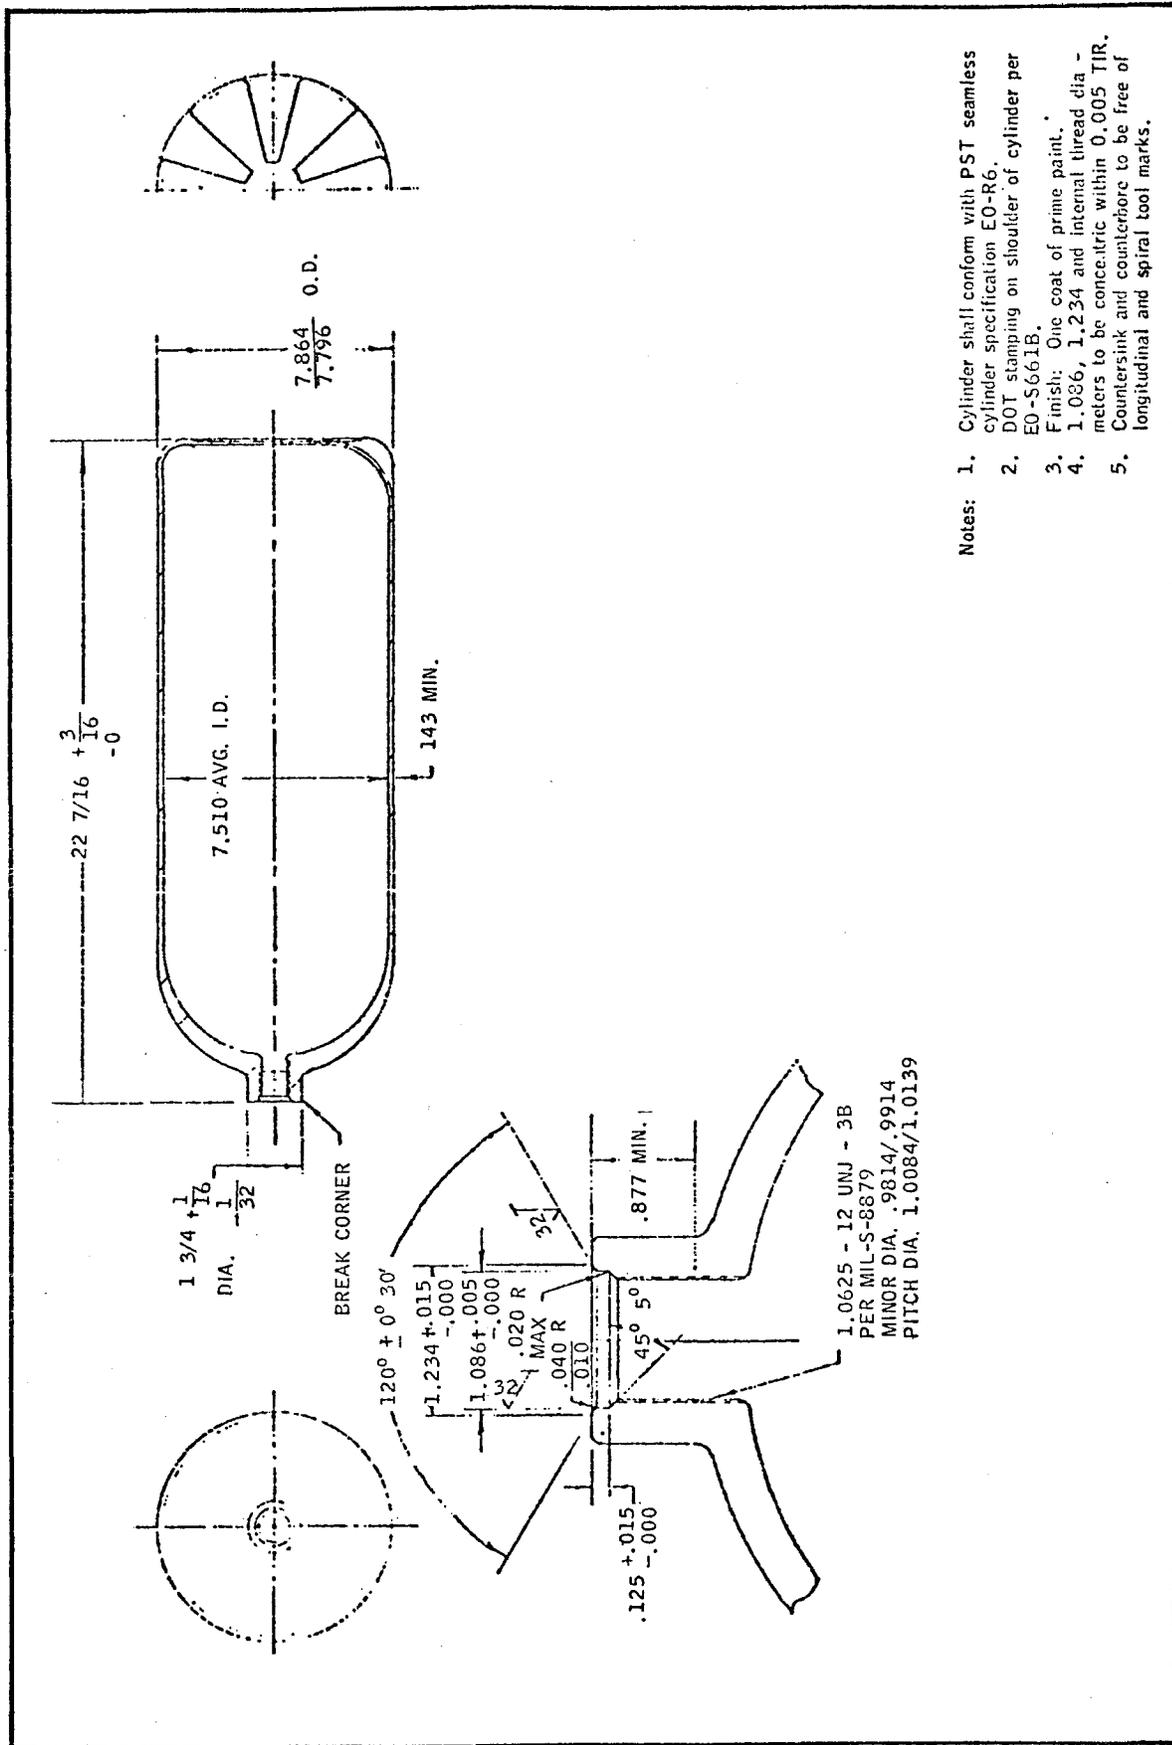
Figure 19 PRESSED STEEL TANK COMPANY CYLINDER, CONSTRUCTION DETAILS

Cylinders are filled with 25 pounds of monammonium phosphate dry-chemical powder and pressurized to 500 psi with dry nitrogen. Pressurizing is accomplished by reversing the nitrogen flow through the solenoid valve

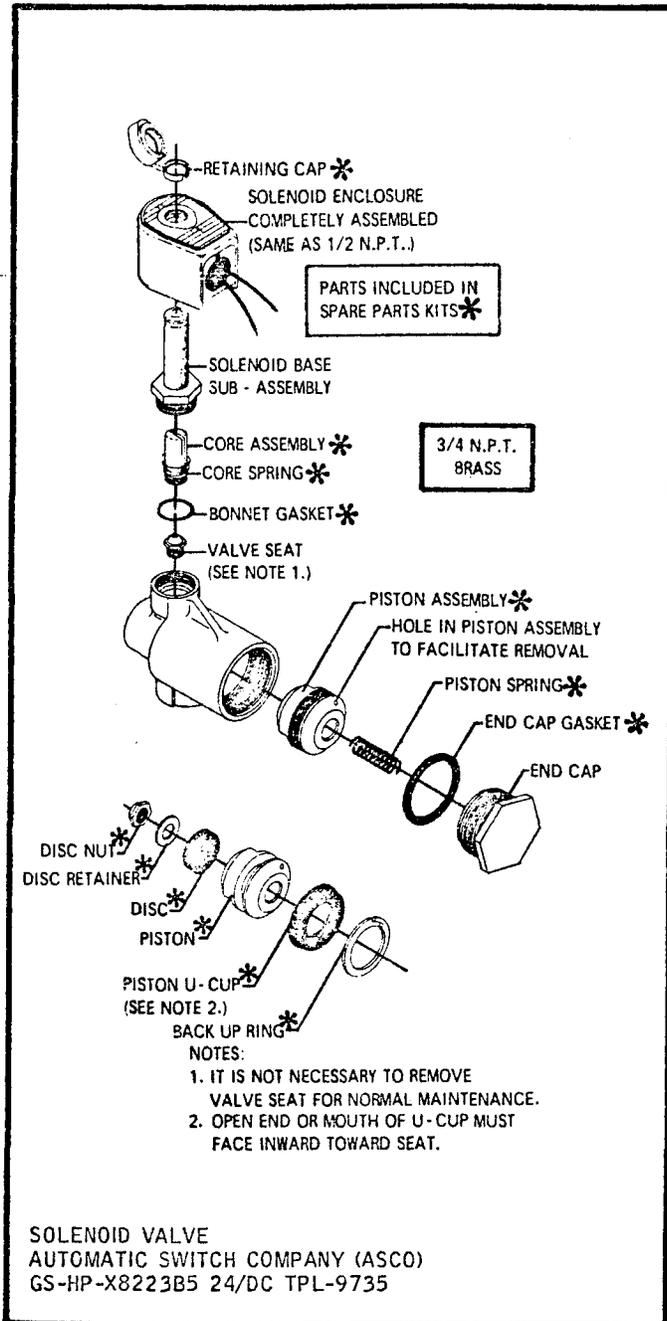
Figure 20 ASCO VALVE ASSEMBLY

replaces another valve used in work under previous contracts. The ASCO simplicity of design and use of fewer parts should result in less maintenance. One large nut (end cap of Figure 20) replaces four capscrews on the previously used valve; the operational pressure ratings and continuous-duty solenoids also were not features of the previous Bureau of Mines system.

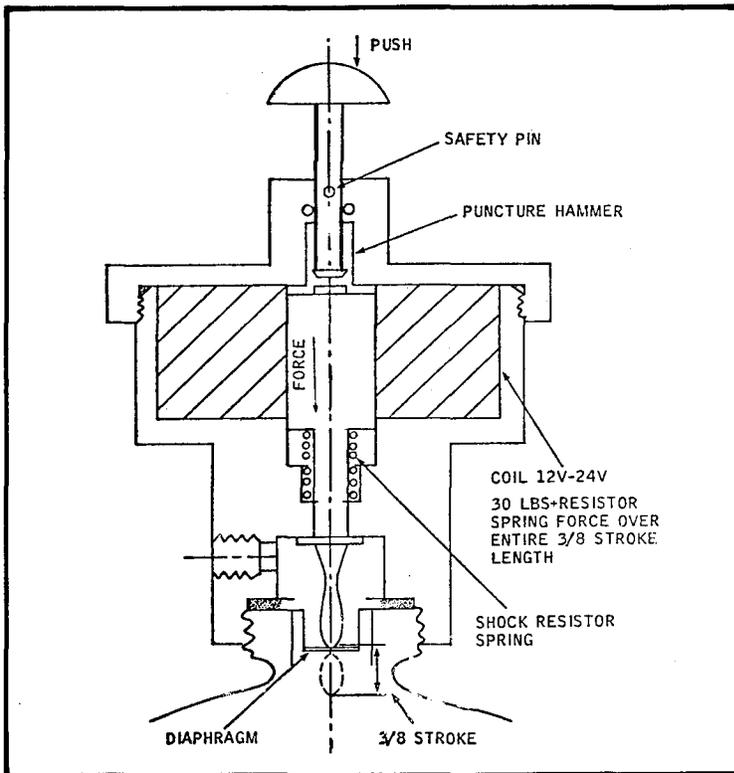
Figure 22 CARTRIDGE-PUNCTURE VALVE, INITIAL FMC CONCEPT

Prior to initiating the design effort, a search was conducted to determine if the valve needed to accomplish the automation task was commercially available. None was located. An earlier FMC design concept (Figure 22) was then re-evaluated, and effort was directed toward establishing necessary requirements.

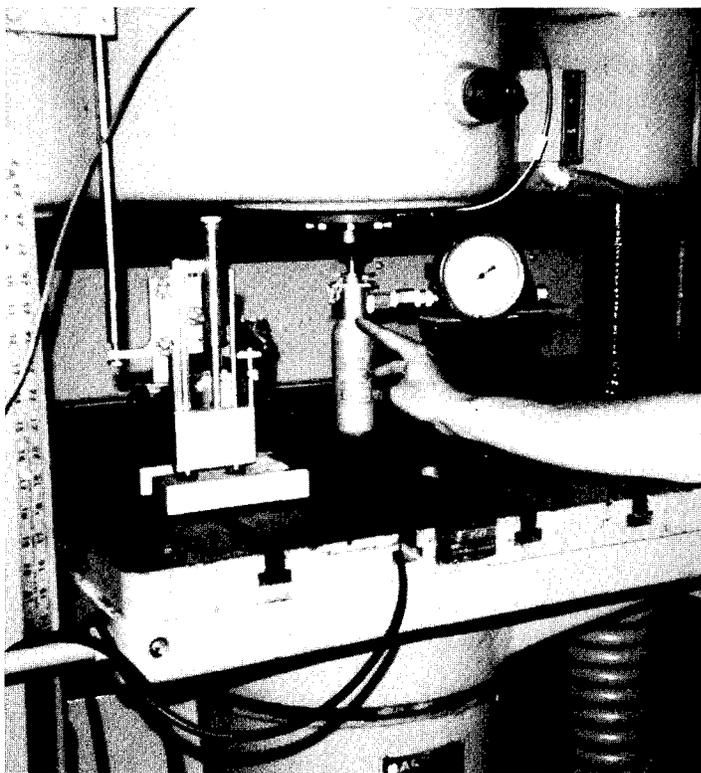
Figure 23 CARTRIDGE SEAL PENETRATION TESTS

Because higher-than-anticipated forces were encountered, the design being considered would require a larger solenoid. Shocks would also require a large retaining spring be used if the solenoid core were used to puncture the cartridge.

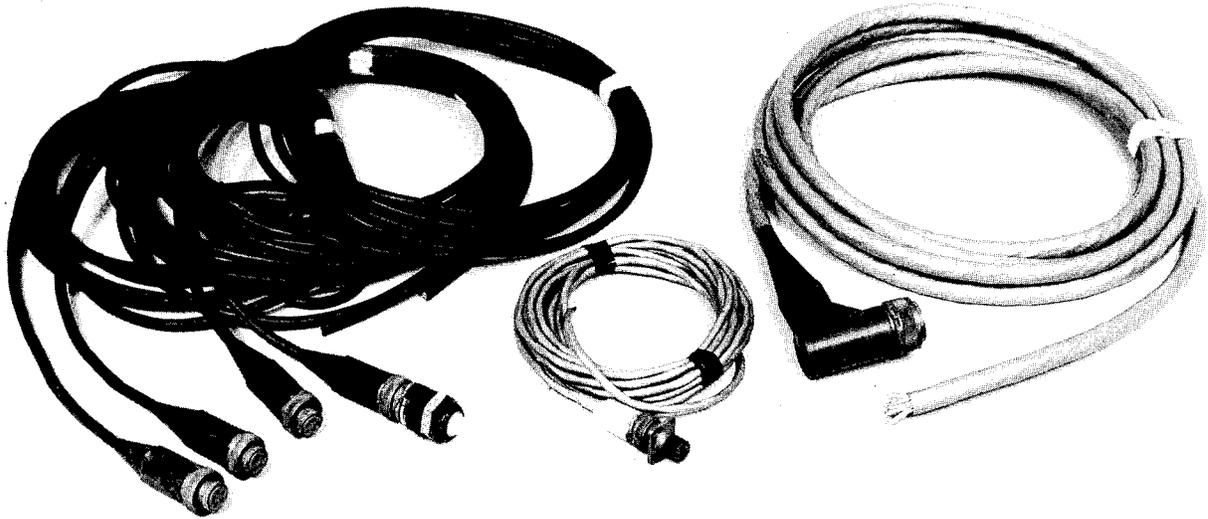
Figure 25 MOLDED CABLES (FMC Photo 66526)

Sample cables are shown in Figure 25. Specially molded cables are used in Systems I, II, III, and V in connections to ambient thermistors and optical sensors and to interconnect the main control panel to a remote junction box. The cables provide improved reliability in harsh mine environments, a definite requirement determined from problems encountered in previous Bureau of Mines contracts.

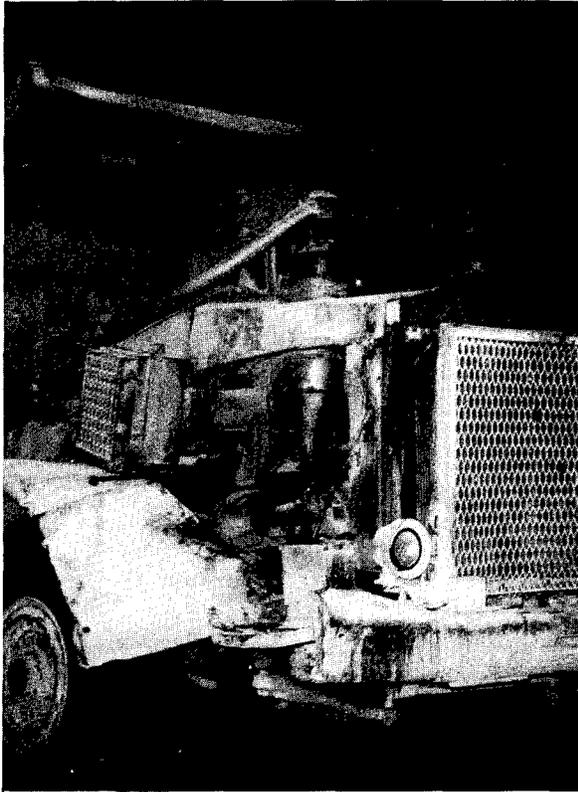
Figure 29 EUCLID TRUCK
(Heat-Sensing Wire
Under Engine Hood)

After installing all components, it was learned that the vehicle electrical system ground was positive and the system was not compatible with the negative-ground automatic fire sensing system. No explanation existed, because the vehicle maintenance manuals and drawings indicated the vehicle was designed for negative ground.

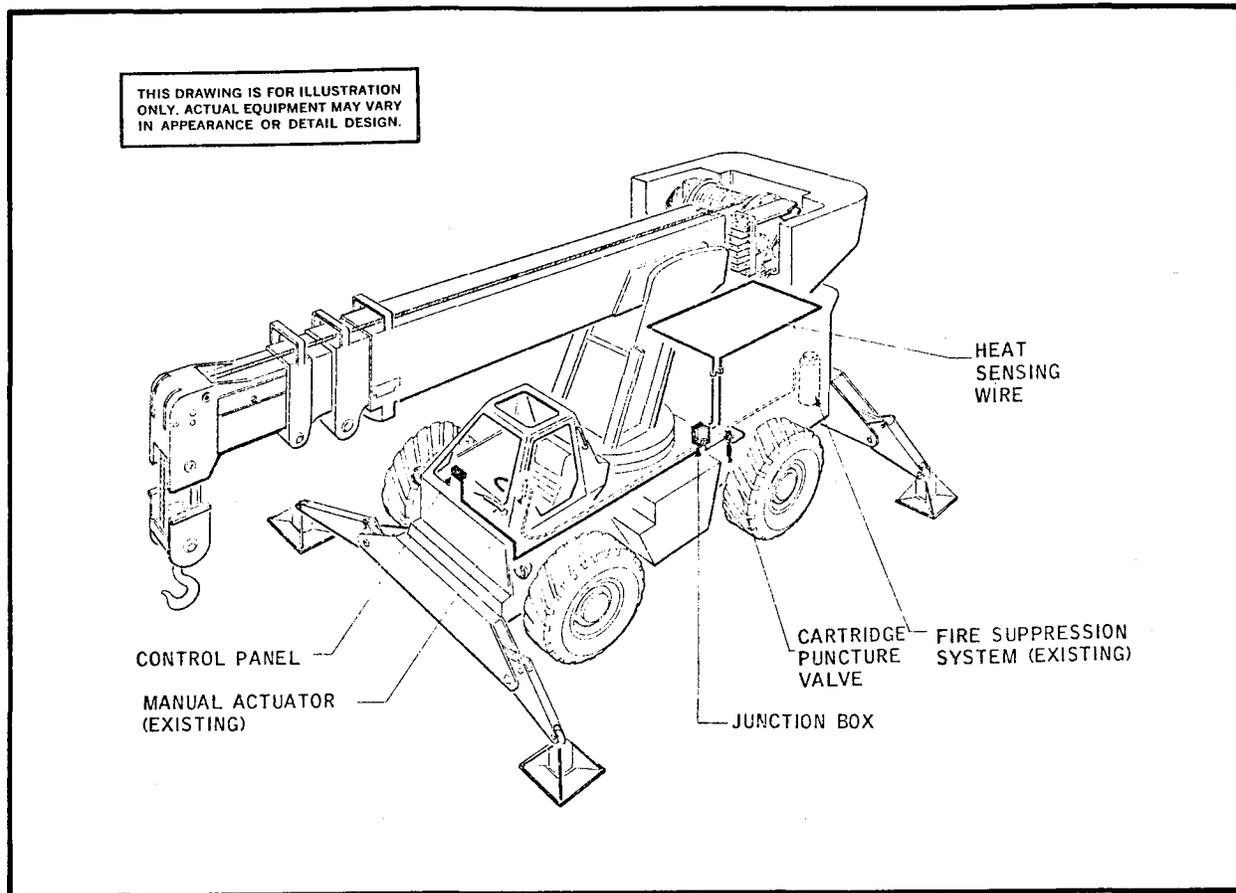
Figure 37 ARTIST'S CONCEPT, SYSTEM V INSTALLATION ON GALION 125A CRANE

Figure 37 depicts the installation of System V on a Galion 125A crane.

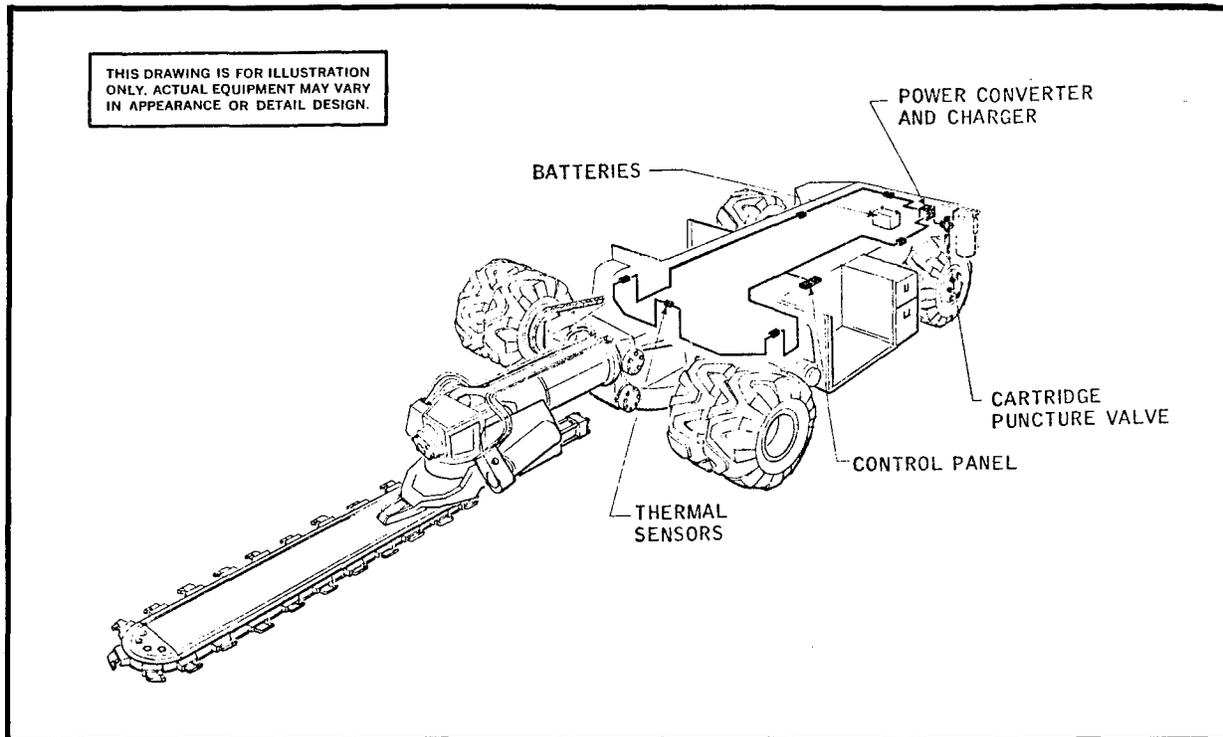
Figure 44 ARTIST'S CONCEPT, SYSTEM V INSTALLATION ON GOODMAN 2500 CUTTER

depicted in Figure 44. The isolated batteries on this vehicle again were the small Delco 349 units, rated at 32 ampere-hours. As with the crane, the larger MF-type batteries were later installed.

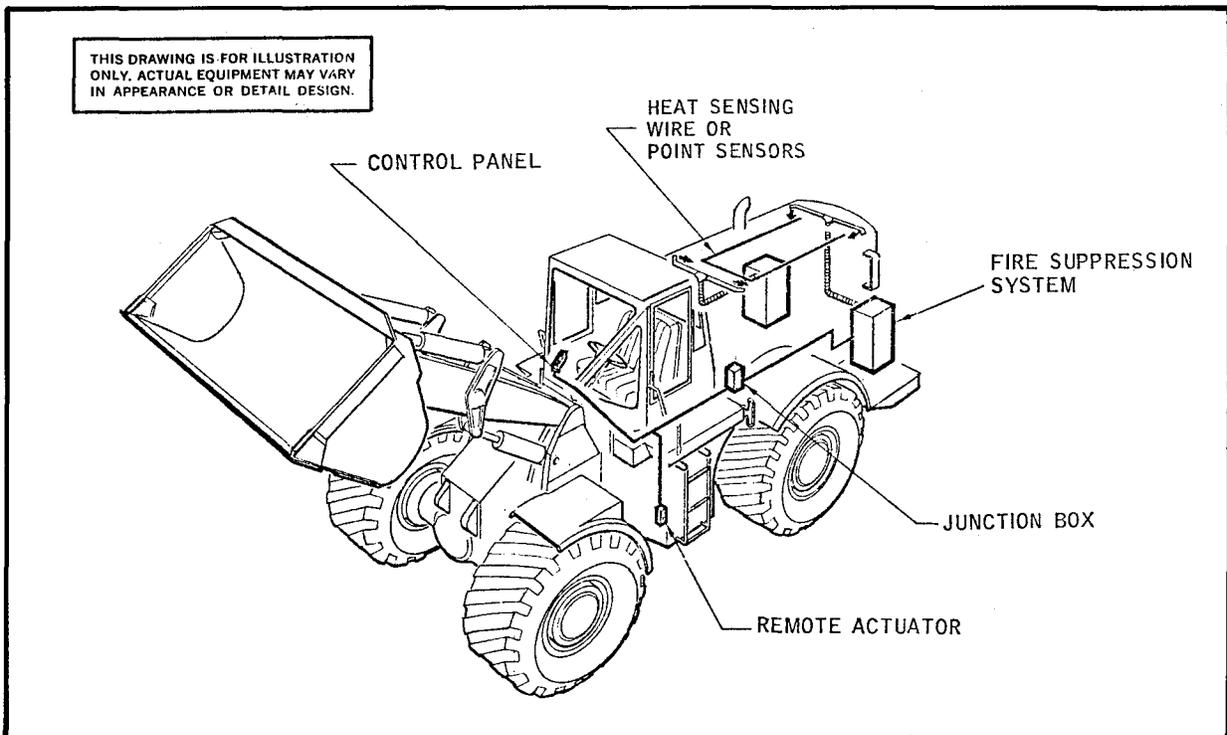
Figure 60 ARTIST'S CONCEPT, SYSTEM II INSTALLATION ON CATERPILLAR 992 FRONT-END LOADER

Difficulty was again experienced with vehicle availability, and the fire system installation on the Caterpillar loader was not fully completed during the February visit. System II, used for this installation, is described in Subsection 3.5.2 and illustrated in Figure 12. Figure 60 depicts System II installed on Caterpillar loader.
