**DEVELOP GROUNDING
PRACTICES
FOR
METAL/NON-METAL MINES**

Bureau of Mines Open File Report 154-81

Contract J0308025
West Virginia University

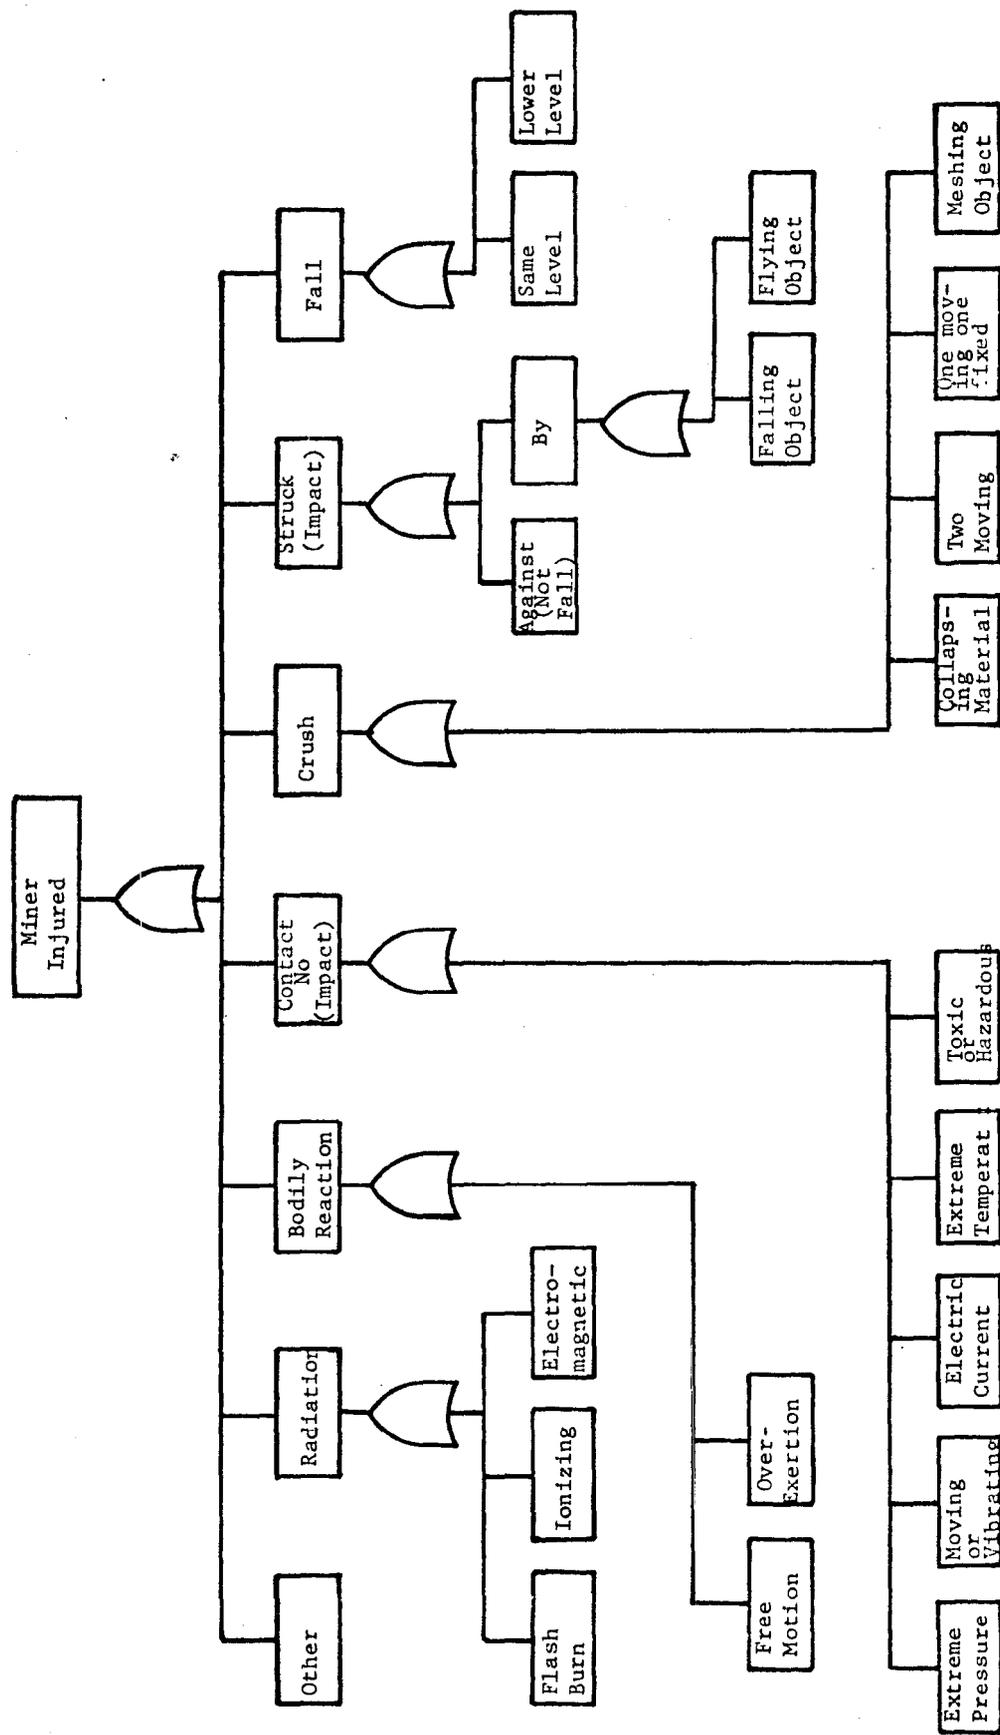
FIGURE 2.1. - Mine accident tree.

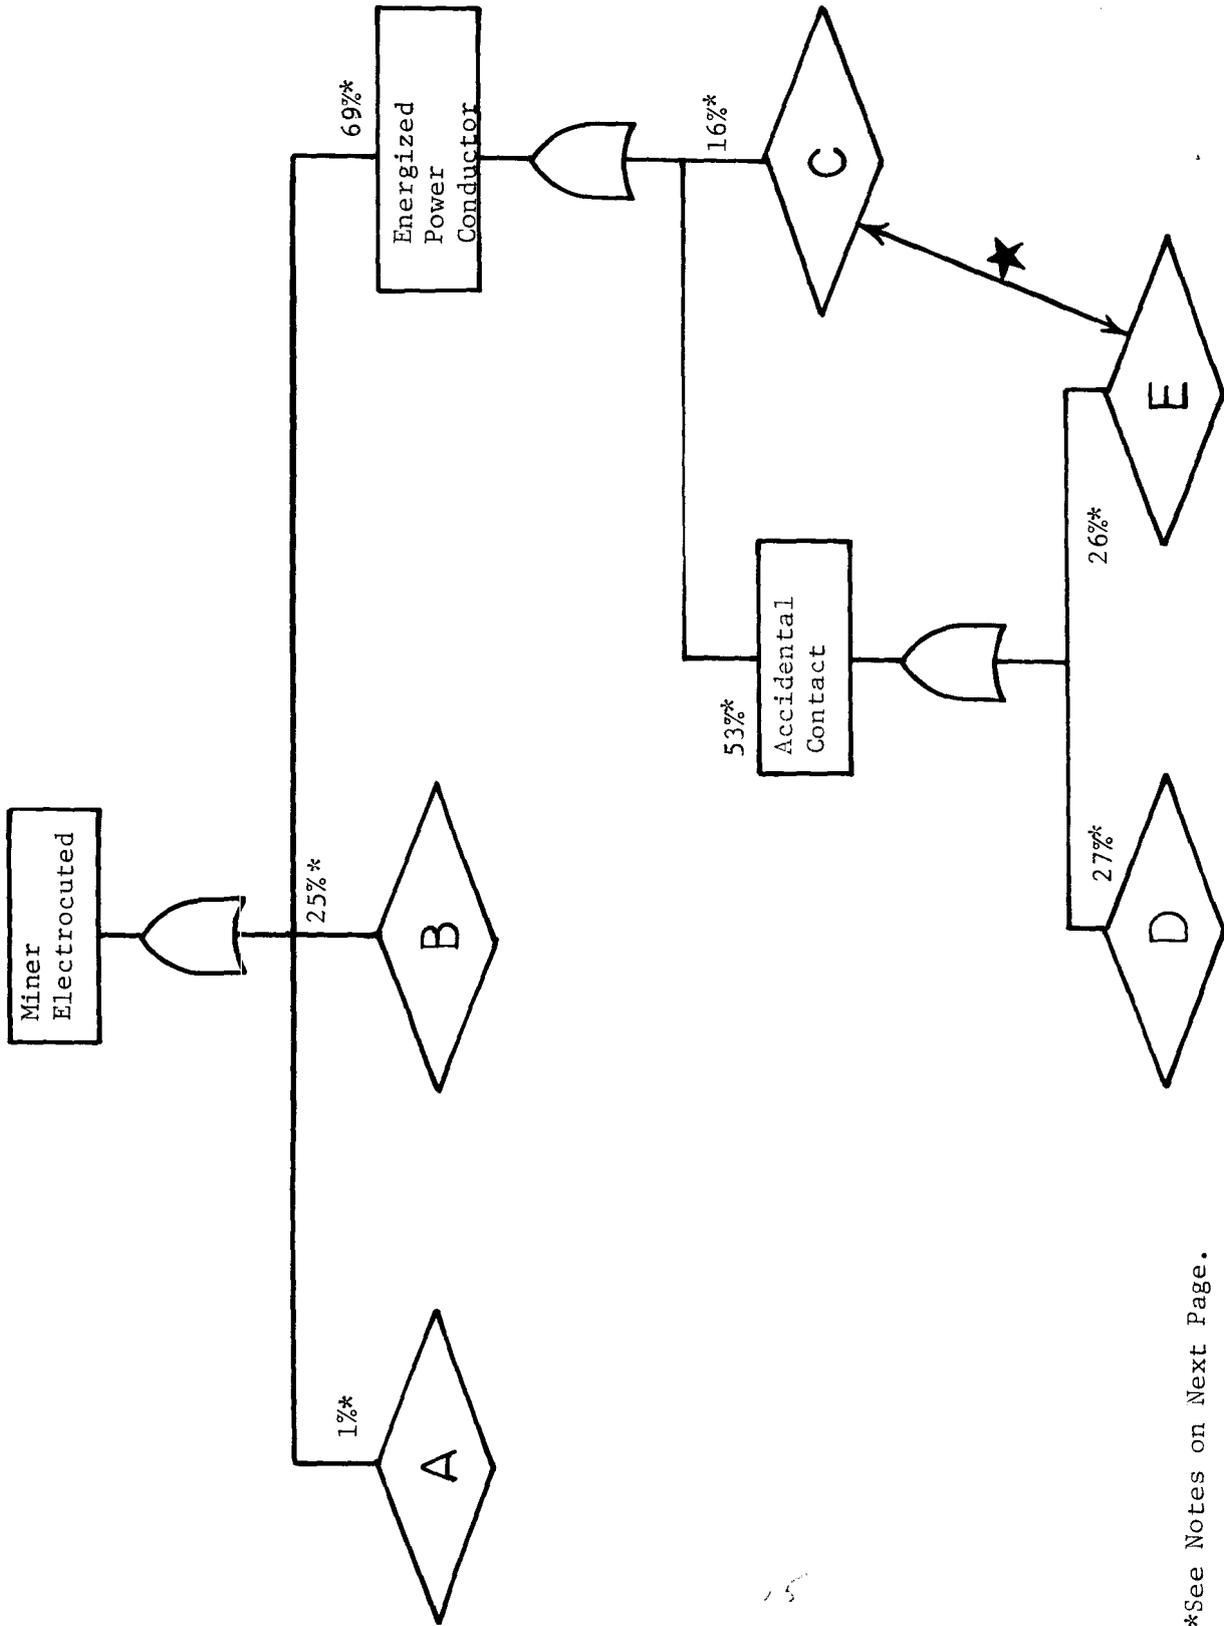
FIGURE 2.2. - Mine electrical fatality event tree.

- A. Shock caused by current flow as the result of voltage gradients in non-metallic objects.
- B. Shock caused by touching normally unenergized portions of equipment to which a fault has occurred from wiring normally associated with that equipment.

- C. Shock caused by purposefully contacting directly or via a tool a conductor which would normally be energized. Purposefully contacting the insulation of an energized conductor, which insulation proves to be defective, is herein classified.

- D. Shock caused by inadvertently and indirectly contacting an uninsulated power conductor via a conducting object such as a vehicle body, unconnected pipe, or other metallic object which would ordinarily be assumed to be at ground potential.

A review was made of the known activities of mine personnel with respect to electrical equipment or equipment which could become energized. These activities were used to generate a graphical description of the possible events surrounding those types of accidents which occurred in the mining industry. Figure 2.1 shows a diagram of the broad classes of accidents which can occur based on MSHA accident categorization techniques. Most of these accidents are not electrical. Electrical accidents appear mainly in two categories, radiation (flash burn), and contact-no impact (electric current, extreme temperature). Several other categories might contain a few electrical accidents. Since electrical accidents appear in at least two distinct categories, but are not the only type of accidents which occur in these categories, the MSHA classification scheme was dropped in favor of our own. An example of an event tree for electrocution-type fatal accidents only is shown in Figure 2.2.

It turned out that all of the electrocutions studied (essentially all fatal electrical accidents are electrocutions) could be broken down into the small number of categories shown in Figure 2.2. When the 96 electrical fatalities which occurred from 1970 through 1979 were analyzed, about 24% of them appeared to be attributable to energized equipment frames. Table 2.1 gives a short description of each of these accidents and an indication of the category (from Figure 2.2) into which it was placed.

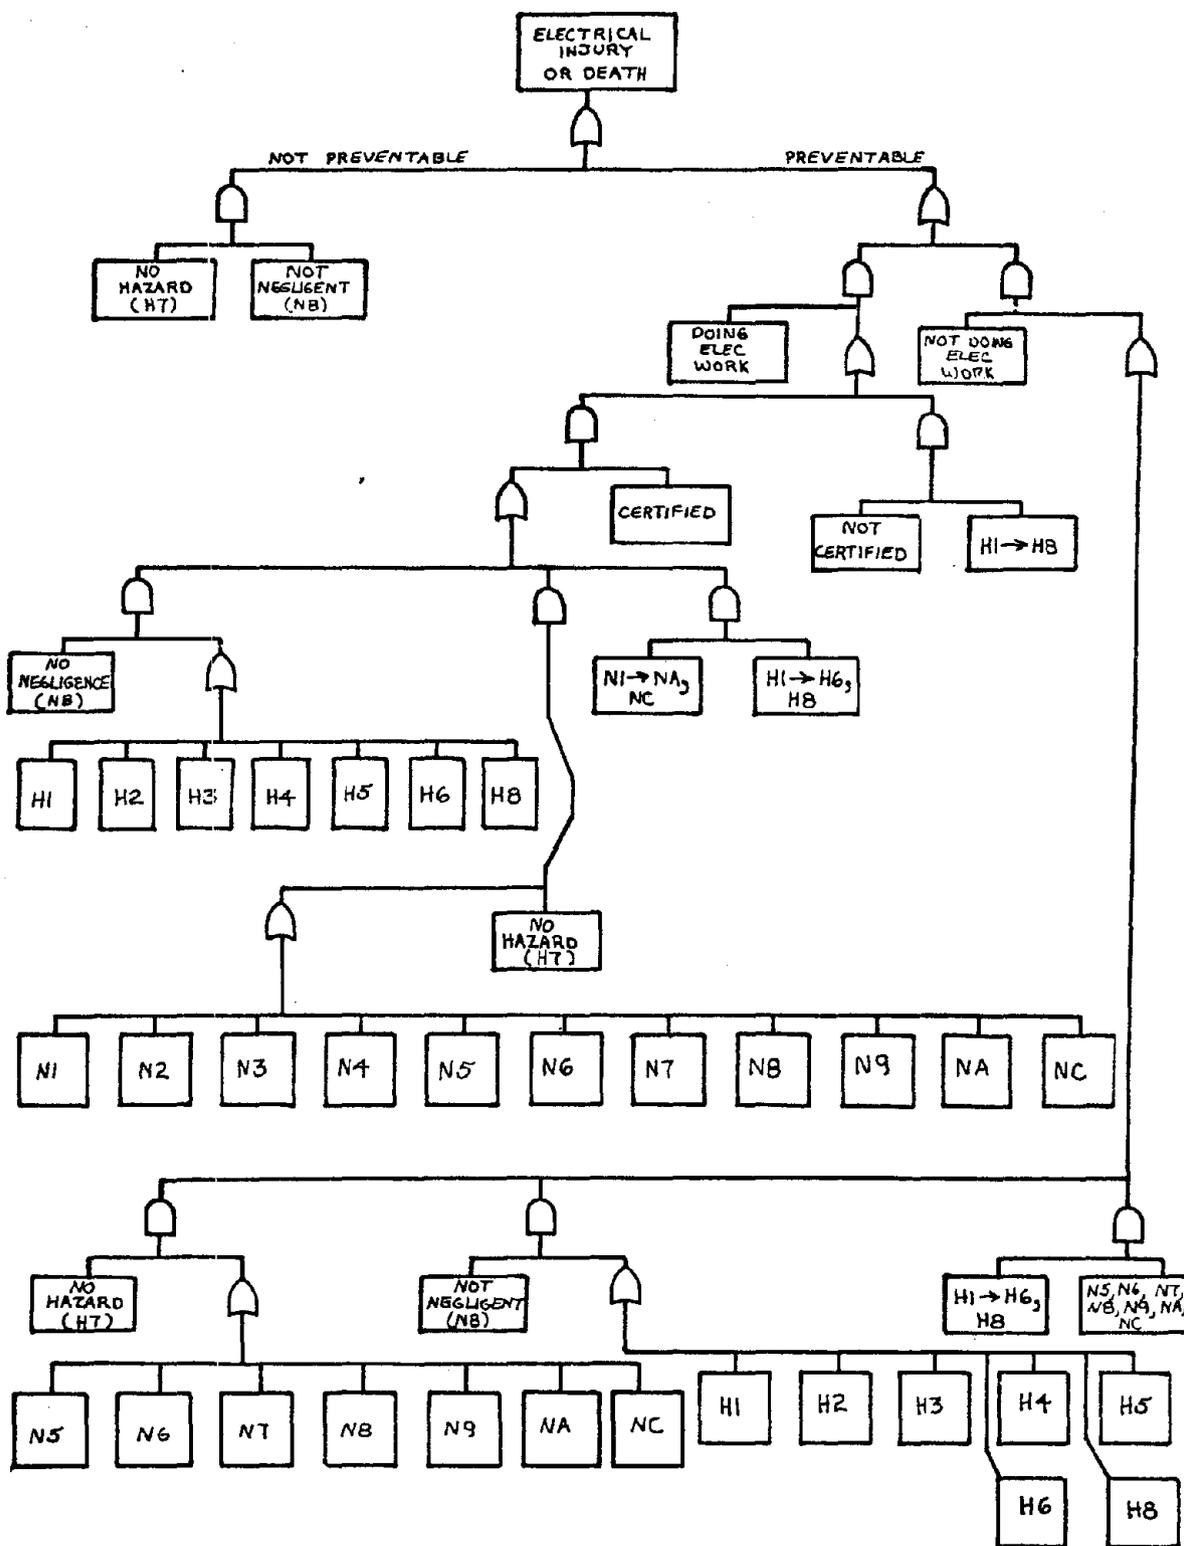
FIGURE 2.3. - Detailed electrical accident event tree.

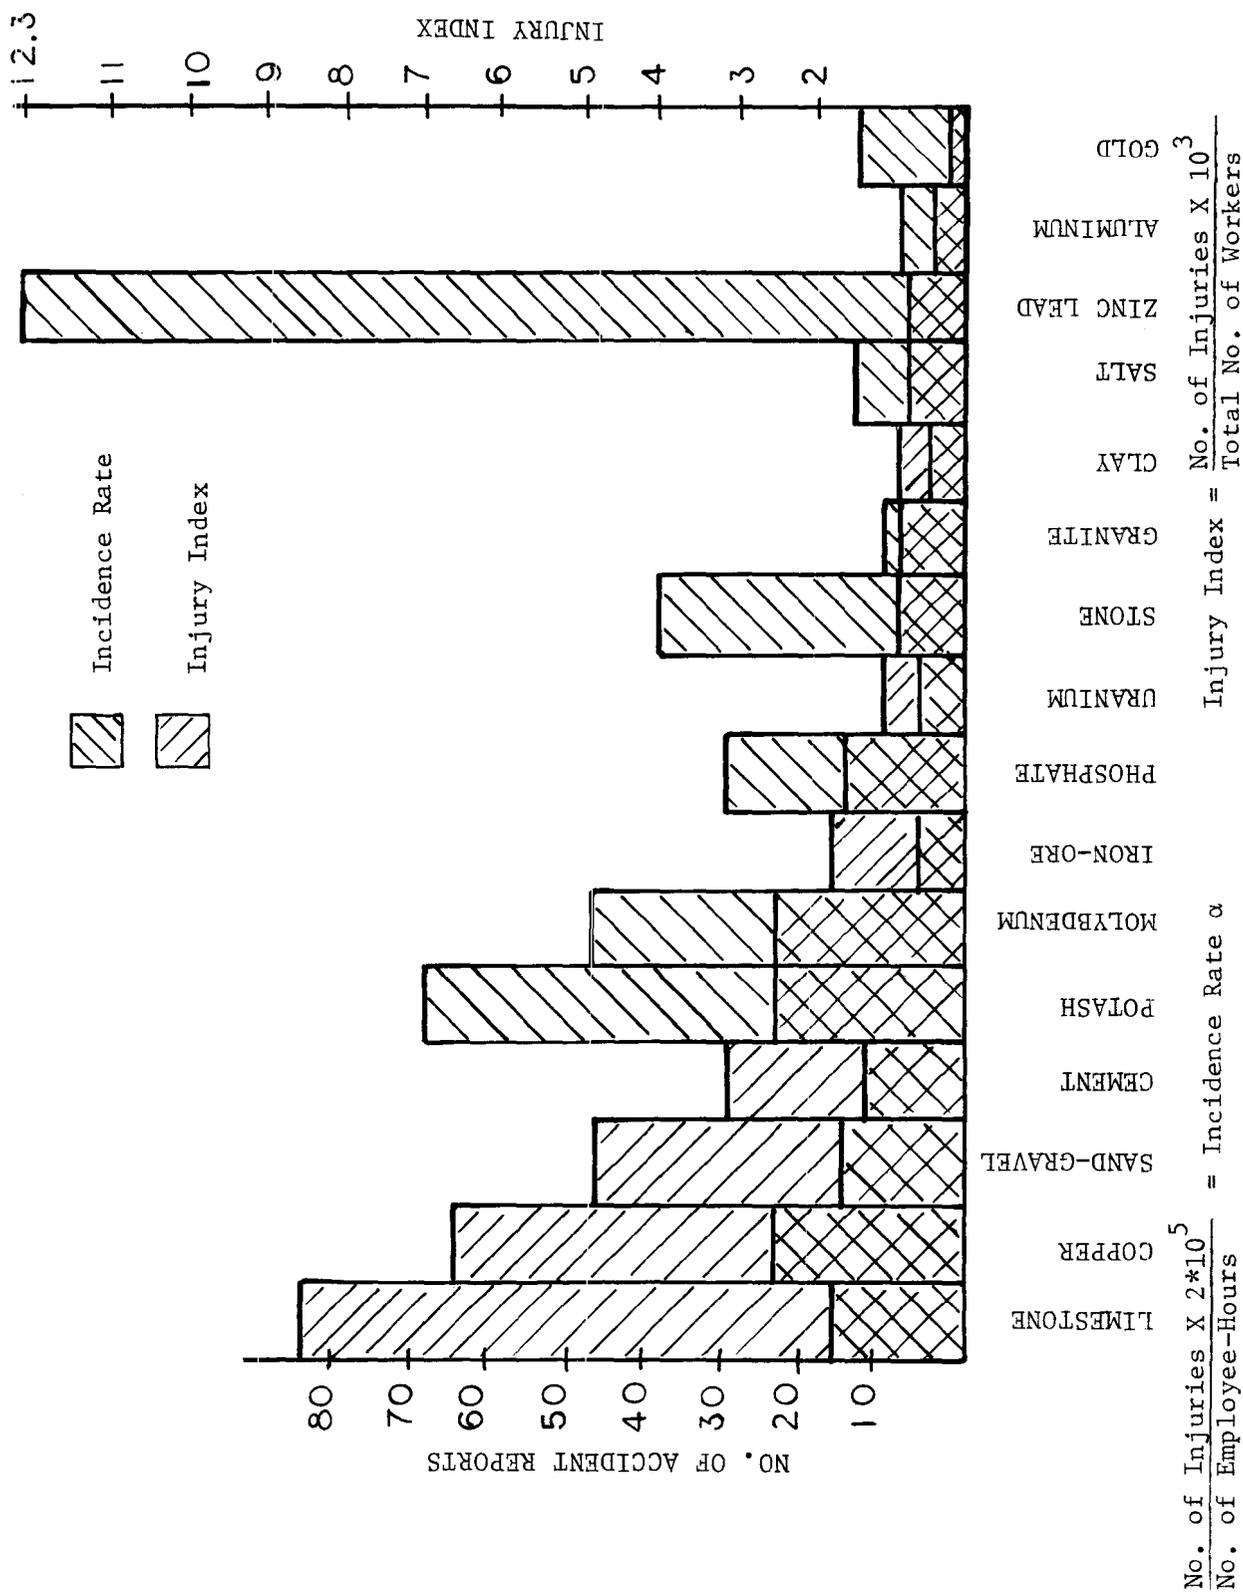
FIGURE 3.2. - Injury index and number of accident reports vs industry type.

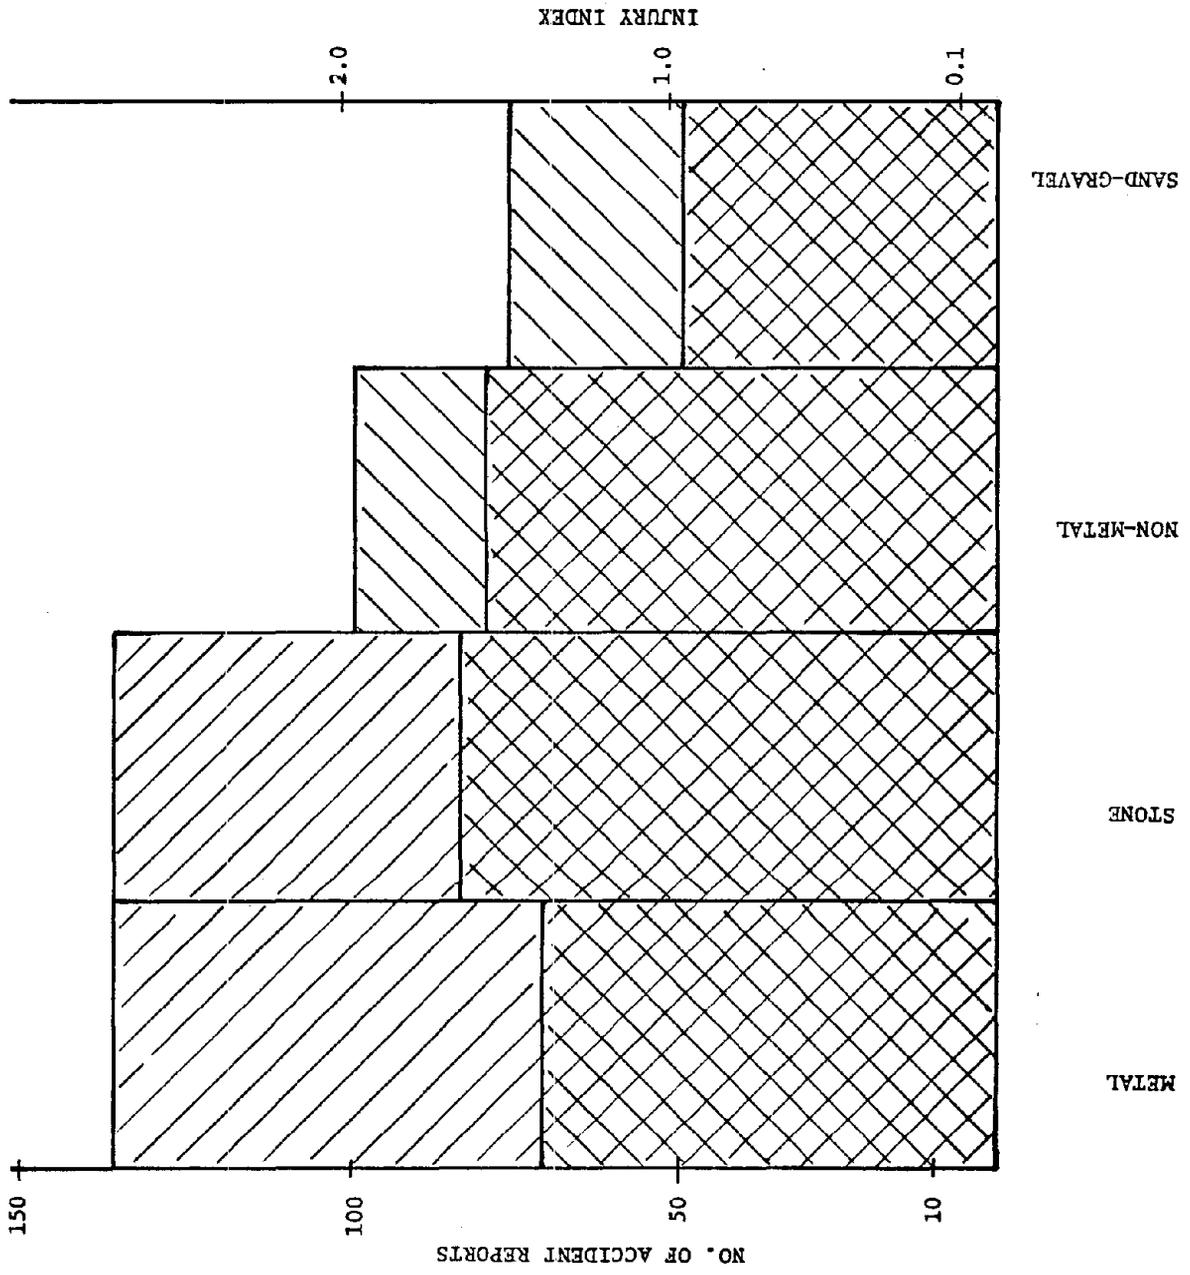
FIGURE 3.3. - Injury index and number of accident reports vs industry type.

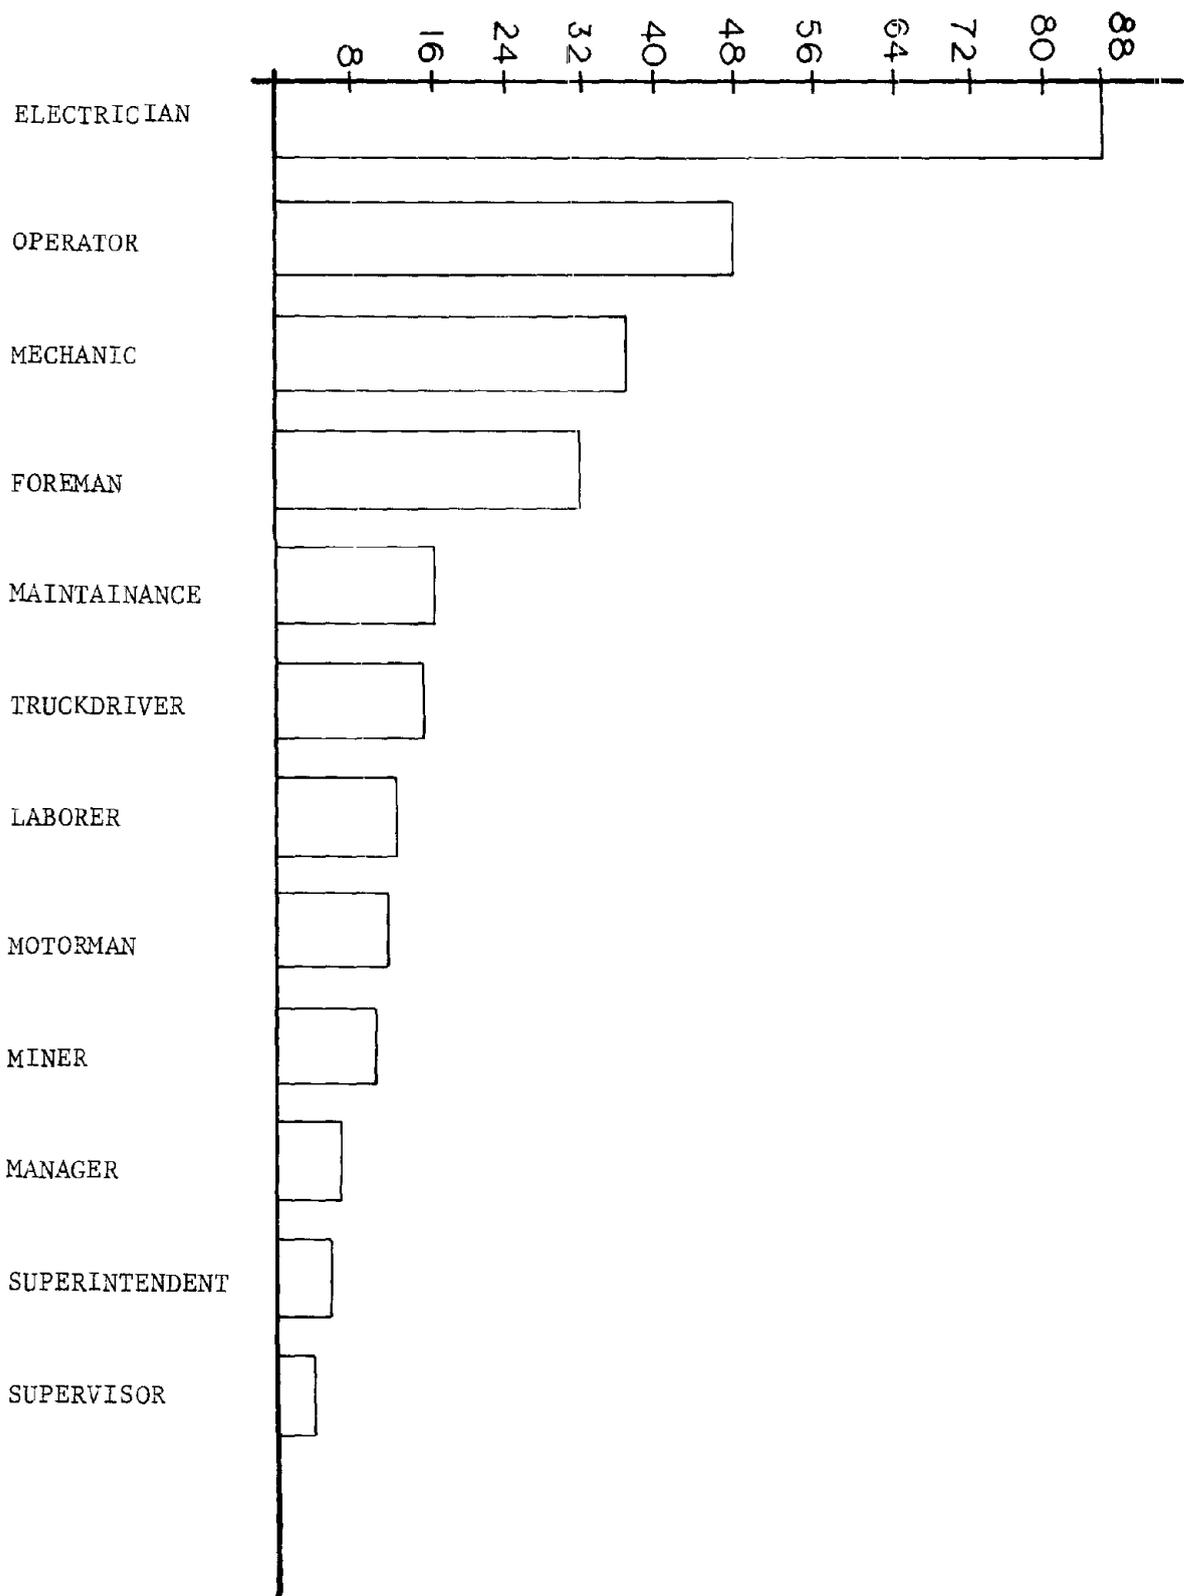
FIGURE 3.4. - Non-fatal electrical accidents for various job titles.

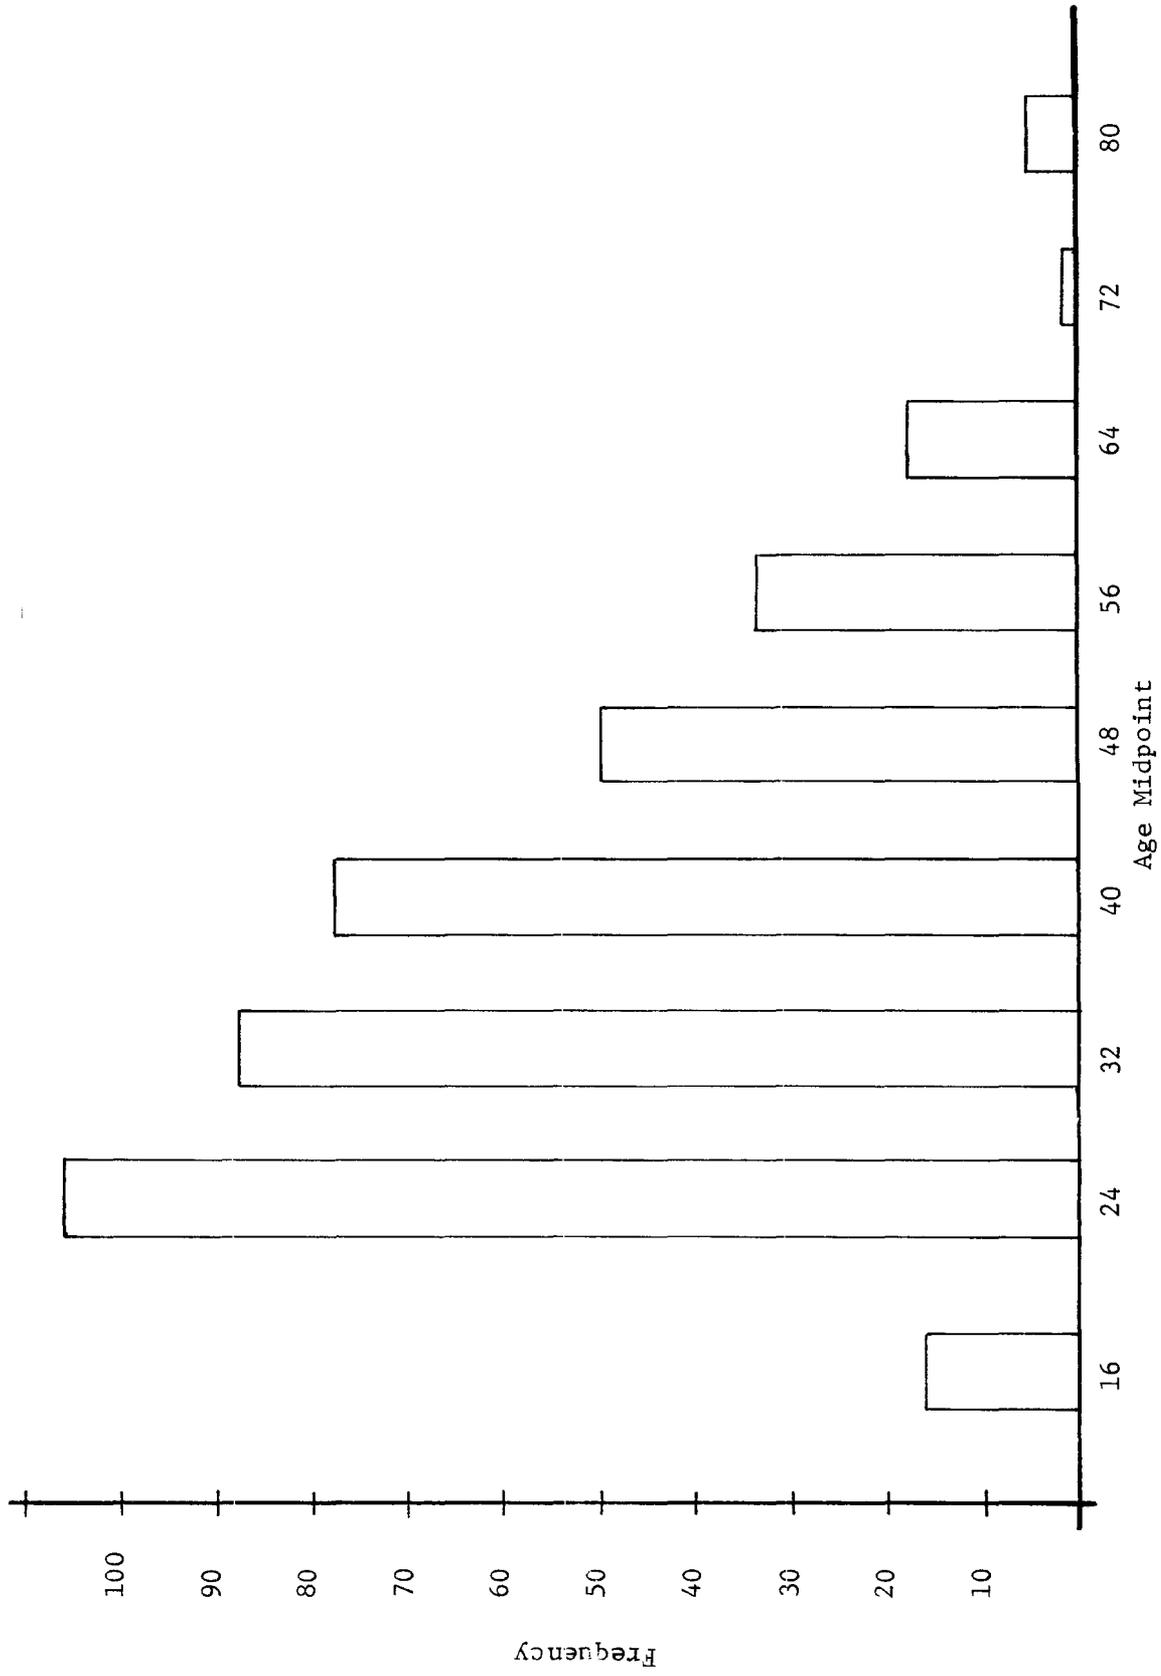
FIGURE 3.5. - Electrical accidents versus injured age.

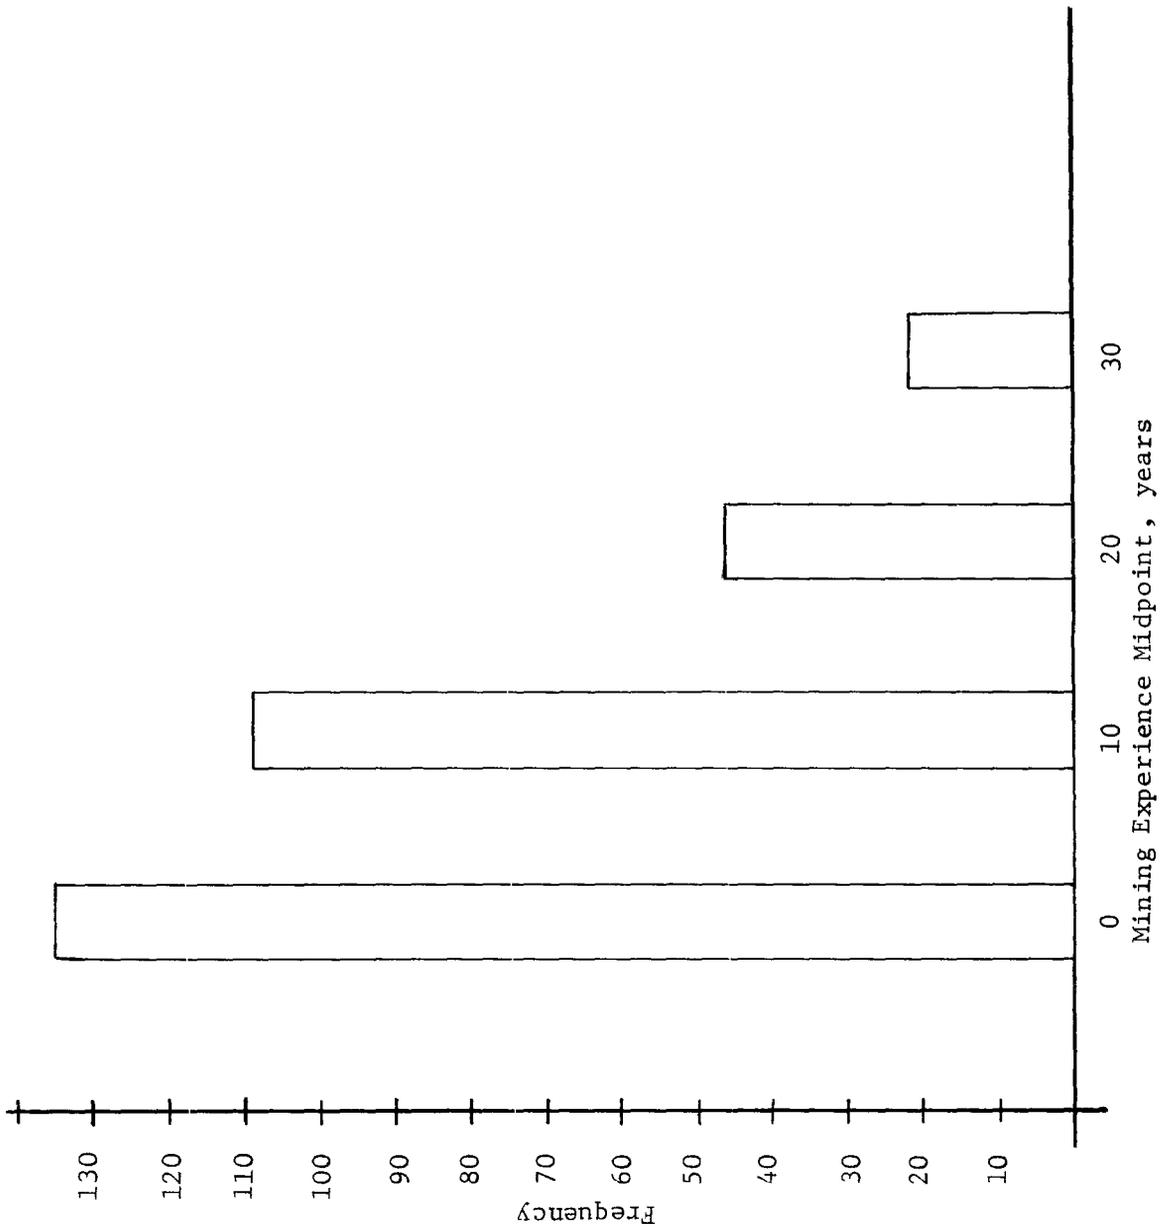
FIGURE 3.6. - Accident rate versus mining experience.

Figures 3.6 and 3.7 show the detail. As expected in both cases, the higher the experience the lower the chances of an accident. Table 3.19 and 3.20 summarize the study.

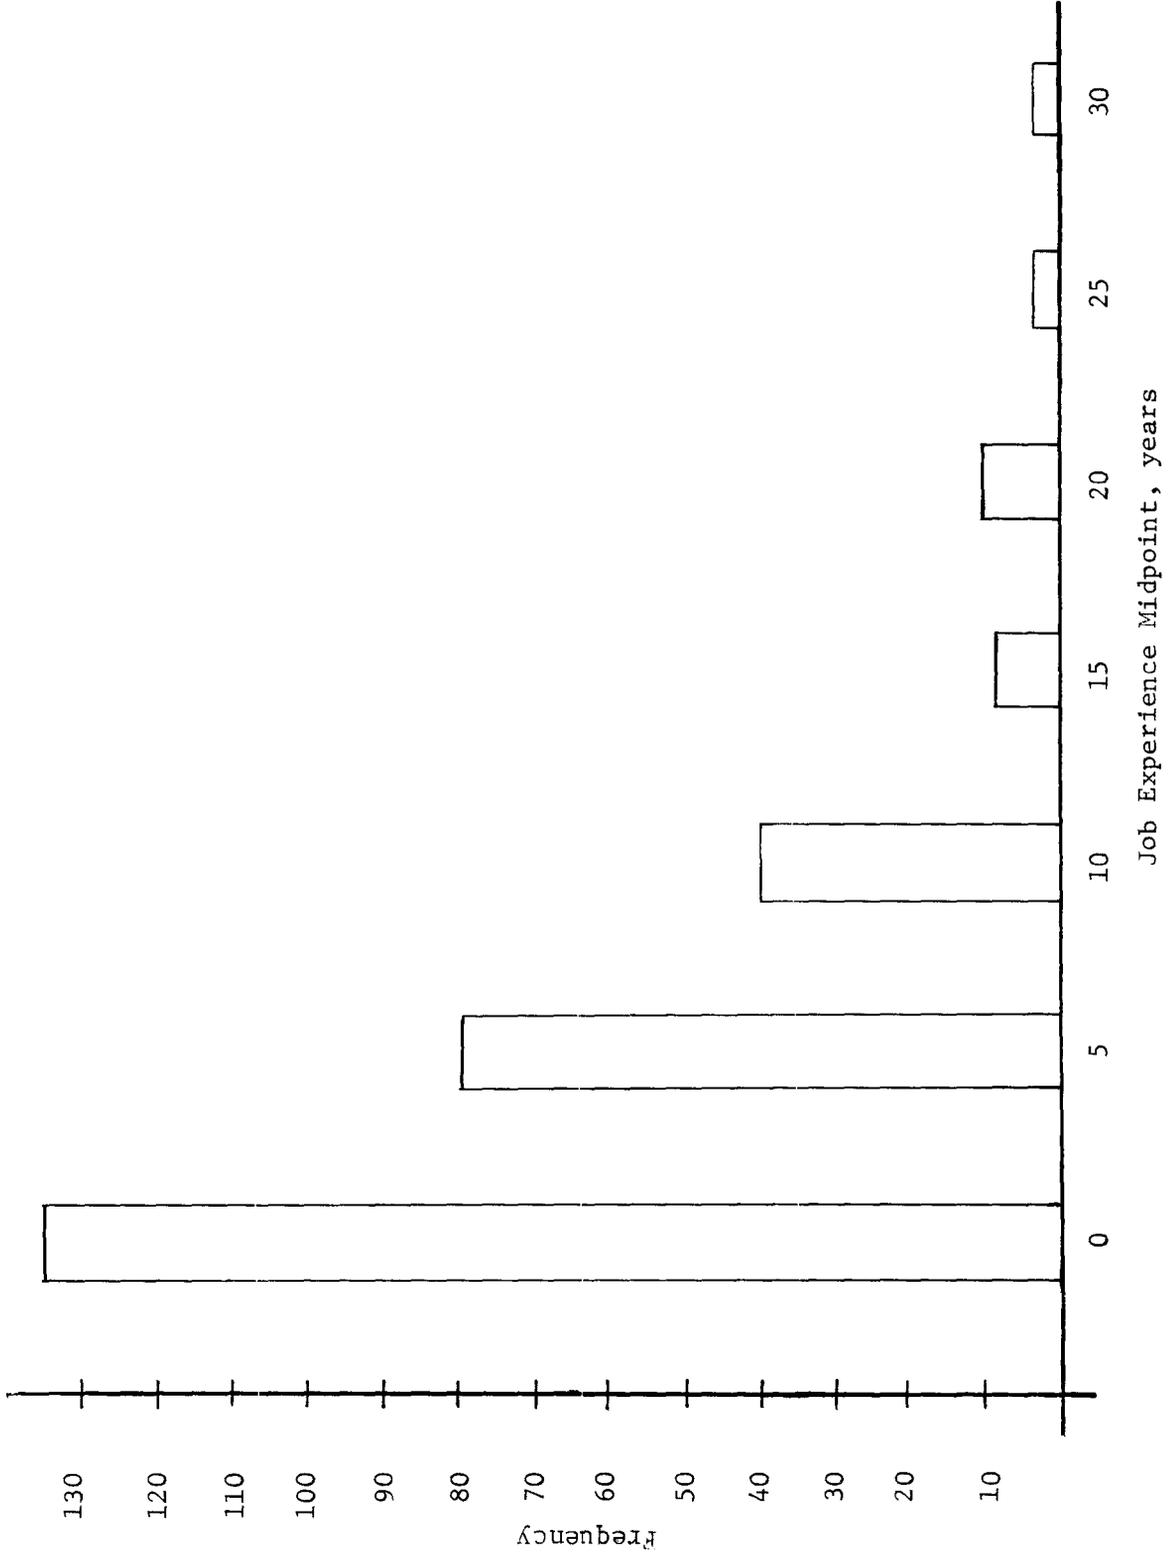
FIGURE 3.7. - Accident rate versus job experience.

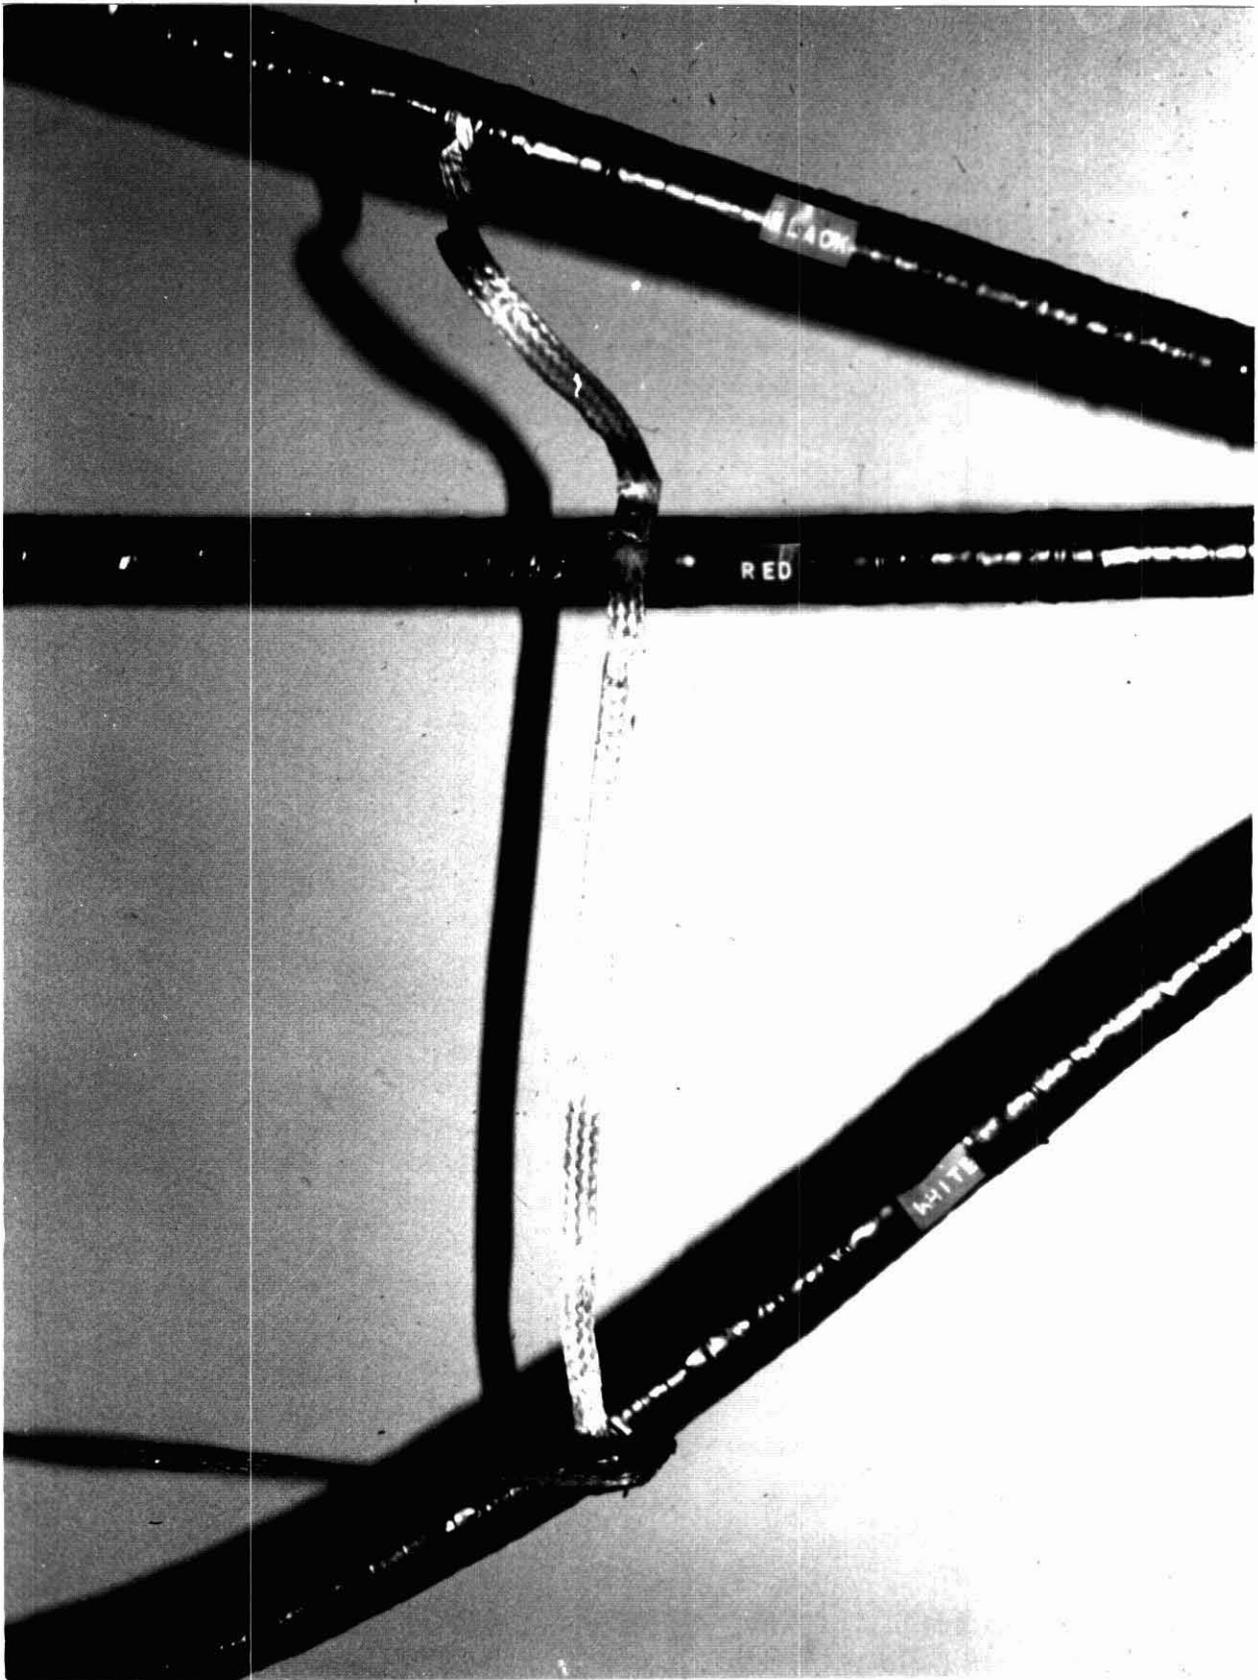
FIGURE 4.1. - 4160 V shielded trailing cable in underground phosphate mine.

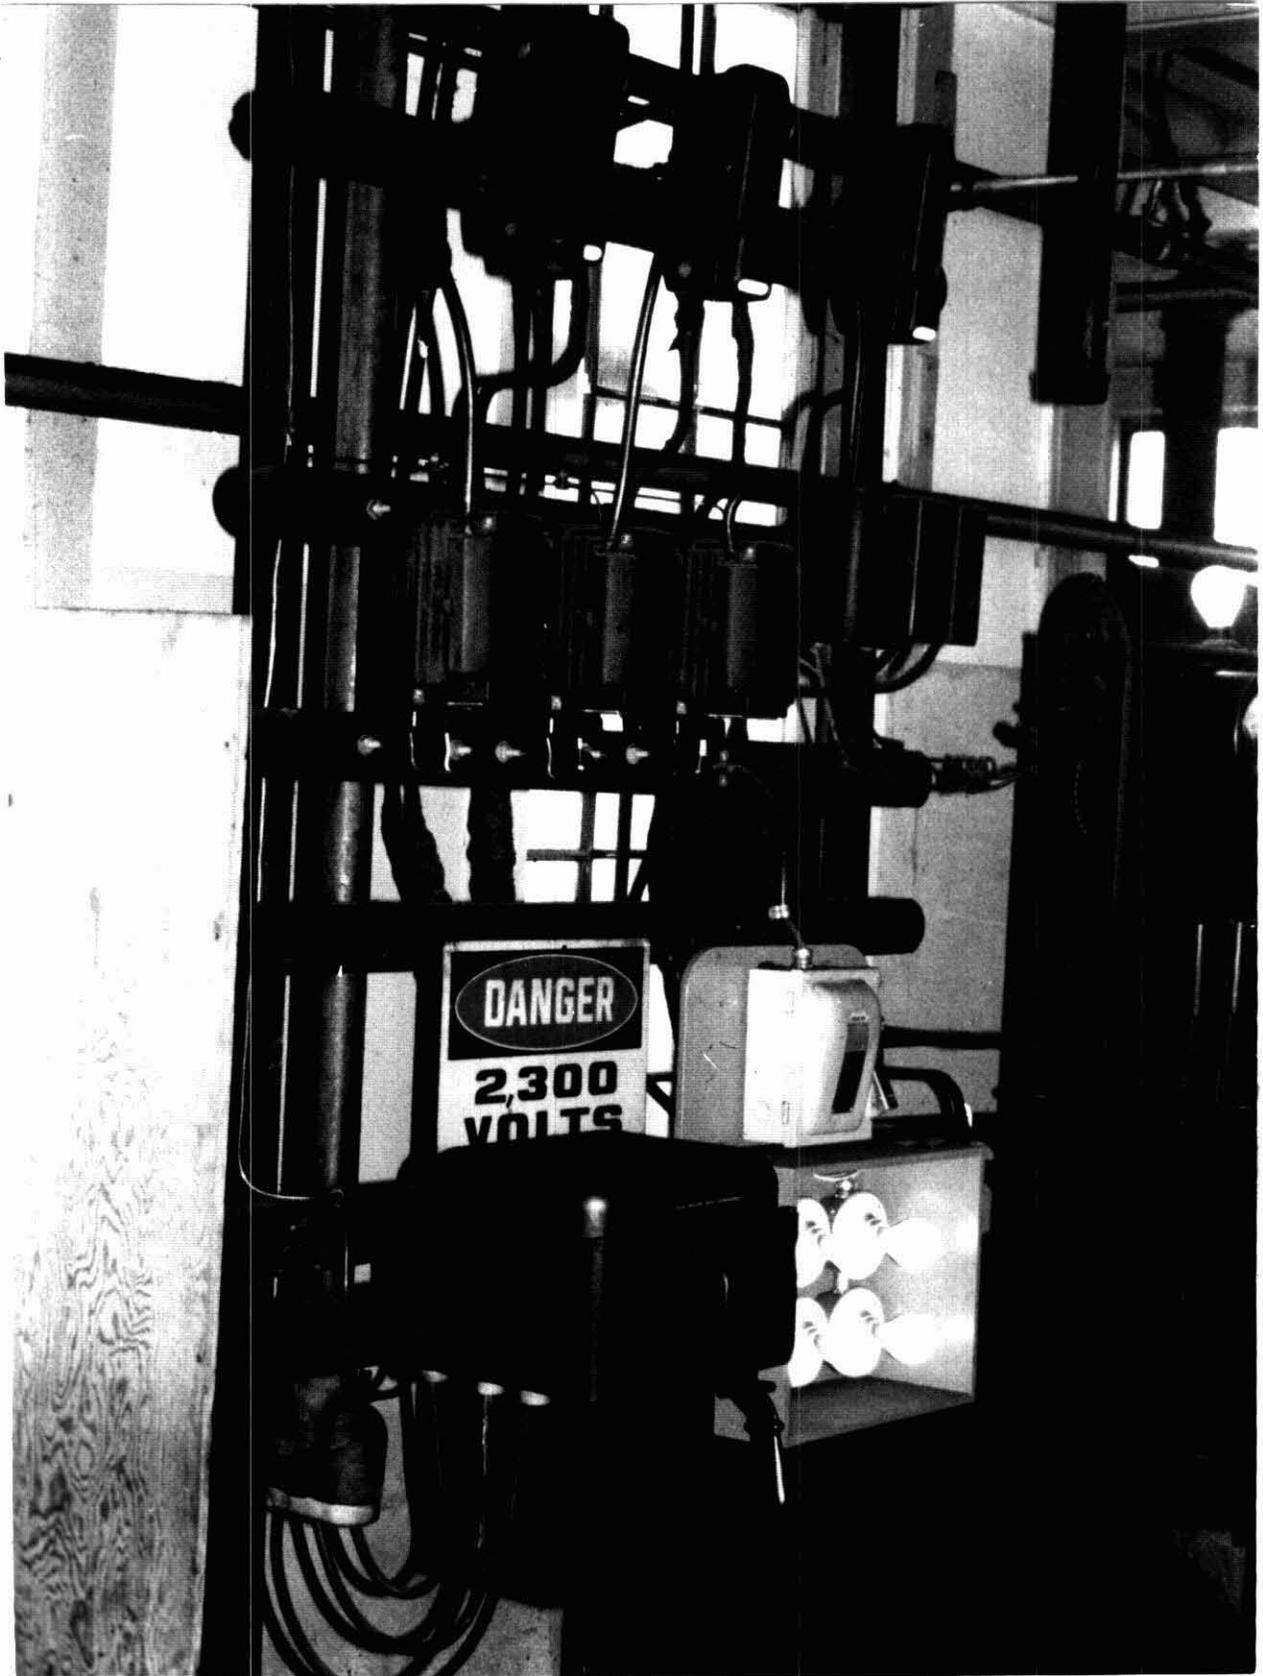
FIGURE 4.2. - Ground indicating lights in granite quarry.
