**DEVELOP GROUNDING
PRACTICES
FOR
METAL/NON-METAL MINES**

Bureau of Mines Open File Report 154-81

Contract J0308025
West Virginia University

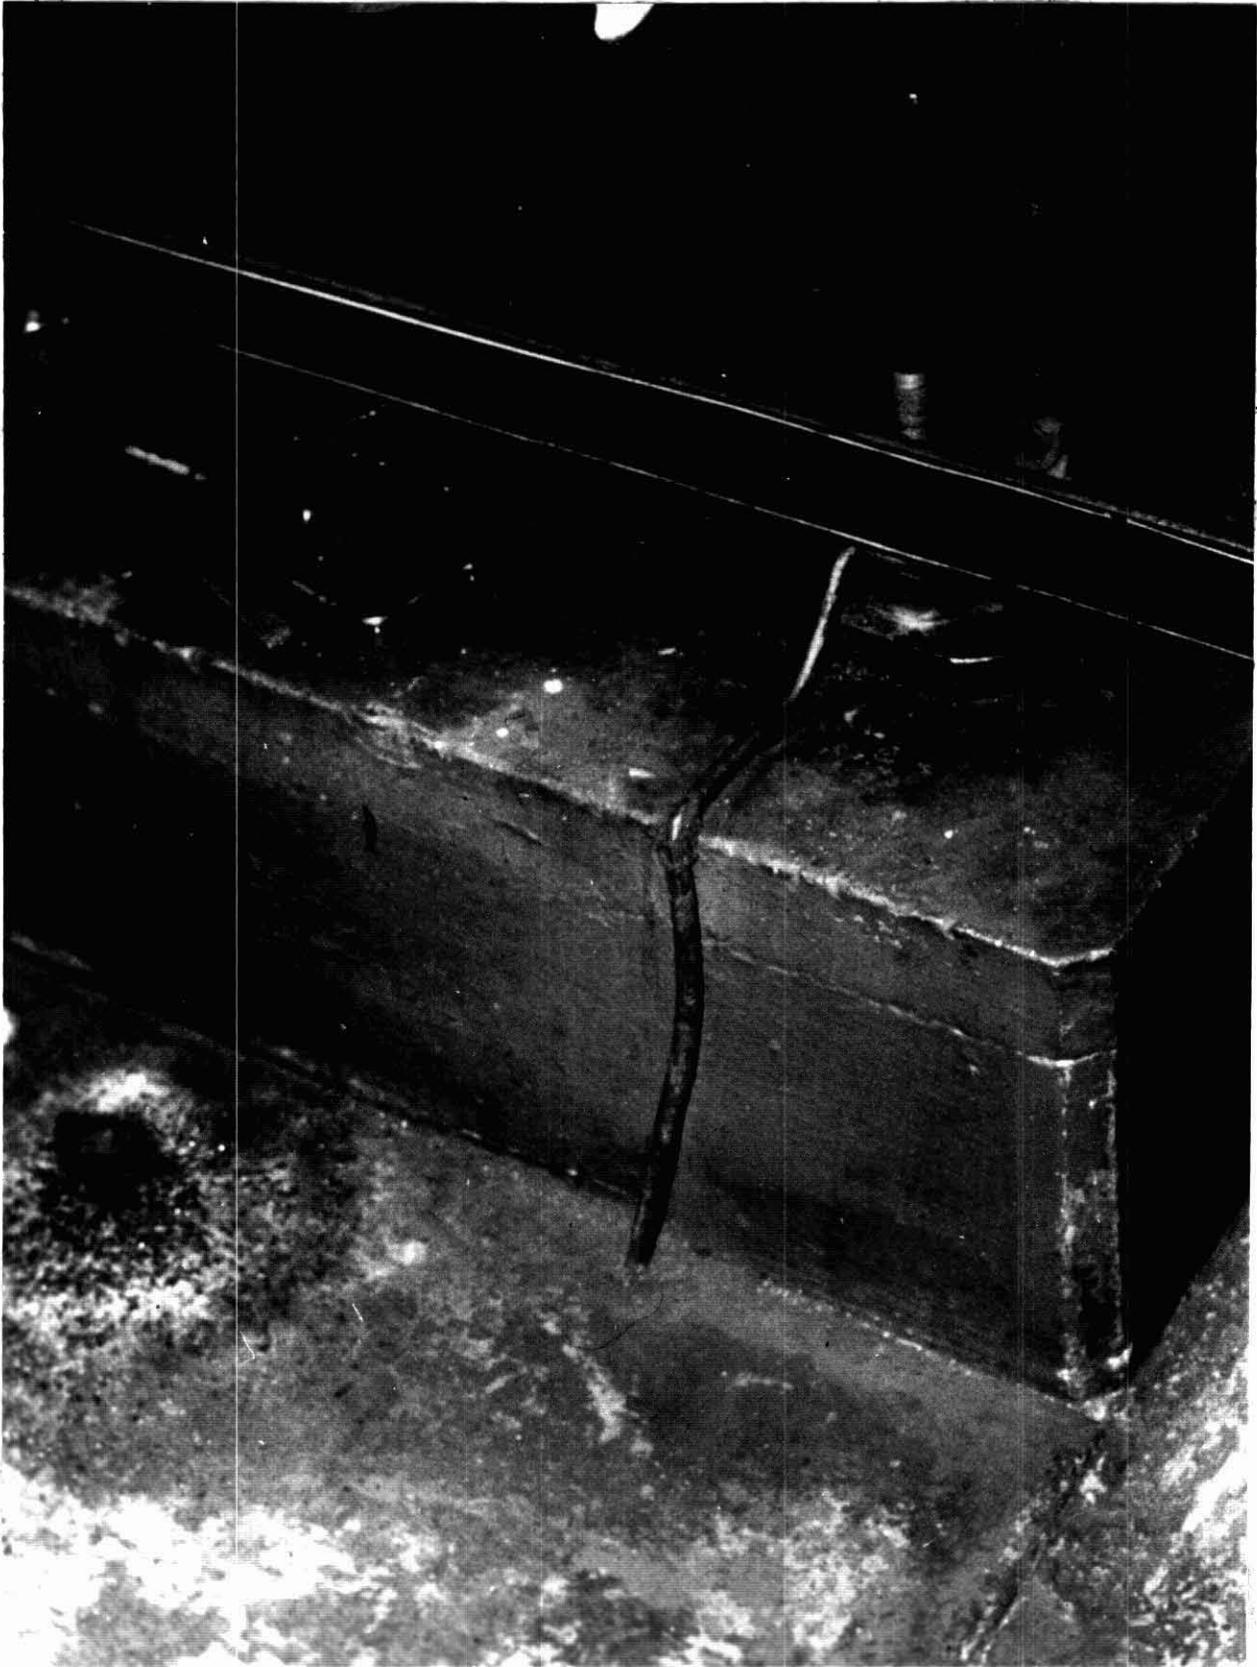
FIGURE 4.3. - Motor frame grounded to building steel in uranium mill.

Heavy copper pigtailed extend from the building steel to the frame of each motor to provide grounding in most plants as shown in Figure 4.3. In addition, the 480 V wiring is usually run in metal conduit which is often used as an additional ground conductor, and which is eventually bonded to the substation ground bed. Conduit ground conductors can be excellent, low-resistance paths if continuity is assured at each union and flex coupling, as shown in Figure 4.4, and if vibration is not a problem. However, in some installations which use shaking screens for size separation, particularly in sand and gravel or dredge plants, vibration may be so severe that conduit can literally be shaken to pieces. In these instances, conduit does not make an adequate frame-grounding conductor.

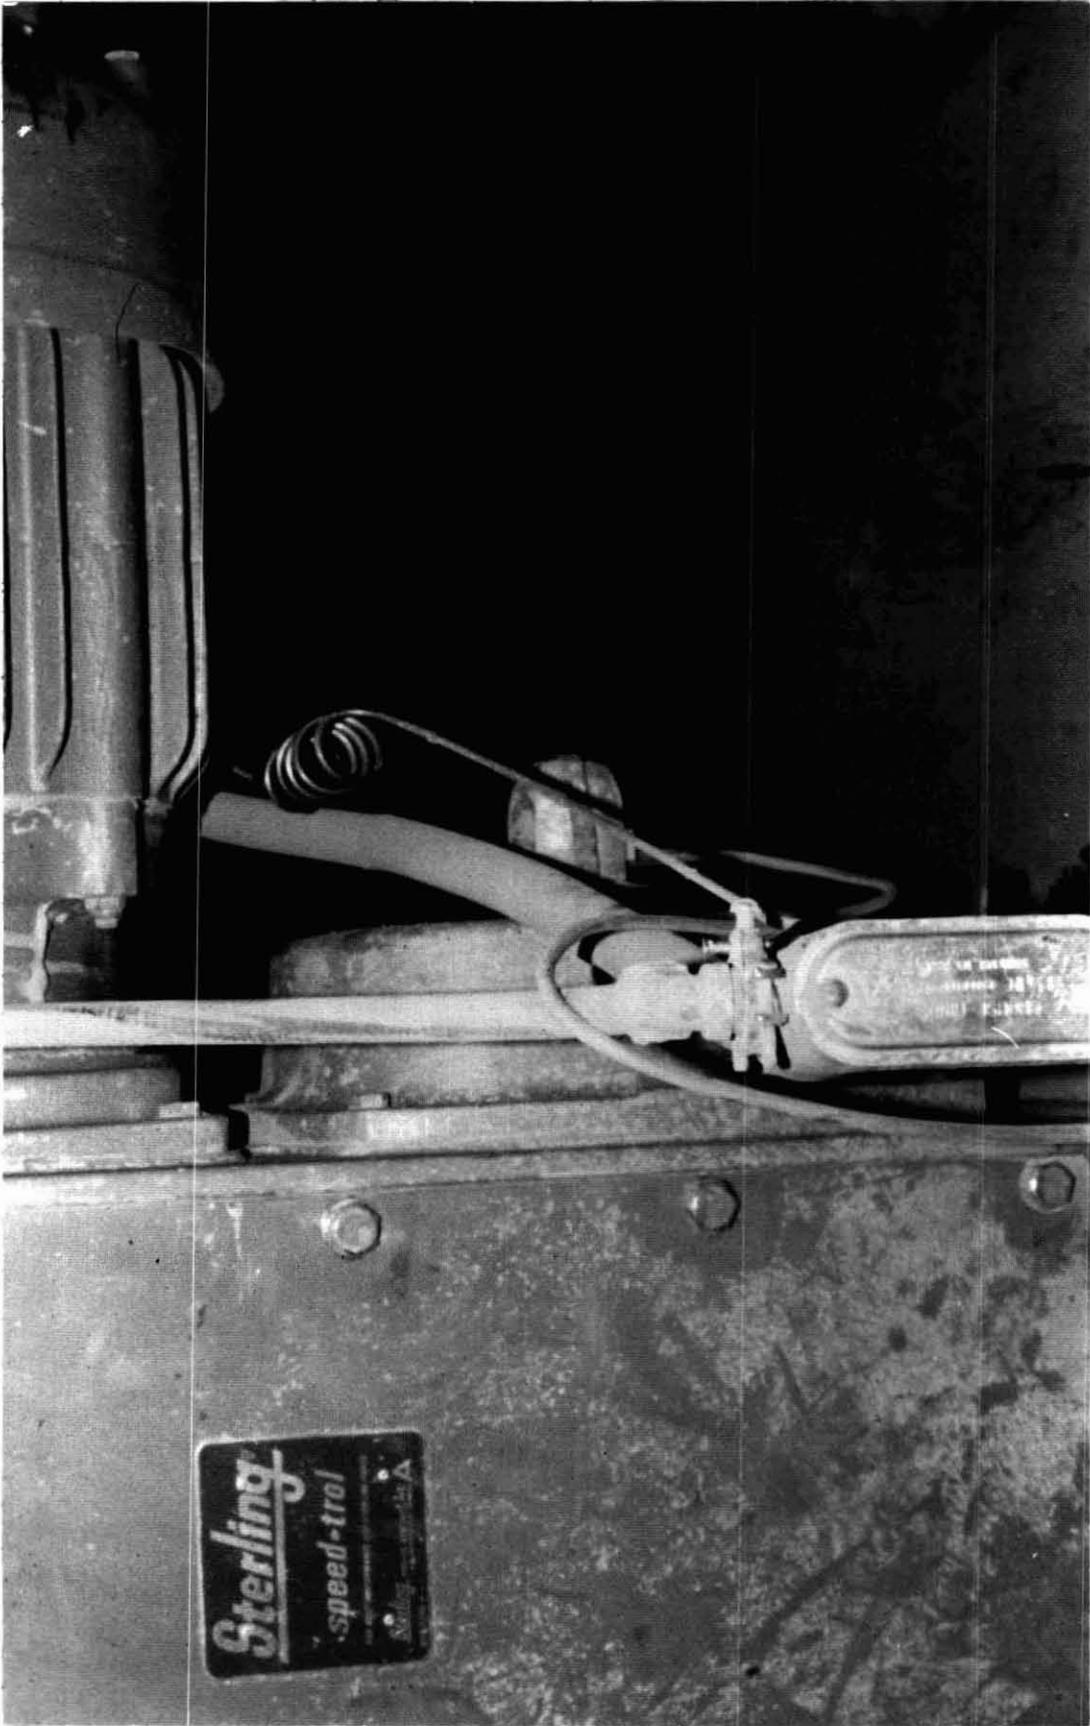
FIGURE 4.4. - Conduit and jumper used as ground in uranium mill.

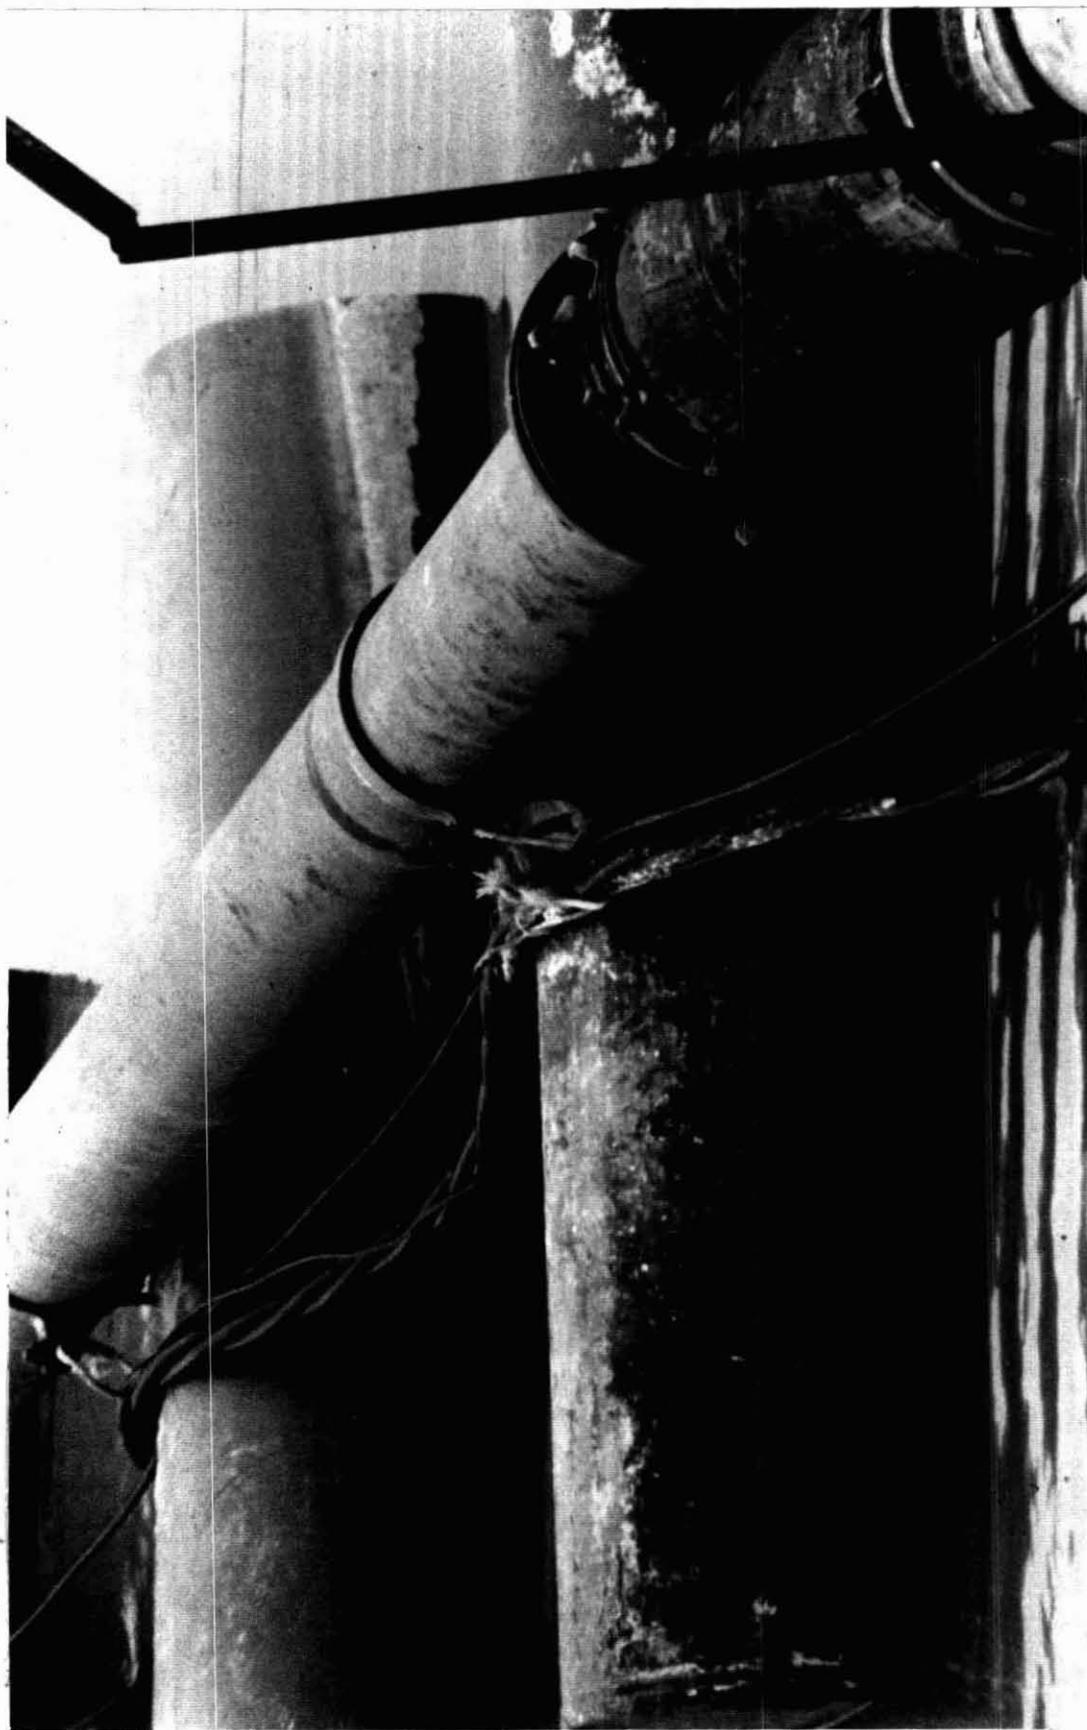
FIGURE 4.5. - Individually shielded cable on sand dredge.

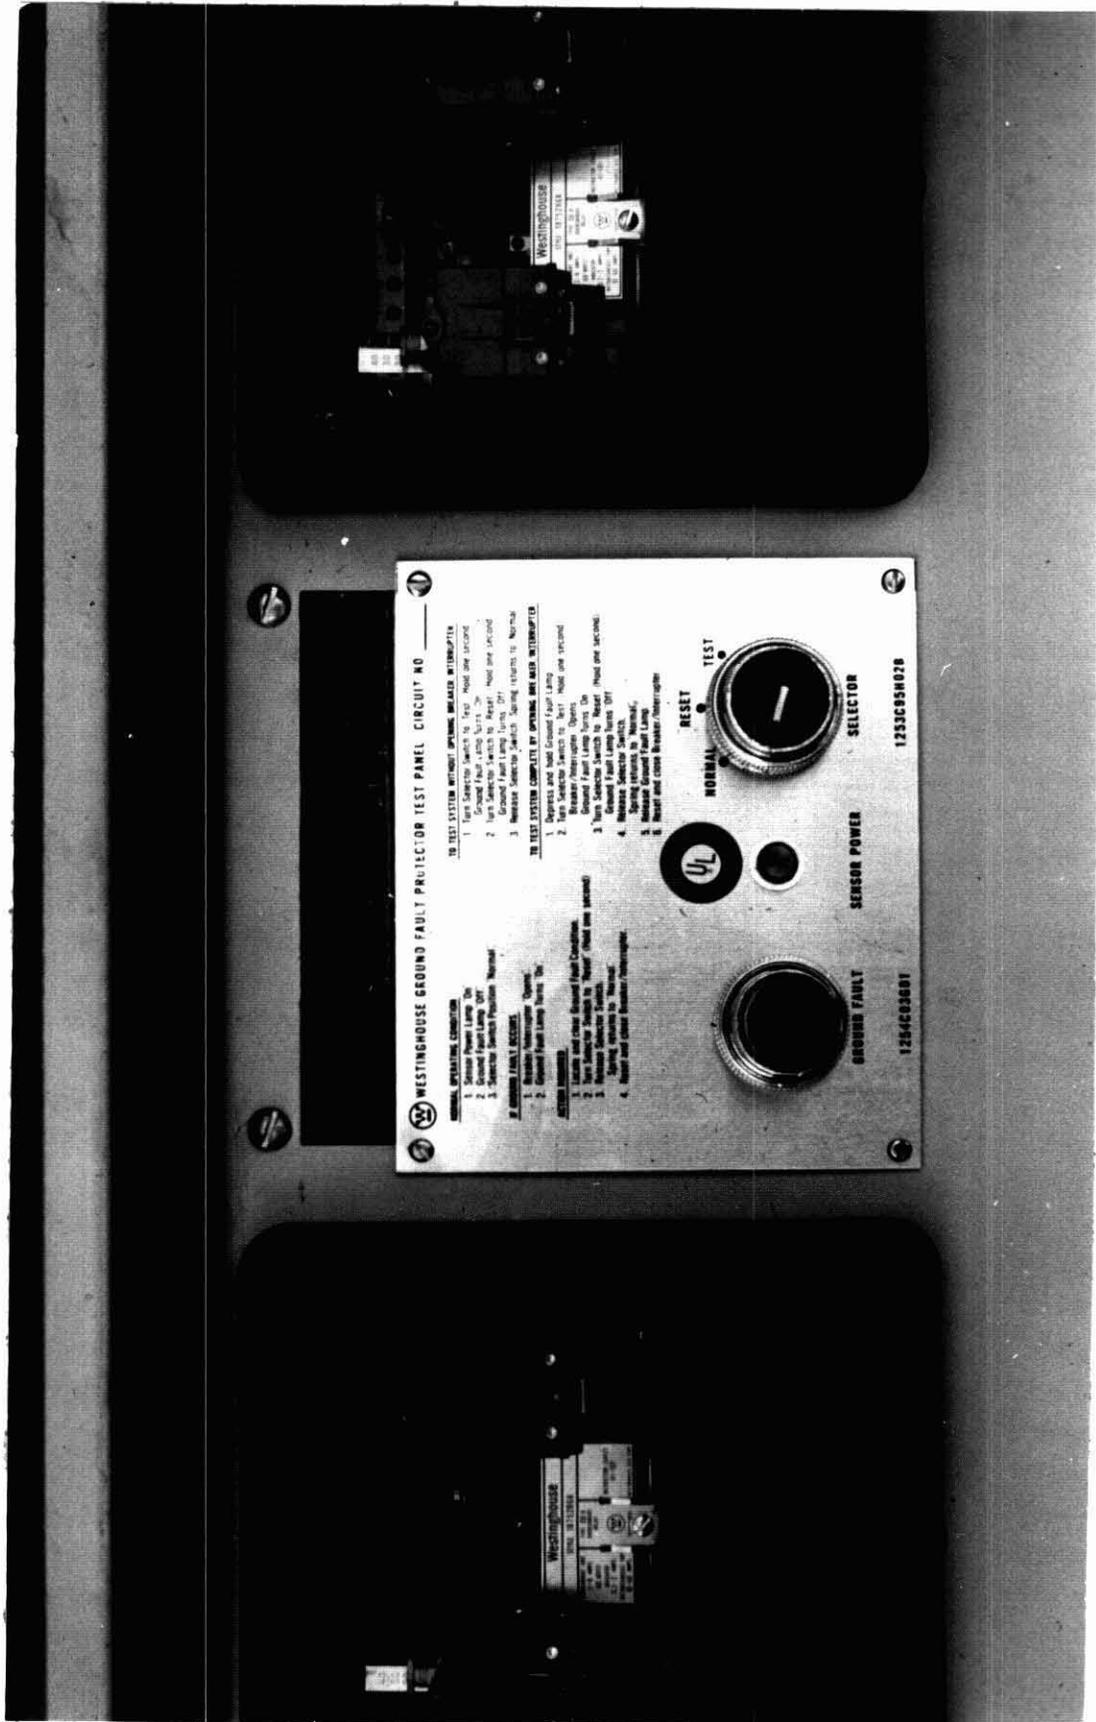
FIGURE 4.6. - OEM ground fault on phosphate dragline.

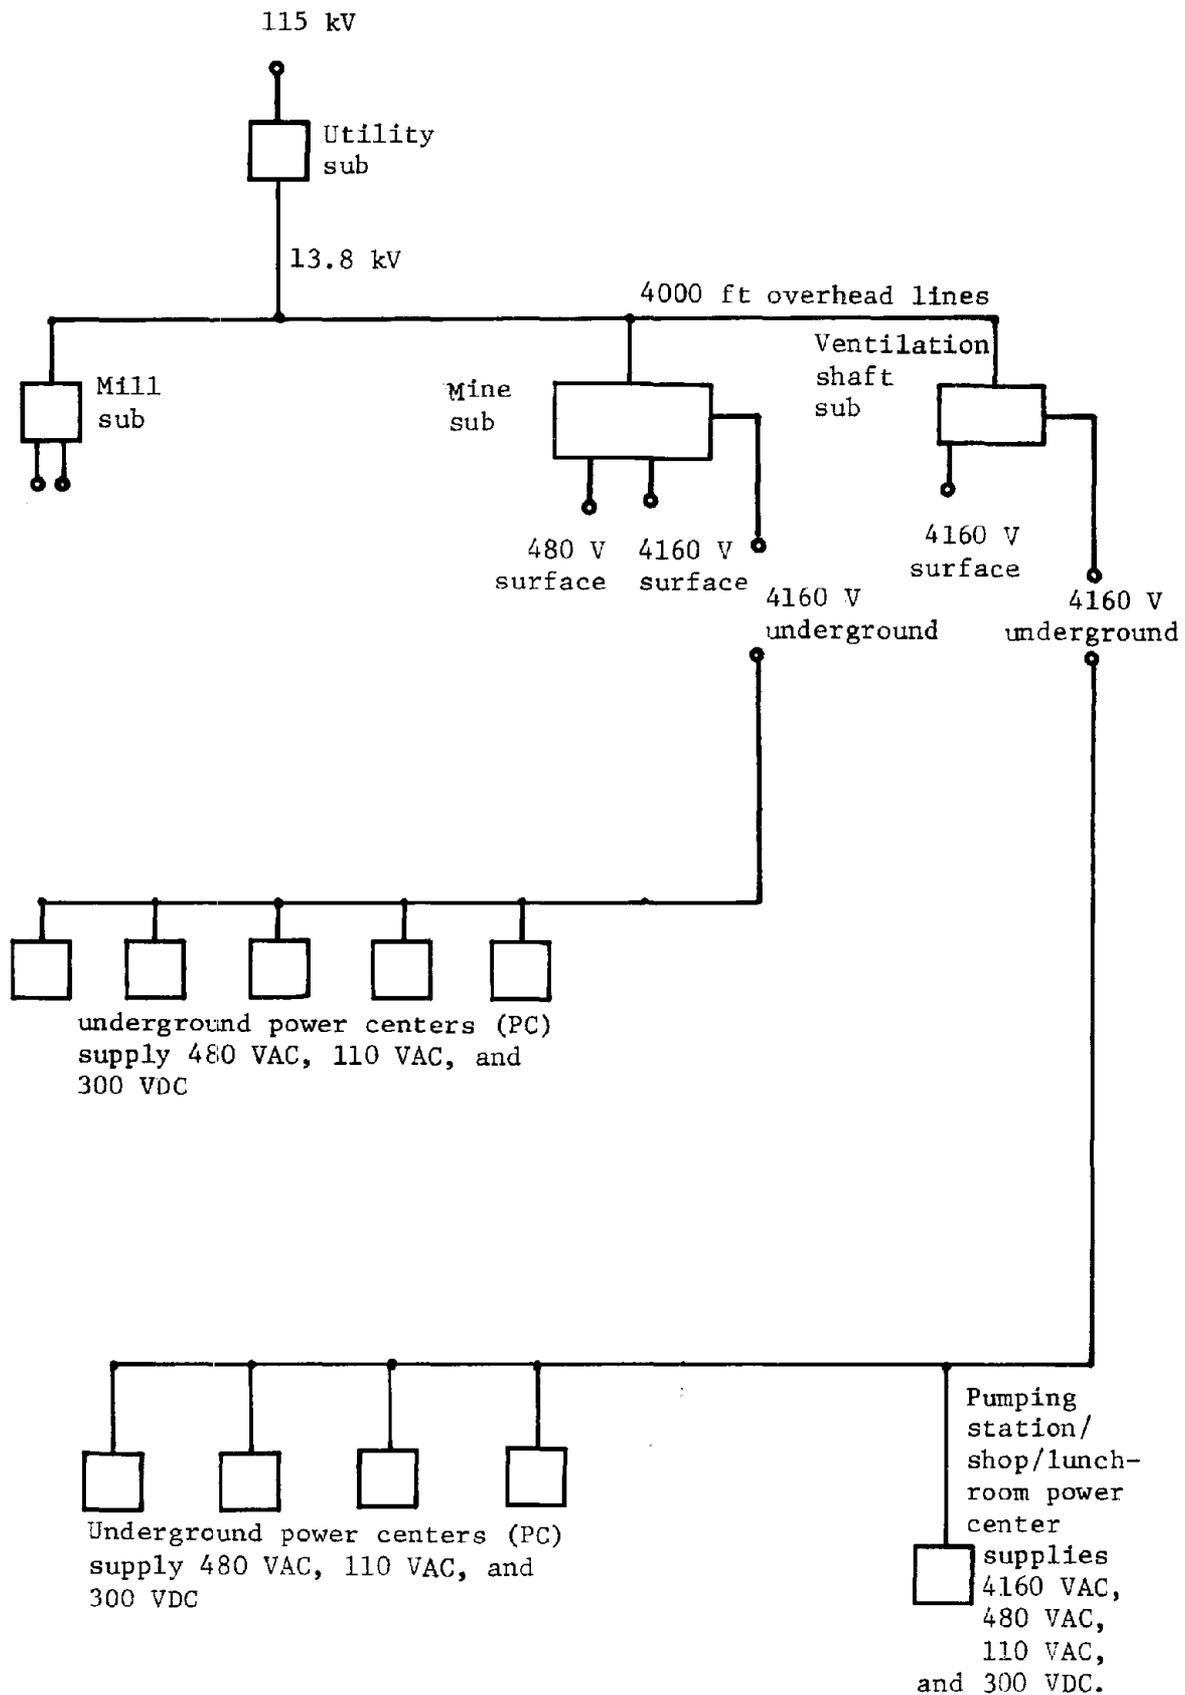
FIGURE 4.7. - Overall one-line of UG metal mine power system.

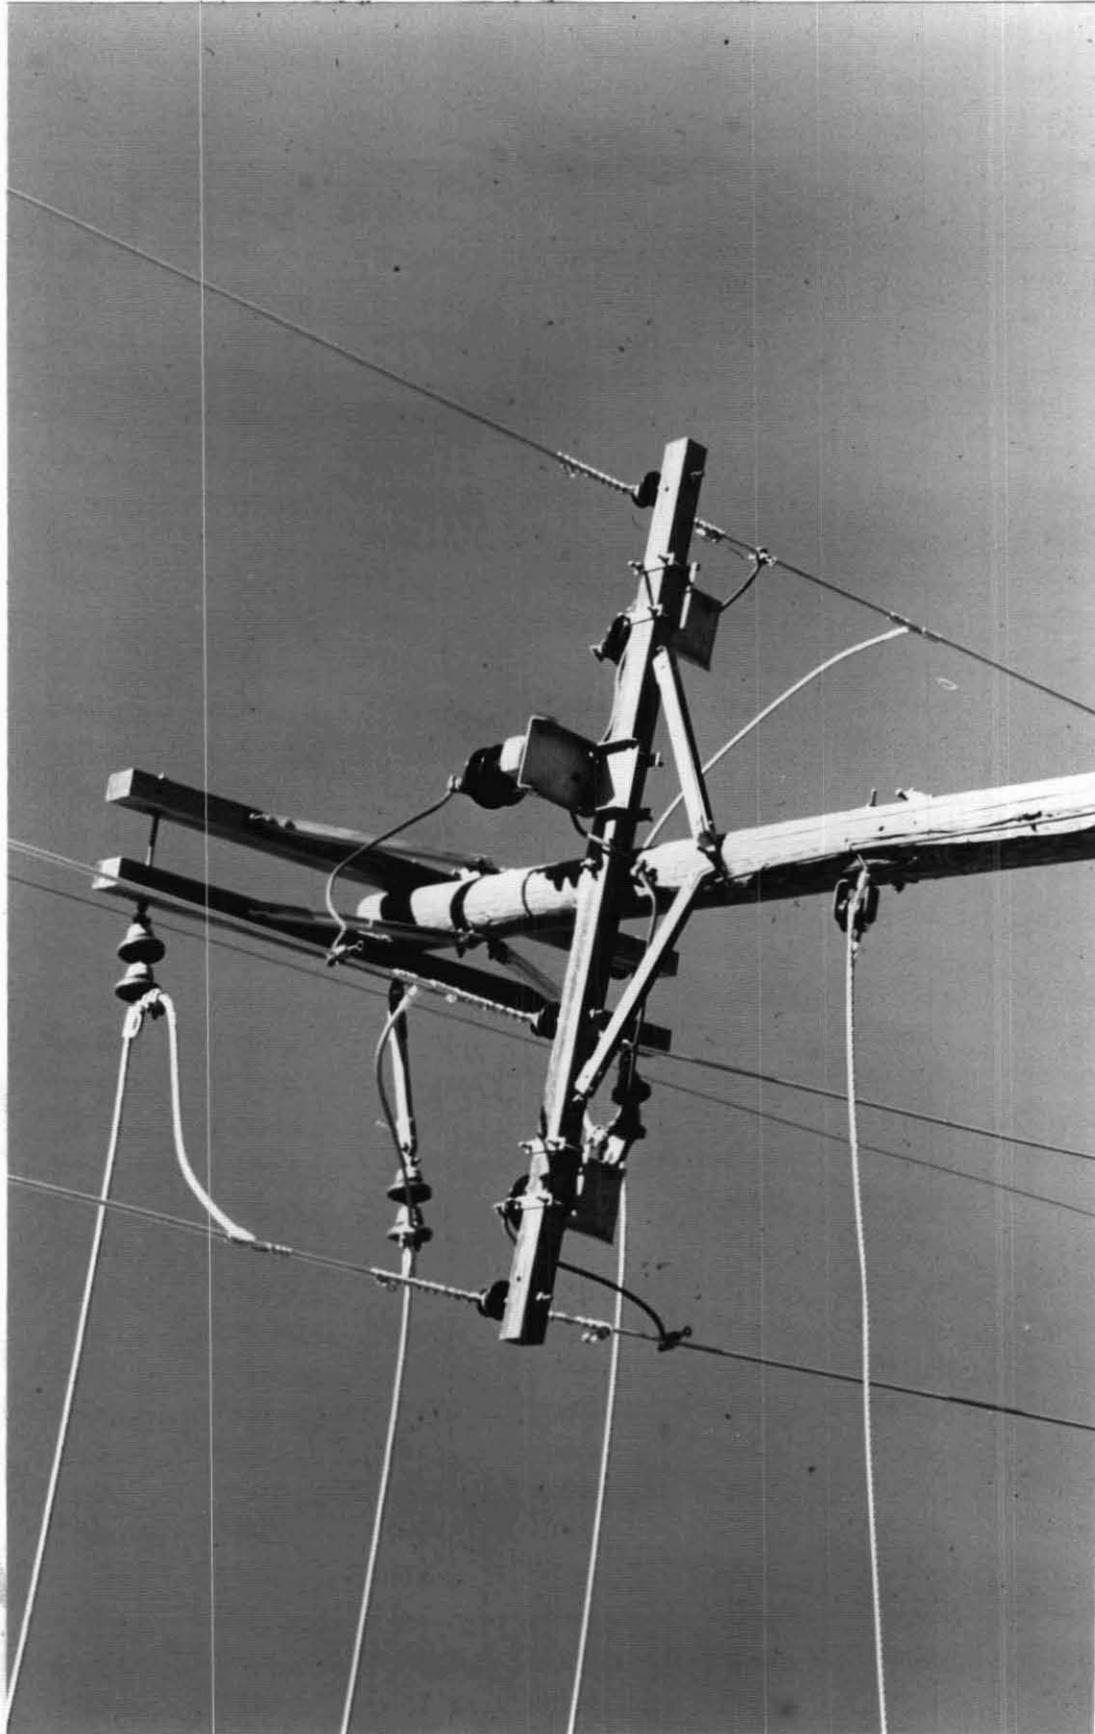
FIGURE 4.8. - Four wire overhead distribution at underground copper mine.

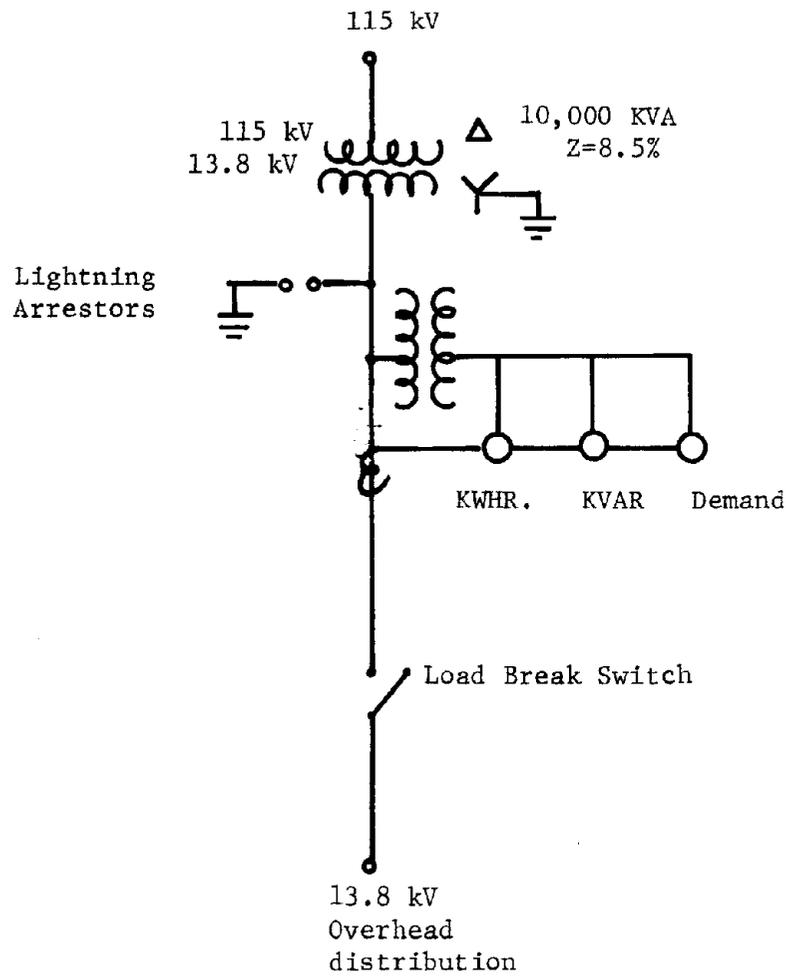
FIGURE 4.9. - Utility substation.

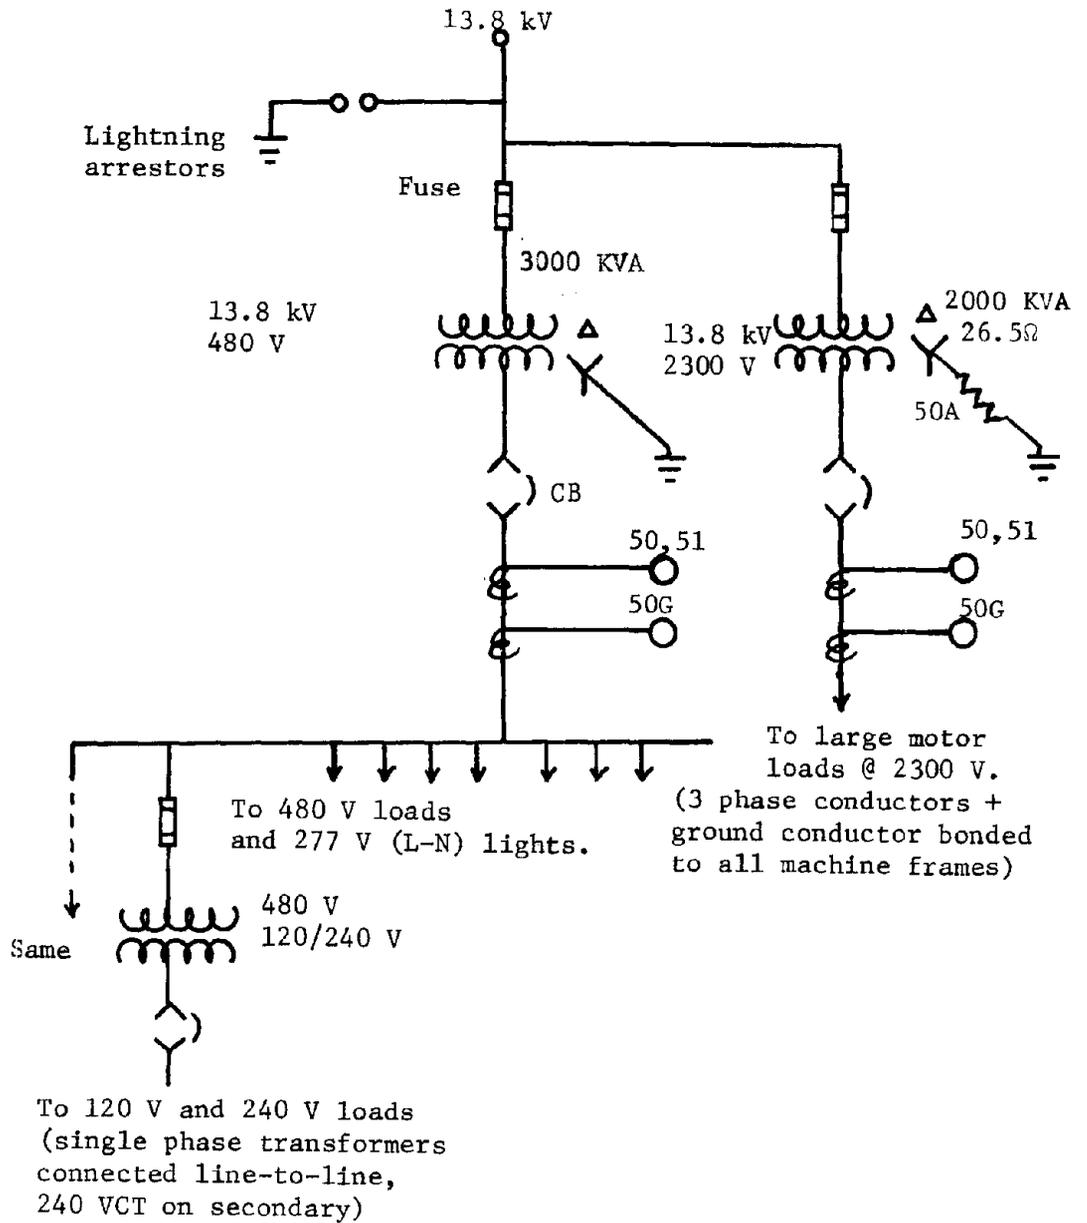
FIGURE 4.10. - Substation feeding surface mill or plant.

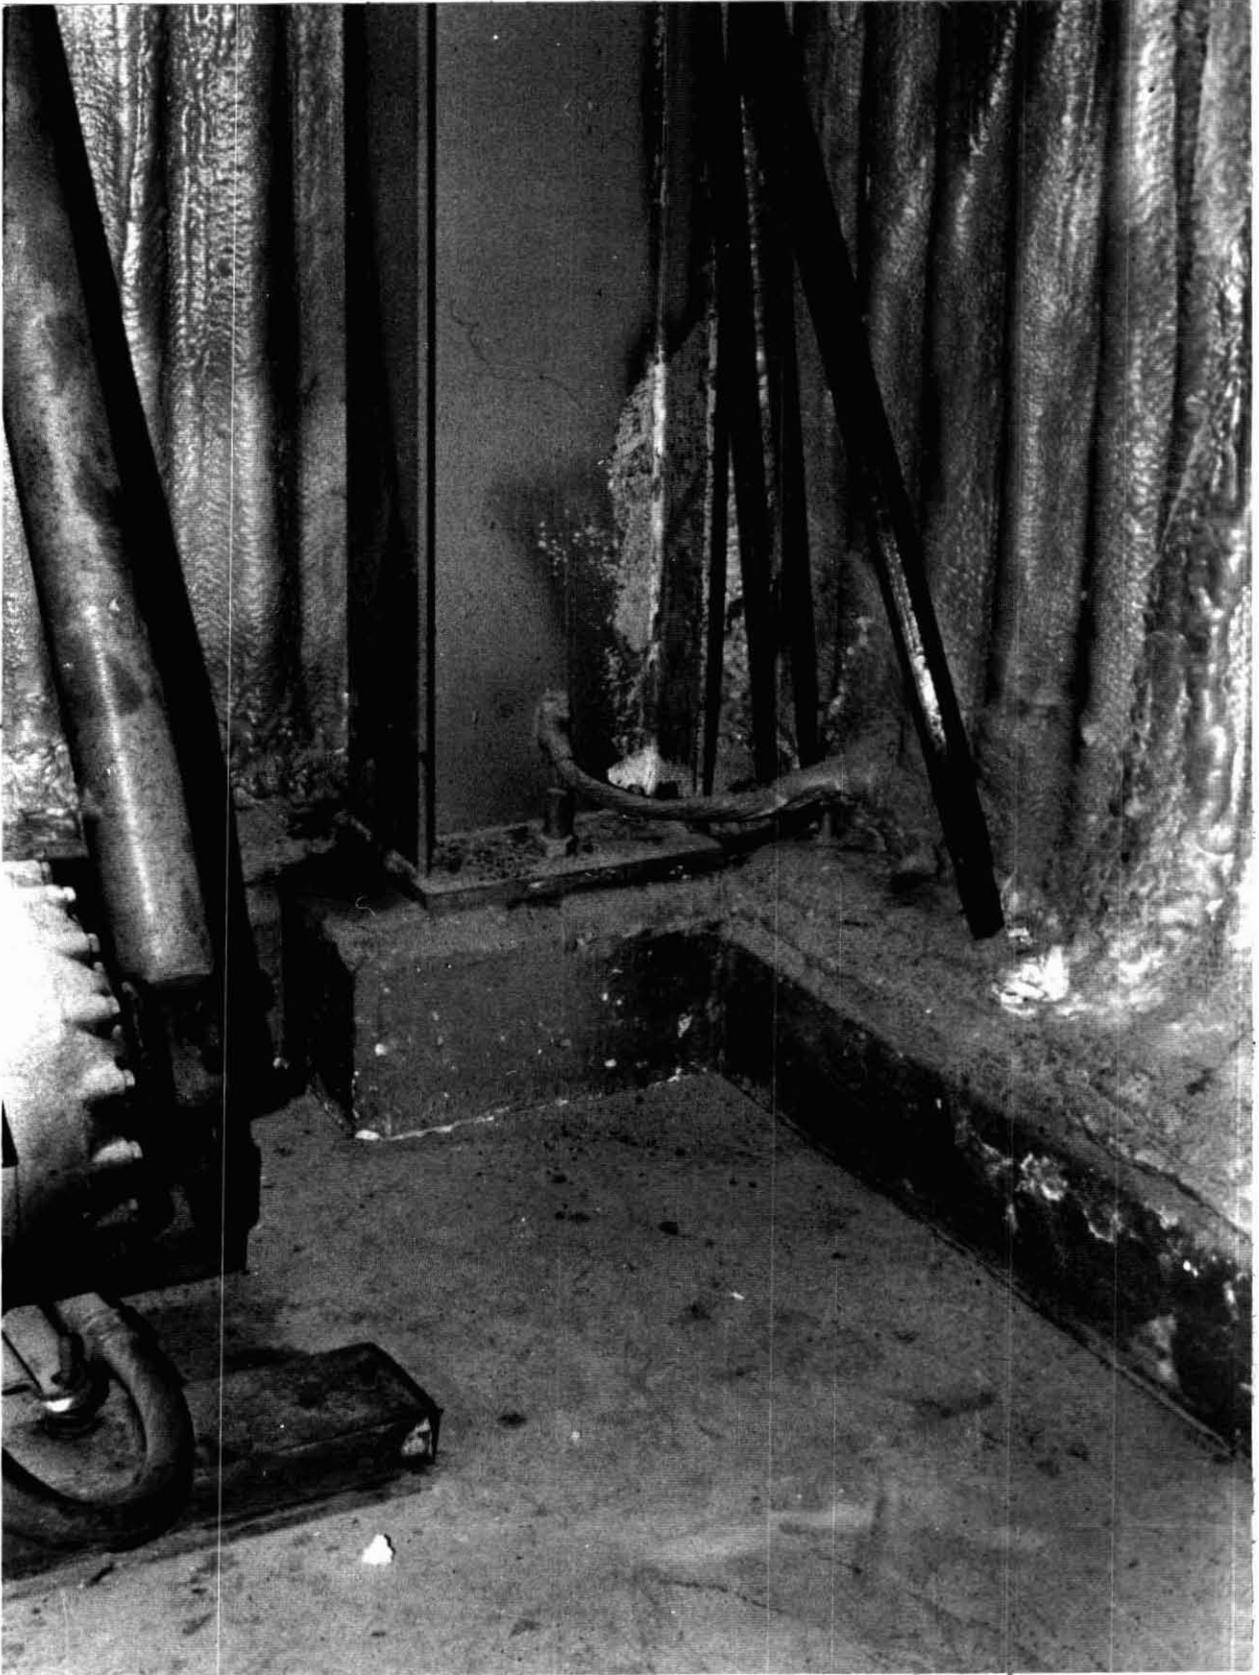
FIGURE 4.11. - Ground conductor bonded to building steel at underground uranium mine.

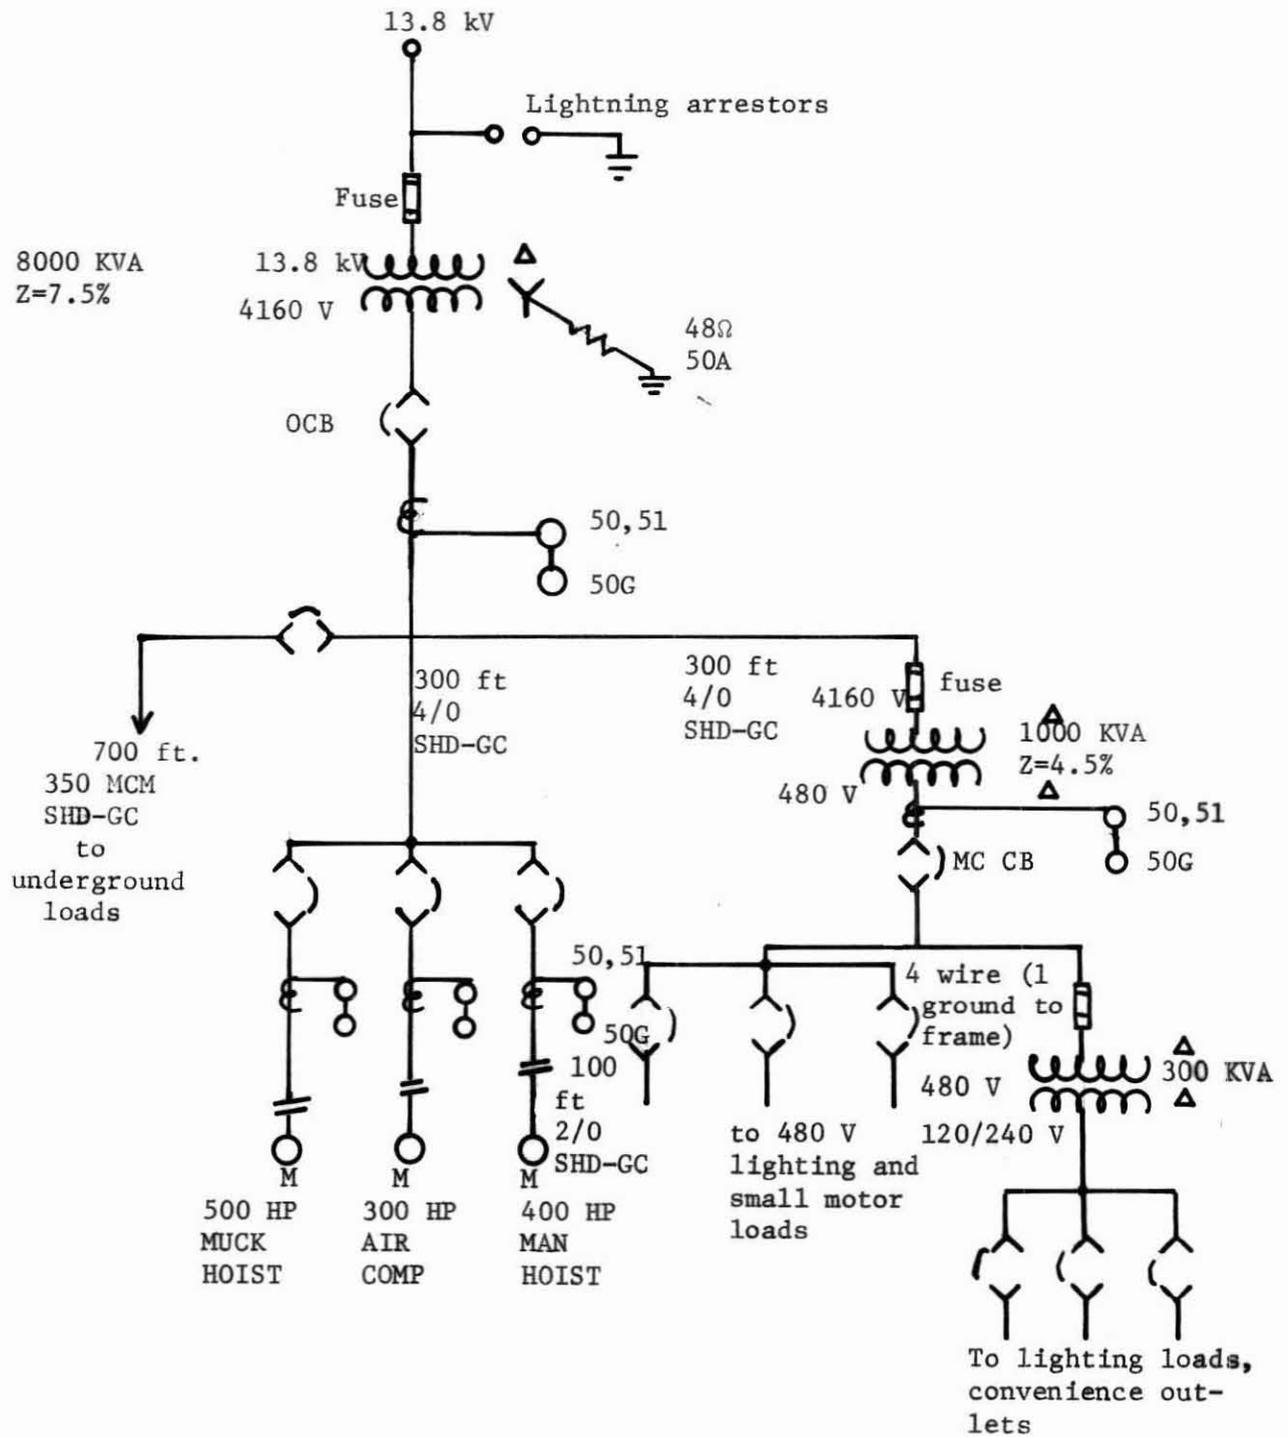
FIGURE 4.12. - Mine Substation feeding underground loads and surface support facilities.

Figure 4.12 shows the schematic diagram of the major mine substation, which feeds both surface and underground loads. A resistance-grounded neutral is installed on the transformer secondary, as shown in Figure 4.13, and fault current is limited to a maximum value of 50 A. Large loads such as the fan, hoist motors, and air compressor are powered directly at 4160 V, while step-down transformers are provided to supply 3-phase 480 V loads. An additional single phase transformer provides 120 and 240 V sources for lighting, convenience outlets, etc. A shielded mine power feeder cable extends from the substation approximately 700 feet down the shaft to transmit power to underground loads on the mine's upper production level.

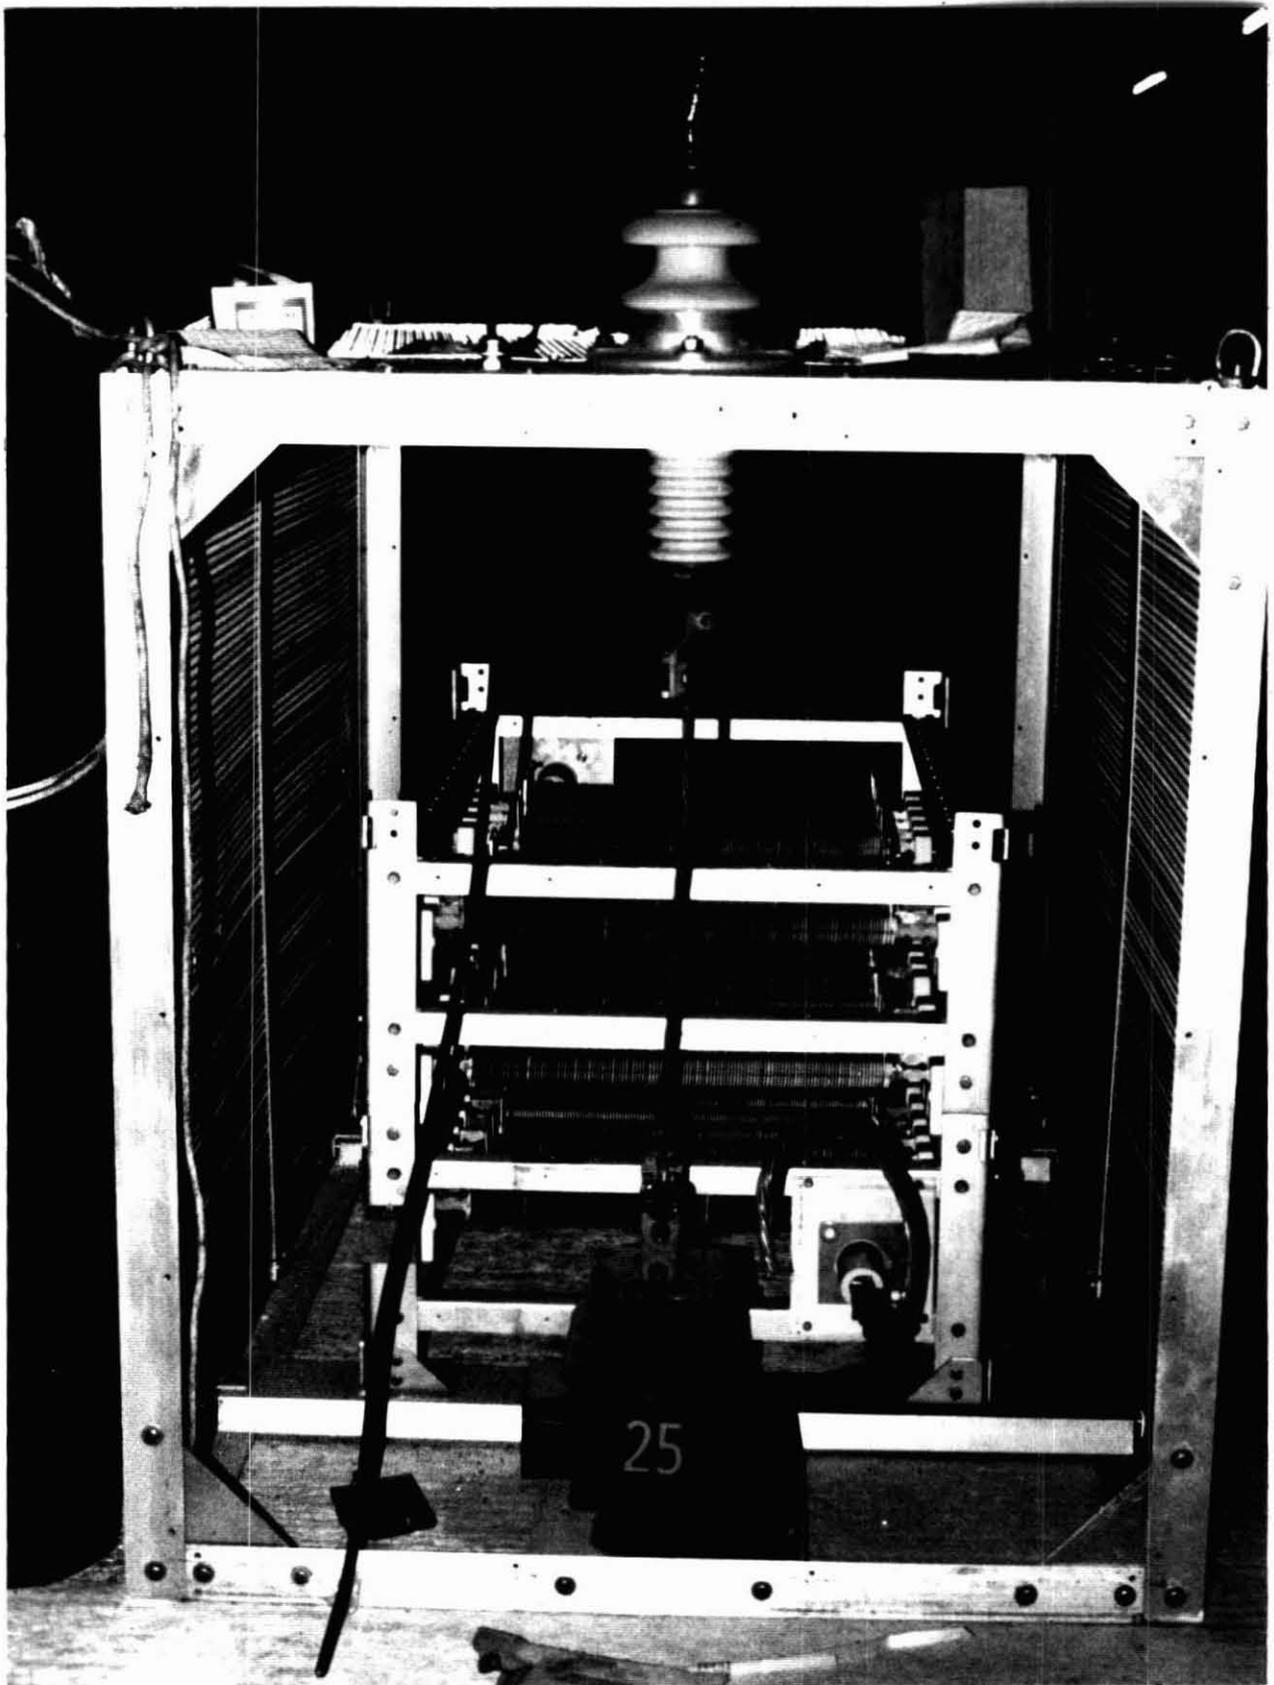
FIGURE 4.13. - Secondary neutral resistor in underground salt mine.

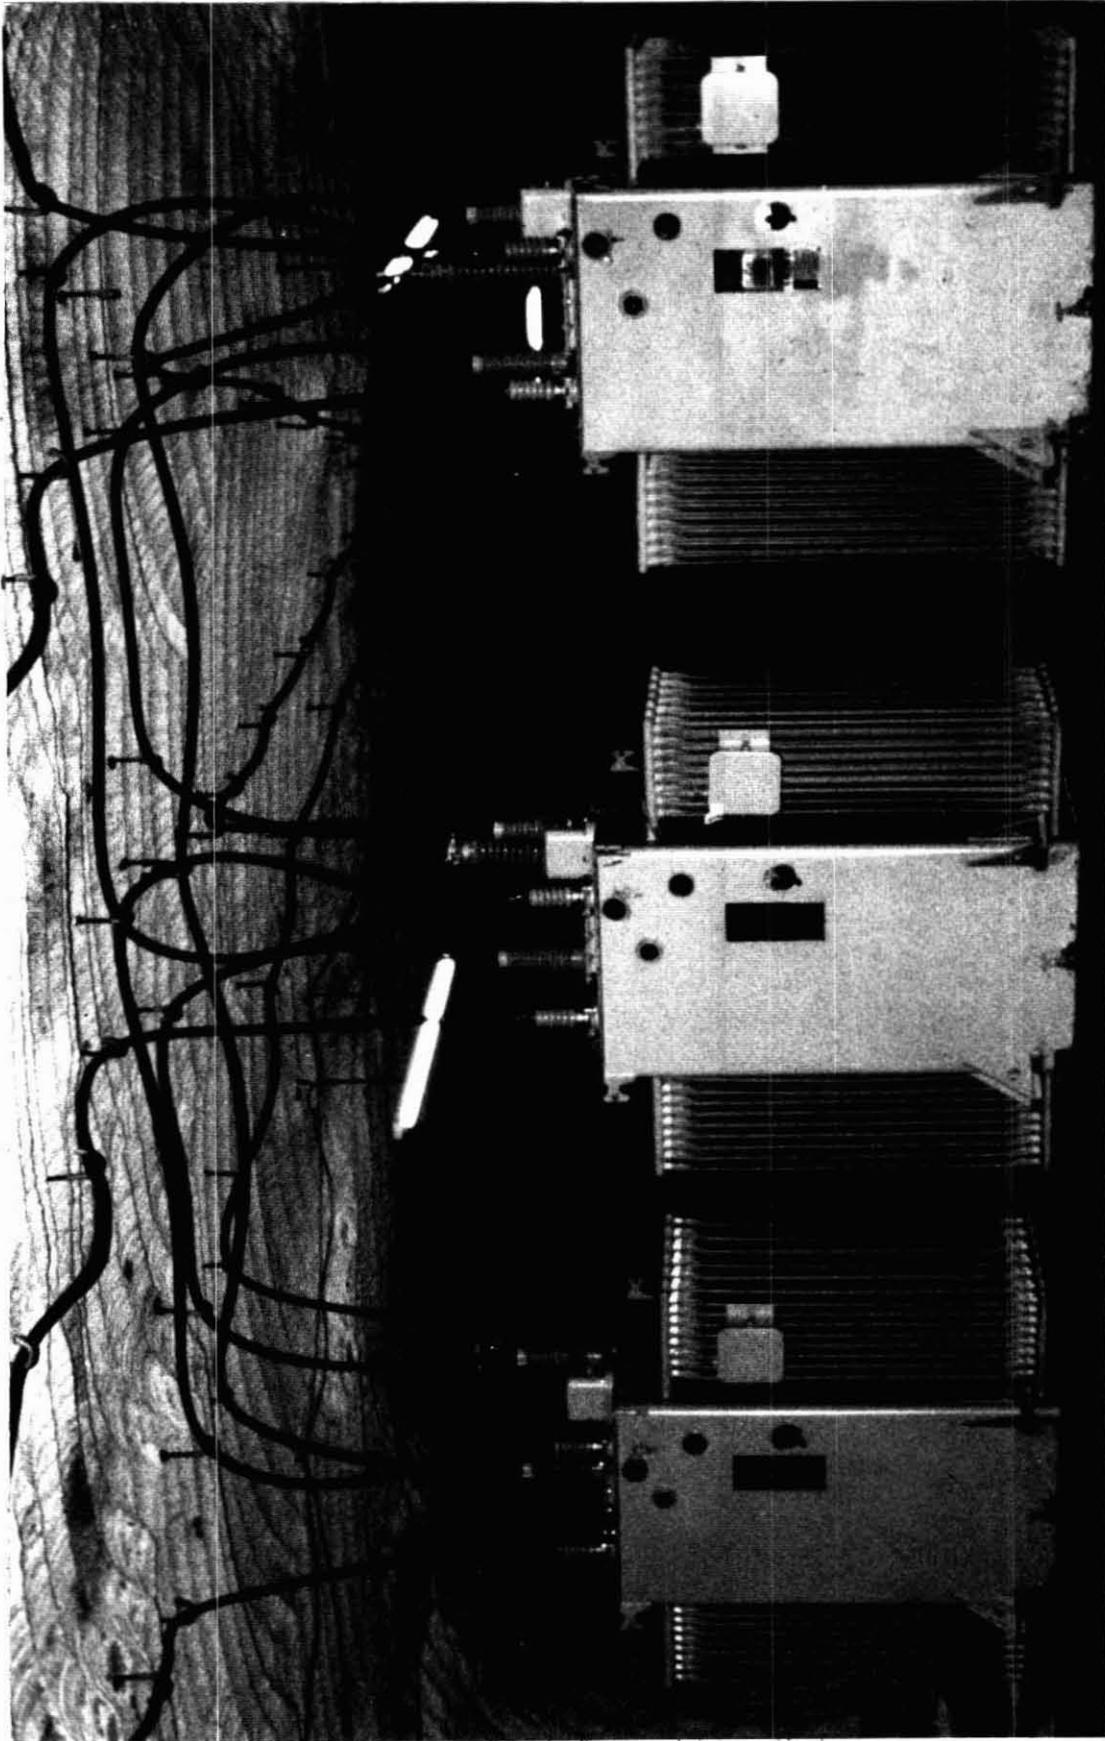
FIGURE 4.14. - Ventilation substation in underground salt mine.

The ventilation shaft substation is shown on Figure 4.14. A mine of reasonable size will have at least one ventilation shaft in addition to the one containing the man and muck hoists. This ventilation shaft, which is generally several thousand feet away from the main shaft, will often have its own substation, shown in Figure 4.15, both for supplying power to the fan, and (in this case) to feed power to the second production level of the mine. This substation is somewhat similar to the substation shown in the Figure 4.12, but is simpler due to the absence of surface facilities. Again, a resistance-grounded neutral is used on the transformer secondary, with fault current limited to 50 A.
