**DEVELOP GROUNDING
PRACTICES
FOR
METAL/NON-METAL MINES**

Bureau of Mines Open File Report 154-81

Contract J0308025
West Virginia University

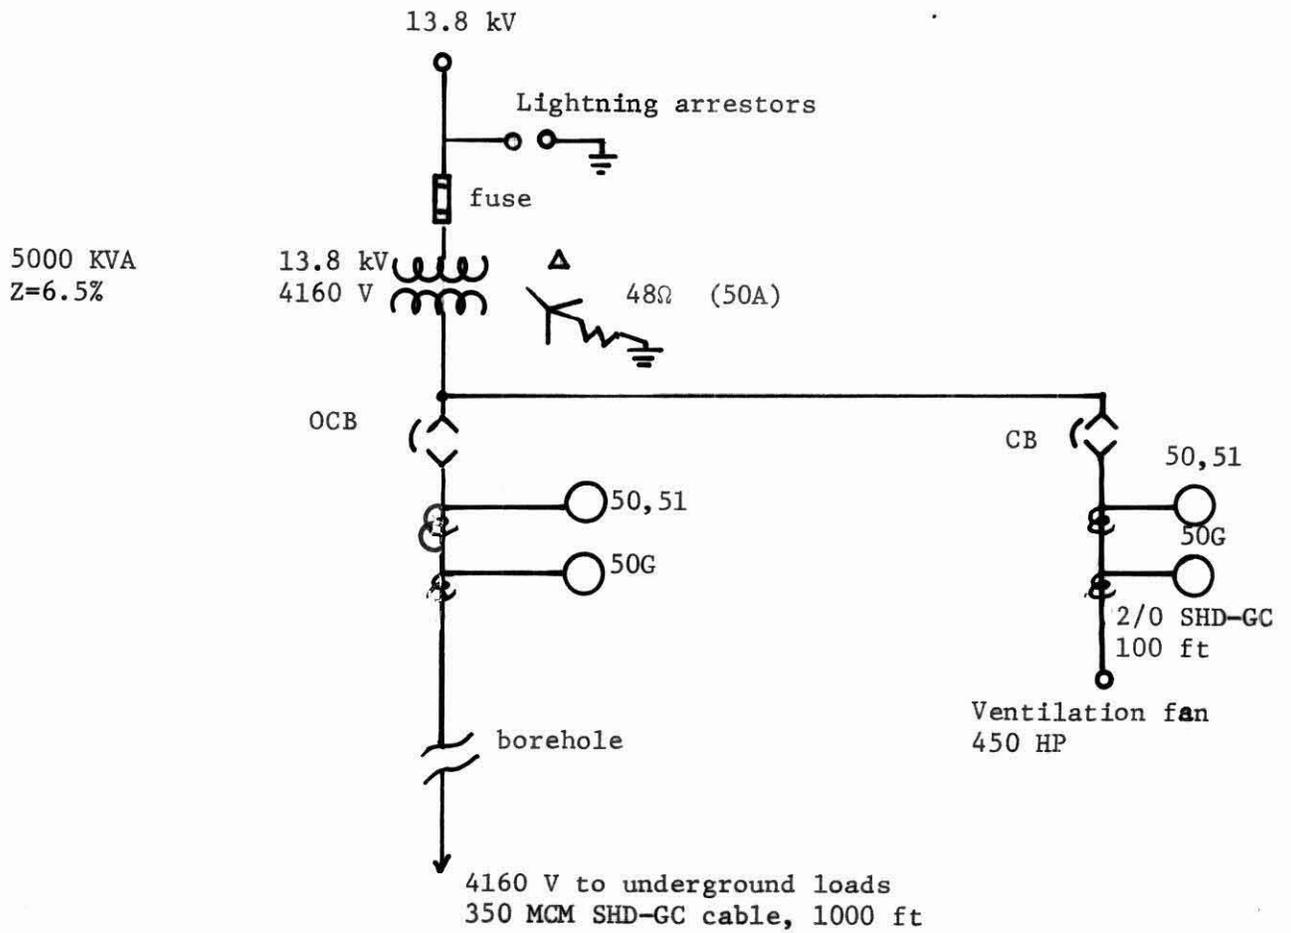
FIGURE 4.15. - Ventilation shaft substation feeding underground loads and fan on the surface.

The ventilation shaft substation is shown on Figure 4.14. A mine of reasonable size will have at least one ventilation shaft in addition to the one containing the man and muck hoists. This ventilation shaft, which is generally several thousand feet away from the main shaft, will often have its own substation, shown in Figure 4.15, both for supplying power to the fan, and (in this case) to feed power to the second production level of the mine. This substation is somewhat similar to the substation shown in the Figure 4.12, but is simpler due to the absence of surface facilities. Again, a resistance-grounded neutral is used on the transformer secondary, with fault current limited to 50 A.

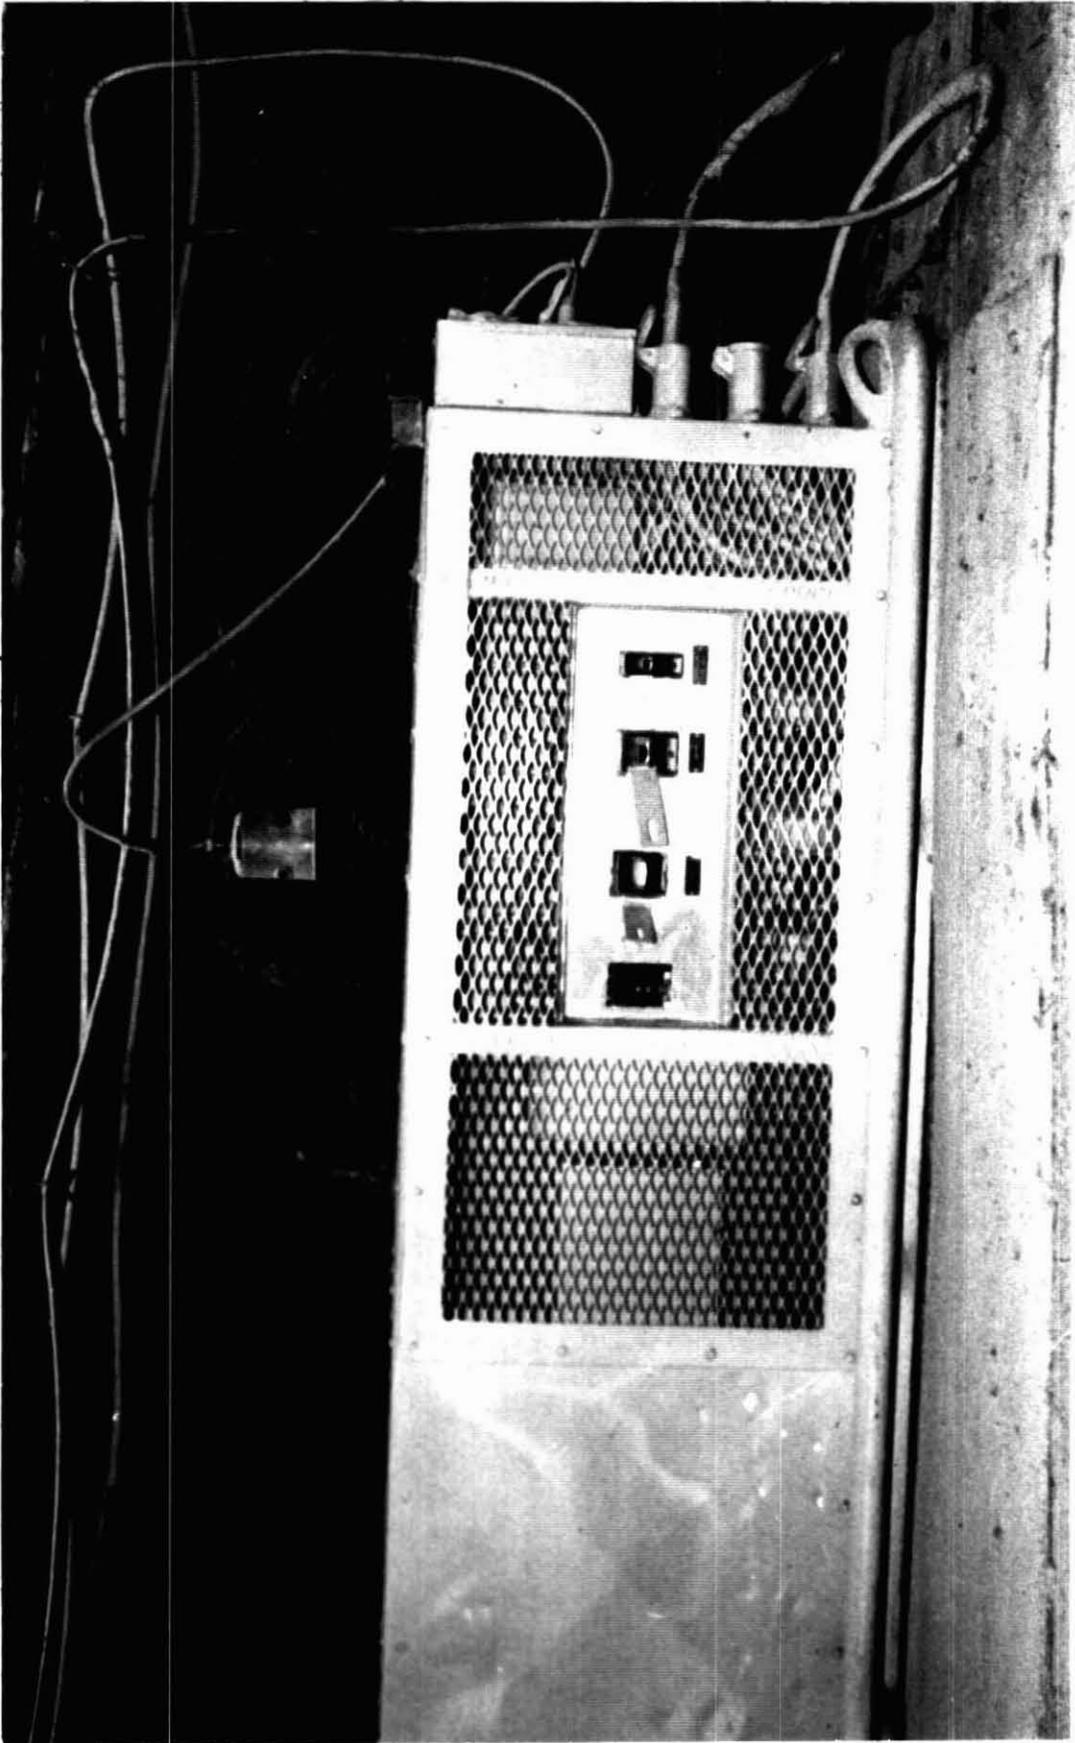
FIGURE 4.16. - Underground power center in phosphate mine.

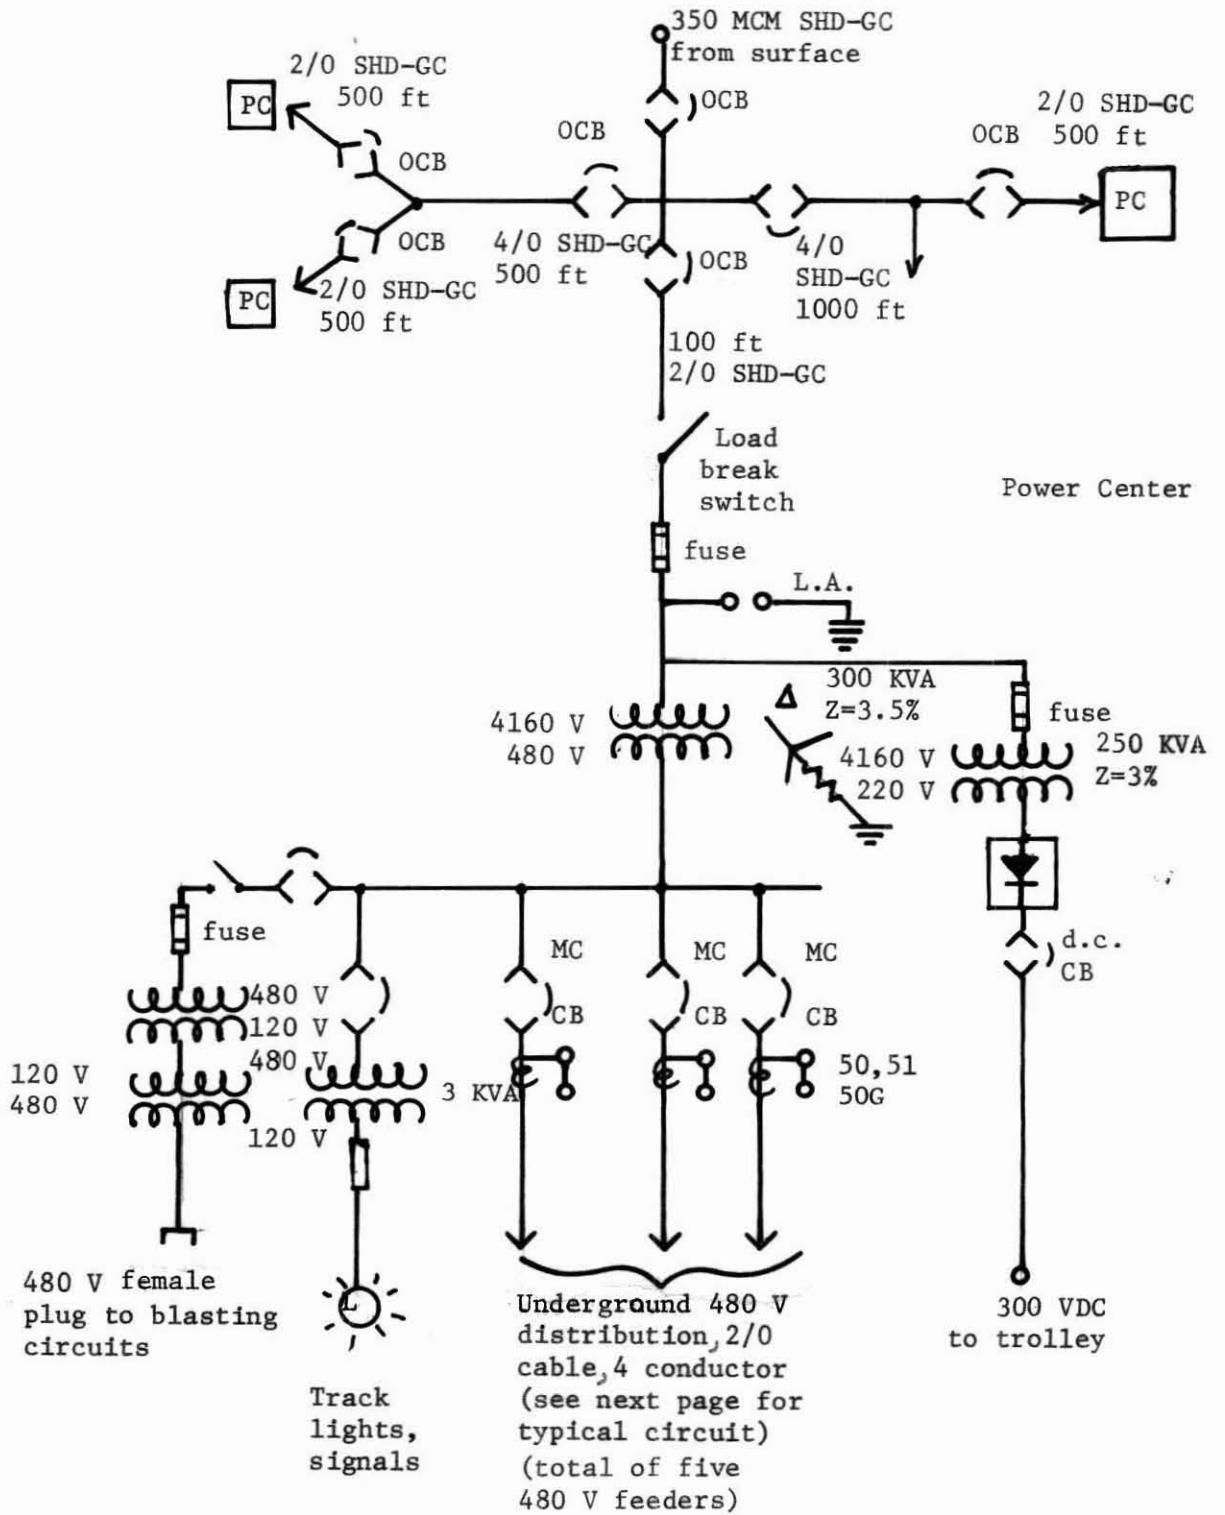
FIGURE 4.17. - Typical underground power center.

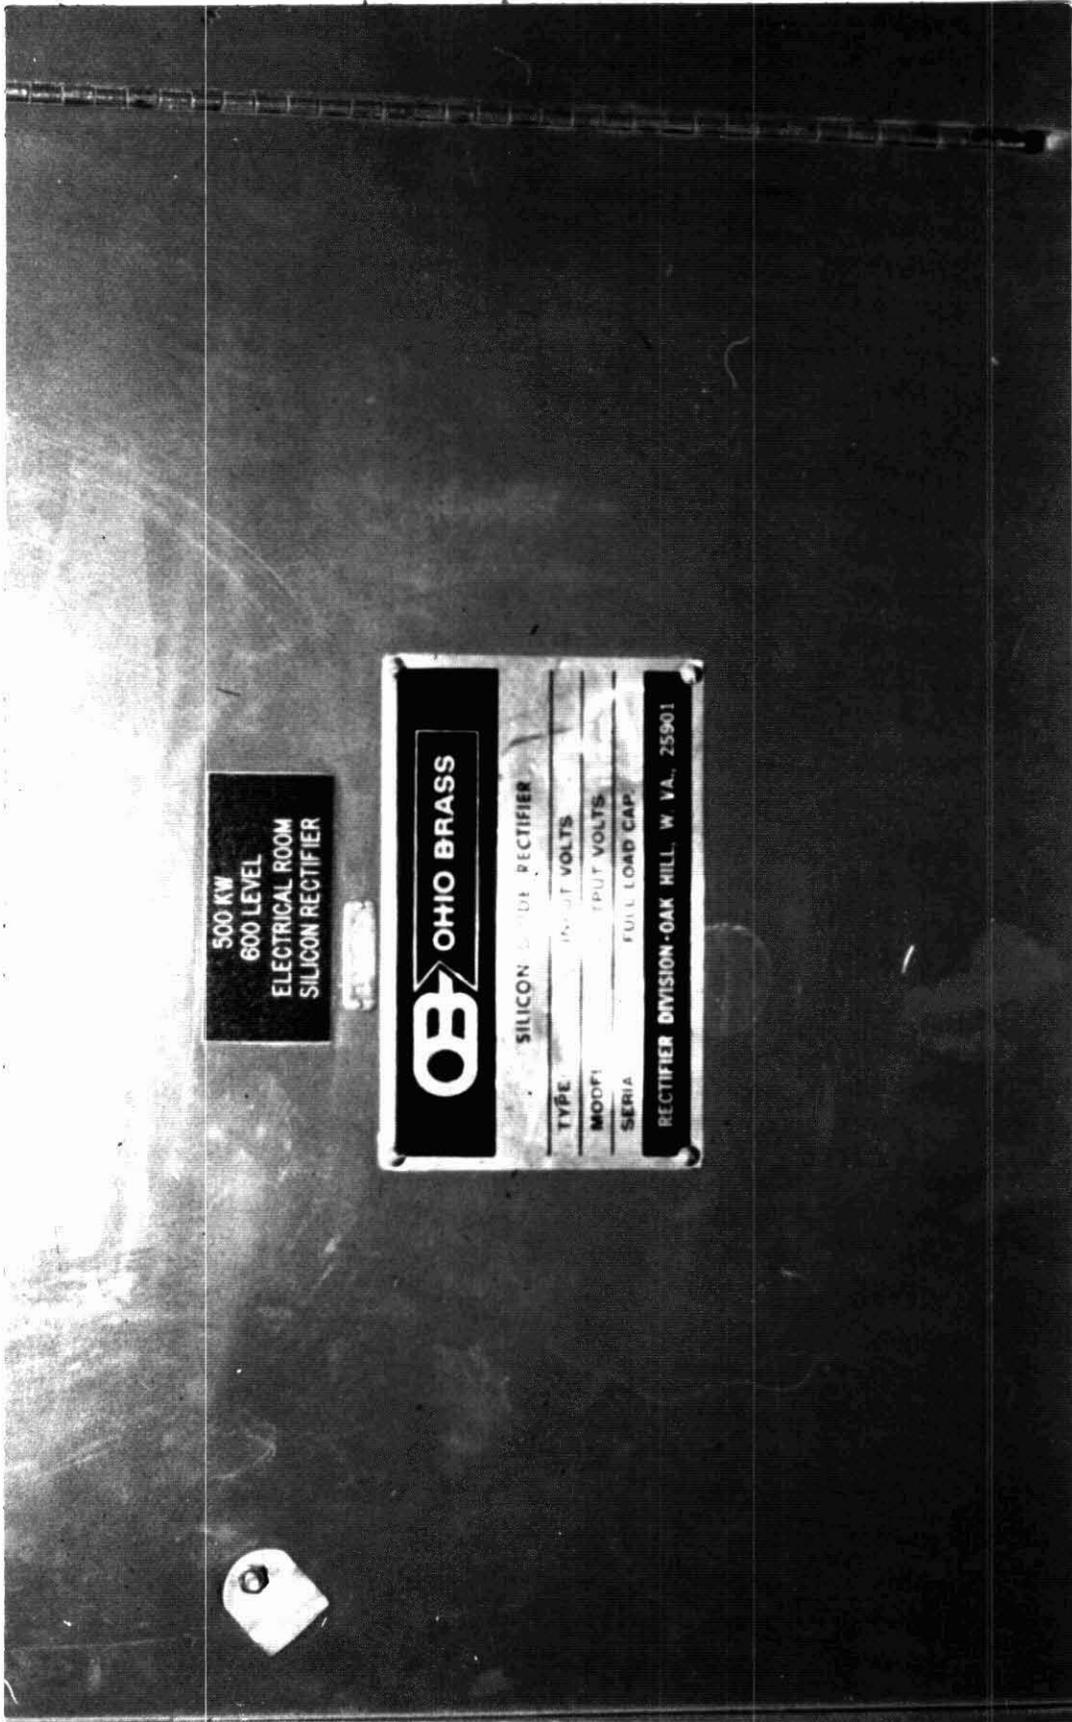
FIGURE 4.18. - 600 V rectifier underground molybdenum mine.

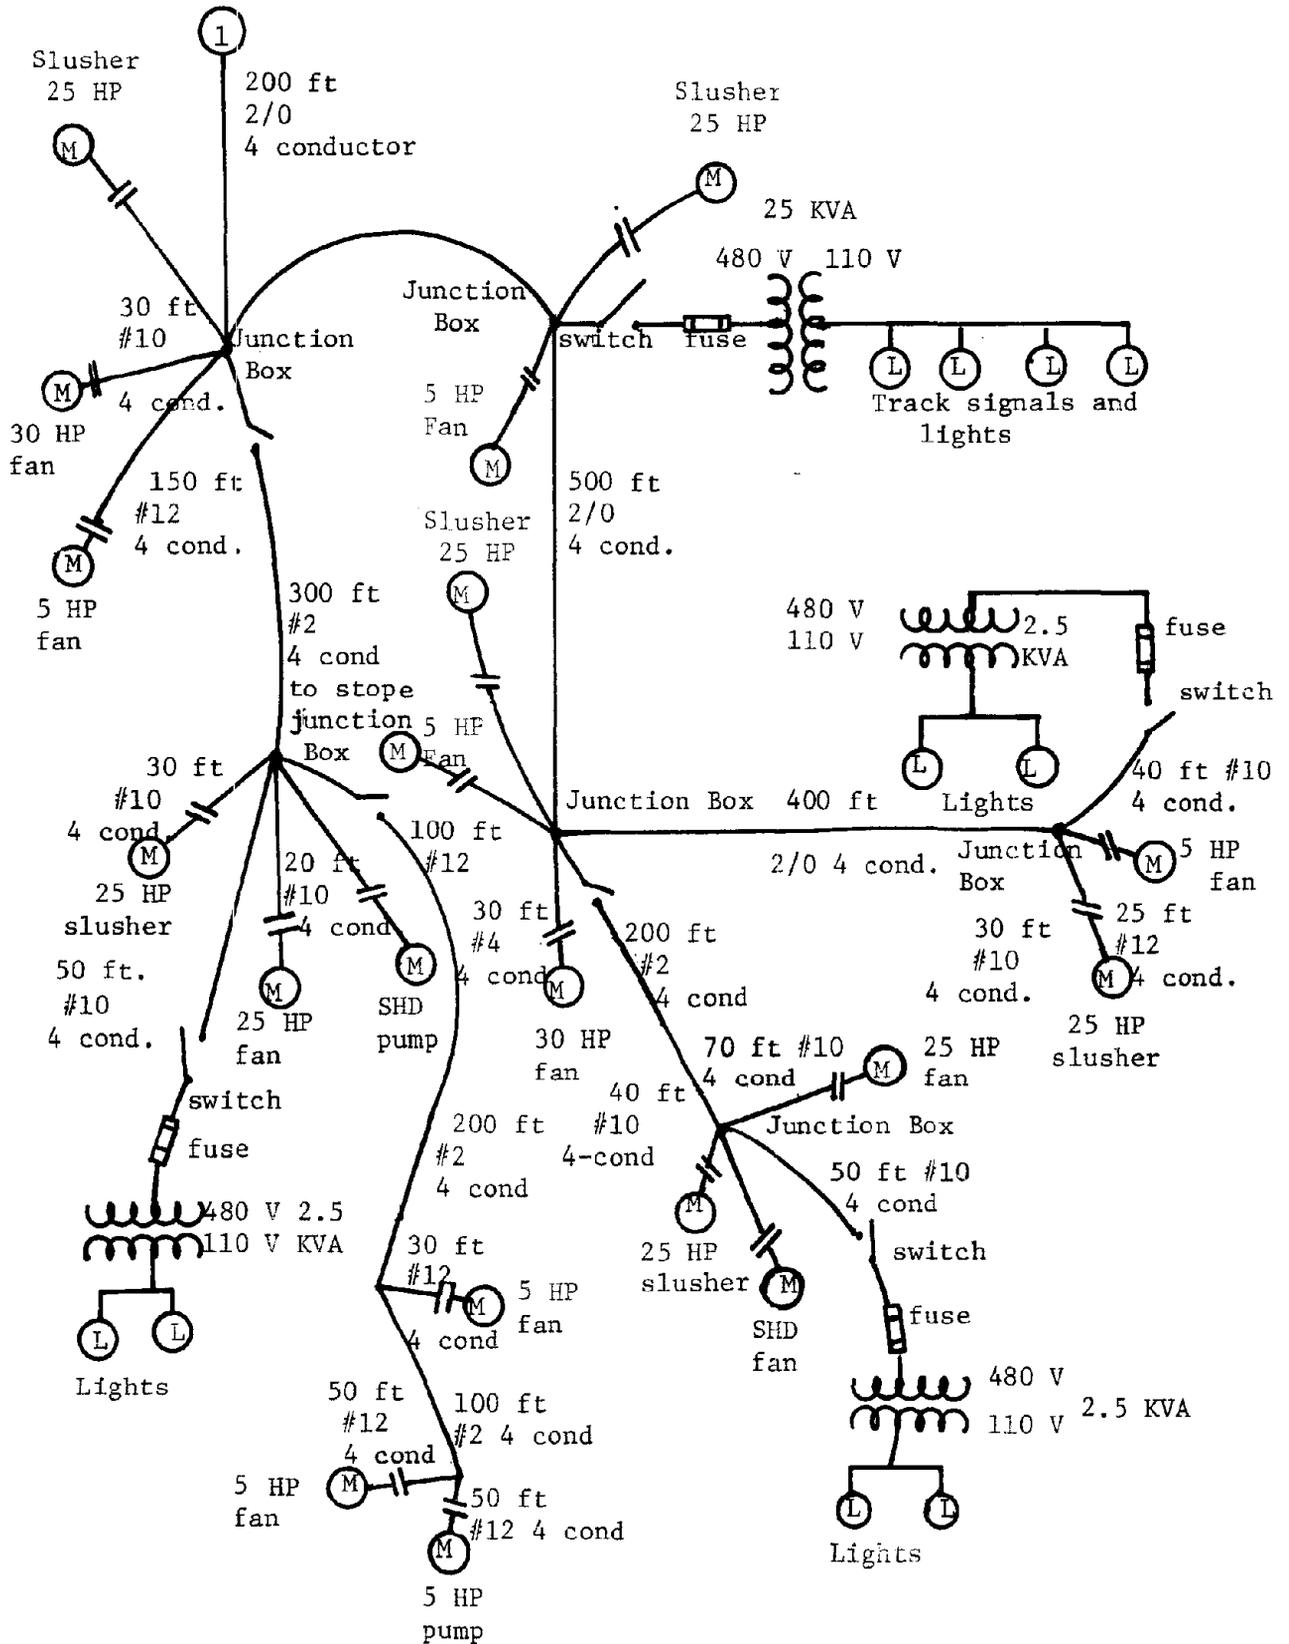
FIGURE 4.19. - Typical 480 V distribution circuits from power center.

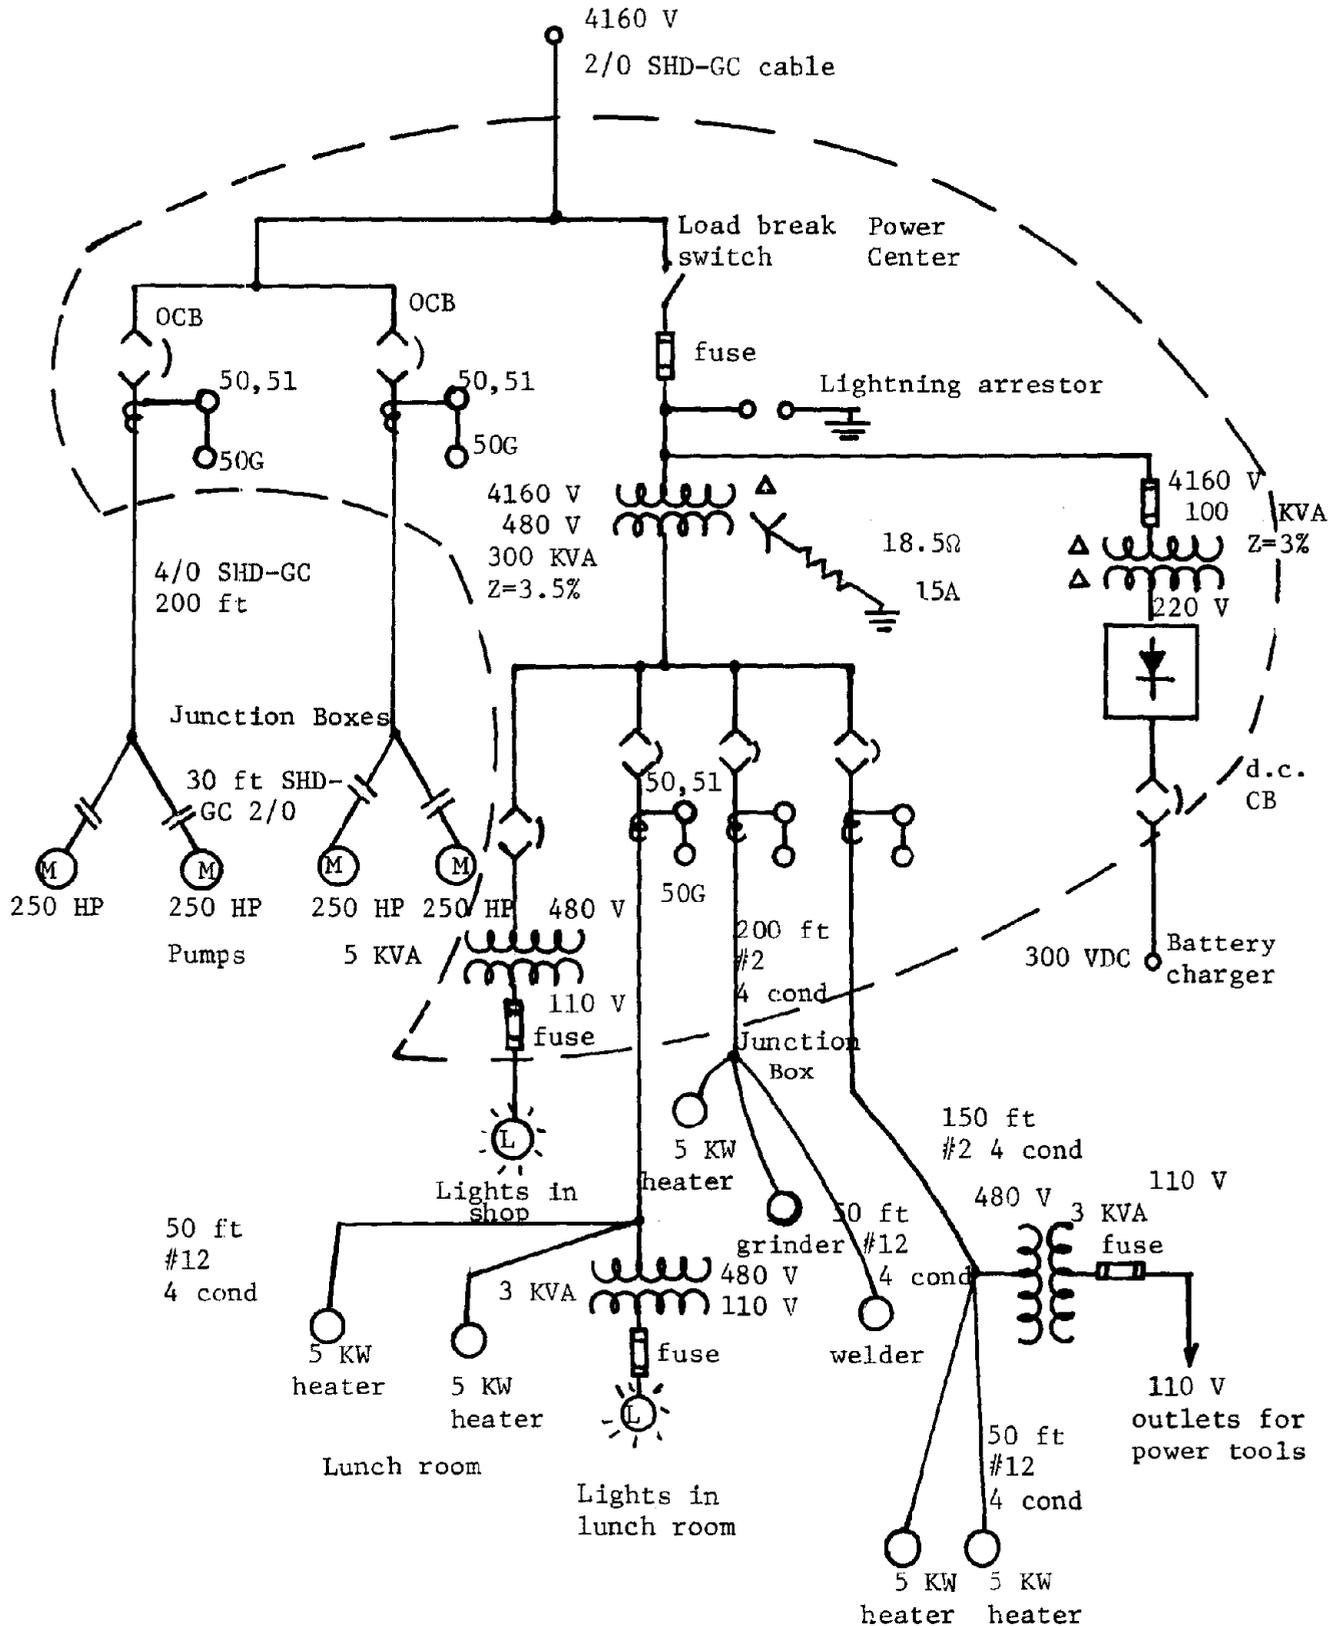
FIGURE 4.20. - Underground power center for pumping station/shop/lunch room.

The underground power center shown in Figure 4.20 is different from the others described previously, and performs several special functions. It supplies power at 4160 V directly to several large pumps, located in the mine sump, which transport water to the surface. In addition, an underground shop and lunch room are serviced by this power center, including 480 V heaters, a grinder and welder, as well as 120 V and 240 V single-phase circuits for power tools and lights. A small transformer feeding a rectifier is included for battery charging purposes.

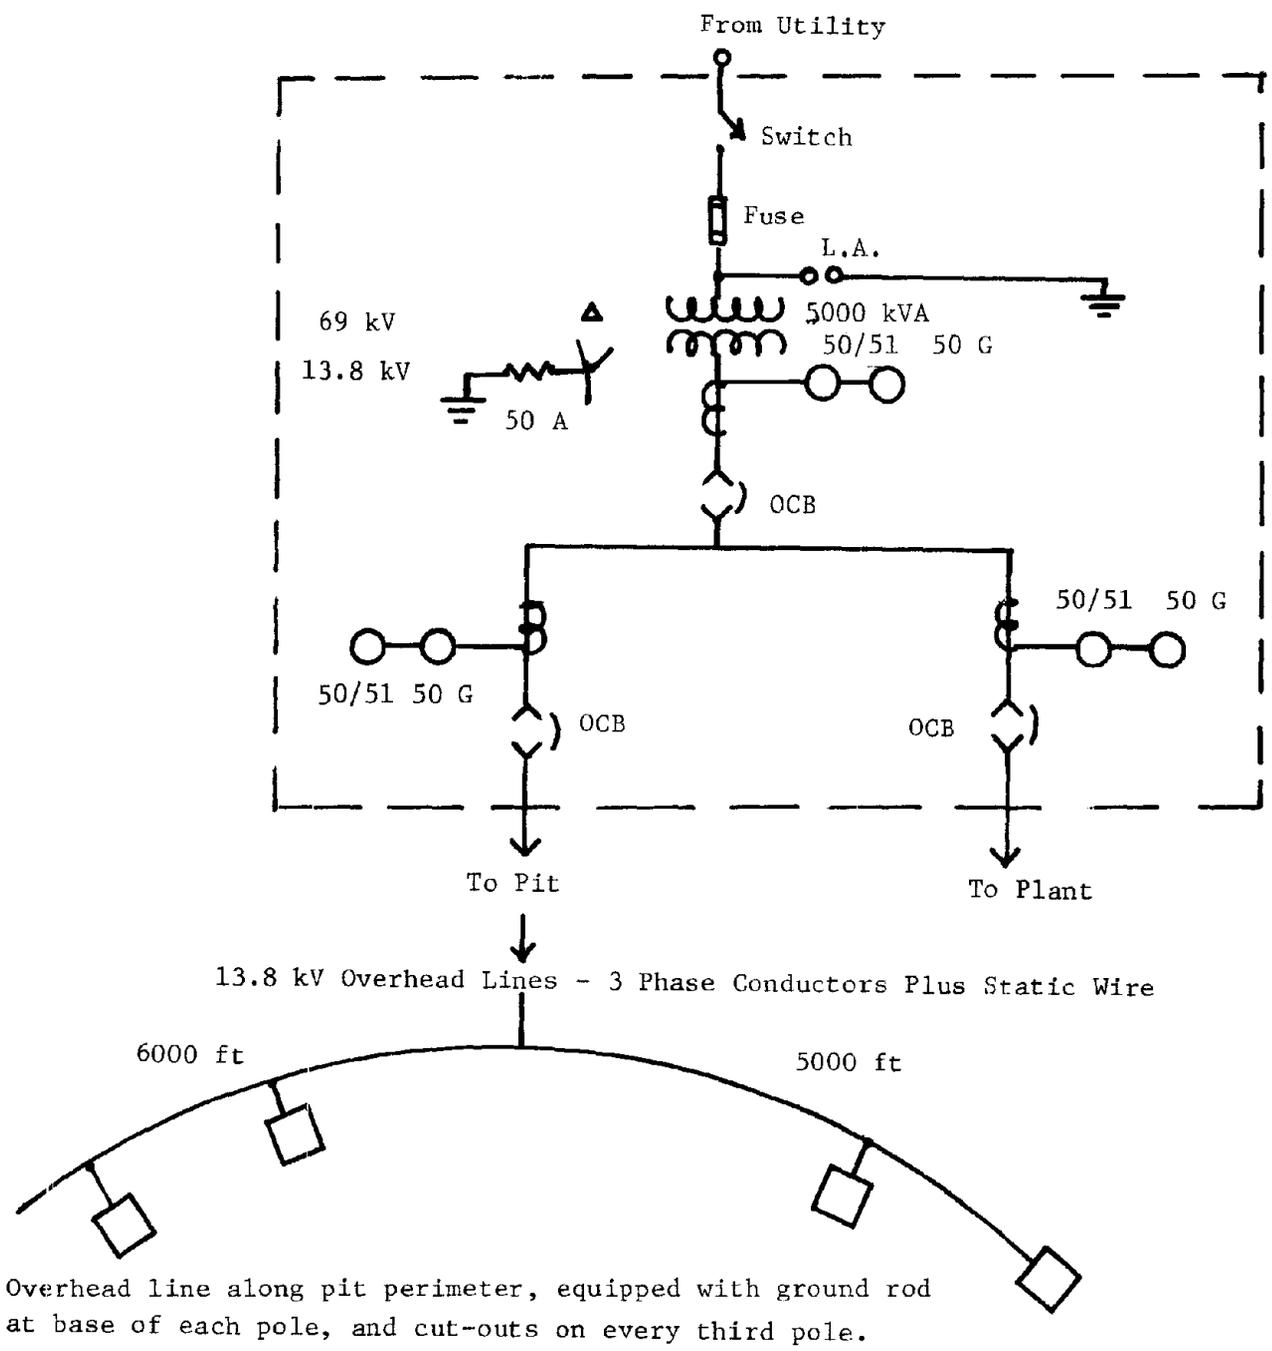
FIGURE 4.21.- Main substation.

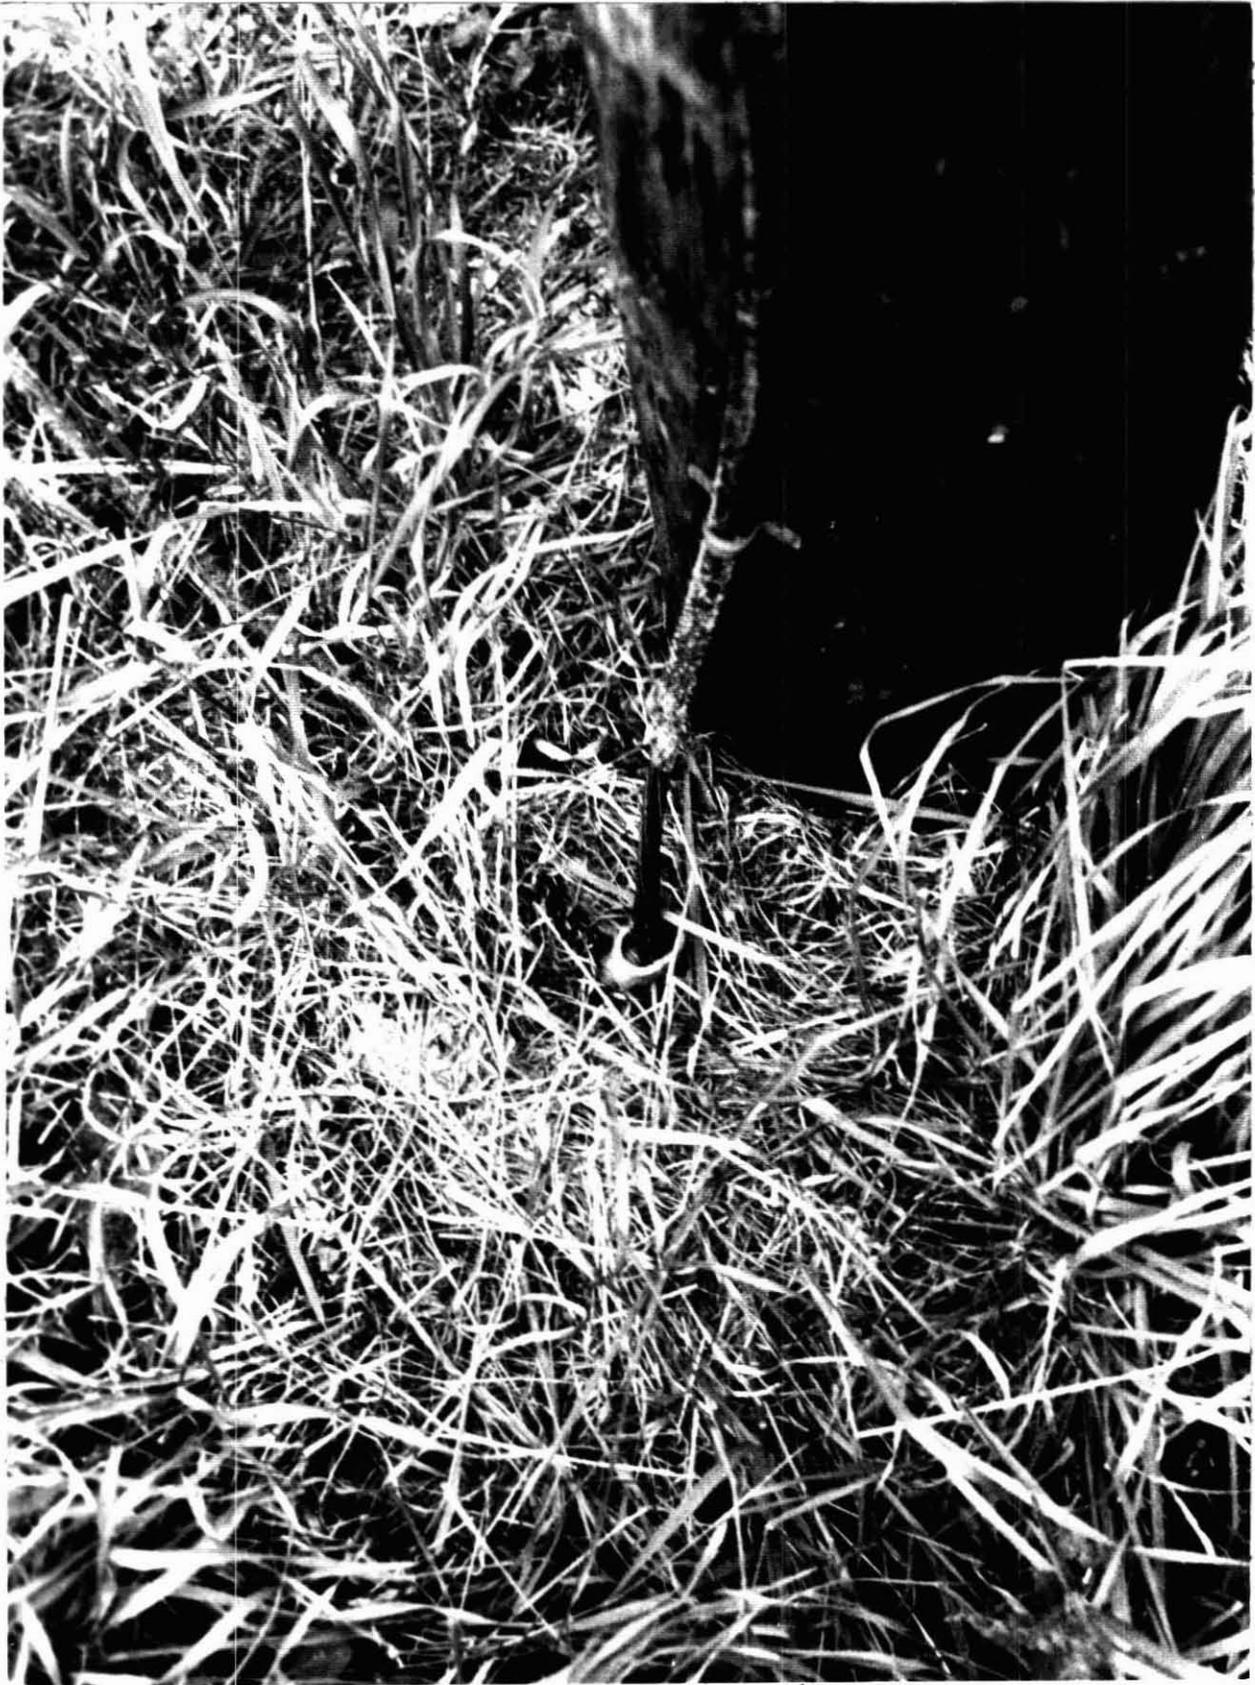
FIGURE 4.22. - Static wire ground at pole base near sand dredge.

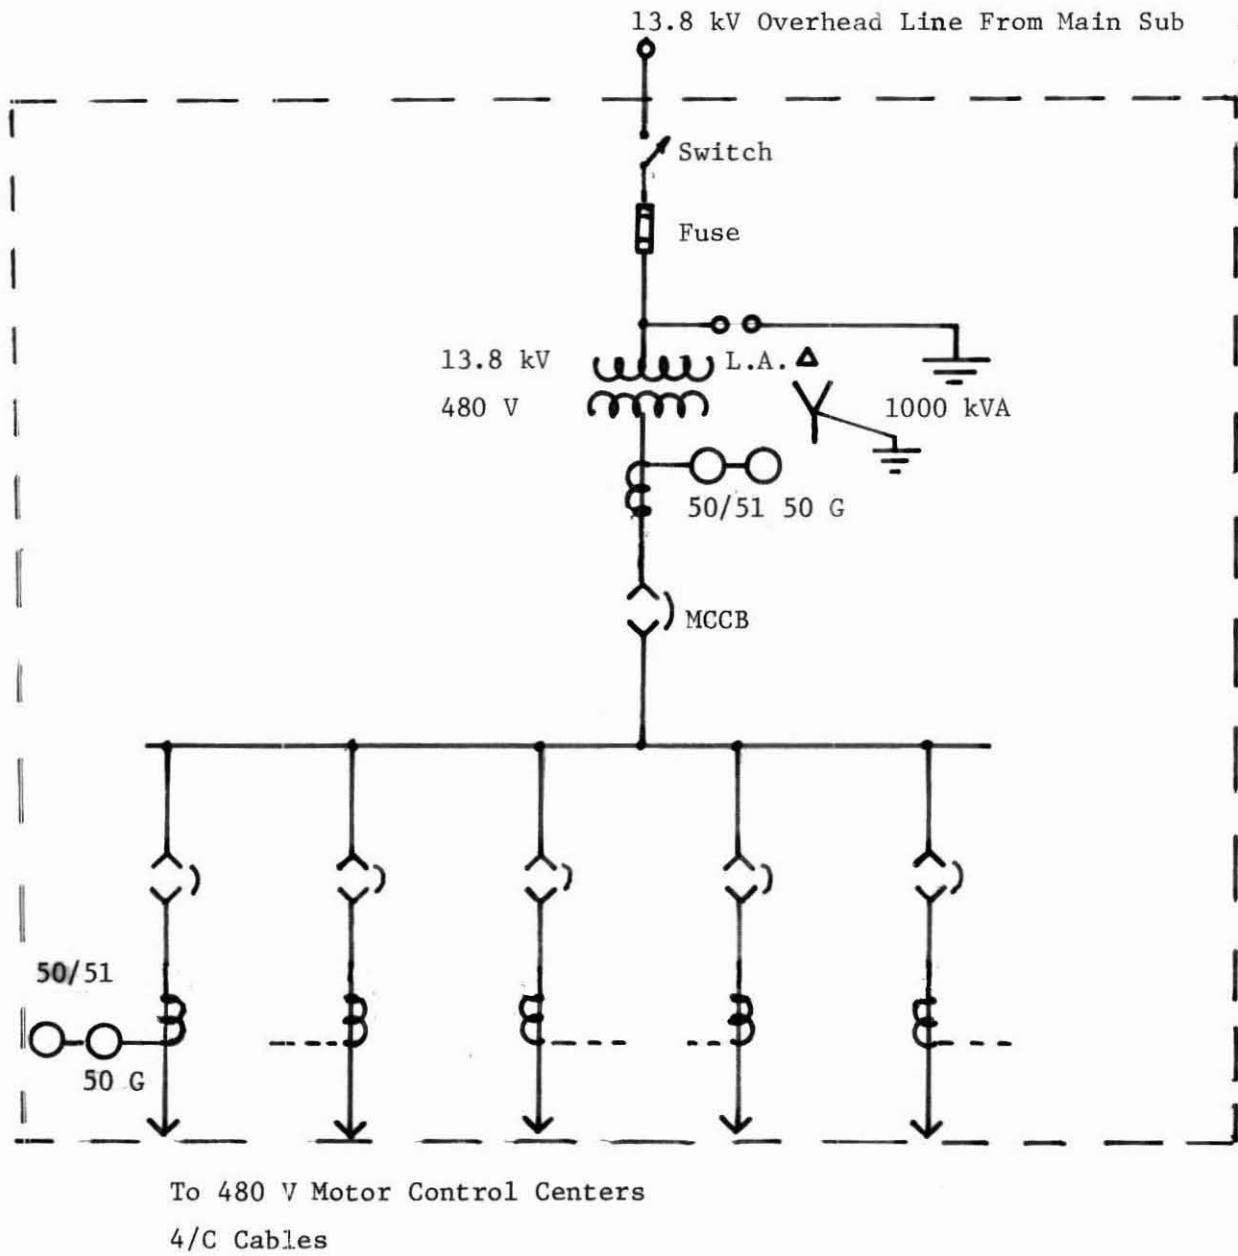
FIGURE 4.23.- Plant substation.

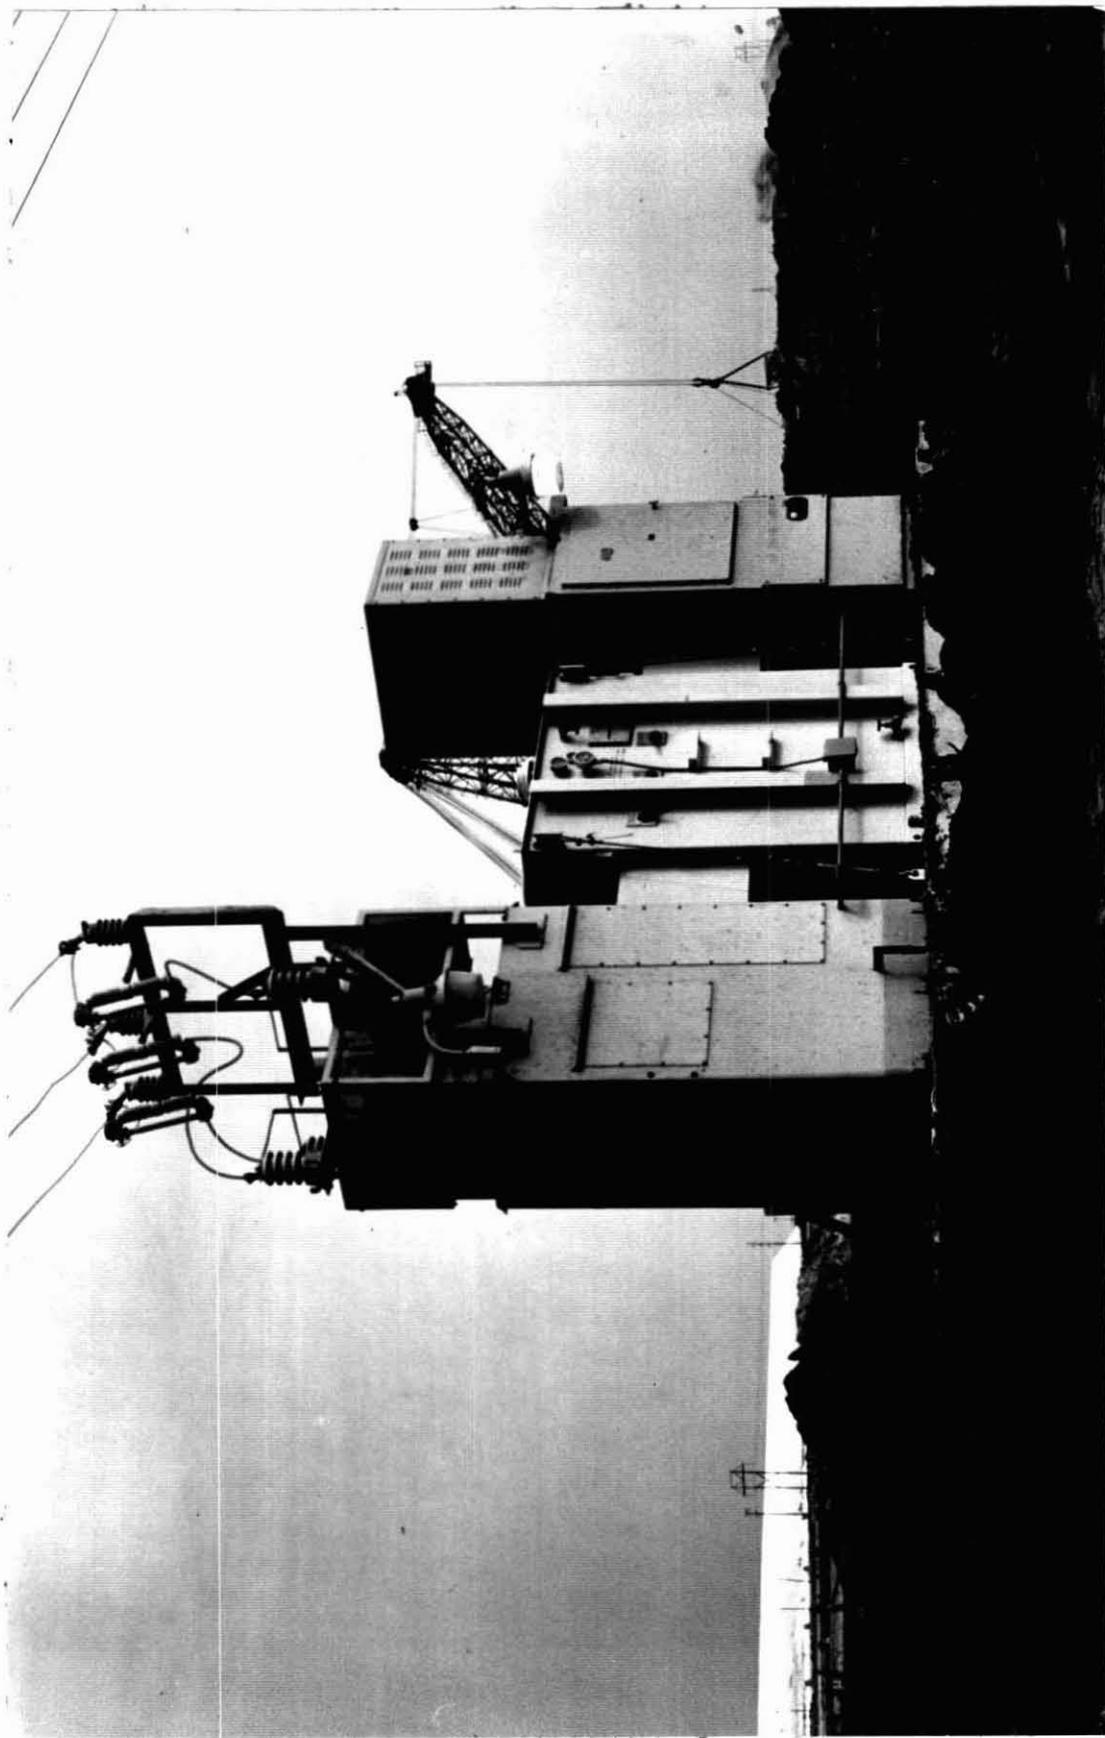
FIGURE 4.24. - Skid mounted substation at phosphate mine.

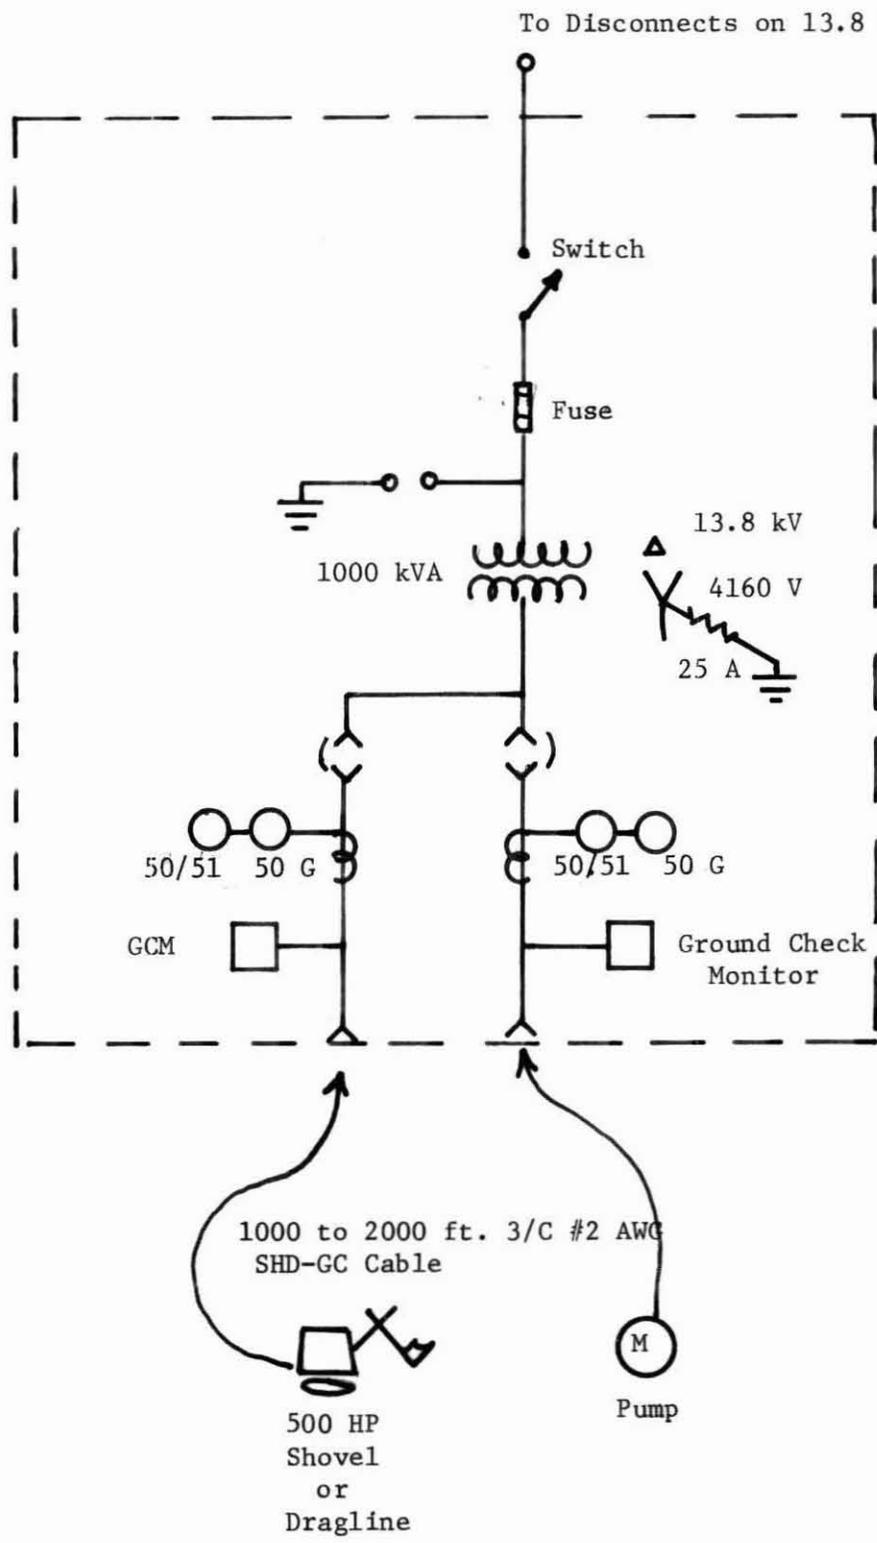
FIGURE 4.25. - Pit substation.

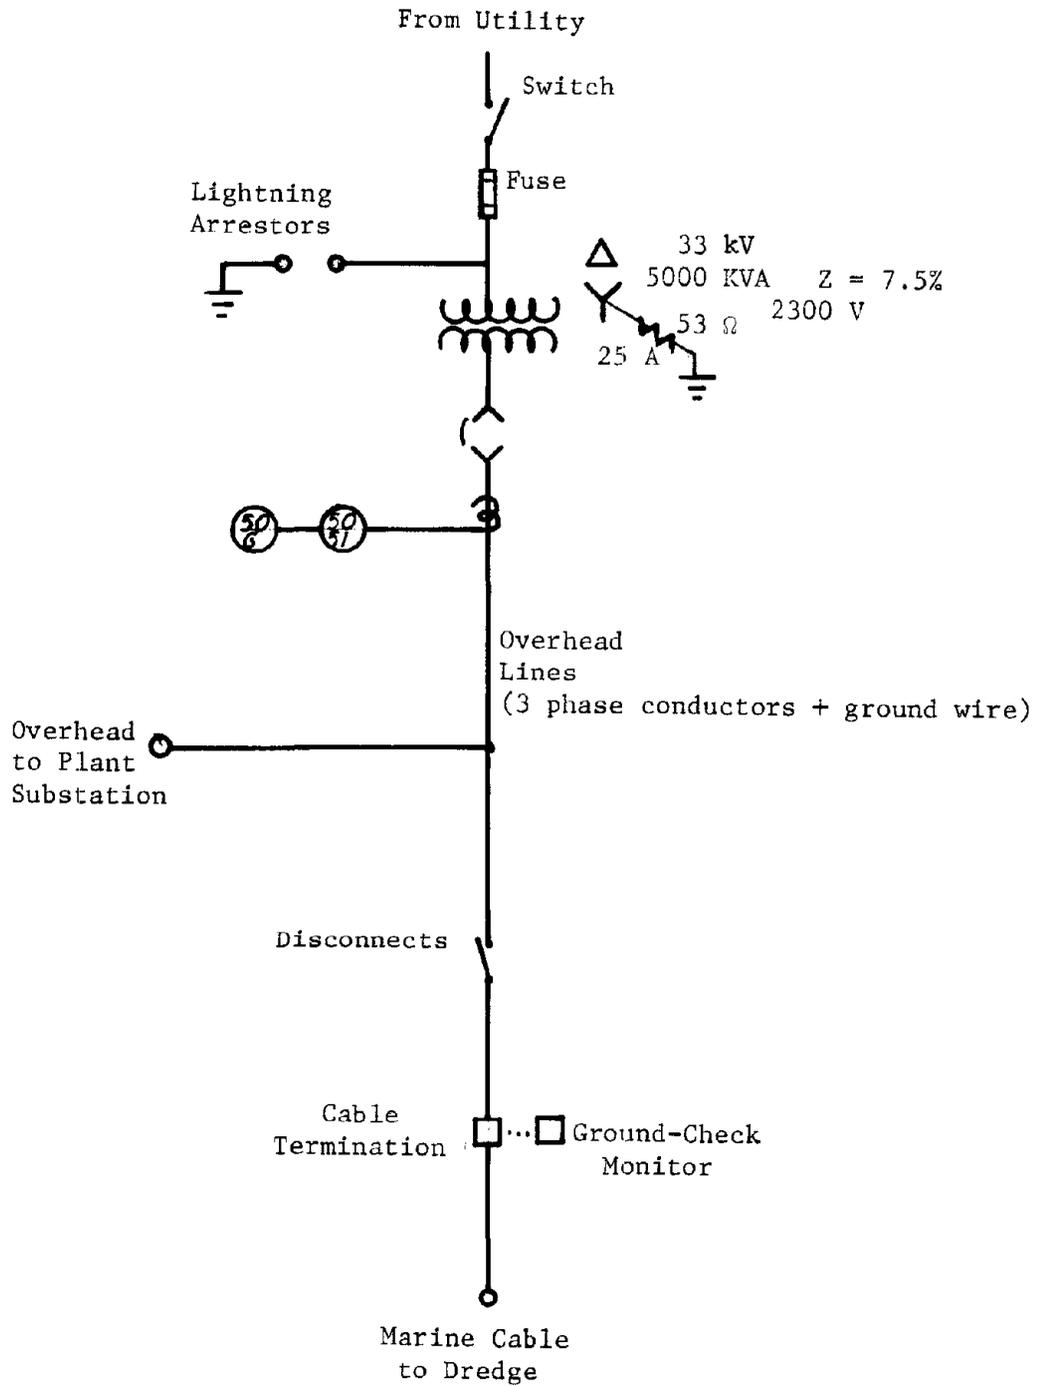
FIGURE 4.27. - One-line diagram of main substation.
