**DEVELOP GROUNDING
PRACTICES
FOR
METAL/NON-METAL MINES**

Bureau of Mines Open File Report 154-81

Contract J0308025
West Virginia University

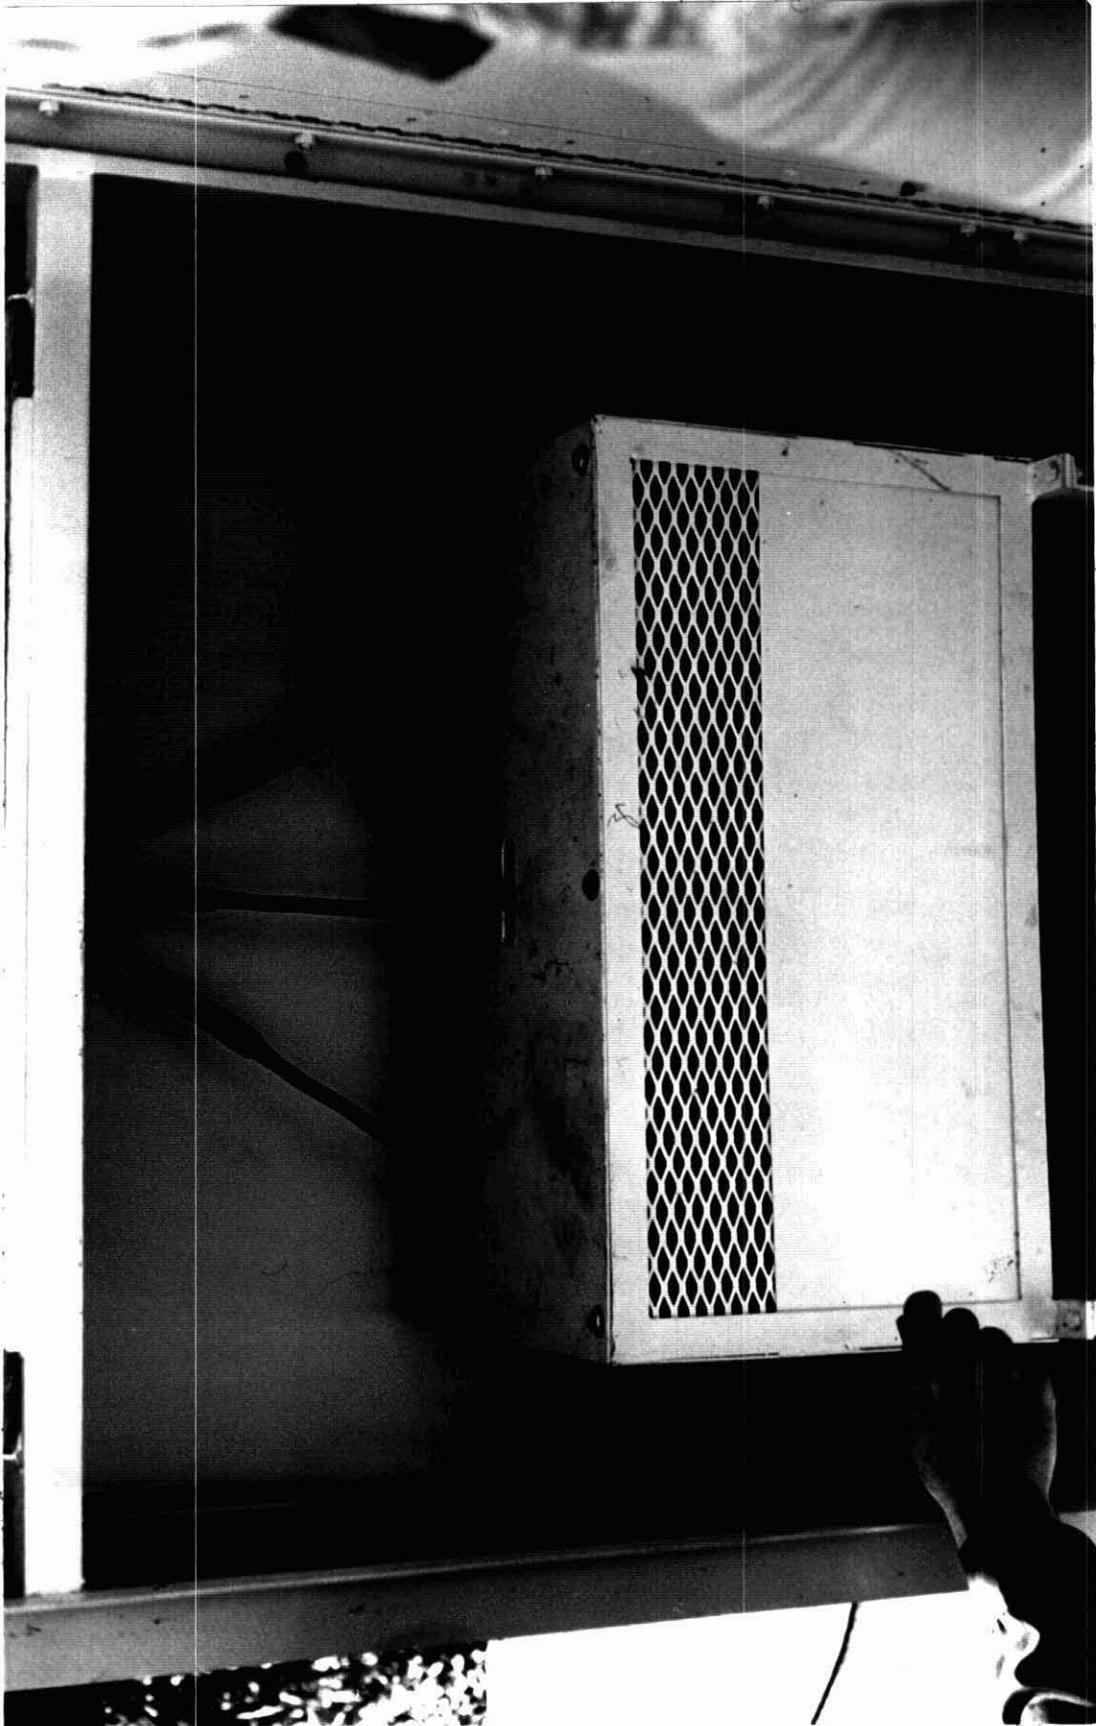
FIGURE 4.28. - Zig-zag transformer at sand dredge.

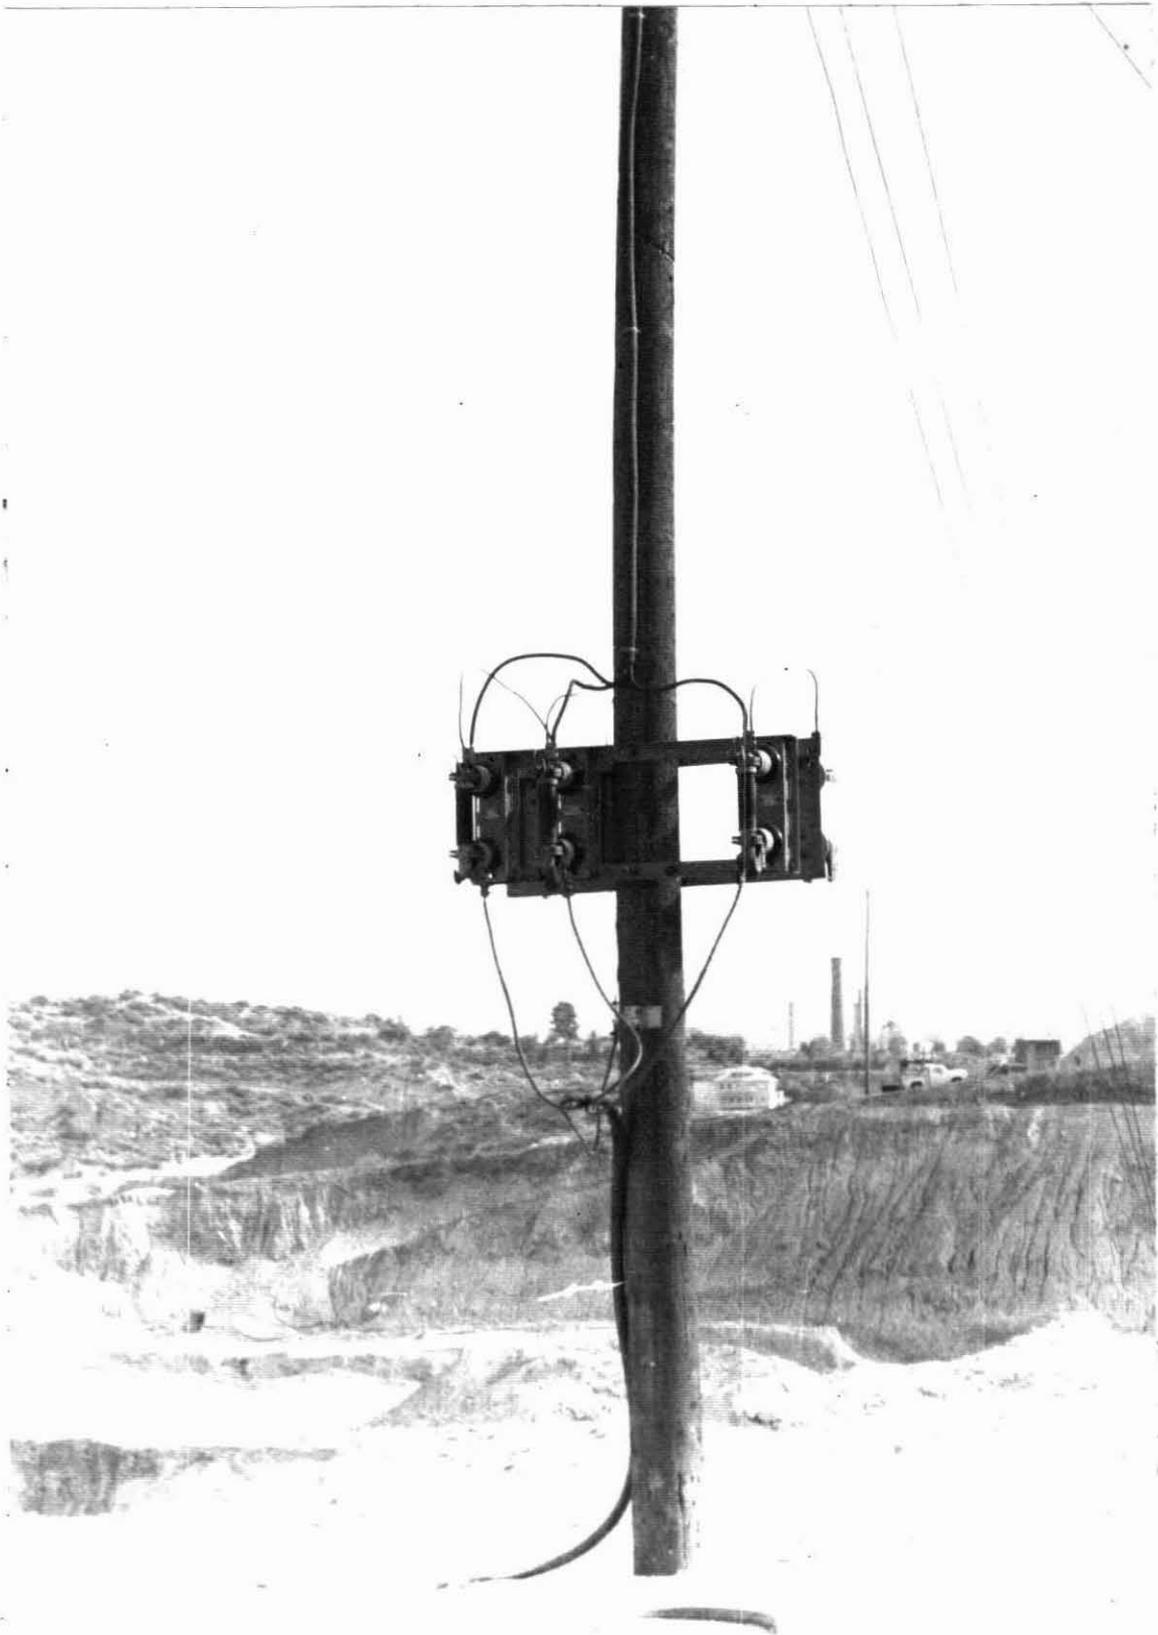
FIGURE 4.29. - Pothead at surface copper mine.

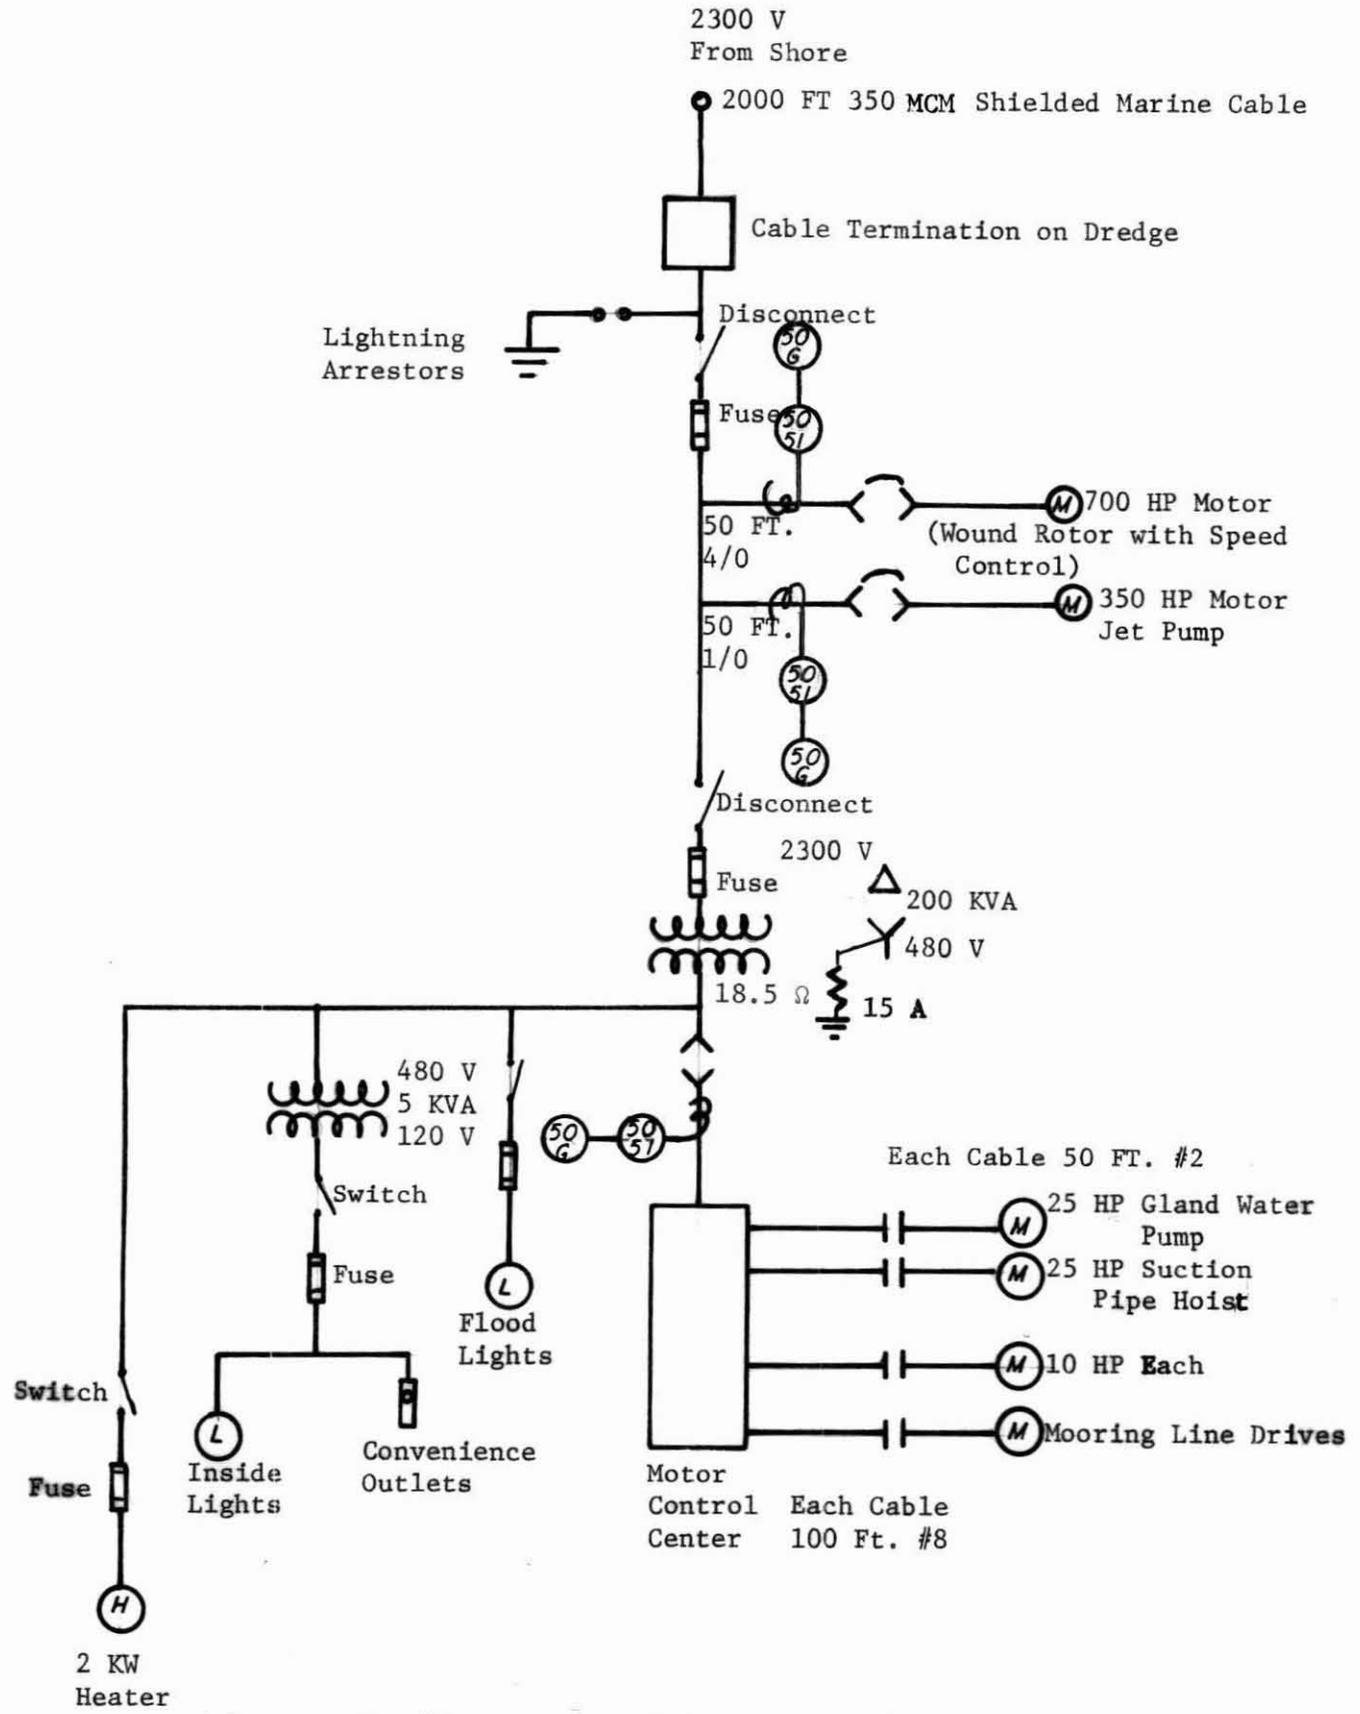
FIGURE 4.30. - One-line diagram of dredge power system.

A detailed diagram of the power system on the dredge is given in Figure 4.30. The suction dredge is equipped with a 350 hp motor driving a jet pump to produce a high-pressure water stream for breaking loose in-situ material beneath the surface of the dredge pond. This material is then drawn up by the suction pump through a large-diameter pipe and transported to shore via the pontoon-mounted pipeline. In this case the suction pump is driven by a 700 hp wound-rotor motor equipped with a "liquid controller" for speed adjustment. The "liquid-controller" is a tank filled with water and soda ash into which are placed three fixed and three movable grids, as shown in Figures 4.31 and 4.32. By varying the separation between the two sets of grids, the total resistance of the motor field circuit is adjusted to achieve speed control. Operators in hot humid climates have found that this method of control is much more compact and reliable than the more conventional system, which uses large banks of resistor grids switched into or out of the circuit by contactors. Both of these large motors are run at 2300 V, and include both phase overcurrent (instantaneous and time-delay) as well as ground-fault protective relaying. A small three-phase transformer mounted on the dredge steps down the 2300 V feed to 480 V for use by the remaining motors, which are fed through a motor control center (MCC). The transformer is connected delta-wye, and includes a resistance-grounded neutral to limit

ground fault current to 15 A or less. Large flood-lights mounted on the exterior of the dredge for night-time operation are also powered at 480 V, and a small single-phase transformer provides several 120 V circuits for interior lighting and convenience outlets.

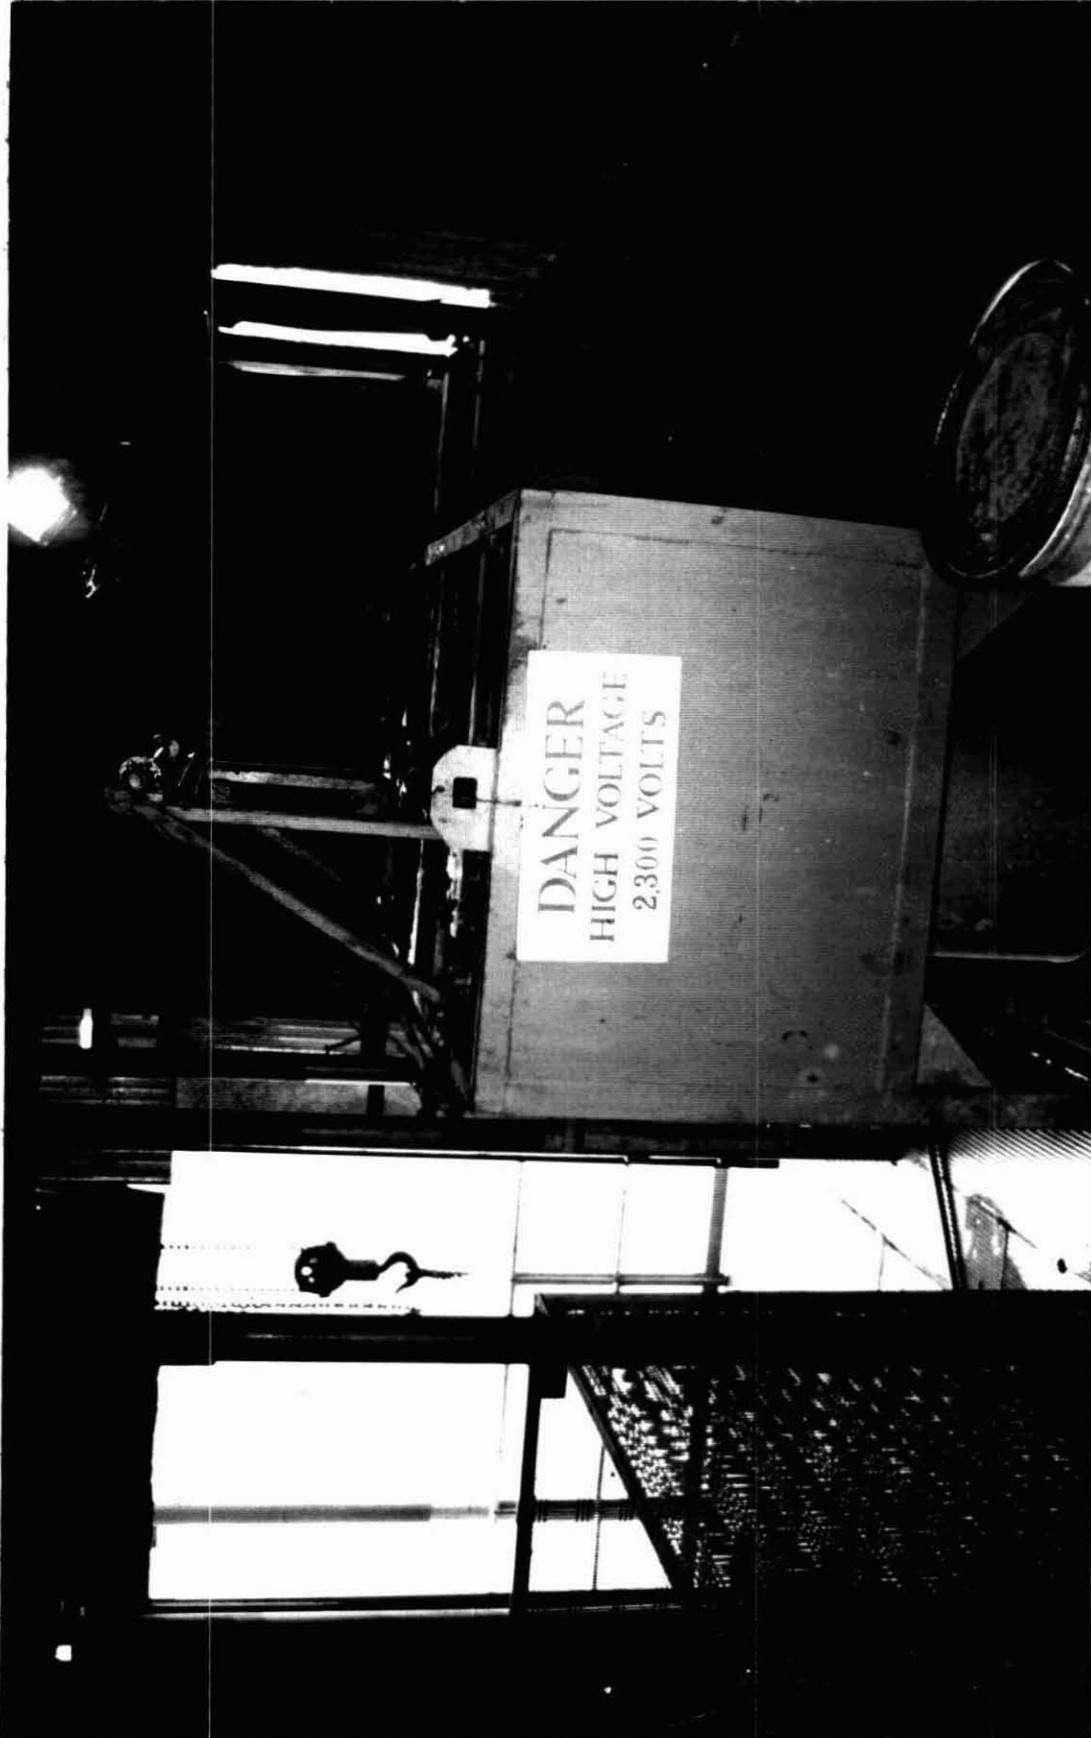
FIGURE 4.31. - "Liquid controller" at sand dredge.

FIGURE 4.32. - "Liquid controller" at sand dredge.

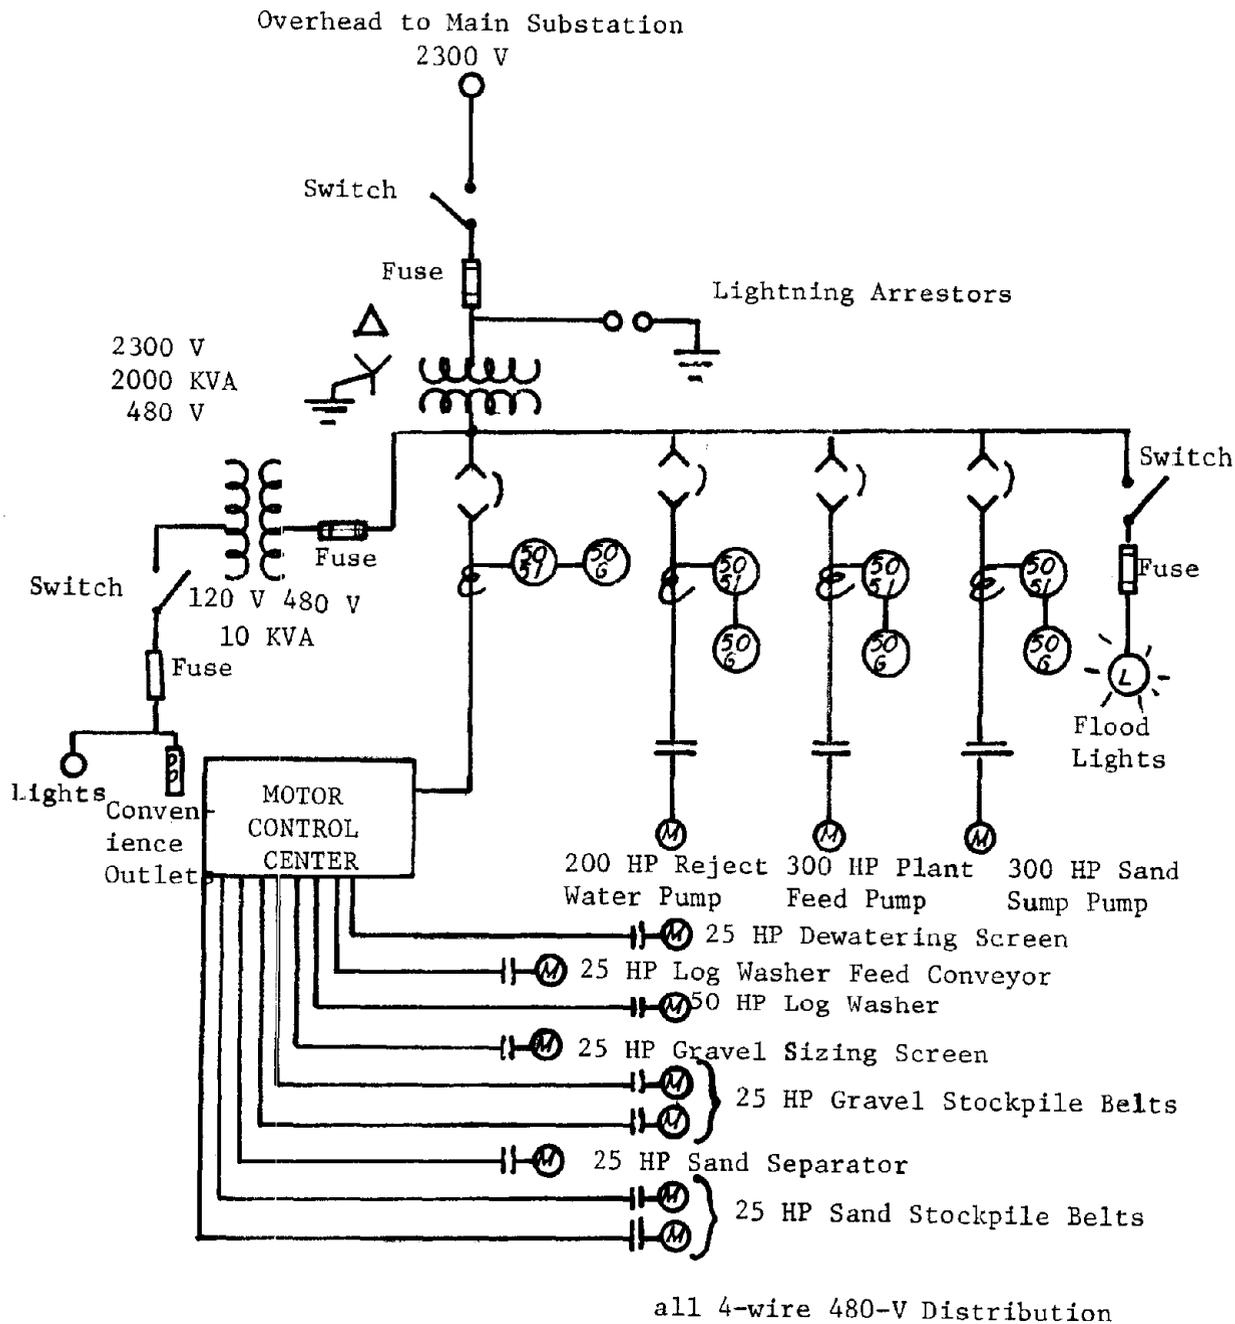
FIGURE 4.33. - One-line diagram of plant Power System.

The processing plant wiring diagram is shown in Figure 4.33. The 4-wire overhead distribution at 2300 V is reduced to 480 V by a transformer connected delta-wye, with a solidly-grounded secondary. Several very large pump motors are fed by individual 480 V circuits, each of which is equipped with protective relaying, while the remaining motor loads are fed from a centrally-located motor control center. The main flood-lights are powered at 480 V, and a small transformer is included for convenience outlets and lighting loads. All 480 V motors are fed by a 4-wire distribution system (3 phase conductors plus a grounding conductor), with the ground bed at the plant substation connected to this grounding conductor and to the frames of all plant equipment. In turn, this ground mat is tied to the main substation ground bed (and therefore to the dredge) by the ground conductor (static wire) of the 2300 V overhead distribution.

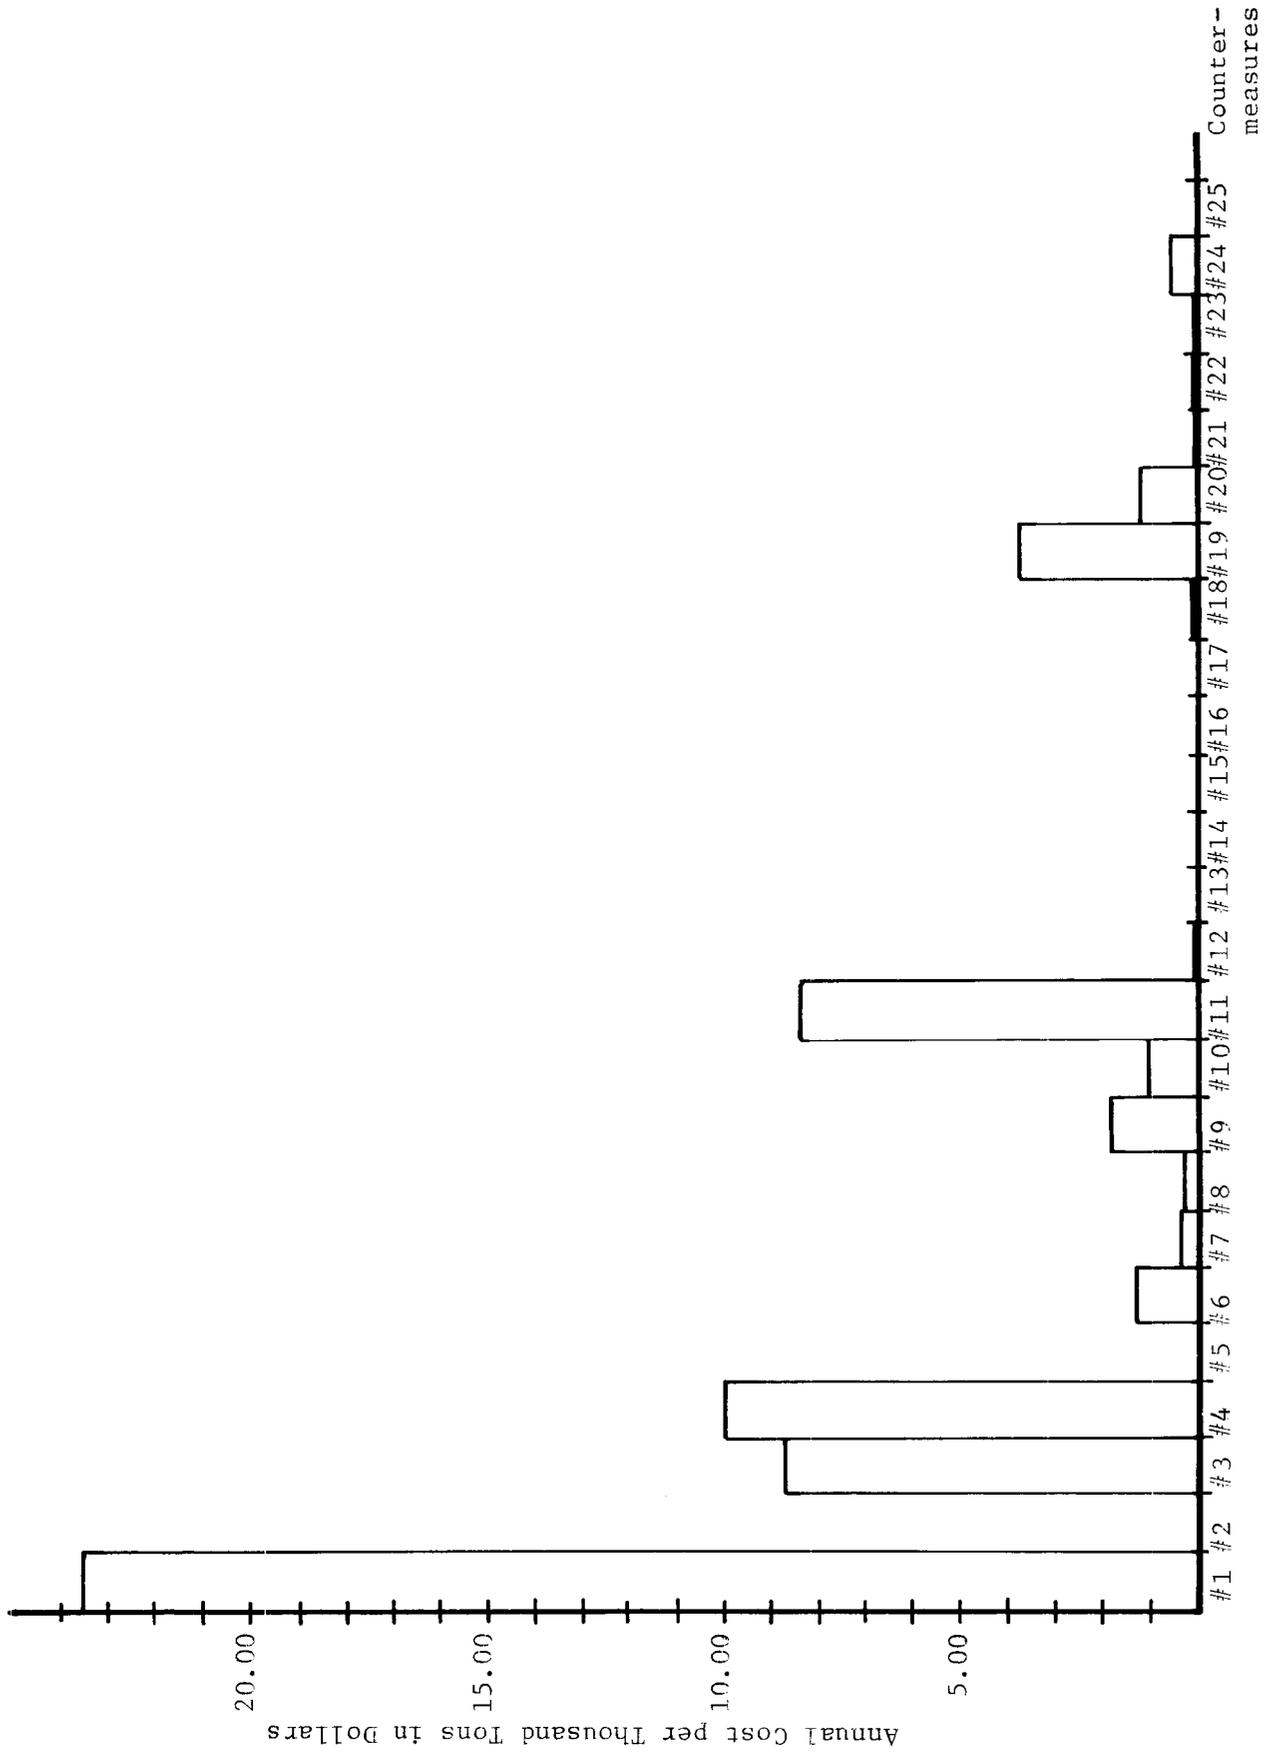
FIGURE 6.1. - Underground hard rock mine.

The primary value of these three bar graphs is in providing a rapid visual comparison of the relative costs of the various countermeasures for a given type of mining operation (i.e. deep mine, dredge, surface mine). The cost information for any particular countermeasure of interest can be quickly identified and then used in conjunction with corresponding information in chapter V to make careful cost-benefit comparisons.

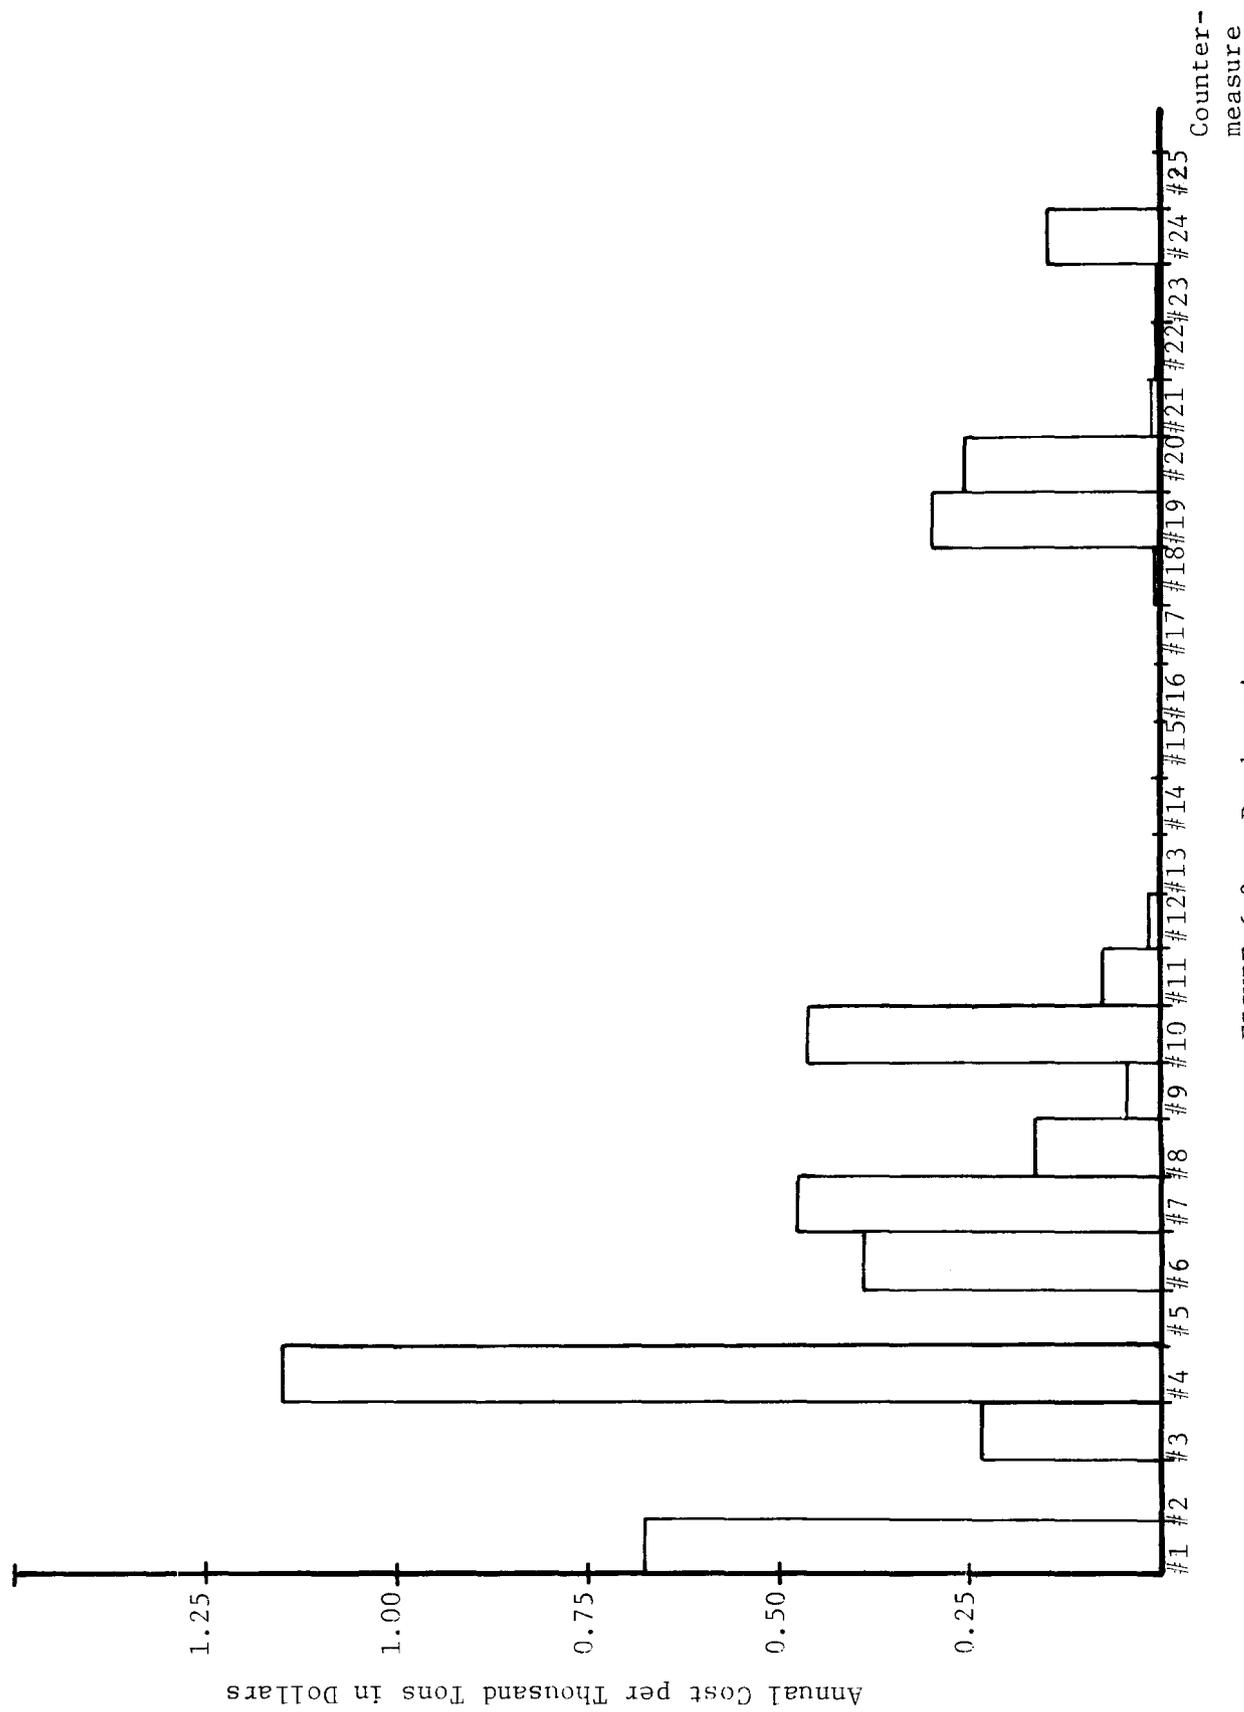
FIGURE 6.2. - Dredge mine.

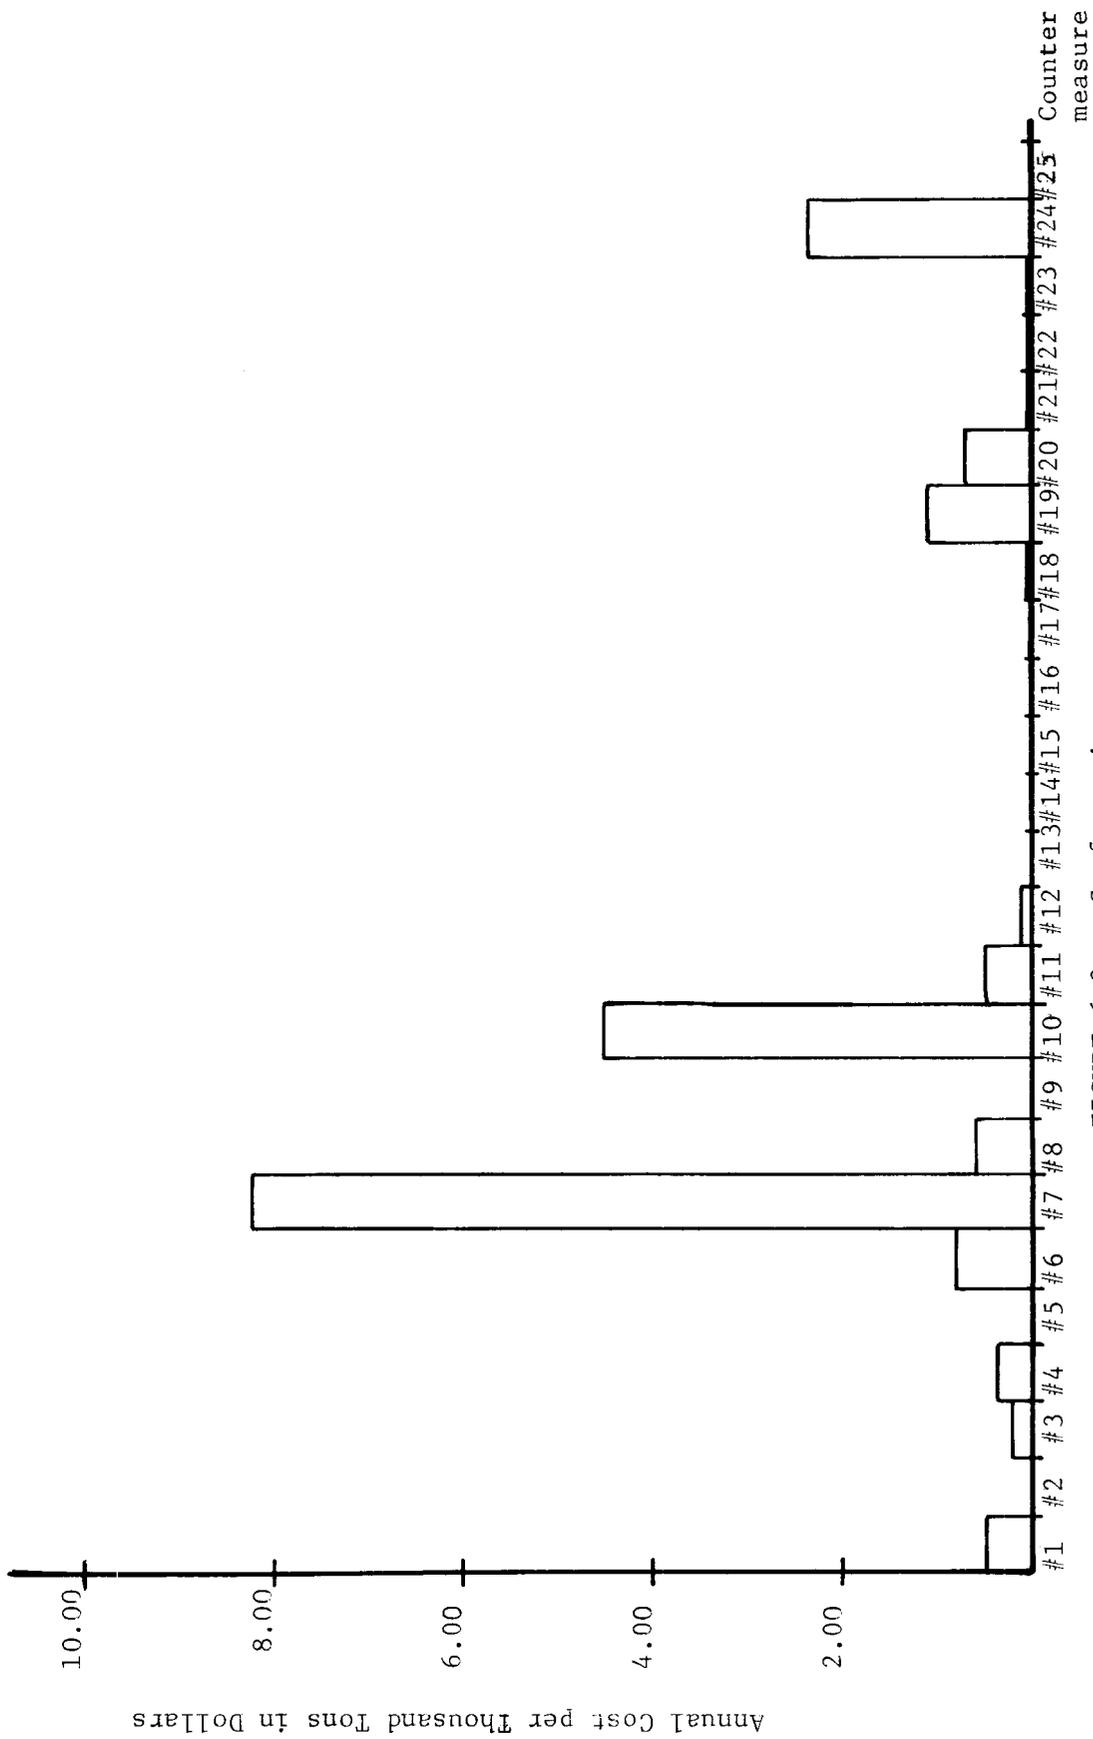
FIGURE 6.3. - Surface mine.

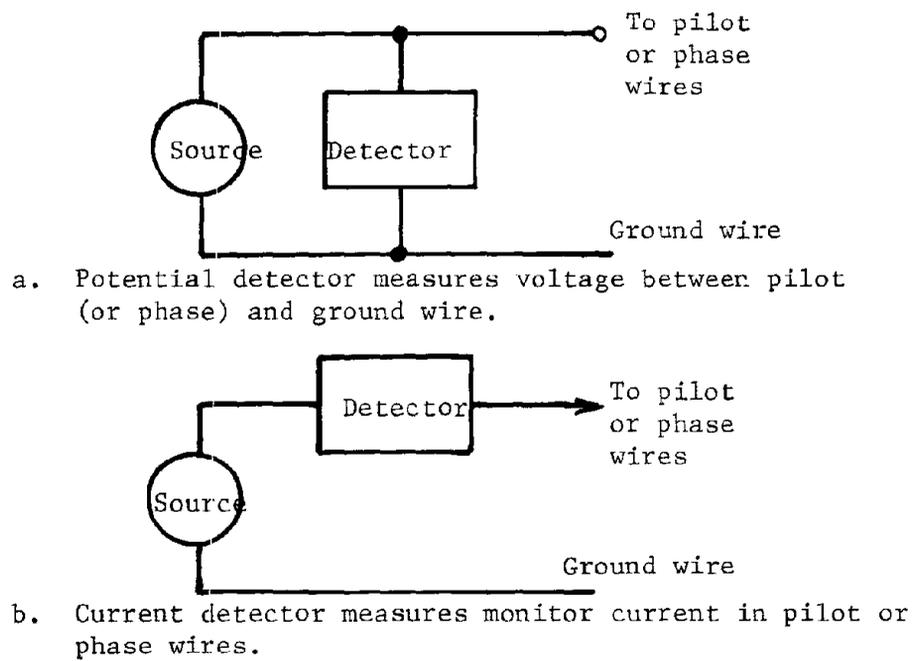
FIGURE 9.1. - Type I monitors.

There are three monitor configurations of interest. For the Thevenin equivalent circuit type (Type I) the monitoring signal source is between the pilot and ground wires and the detector either measures the voltage between the pilot and ground or the current in the pilot wire. This type is shown in Figure 9.1. The Thevenin equivalent circuit type measures the impedance between the pilot wire and the ground wire connections. In as much as a parallel path shunts the ground wire, a low impedance parallel path may mask a break in the ground wire. This problem may be overcome by

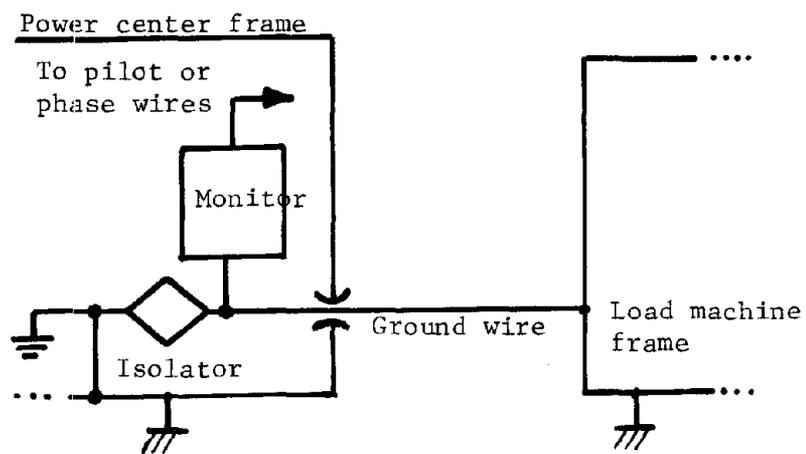
FIGURE 9.2. - An isolator may be used to isolate the ground wire from the earth at the power center.

the use of a ground wire isolator as shown in Figure 9.2.

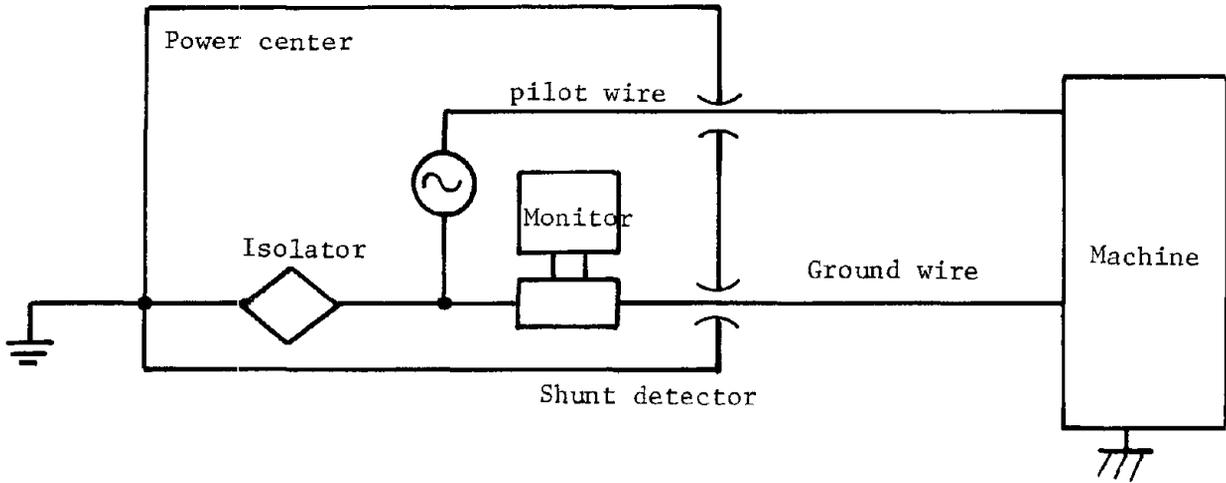
FIGURE 9.3. - A type II monitor with an isolator.

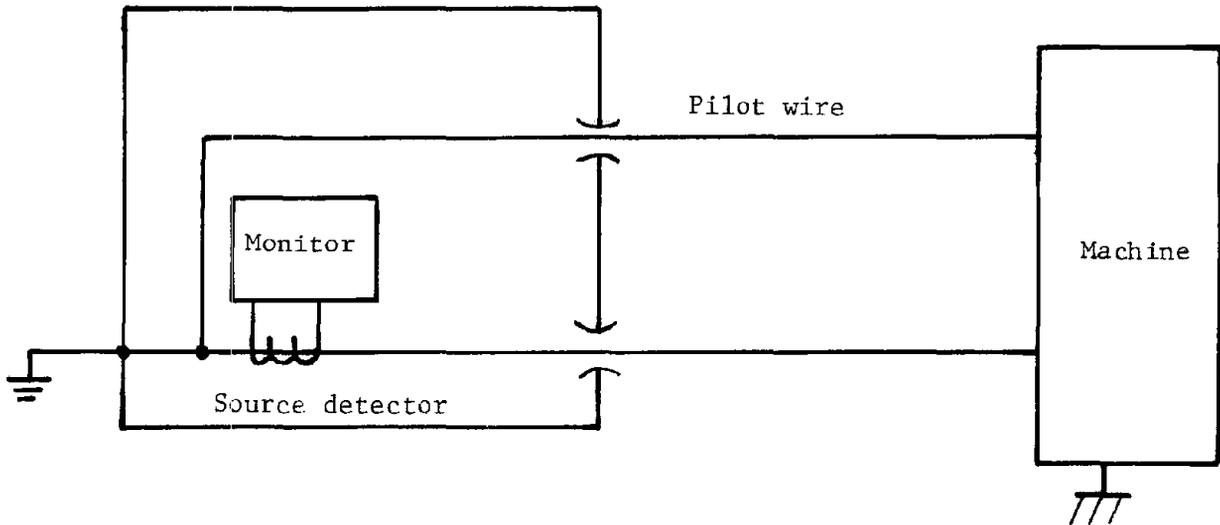
FIGURE 9.4. - A type III monitor.

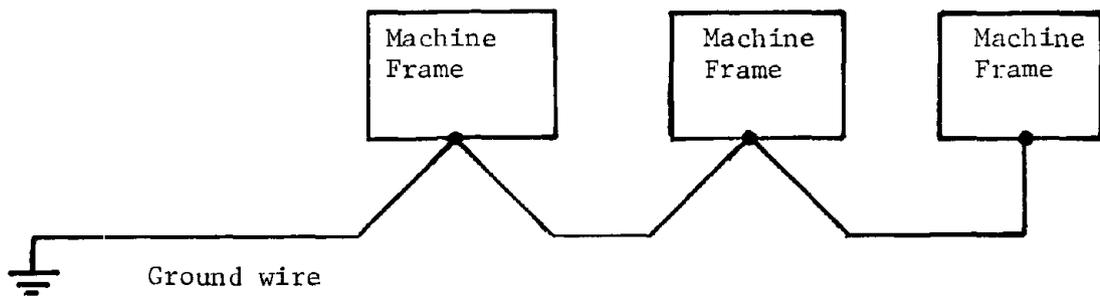
FIGURE 9.5. - Multiple machine frames connected to a ground wire.

The accidental contacts can be eliminated by using an insulated ground wire, and extraneous equipment connected to the ground wire should be eliminated. However, any piece of equipment which, because of its proximity to phase conductors might become energized due to a fault, must be considered

separately. Failure to ground this equipment leaves personnel vulnerable in the case of a fault, while grounding this equipment will nullify certain aspects of the ground check monitor. Under consideration here is any piece of equipment in intimate contact with a power cable including cable hangers and floats for dredge cables.

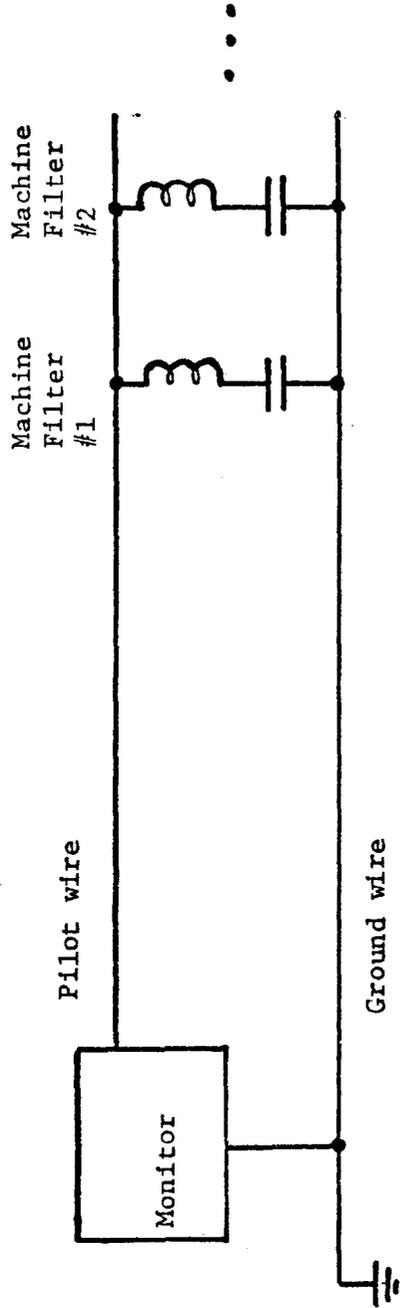
FIGURE 9.6. - A multipath monitor for monitoring multiple machine frames.

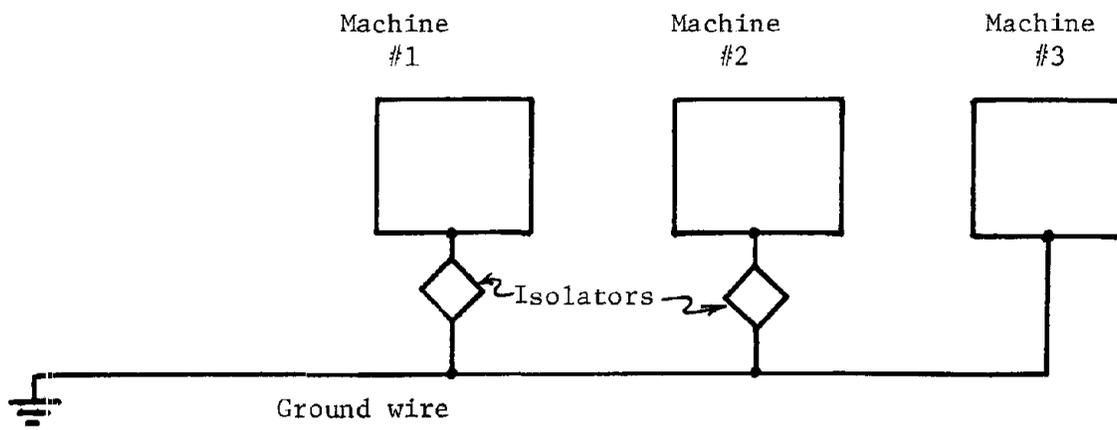
FIGURE 9.7. - Multiple frames grounded through isolators.

A second solution is to use isolators from the float to the ground wire. This will allow monitoring of the ground wire and will also prevent current

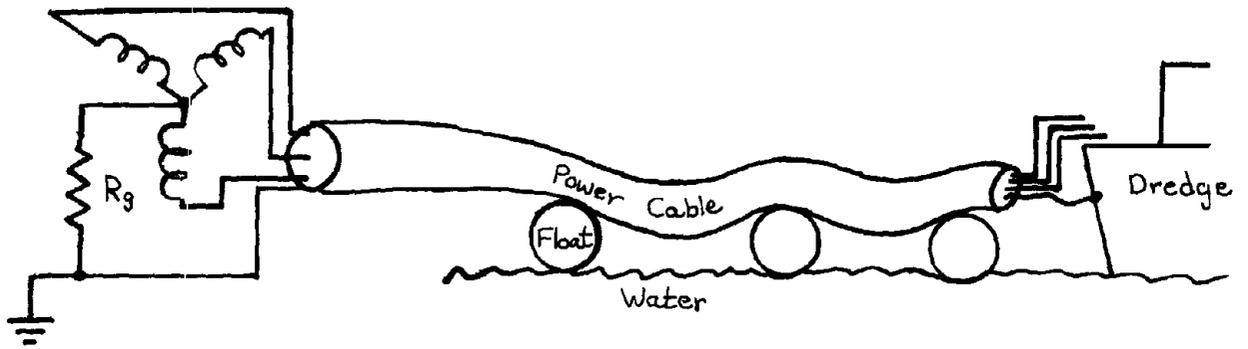
FIGURE 9.8. - A typical power system for a dredge.

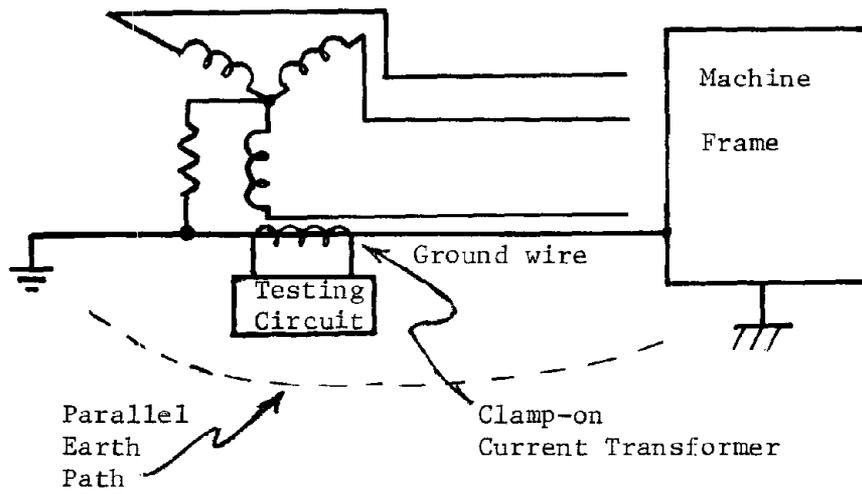
FIGURE 9.9. - A simple system to be tested for ground wire continuity.

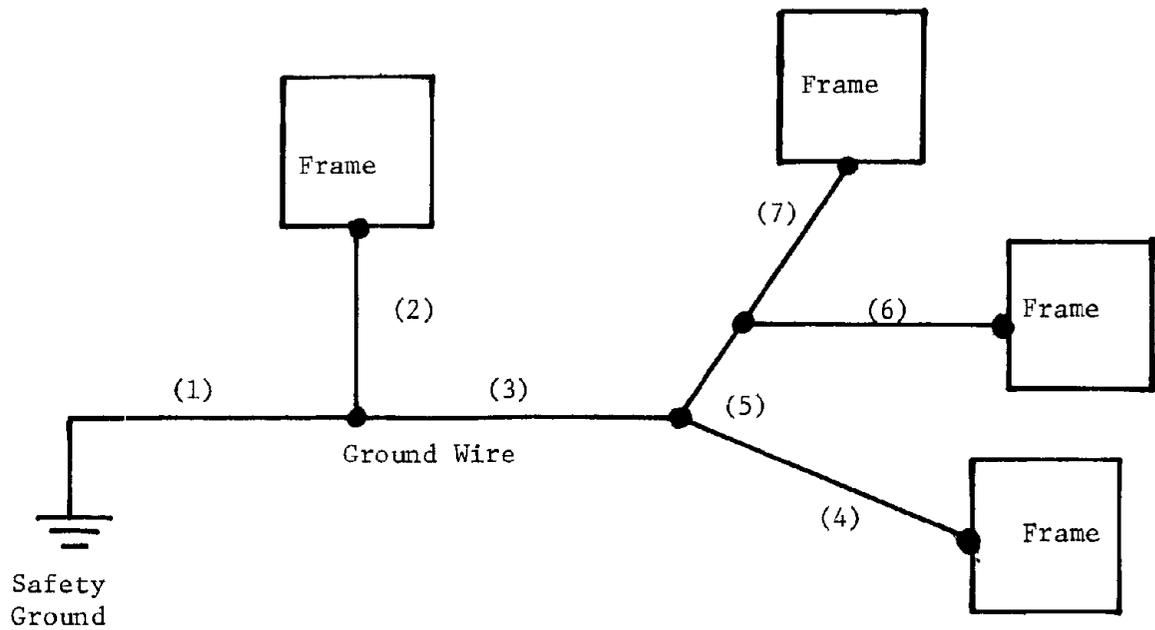
FIGURE 9.10. - Tree arrangement for grounding multiple frames. In this case, seven branches must be tested.

In cases where multiple machine frames are to be grounded, the connections are to be made in a tree or fan type arrangement as shown in Figure 9.10. Each branch of the tree is to be measured individually. This method is a

modification of the separate ground wire for each machine method. The results are identical.
