**DEVELOP GROUNDING
PRACTICES
FOR
METAL/NON-METAL MINES**

Bureau of Mines Open File Report 154-81

Contract J0308025
West Virginia University

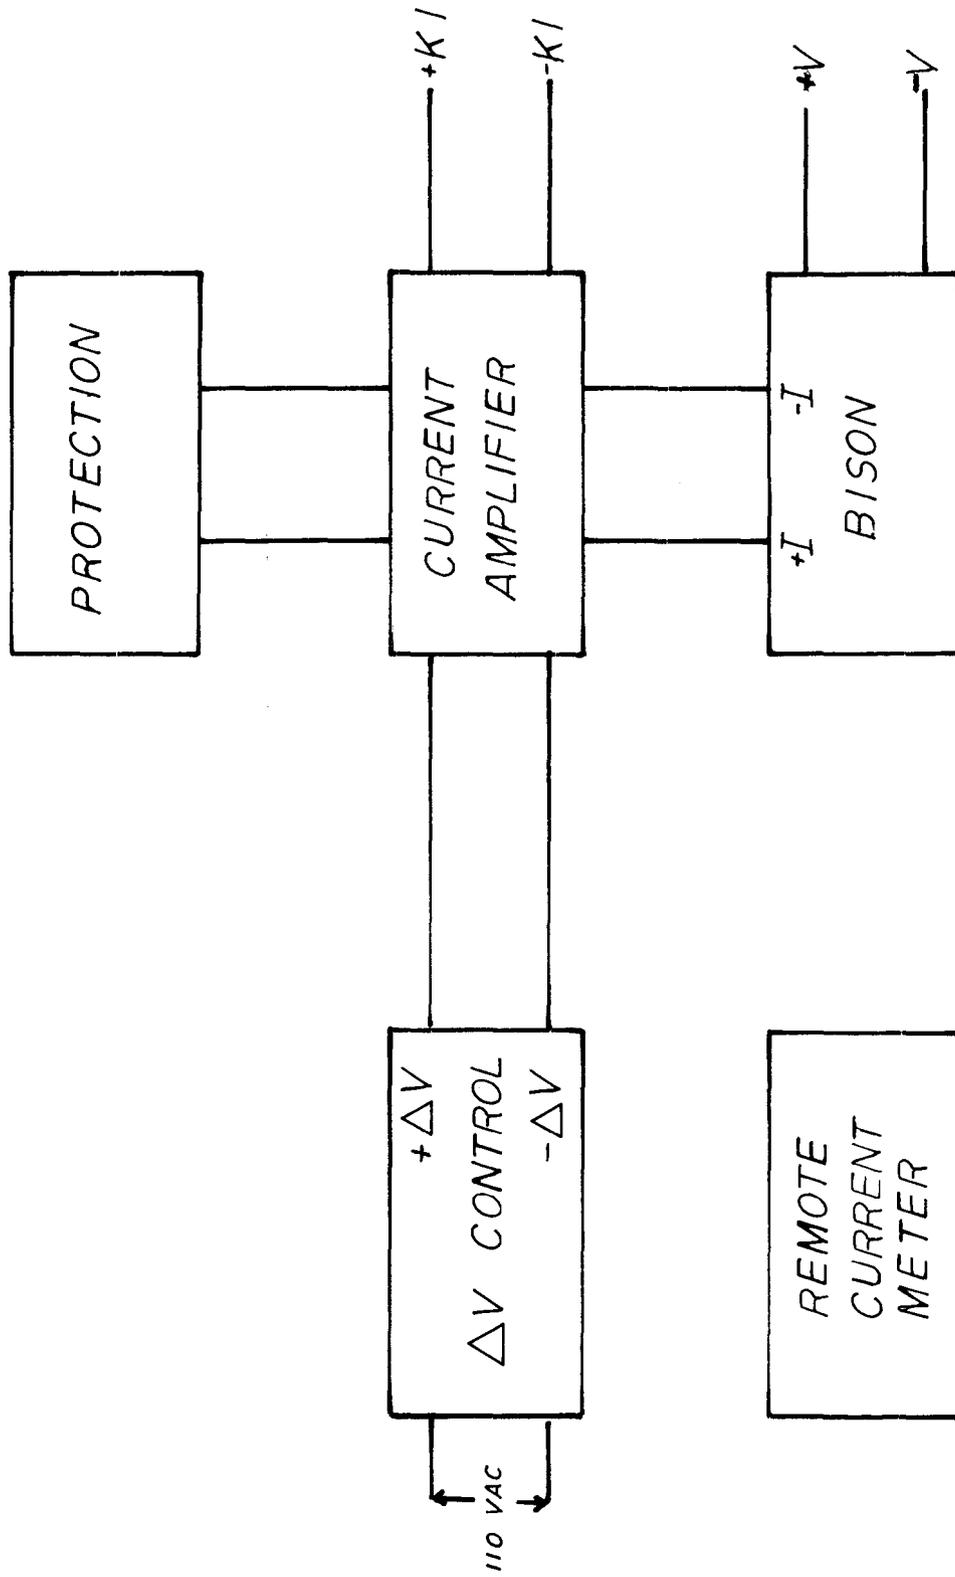
FIGURE B.1. - Block diagram of the CERTS.

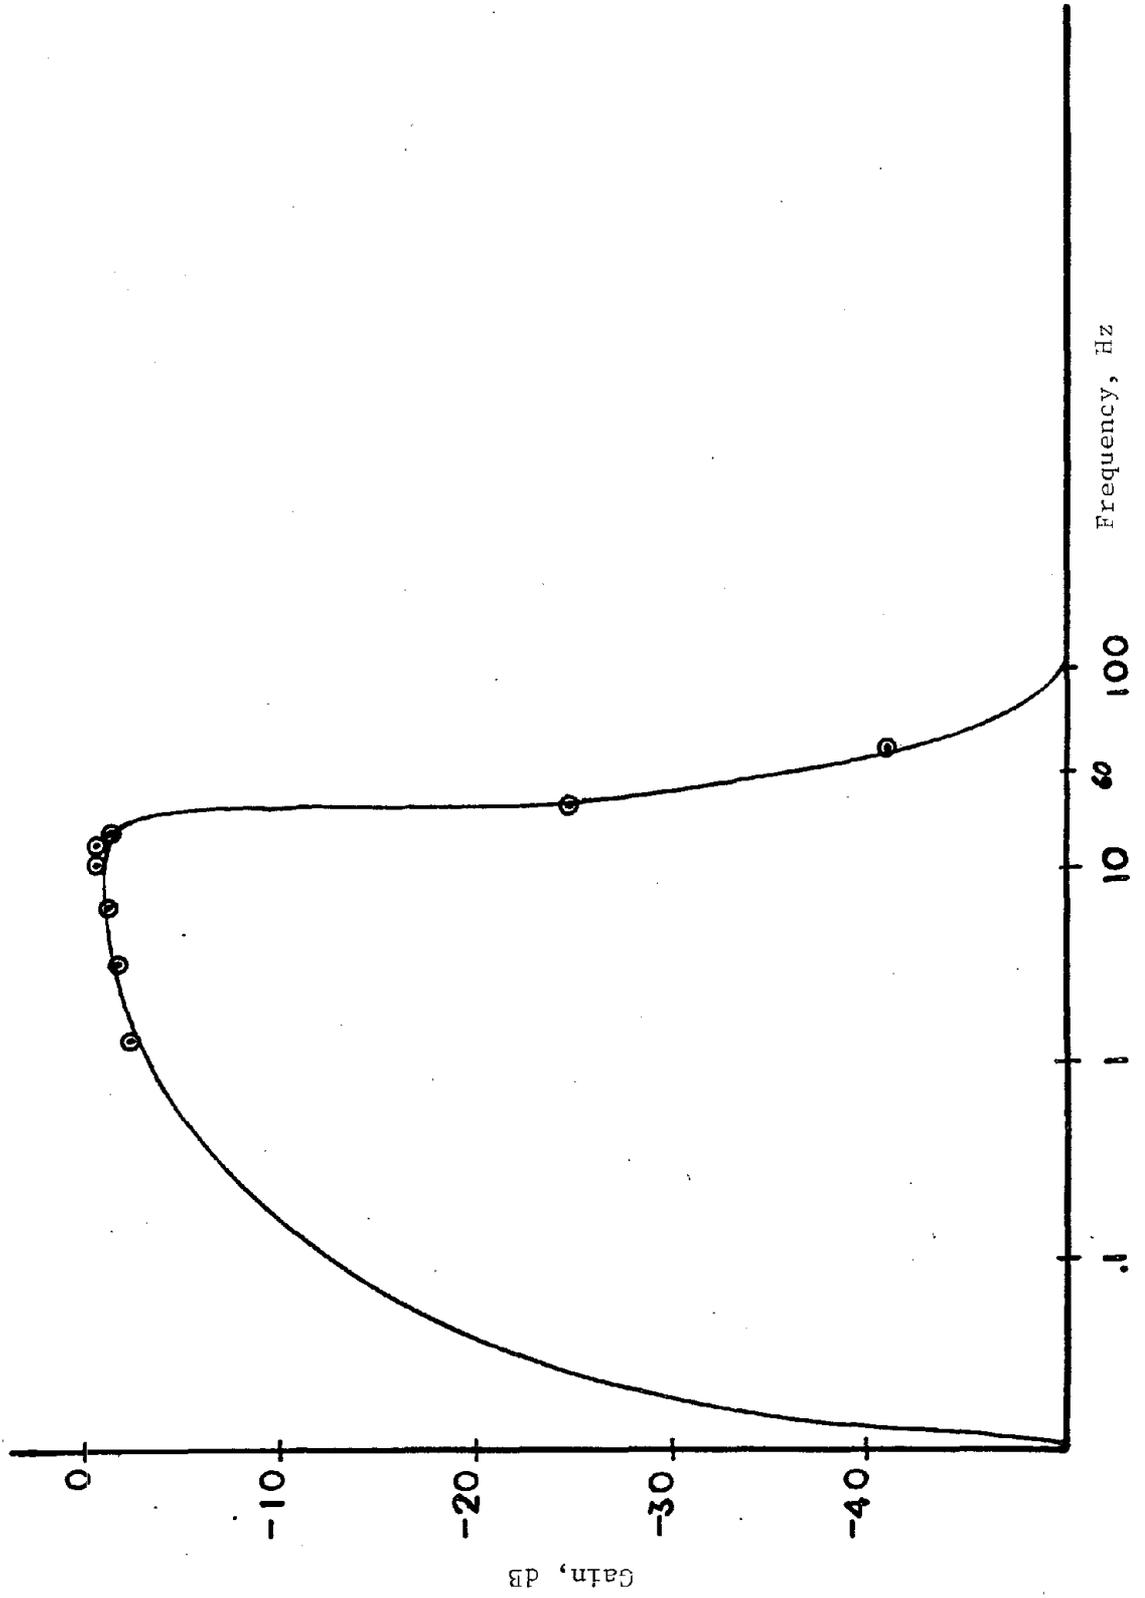
FIGURE B.2. - CERTS 11 Hz filter response.

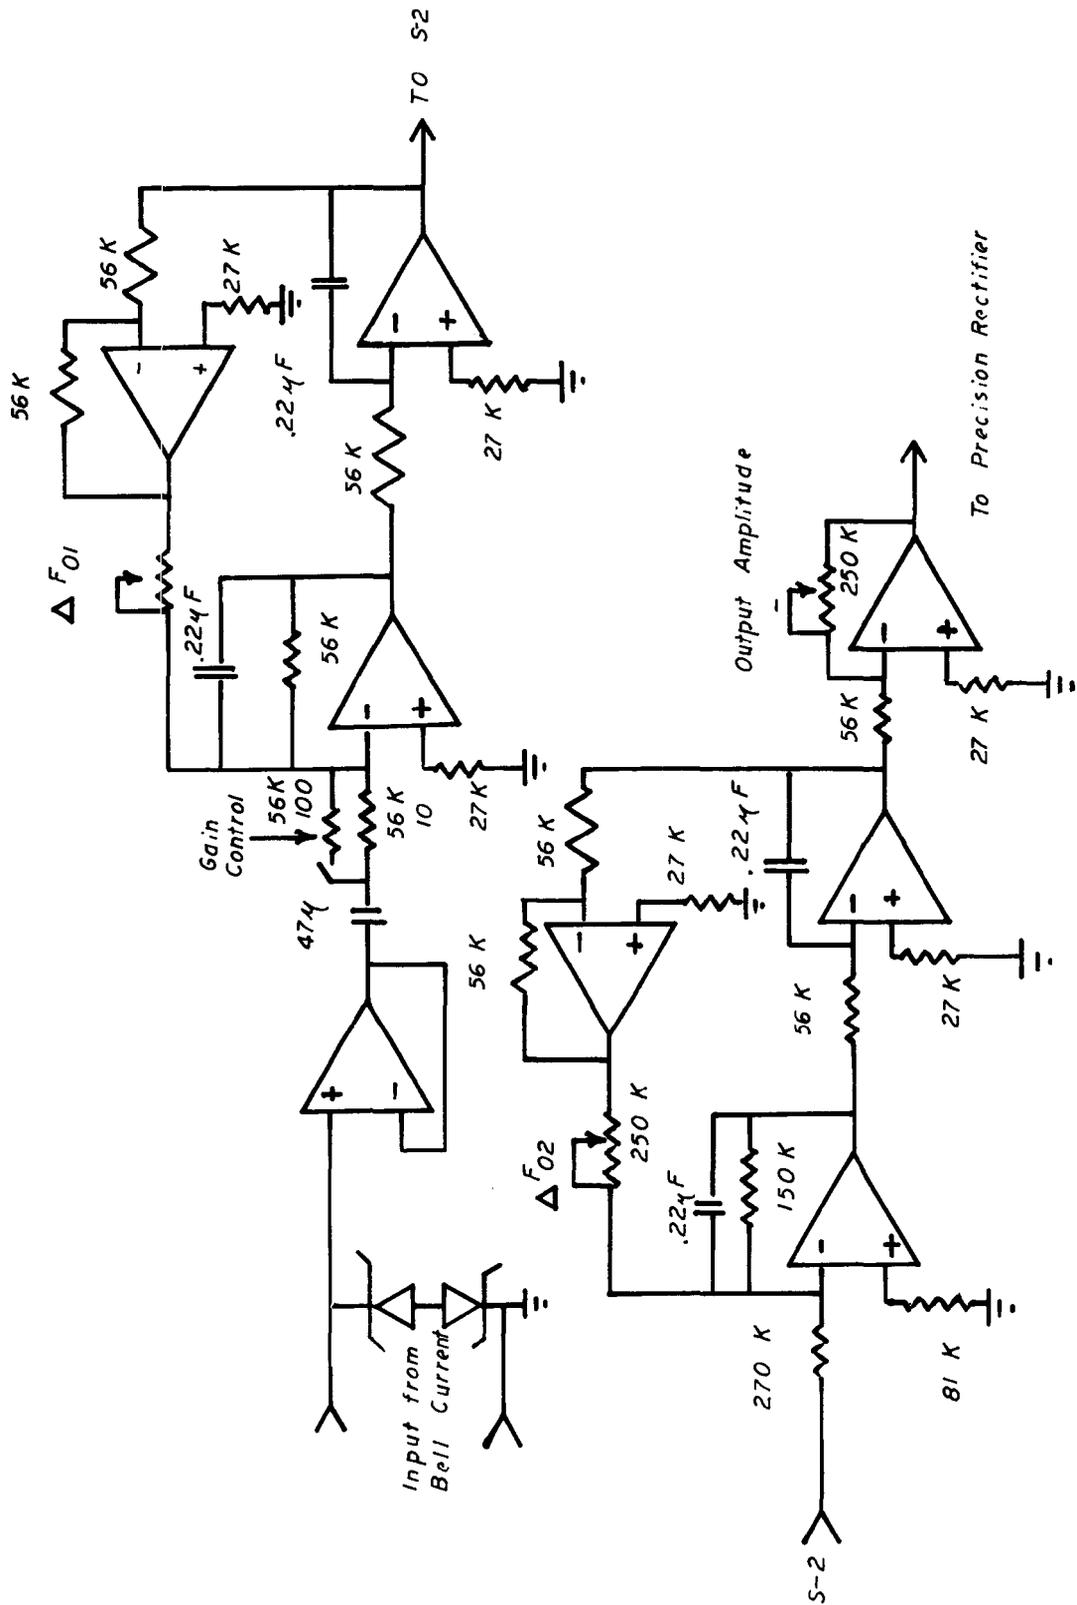
FIGURE B.3. - CERTS 11 Hz filter schematic.

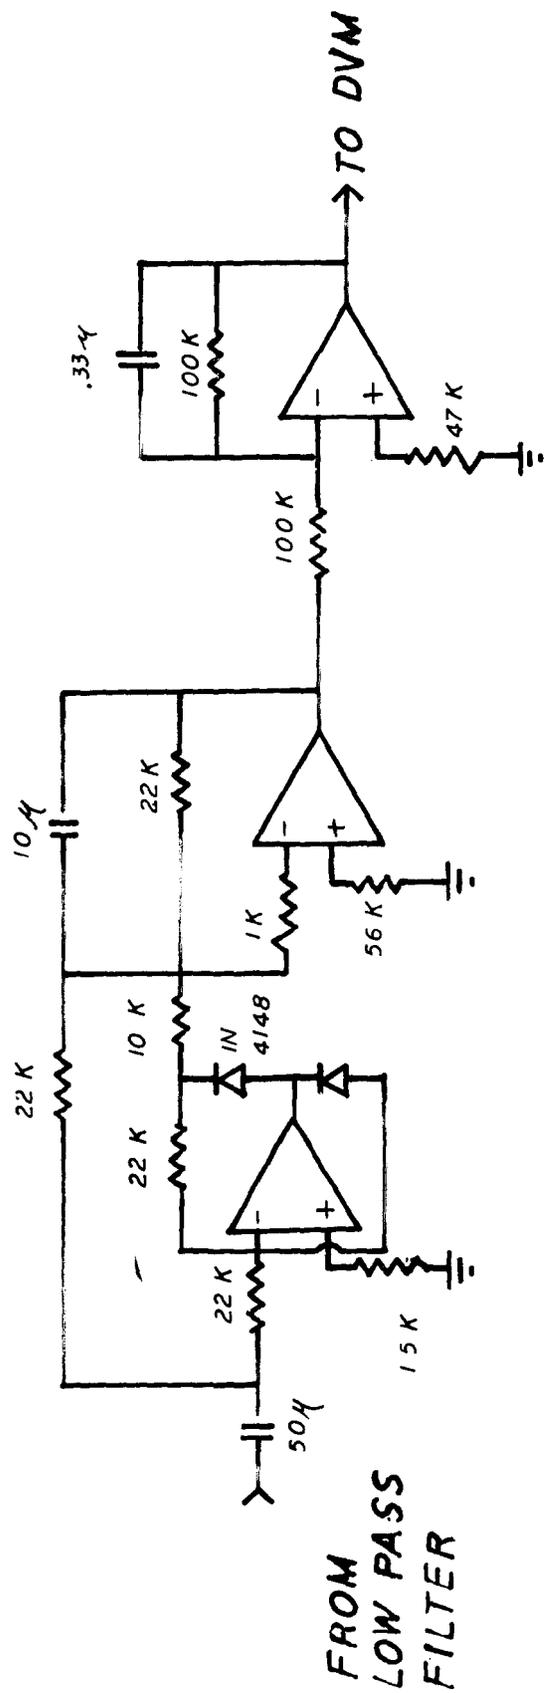
FIGURE B.4. - CERTS precision rectifier schematic.

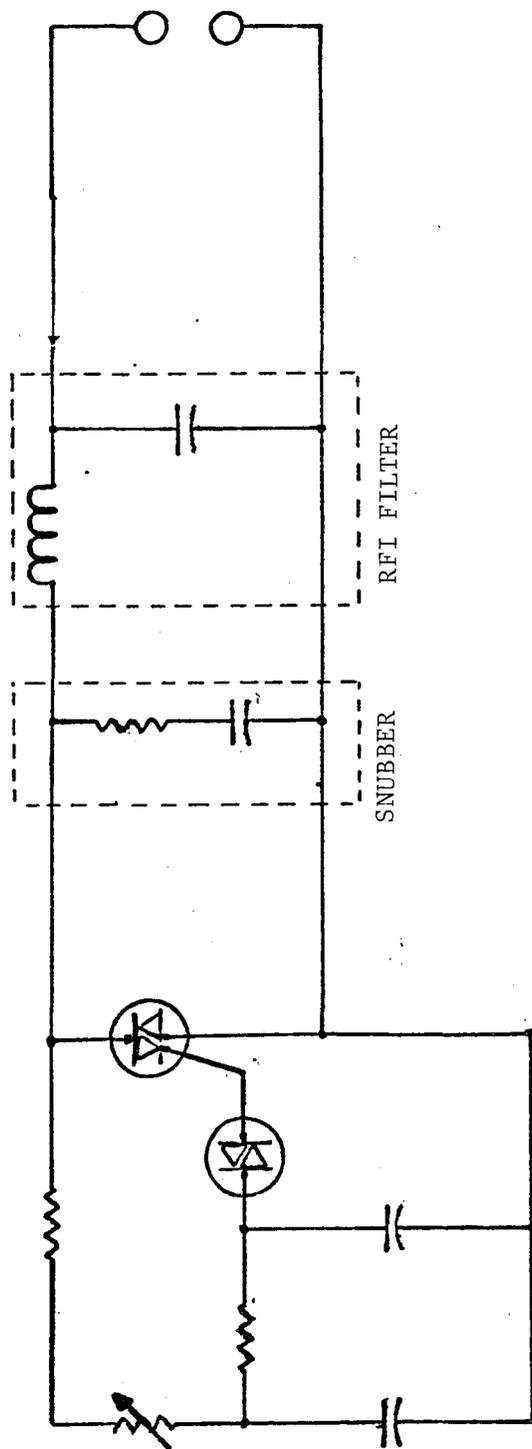
FIGURE B.5. - CERTS triac voltage control schematic.

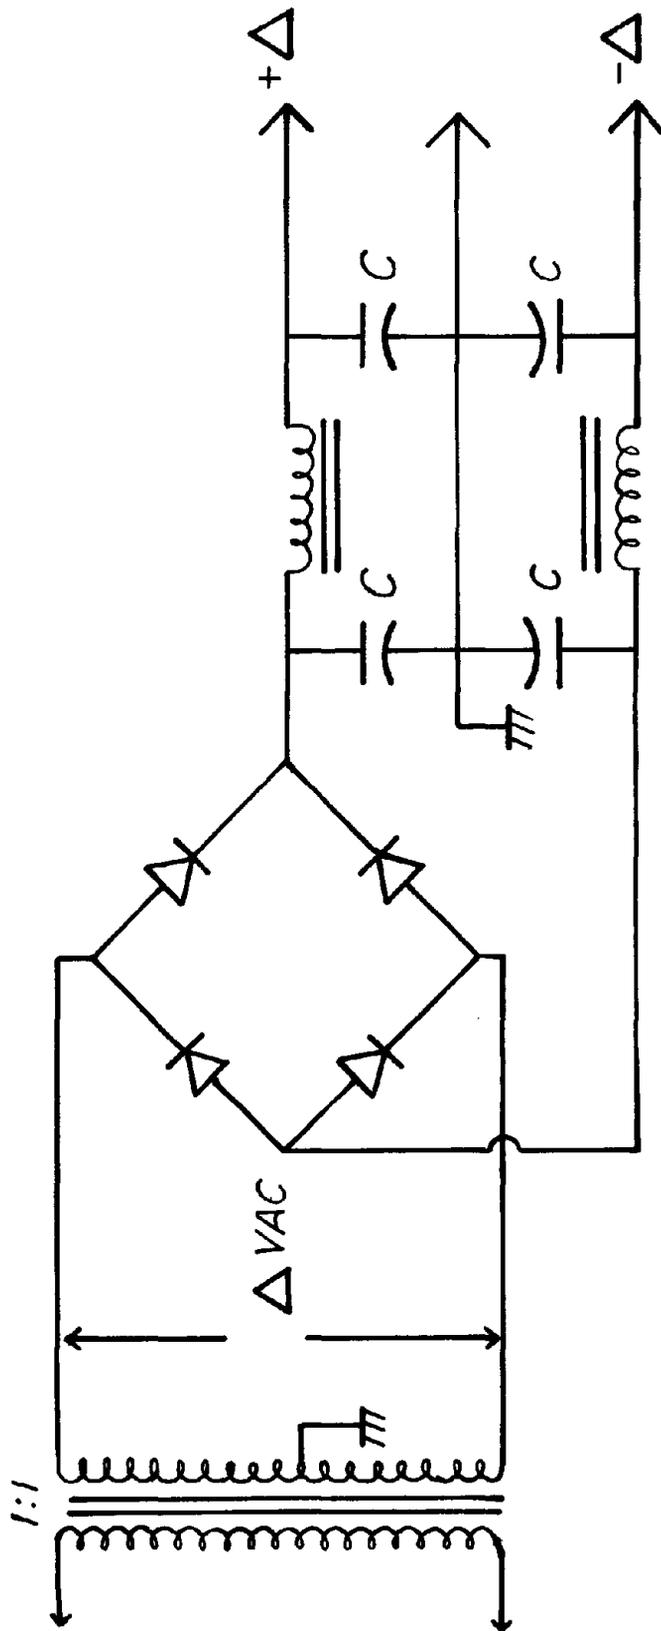
FIGURE B.6. - CERTS power supply schematic.

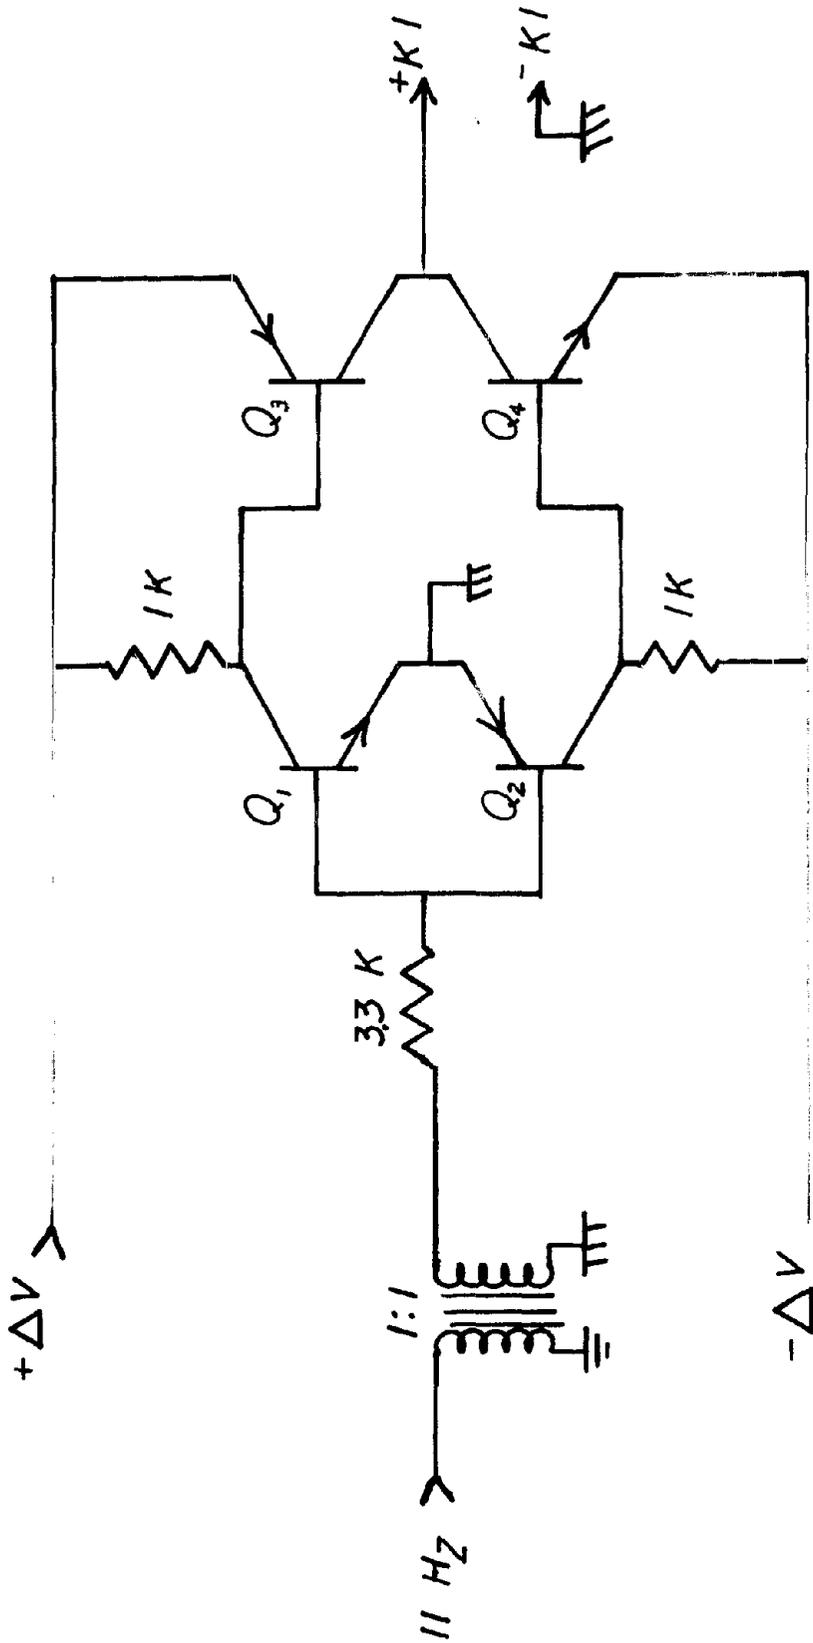
FIGURE B.7. - CERS output amplifier schematic.

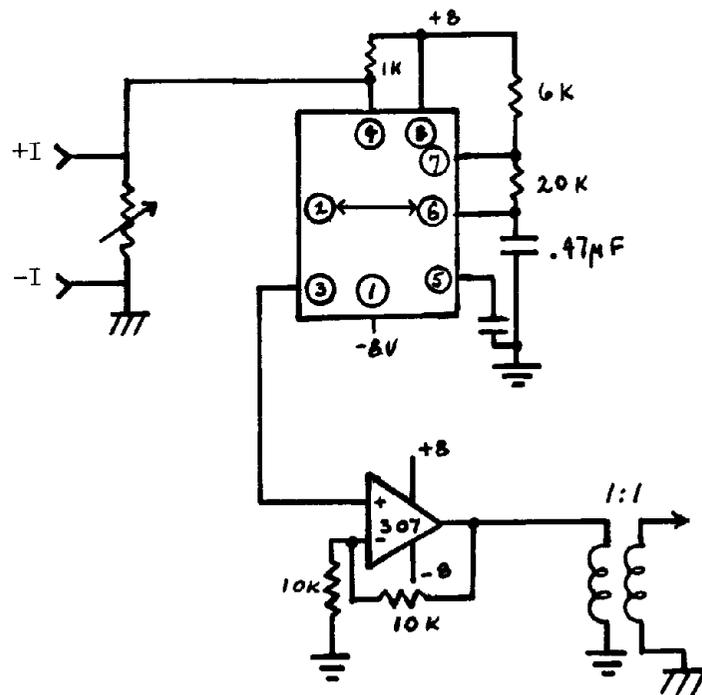
FIGURE B.8. - CERTS protection circuit schematic.
