DEMONSTRATION OF NOISE CONTROL TECHNIQUES FOR THE CRUSHING AND SCREENING OF NONMETALLIC MINERALS

Bureau of Mines Open File Report 50-83

Contract No. J0100038
Foster-Miller, Inc.
350 Second Avenue
Waltham, MA 02254

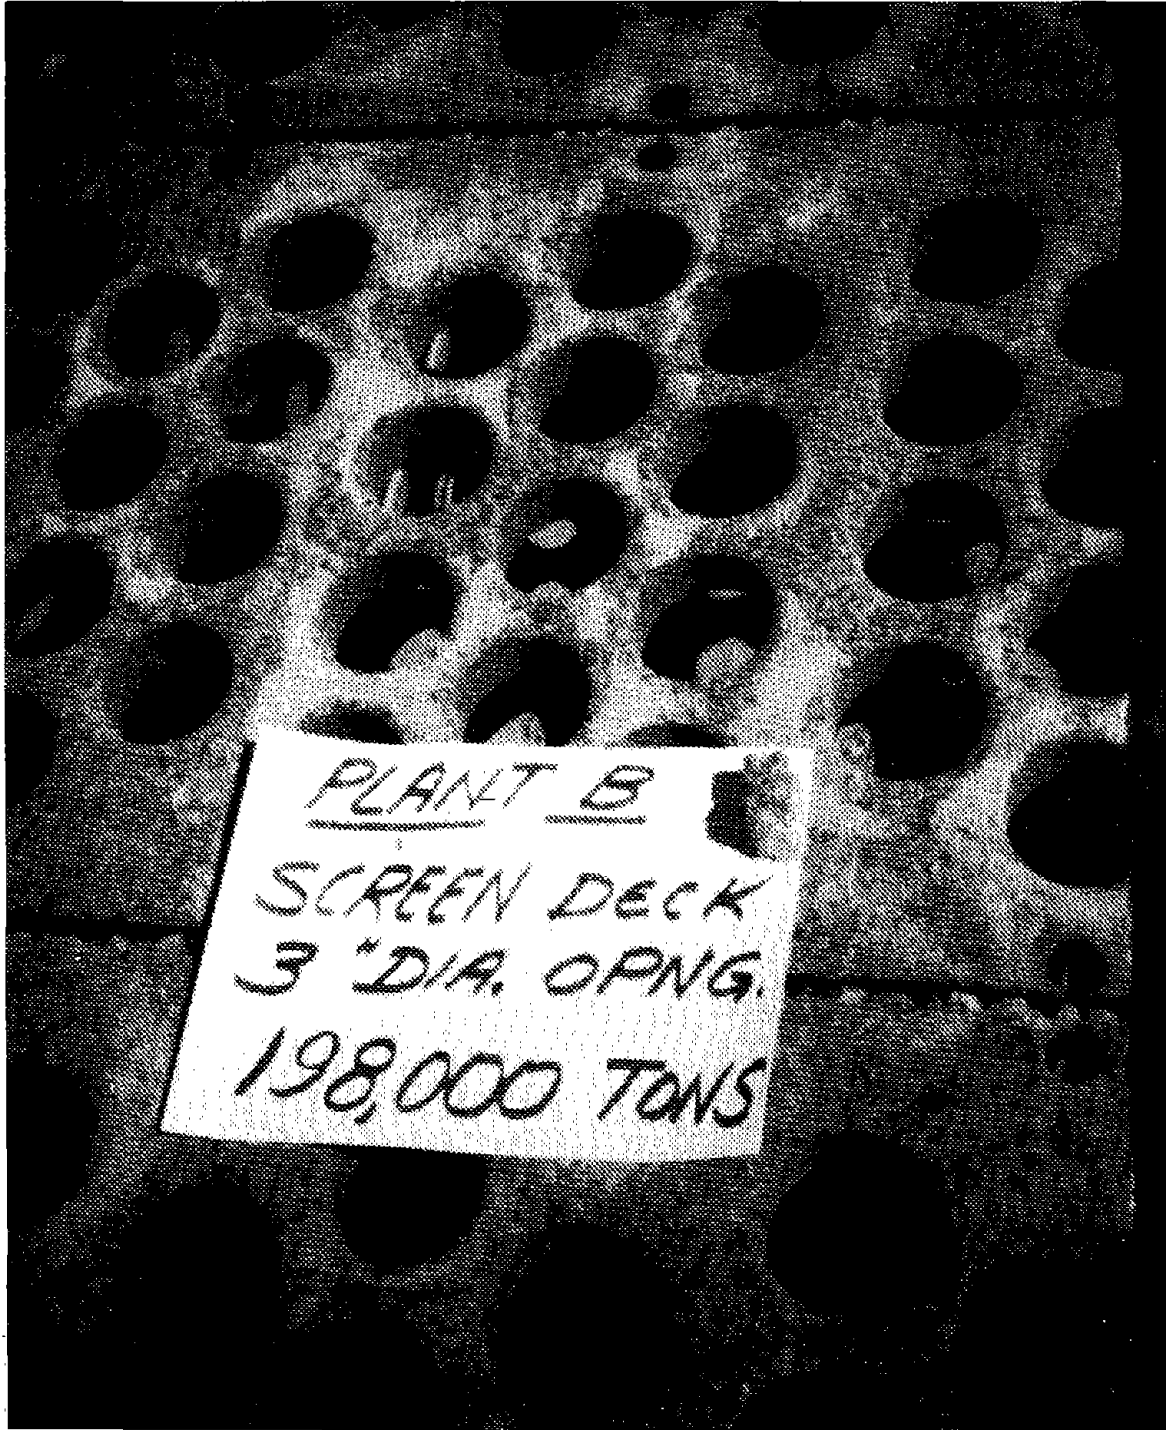
FIGURE ES-5. - Plant B - resilient screen deck after processing 198,000 tons.

The performance of the installed materials was monitored from 26 March to 21 October 1981. During this period, Plant B had processed approximately 198,000 tons. The observed wear of the materials during this period has been minimal. Through 21 October 1981, the screen feedbox liners and discharge lip are showing some dishing at the primary material path (Figure ES-4). The screen cloth (Figure ES-5) has rounded at the edges of the material sizing holes.

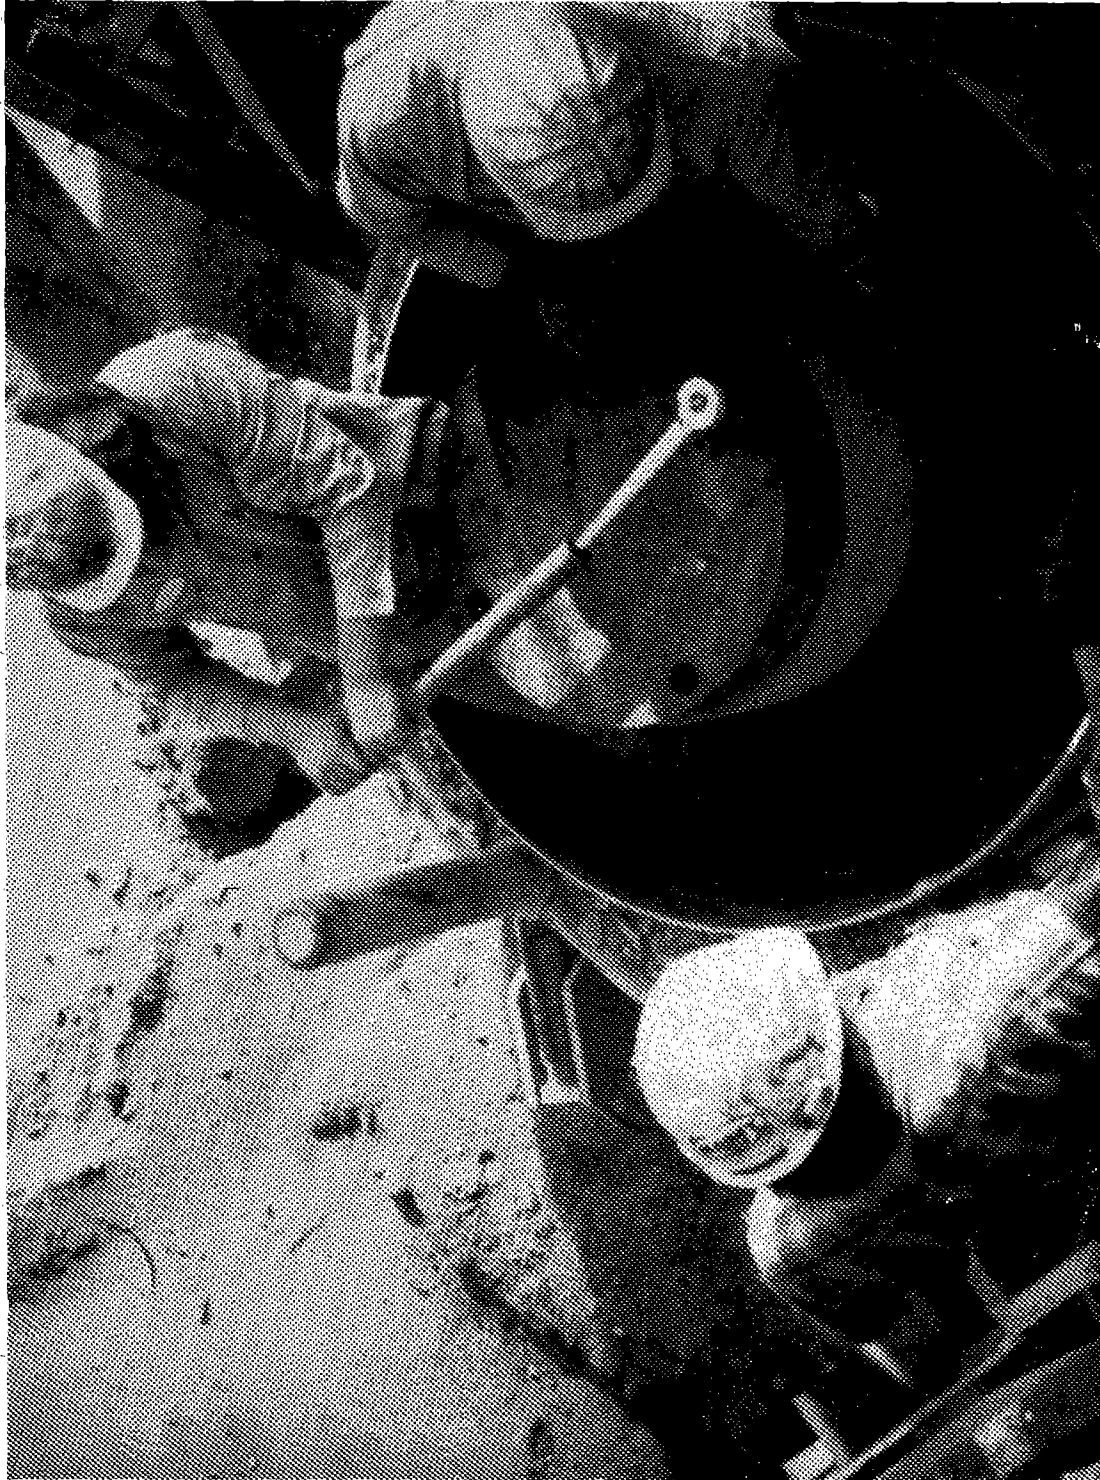
FIGURE ES-8. - Plant B - new resilient crusher feed plate being installed.

The crusher feed hopper liner and screen wing liners have shown virtually no wear (Figure ES-6). The resilient crusher feed plate (Figure ES-7) did wear prematurely due to its being manufactured undersized. It was later replaced with a new resilient feed plate (Figure ES-8).

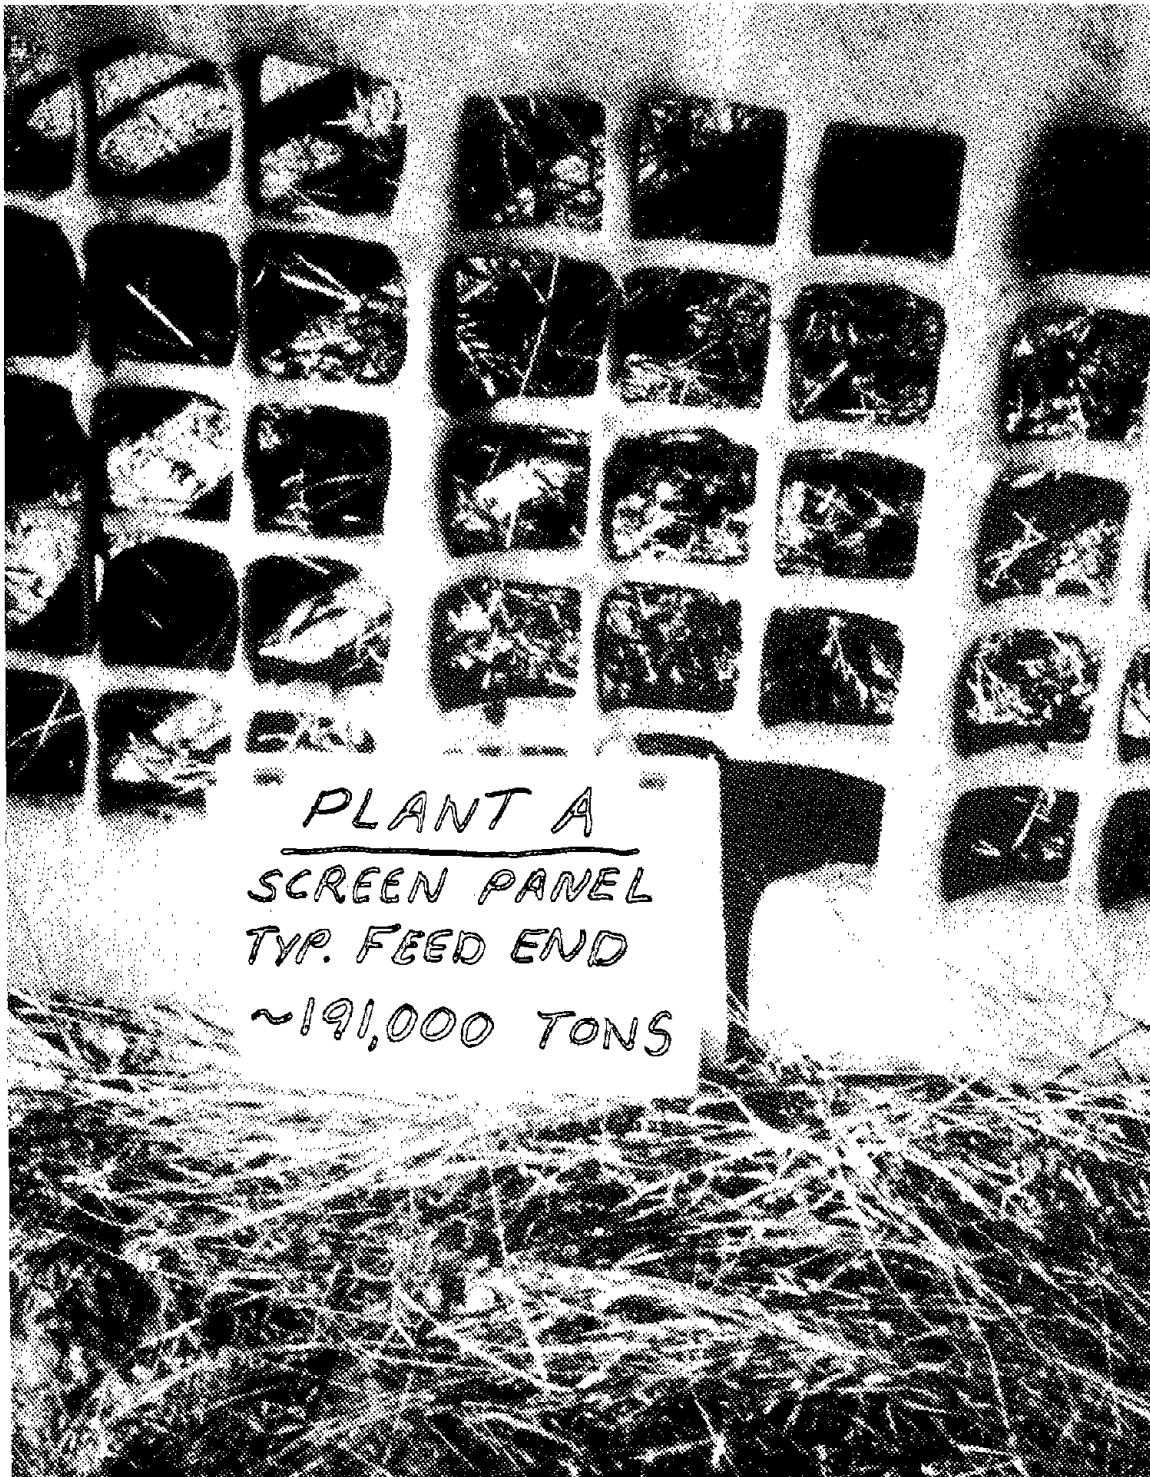
FIGURE ES-11 - Plant A - resilient top screen deck
after processing 191,000 tons.

The installed treatments at Plant A showed significant noise reductions near the primary sources. Significant reductions at ground level cleanup and operation locations, however, were never achieved. Premature wear of installed components coupled with the need for remanufacturing mis-sized components (due to plant modifications) prevented a successful progressive retrofit program at this plant. For example, the impact pad installed on the wall of the screen feedbox had failed prior to the installation of the screen discharge lip. The screen top deck had failed prematurely and was being replaced by the quarry operator before the bottom deck could be delivered and installed. Figure ES-11 shows the wornout top deck after processing only 191,000 tons.

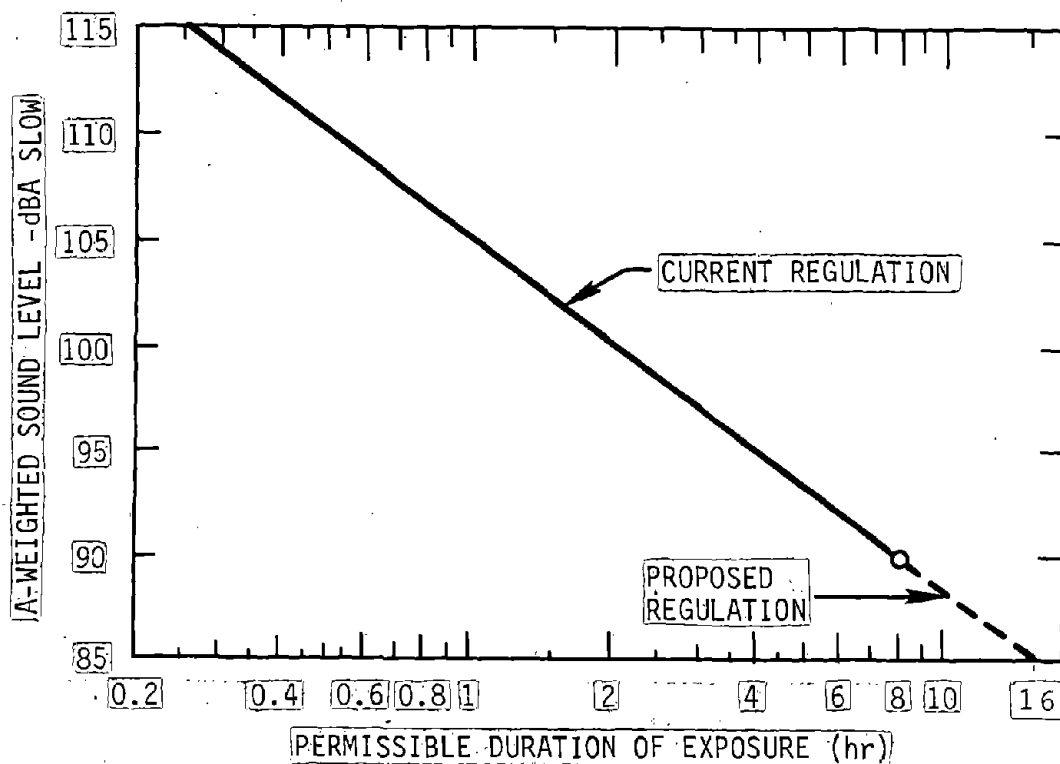
FIGURE 1. - Noise level versus permissible daily exposure.

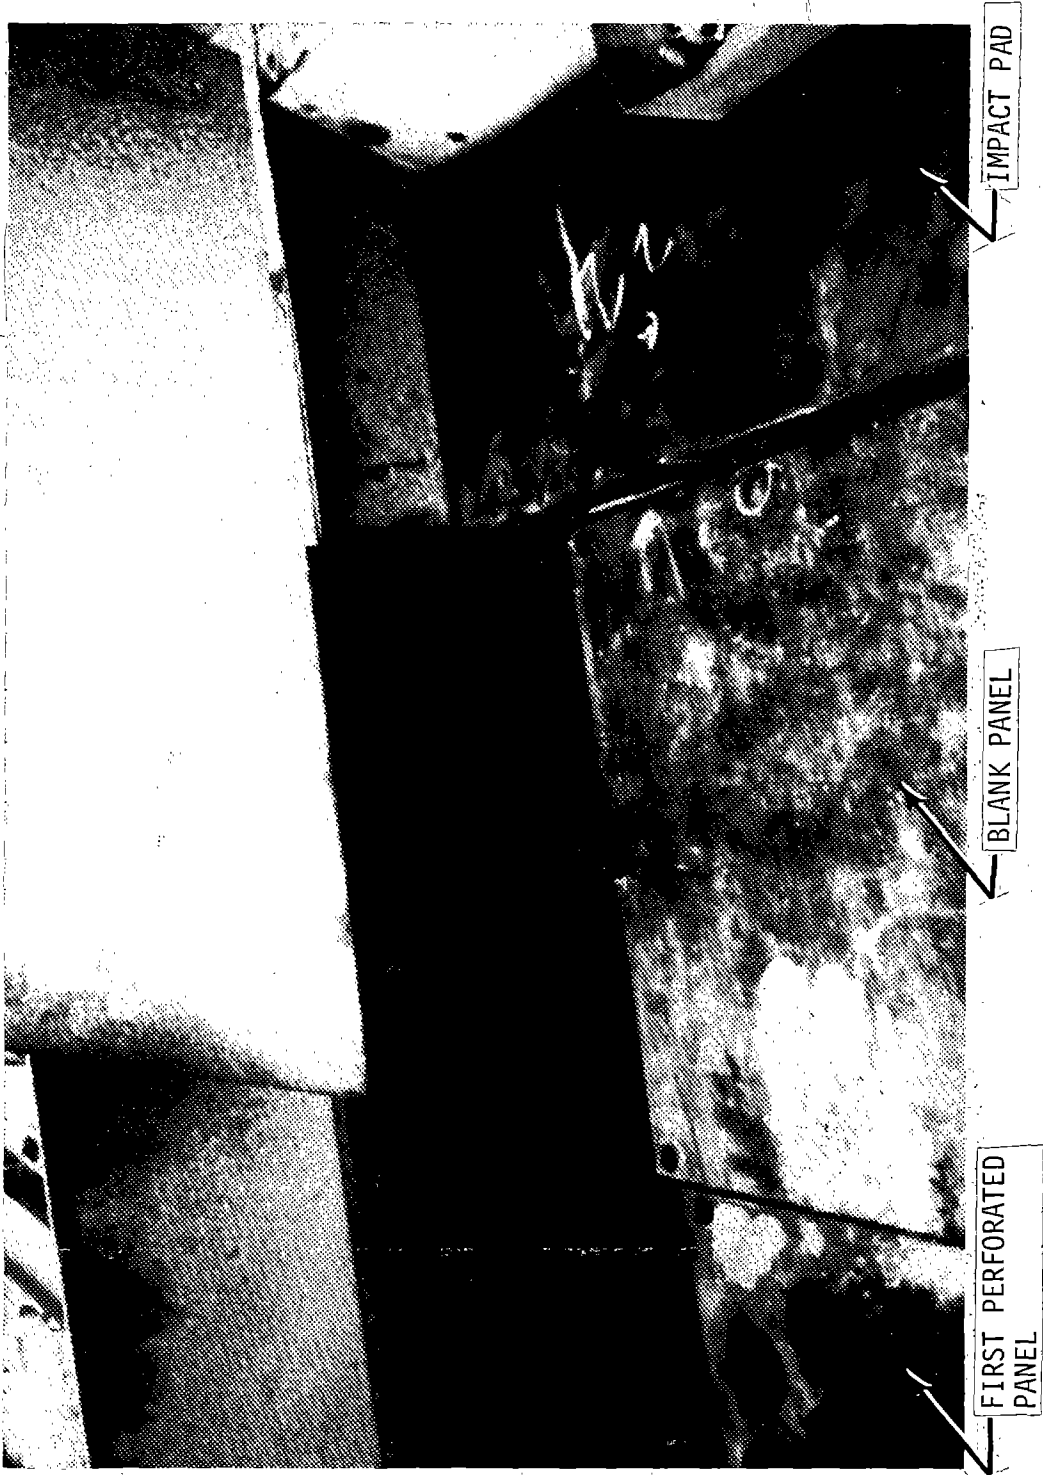
FIGURE 9. - Plant B - screen feed end.

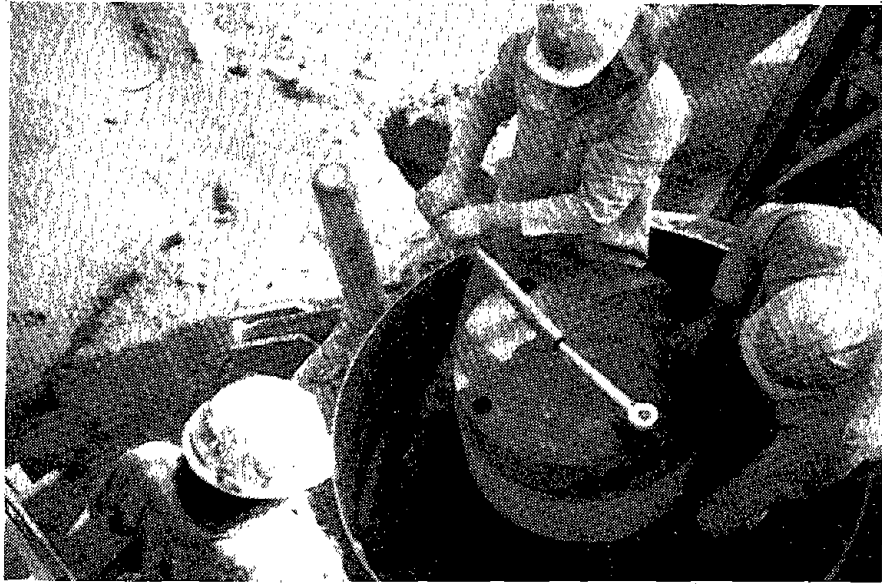
FIGURE 17. - Plant B. - installing rubber crusher feed plate.

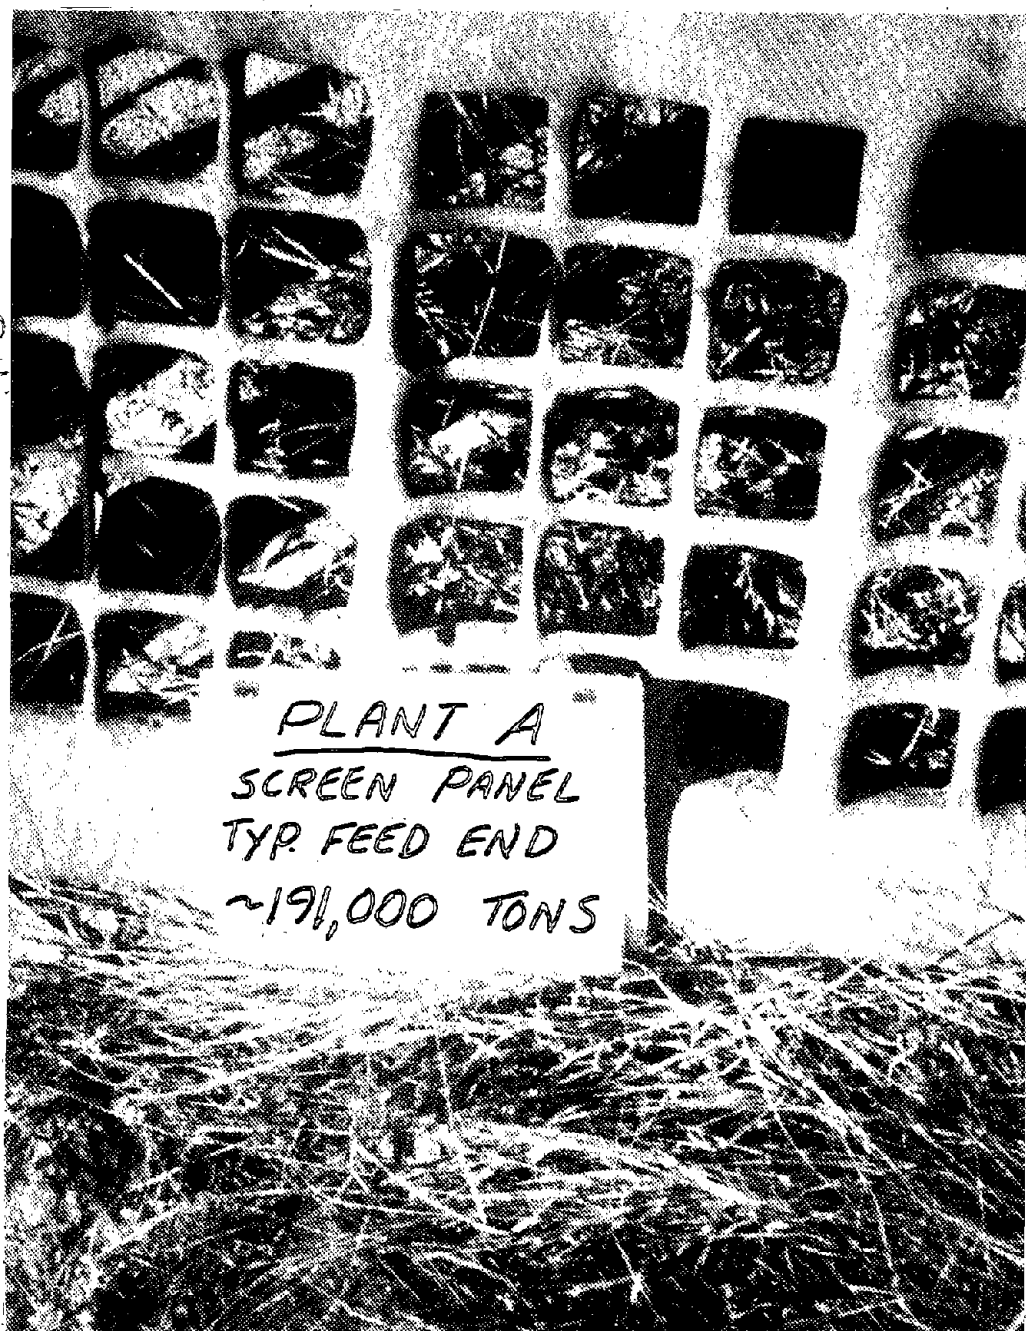
FIGURE 32. - Plant A - top deck screen panels

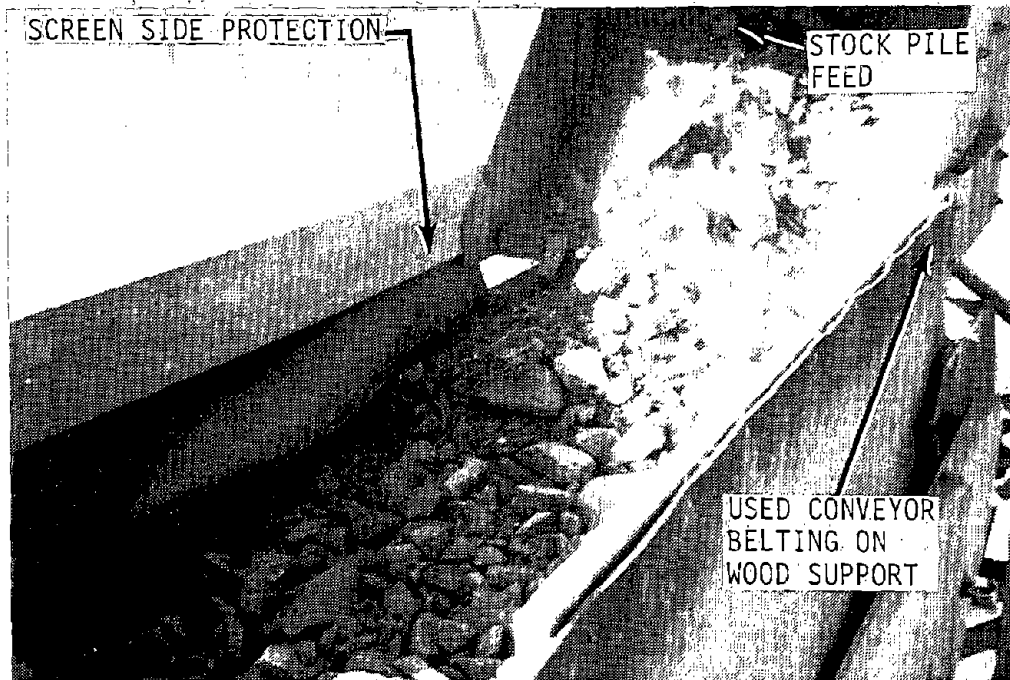
FIGURE 33. - Plant A screen side protection.

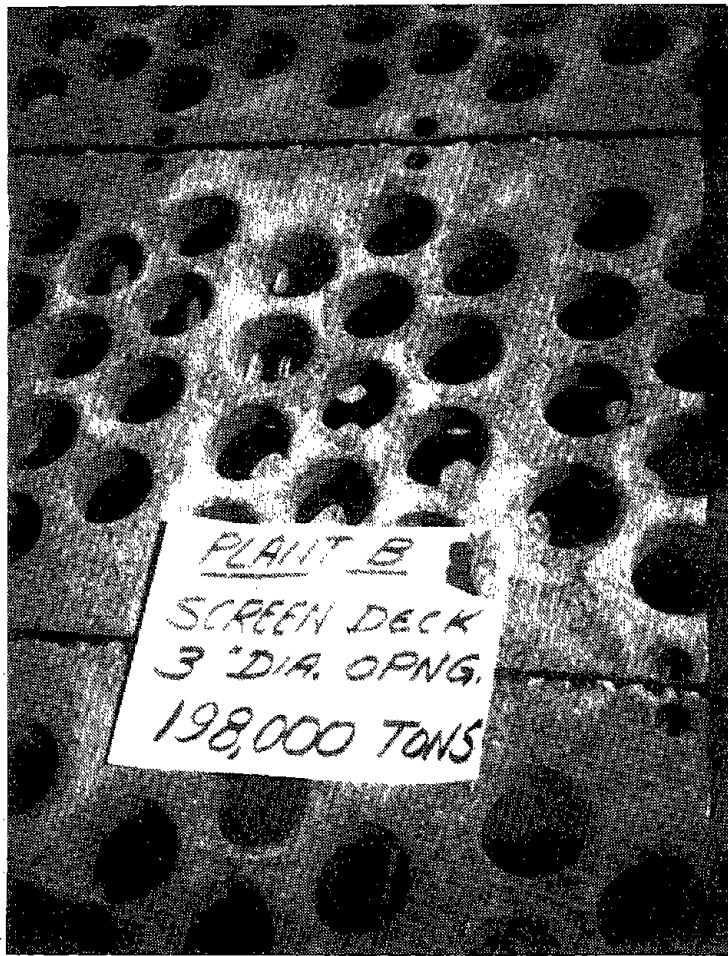
FIGURE 46. -- Plant B screen cloth, typical condition.
