March 1982

SURVEY OF ELECTROSTATIC HAZARDS DETECTION AND MINIMIZATION

**Contract J0308113
HERCULES INCORPORATED**

Bureau of Mines Open File Report 93-84

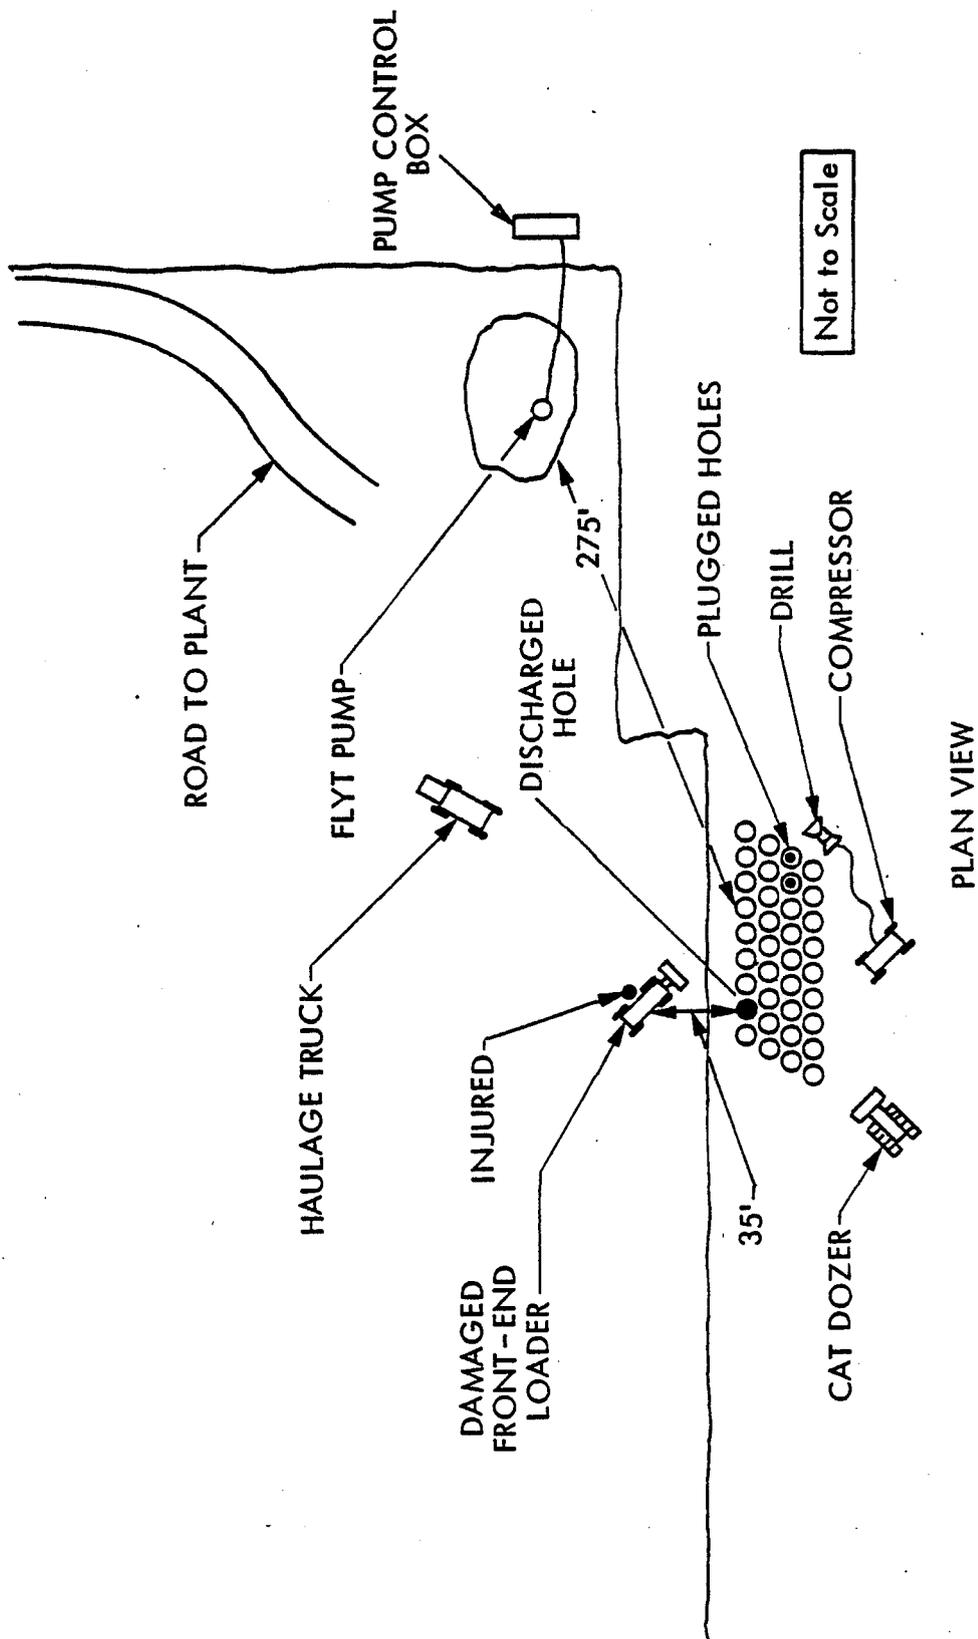
An accident occurred on September 23, 1976, at a limestone quarry. The most likely cause of the accident was stray current from a water pump. The situation at the mine is illustrated in Figure I-1.

Figure I-1. Scene of Nonfatal (Premature) Blasting Accident

A 6-inch centrifugal water pump, "Flyt" brand, powered by a 75-hp, 440-volt 3-phase motor, was being used to pump water from the pit sump. The pump was located approximately 275 feet to the southeast of the face being loaded. The electrical circuit to the pump was comprised of a 100-ampere, 500 VAC, Westinghouse safety switch, located in the main plant distribution center which fed one-half mile of overhead powerlines to a 400-ampere, 600 VAC, Square D switch. The power was then fed through a 170-ampere, 440-volt, pump control box. Neither the control box nor the switch was connected to a low resistance ground; i.e., power company ground line.

A General Electric Geoprene 2/0 A.W.G. four conductor, Type W, power cable supplied power from the pump control box to the pump. The power cable was 200 feet long and contained two poorly constructed, insulated splices. There was also evidence of dry rot within the cable. Approximately 50 feet of the cable was constantly showered with water from a leak in the pump discharge line. The last 15 feet of the power cable leading to the pump was underwater.

The limestone ledge where the accident occurred had a water course running through it, with the rock strata being separated by several narrow horizontal seams of chert and flint. Tests revealed that the ground resistance between the quarry face and the water pump area (~275 ft) was 400 ohms.

The blasthole round consisted of 32 holes, 62 feet deep and 3-1/2 inches in diameter. The shot was drilled in a multiple row pattern with holes and rows fired in sequence from one end. Stemming, (fine rock materials) 3 to 4 feet in depth, was used in each hole. Each hole was double

The cause of the accident was premature detonation of a charged blasthole by stray or static current induced into the blasting circuit. Contributing causes included, (1) charging of holes under adverse weather conditions, (2) operating the pit water pump in the immediate area of the blast site, and (3) the undesirable condition and location of the power cable going to the pit water pump.

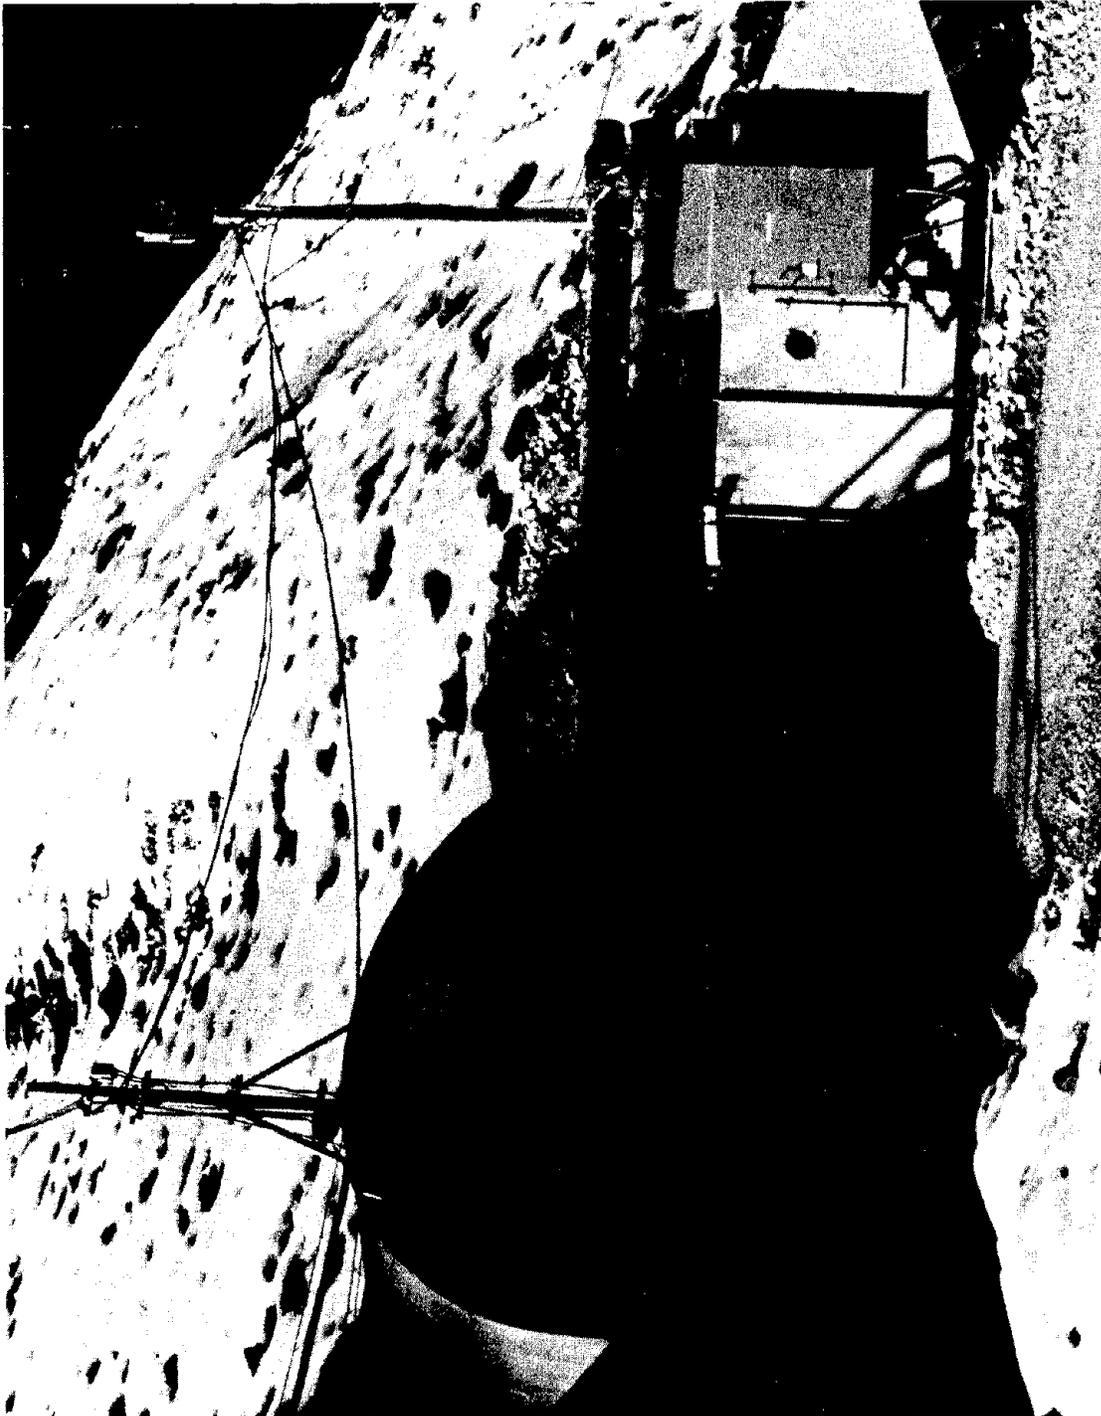
Figure II-1. Surface Power Substation, Termination of Power Company Service,
Beginning of Mine Electrical System

Electrically powered equipment is used in both underground and surface mining operations. The mines observed were supplied with electrical service from the local utilities ranging from 3 Phase 4160 VAC to 60 cycles single phase 120 VAC service. In general, this service terminates at substations on the mine property. From this point the service is installed and maintained by the mining company who uses the National Electrical Code and CFR 30 for guidance. A variety of electrical service installations were observed during the mine visits. A series of photographs (Figures II-1 through II-8) is included to illustrate the working environment as it is related to electrical service. Figure II-1 shows a typical substation where the utility company's responsibility ends. Figure II-2 shows a typical installation of a master breaker/fuse panel for a mine. Figure II-3 illustrates the transfer of utilities to working areas via a tunnel. Figure II-4

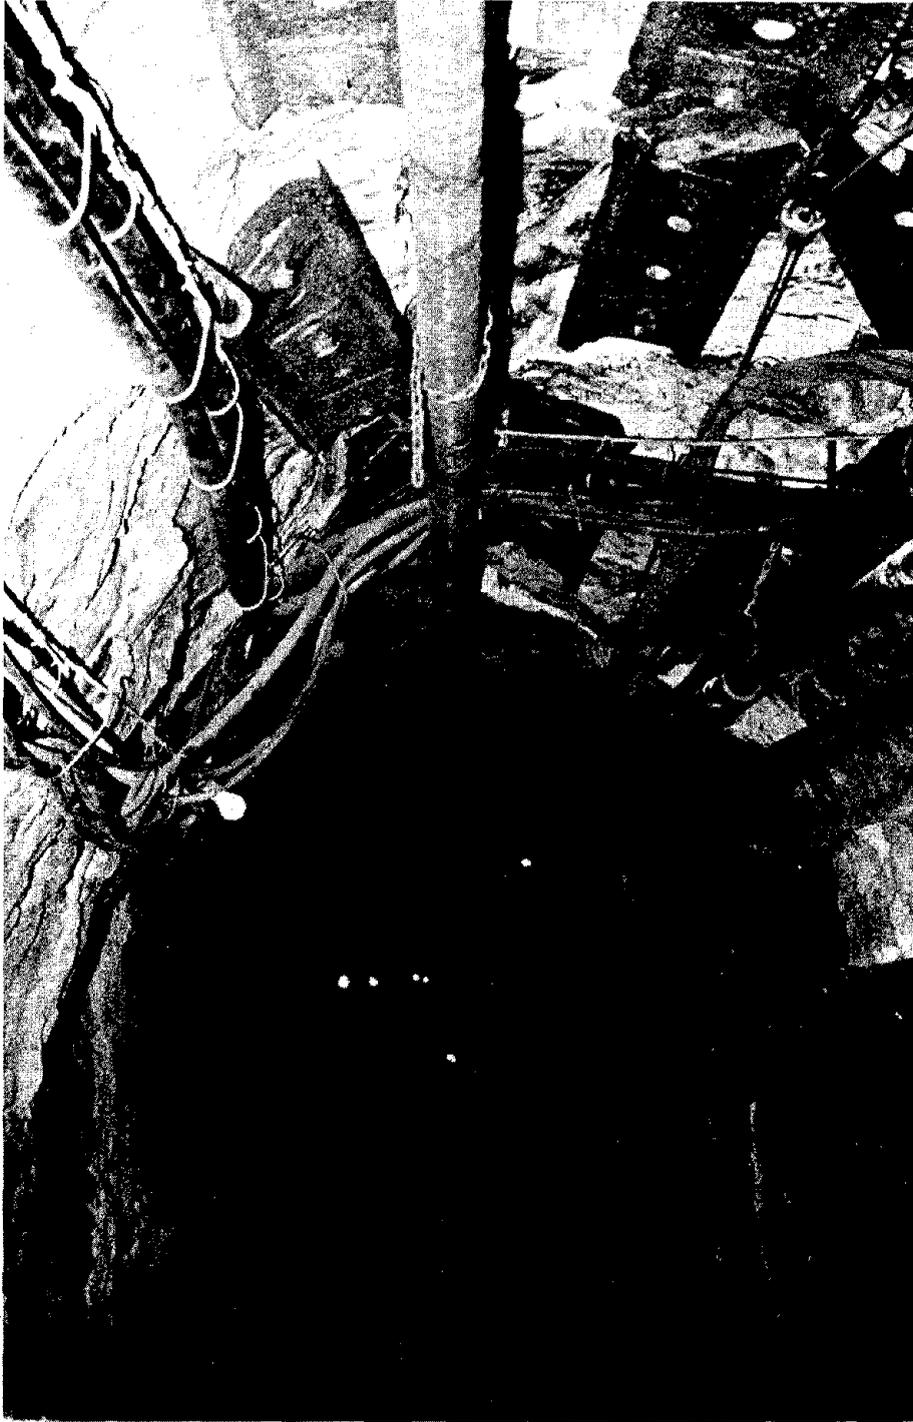
Figure II-3. Typical Service Tunnel Carrying Utilities into Mine
(Air, Water, Electricity, Communications)

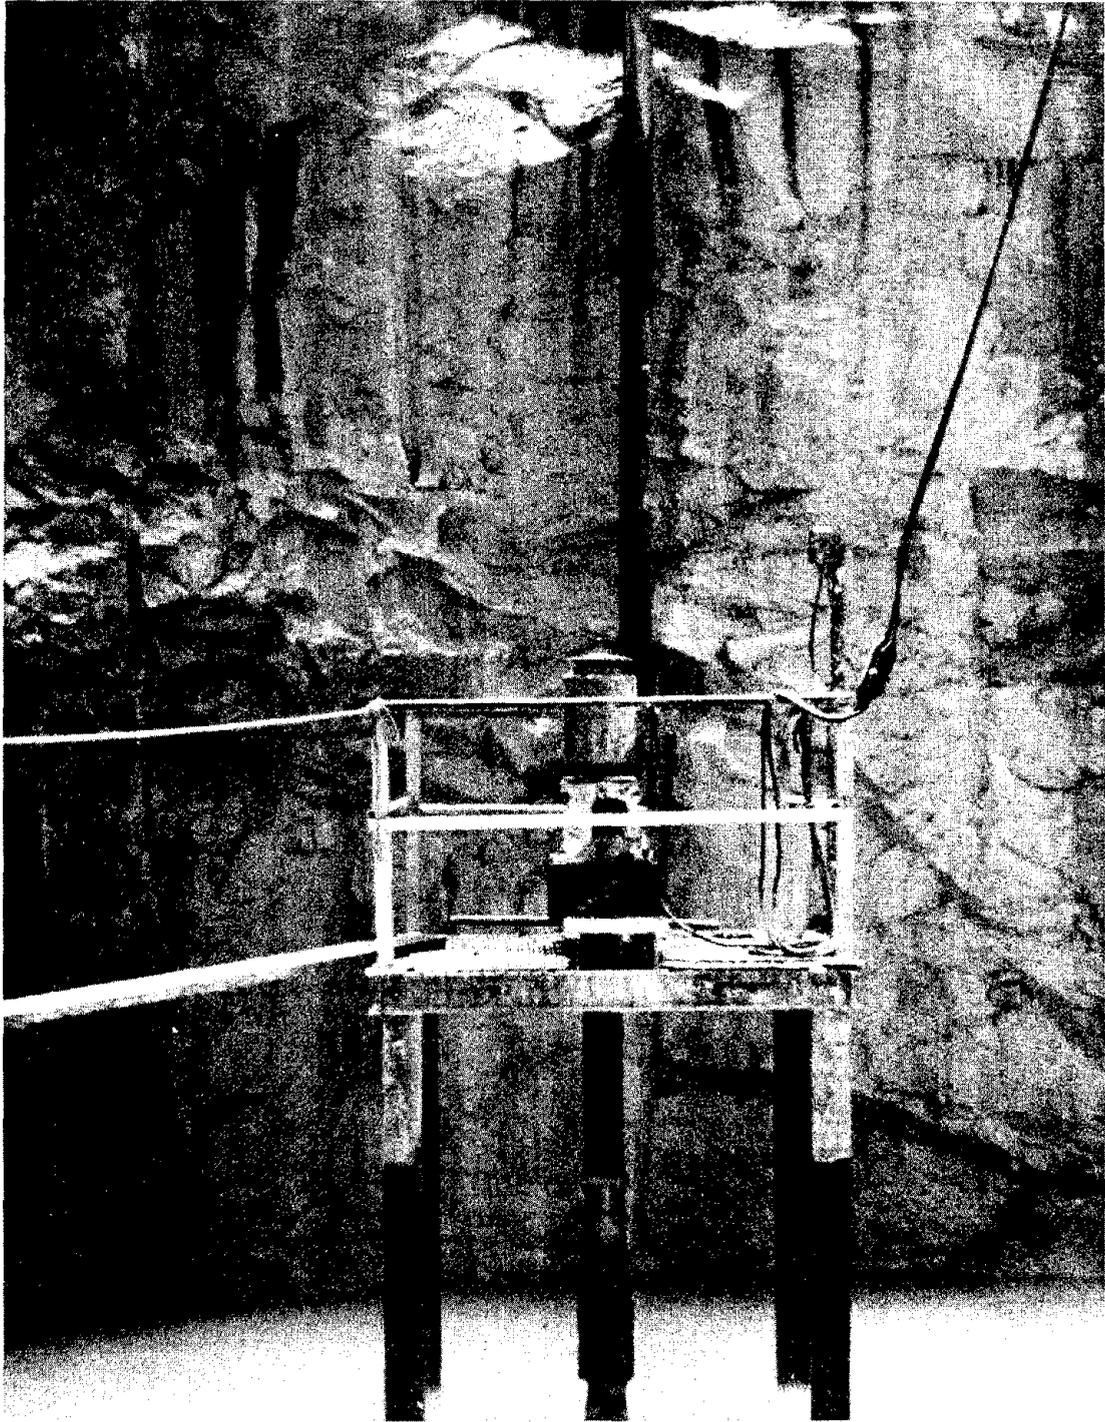
Figure II-5. A 440V Water Pump in Quarry Operation (Note: This is a potential source of electricity that has direct contact with quarry ground water)

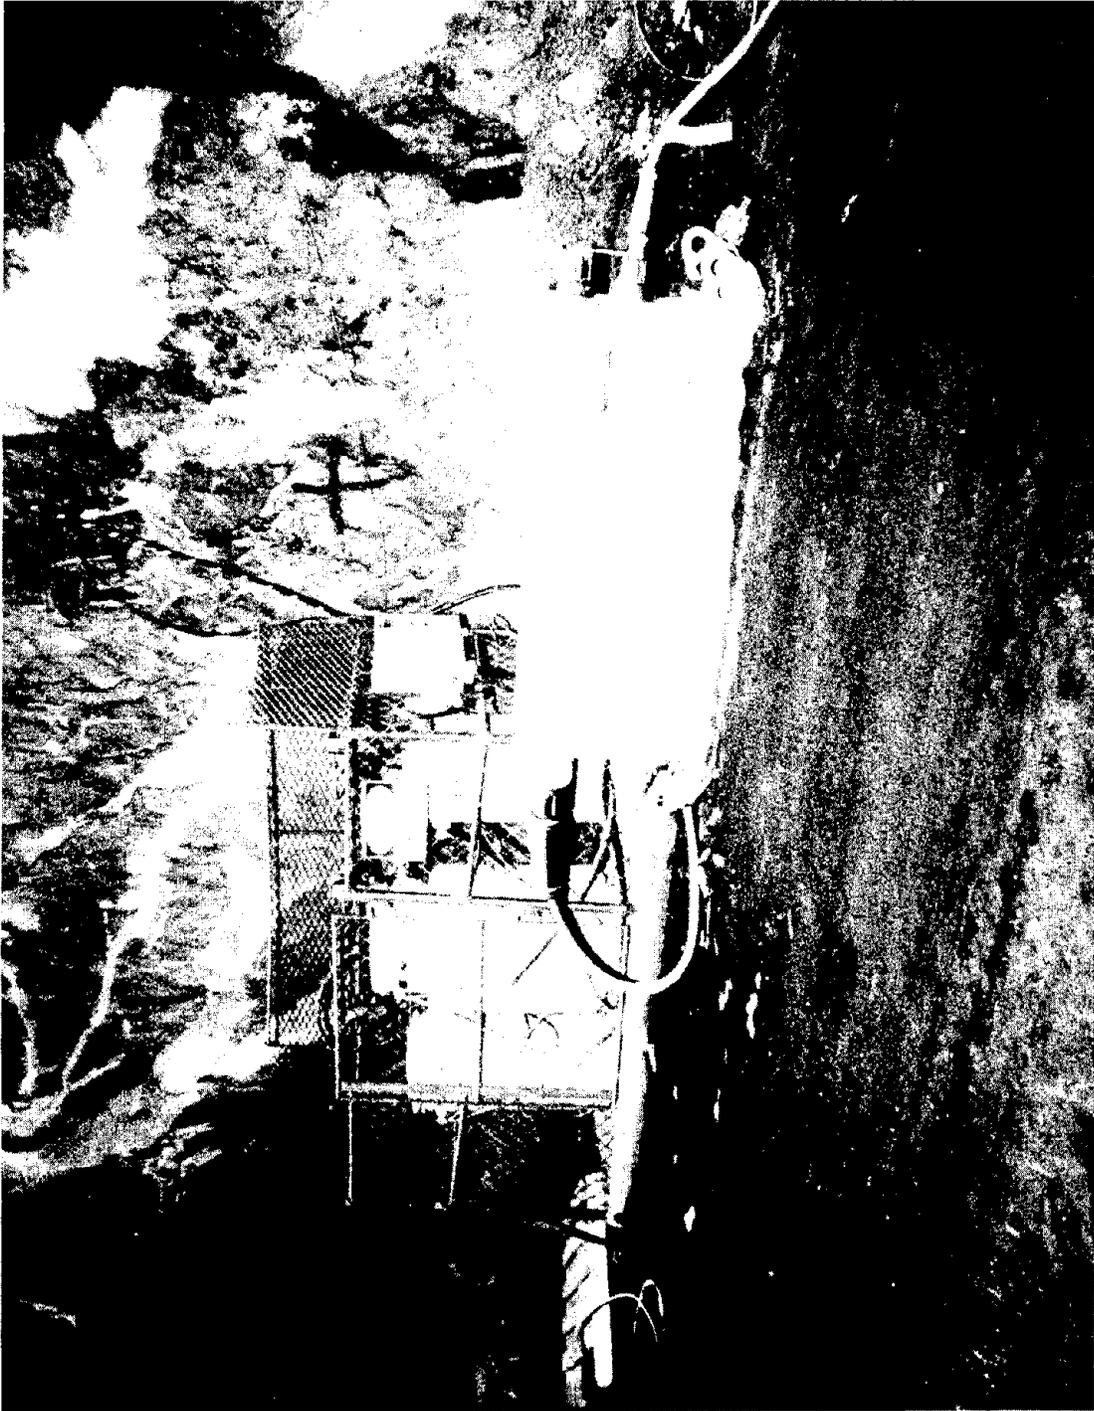
Figure II-6. Underground Power Distribution Station

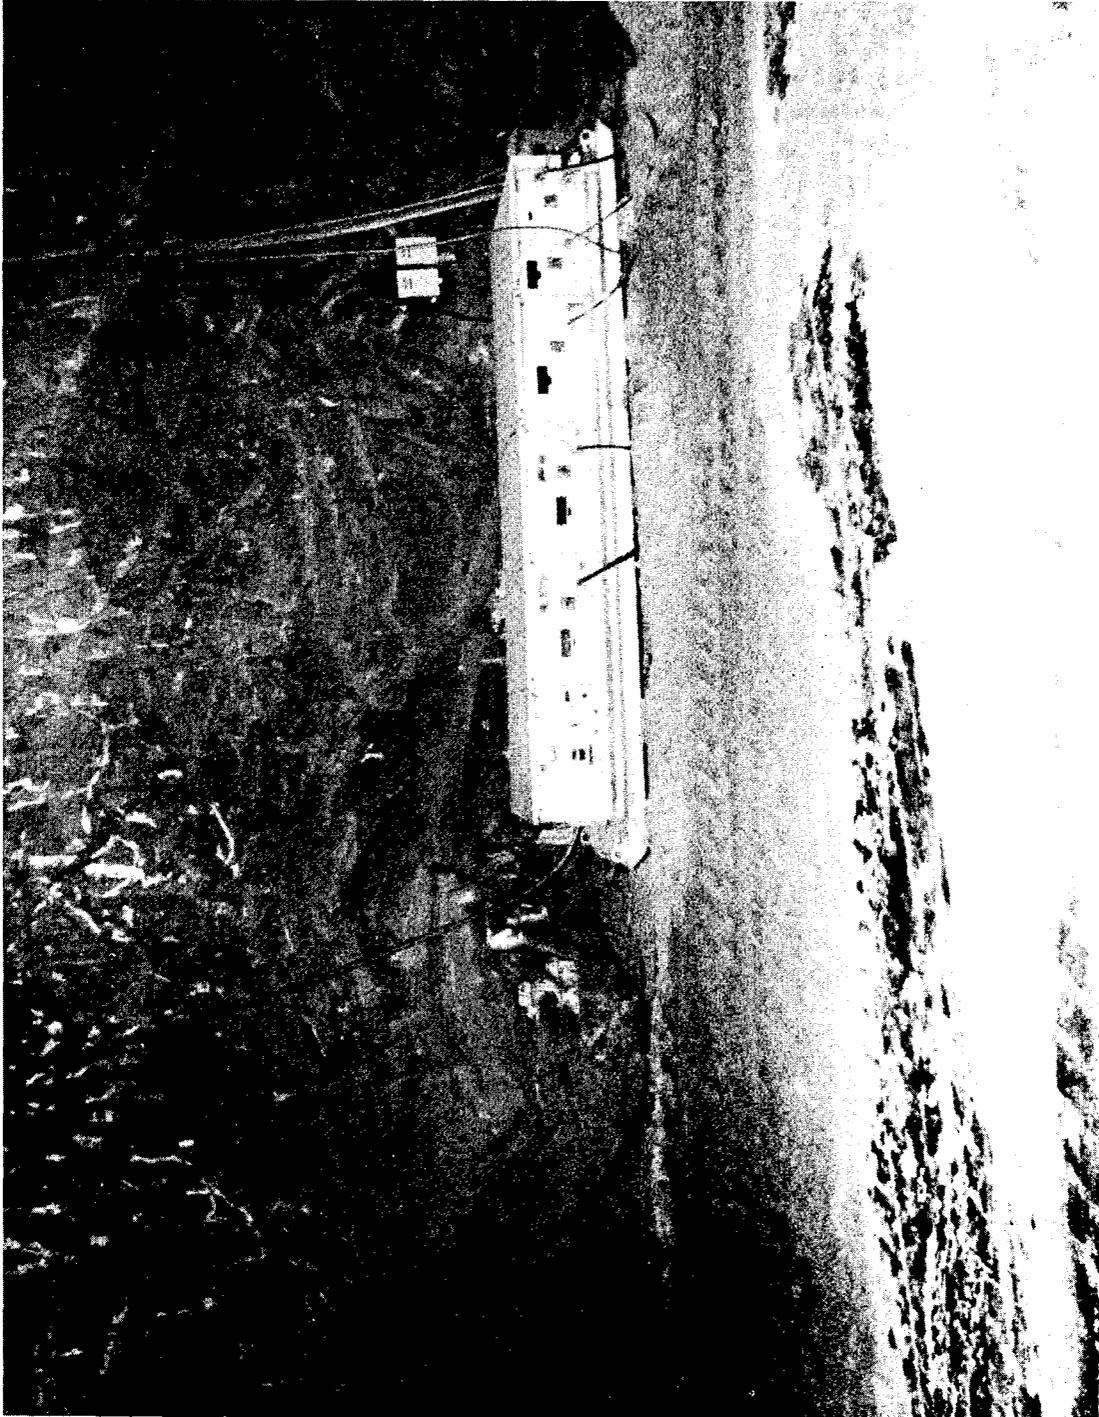
Figure II-7. Portable Power Transformers and Cables (Note: These are moved near electrical crushing, mucking, and hauling equipment in the mine)

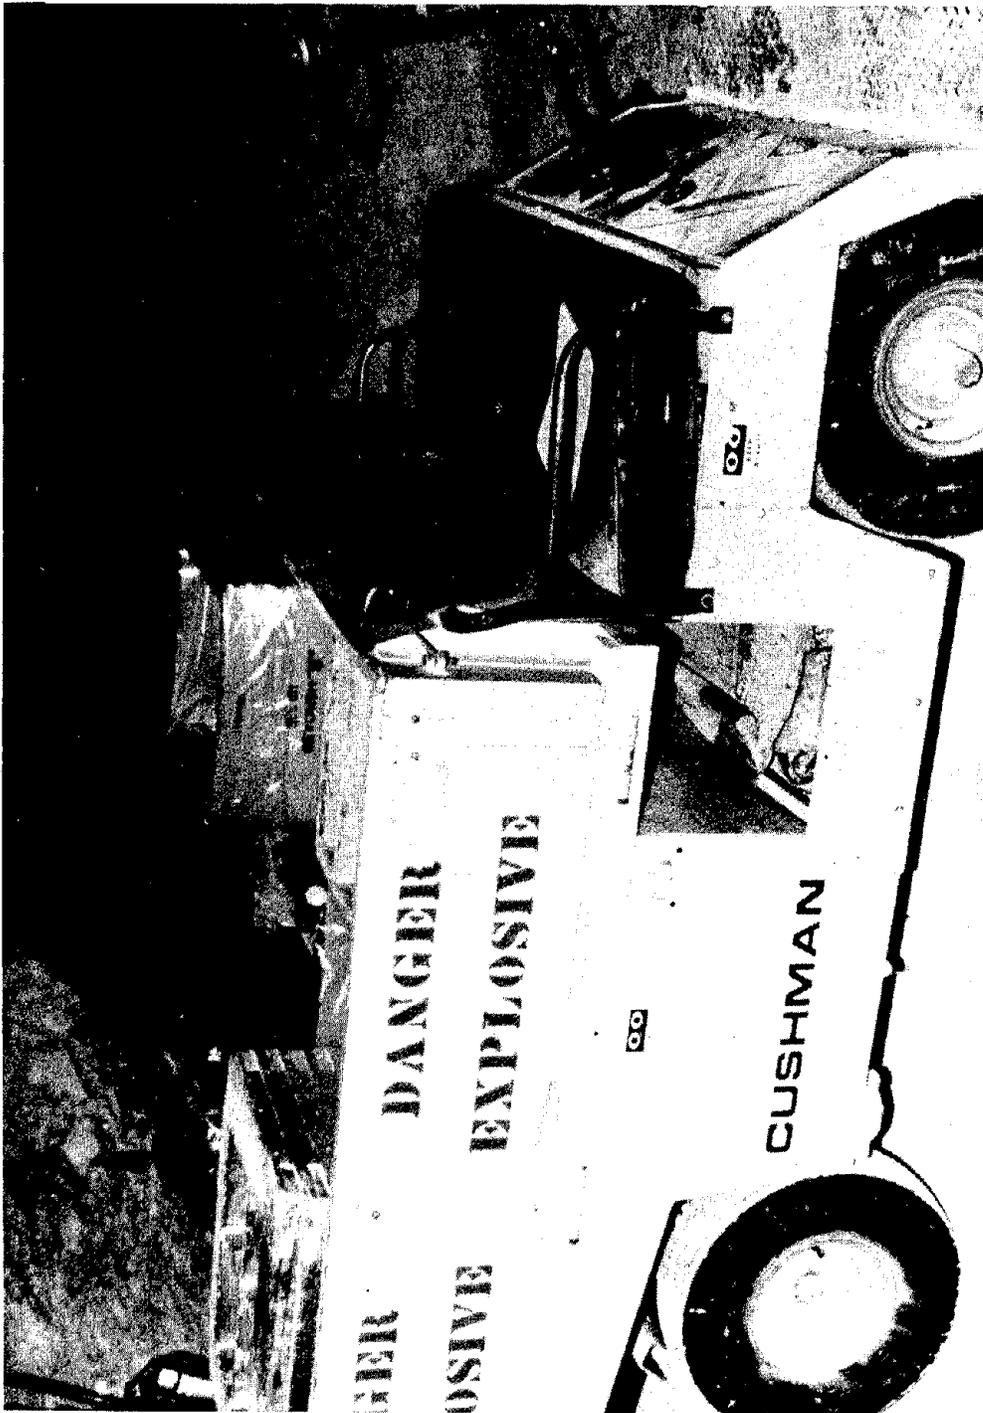
Figure II-9. Electric Explosives Cart for Transporting Explosives to Blast Site

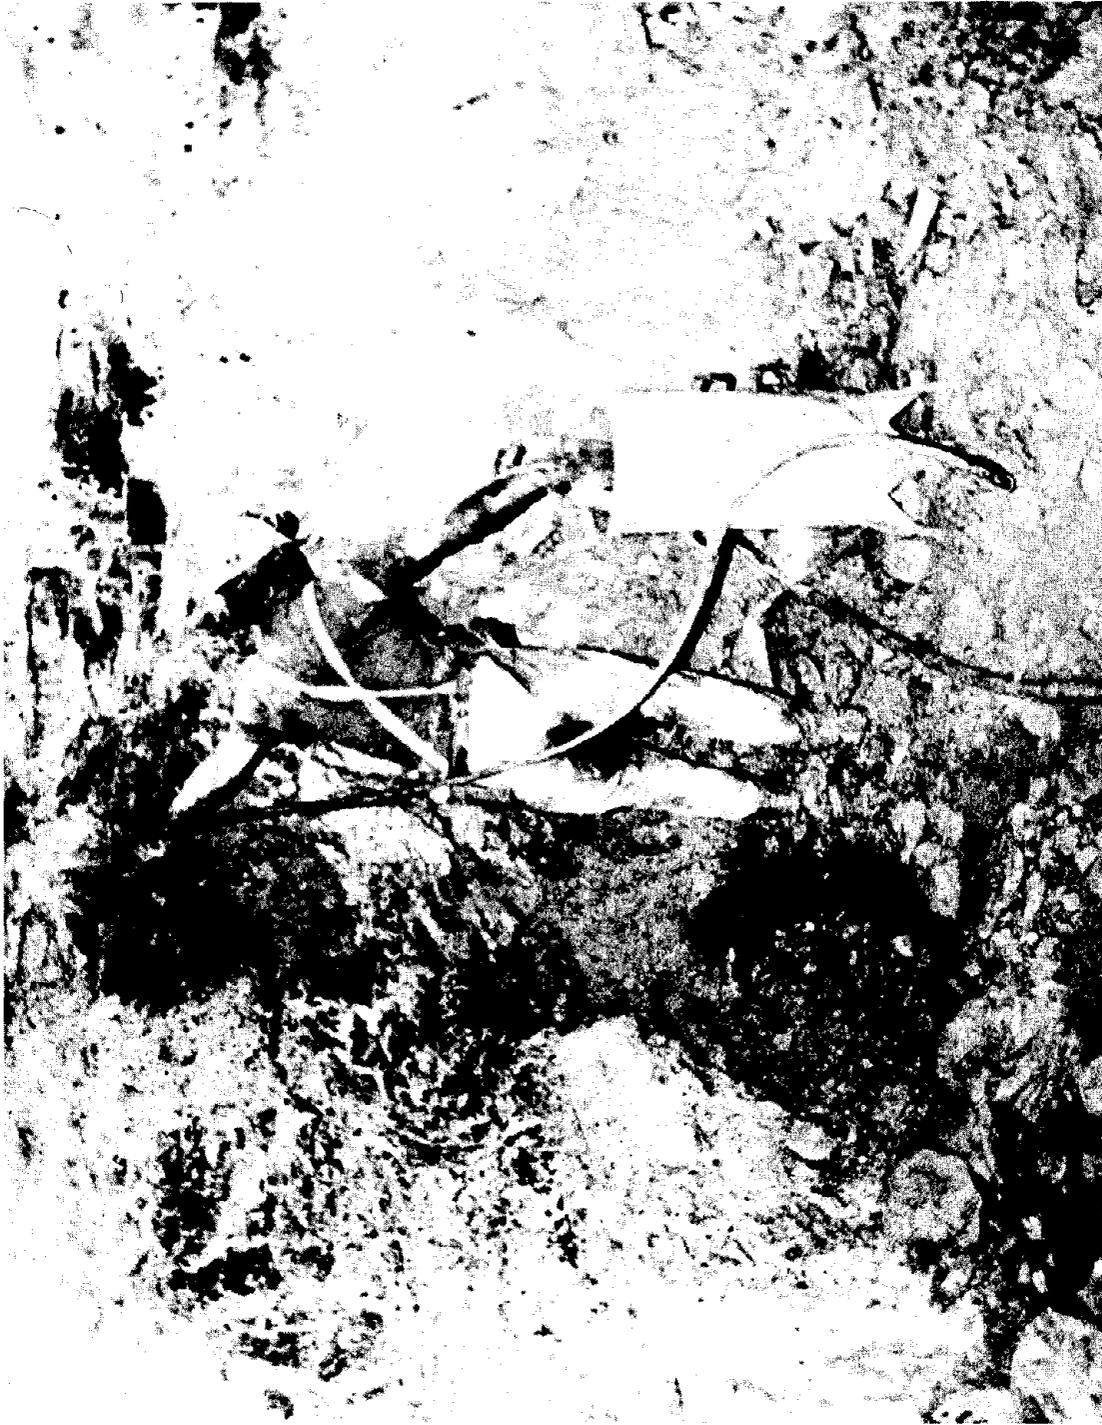
Figure II-12. One Man ANFO Loading Technique

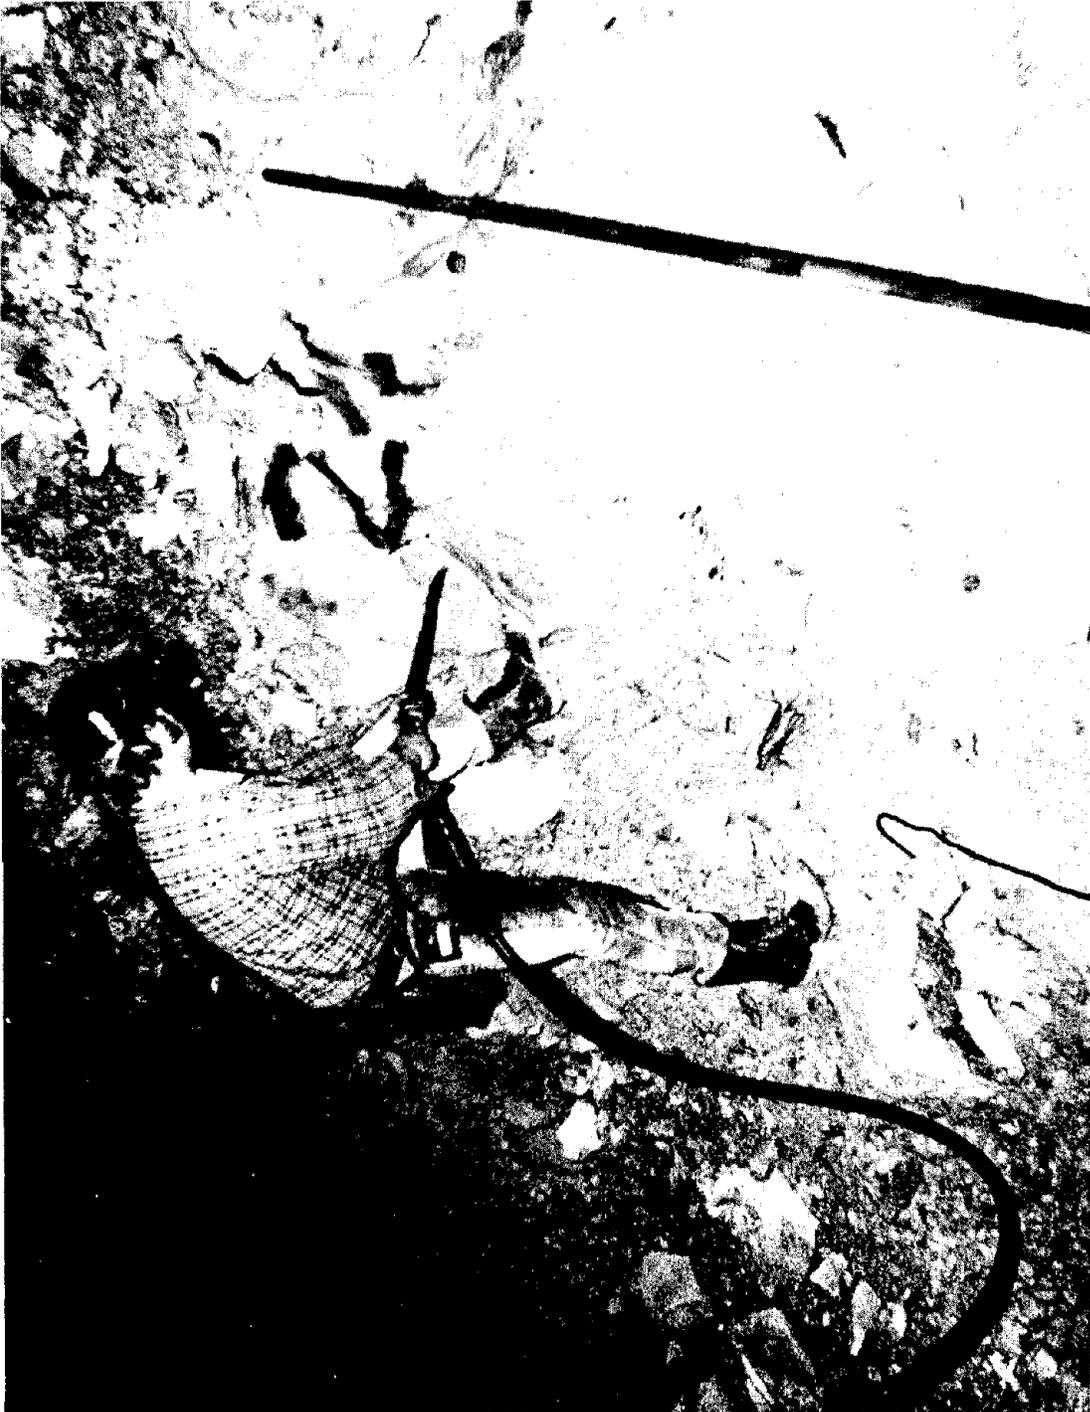
Figure II-14. Miner Loading Bore Hole with ANFO in Typical Two Man Operation

It was observed that there exists much diversity in the pneumatic delivery equipment used. Some of the pots (containers) used were simply containers manufactured for other purposes. In one case a container, initially intended for sand blasting, was used; it could be loaded with ~50 lbs of ANFO. Others used were truck mounted units having a capacity of 250 lb. Figure II-12 shows a one-man loading operation with the operator guiding the hose with one hand while he operated a full throat ball valve with the other hand. In this case, it is more difficult to control the pressure and hence control the loading rate or density. In two man operations observed, a three way valve was operated by one man while the other one did the loading; the loading rate and density were easily controlled here. Figure II-13 shows a larger capacity "prill pot" mounted on a truck with the control valves mounted on the pot. One man controlled the pressure at the truck, and the other one did the loading; he had the capability of loading from the mine floor or from a hydraulic boom. Figure II-14 shows a typical 2 man operation.

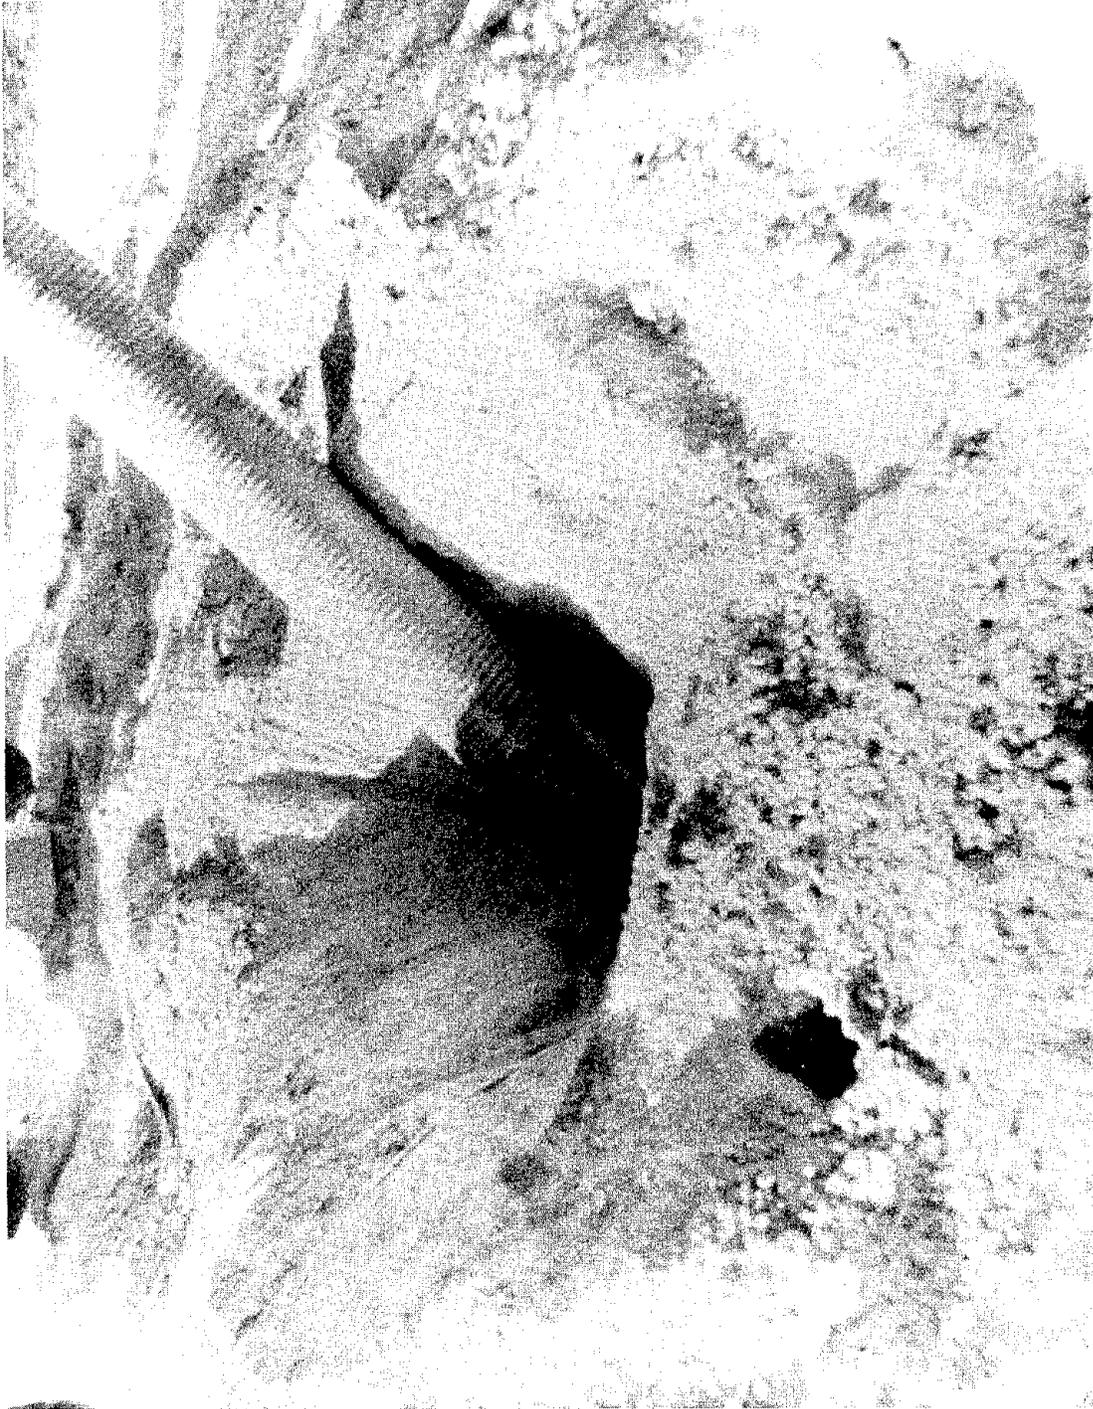
Figure II-16. Primed Borehole without Liner in Process of Being Filled from Overhead Auger Delivery Truck

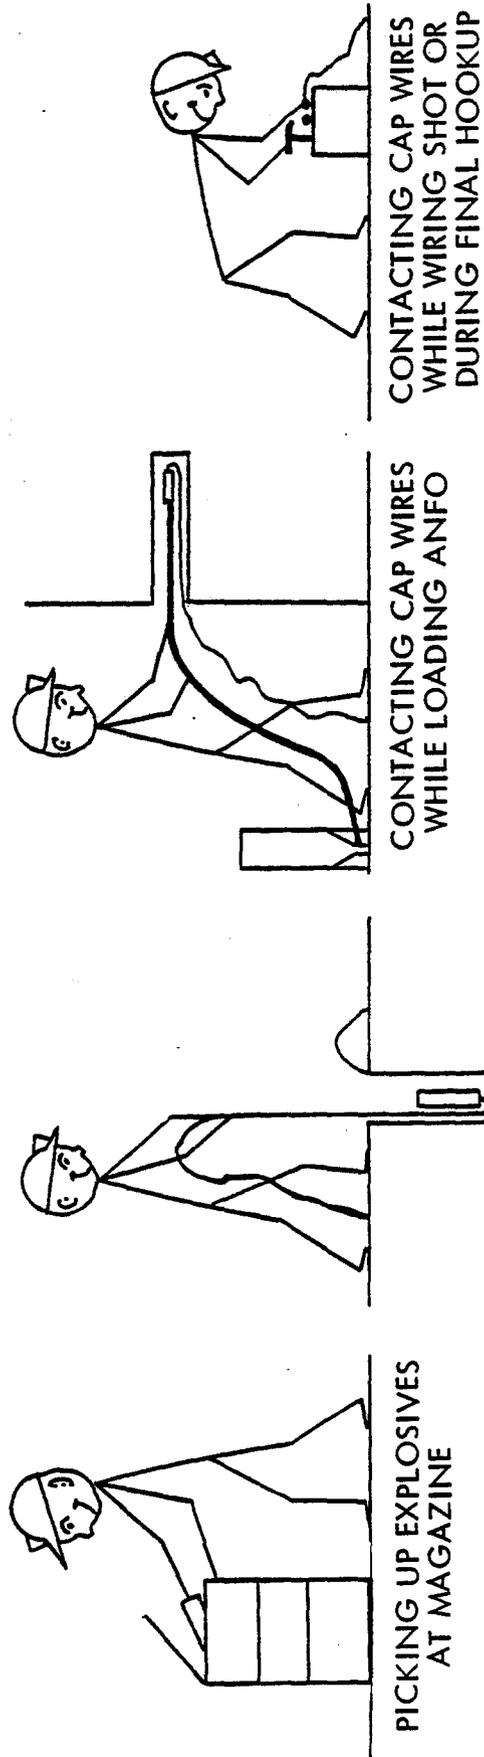
Figure IV-1. Mine Blasting Situations Where Operator is a Potential Source of Initiation from Electrostatic Discharge

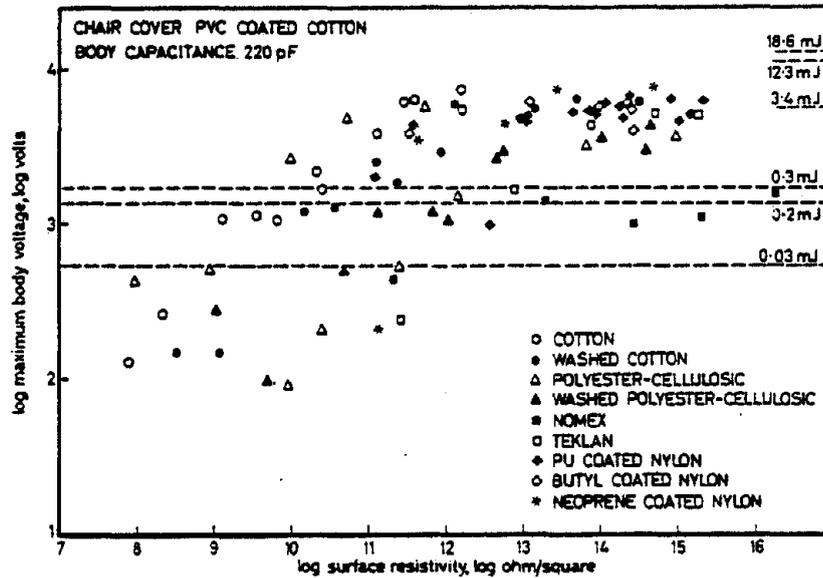
Figure IV-2. Log Maximum Body Voltage vs. Log Surface Resistivity. PVC-Coated Cotton Seat Cover. Body Capacitance 220pF.⁽¹⁷⁾

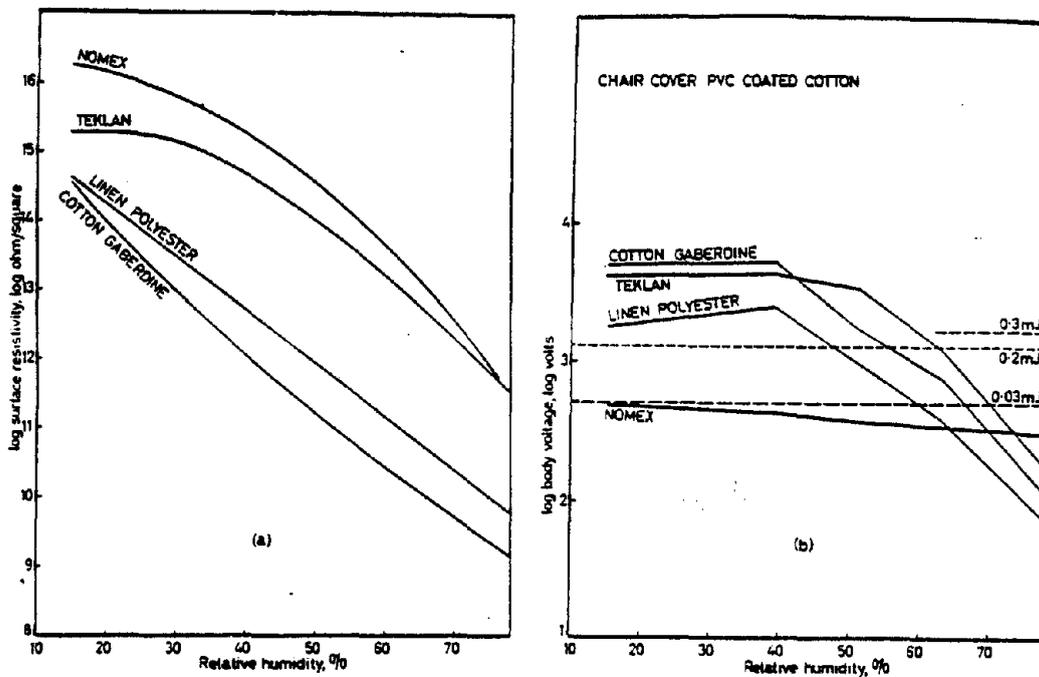
Figure IV-3. (a) Log Surface Resistivity vs. Relative Humidity, and (b) Log Body Voltage vs. Relative Humidity, Using a PVC-Coated Cotton Seat Cover⁽¹⁵⁾

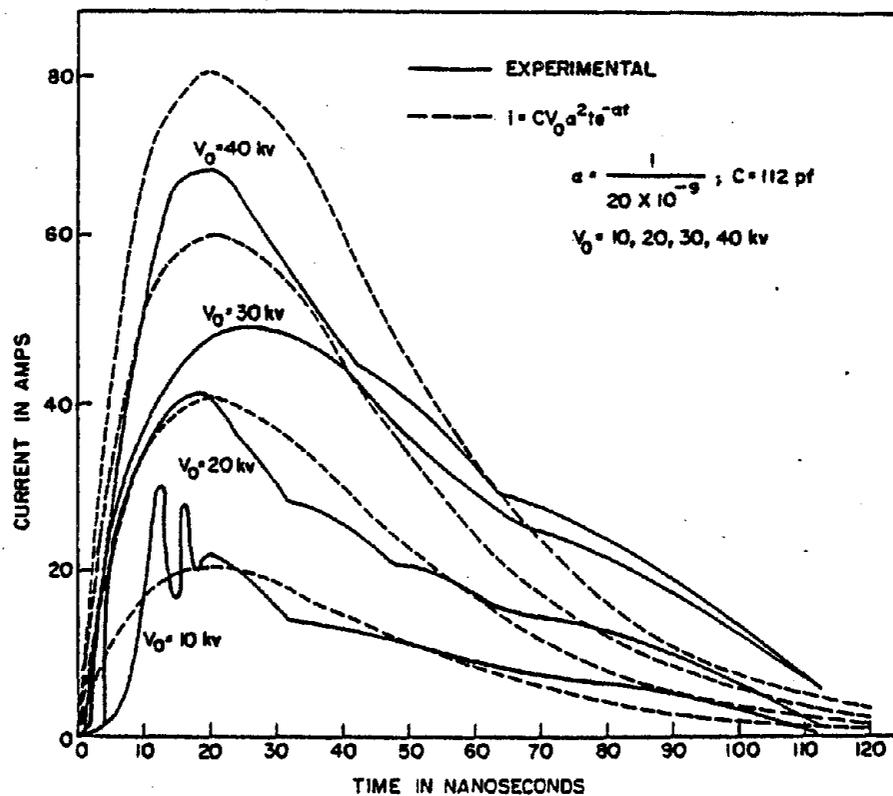
Figure IV-4. Typical Spark Currents Observed for Initial Body Voltages of 10, 20, 30, and 40 kv; Sparks Drawn from the Subject's Finger⁽¹⁷⁾

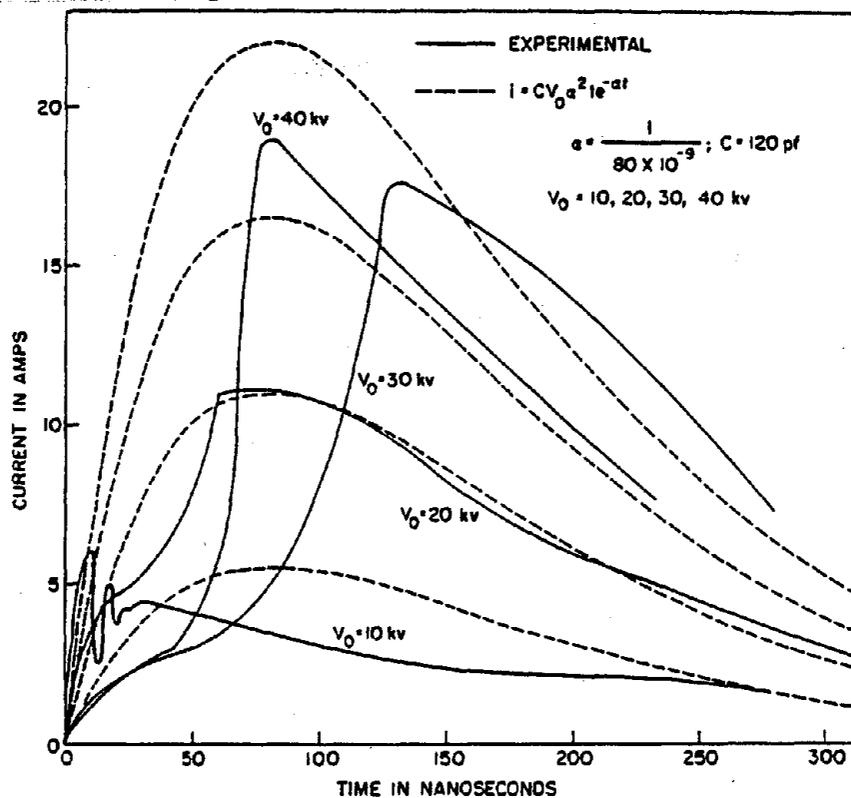
Figure IV-5. Typical Spark Current Observed for Initial Body Voltages of 10, 20, 30, and 40 kv; Sparks Drawn from a Tool Held in the Subject's Hand⁽¹⁷⁾

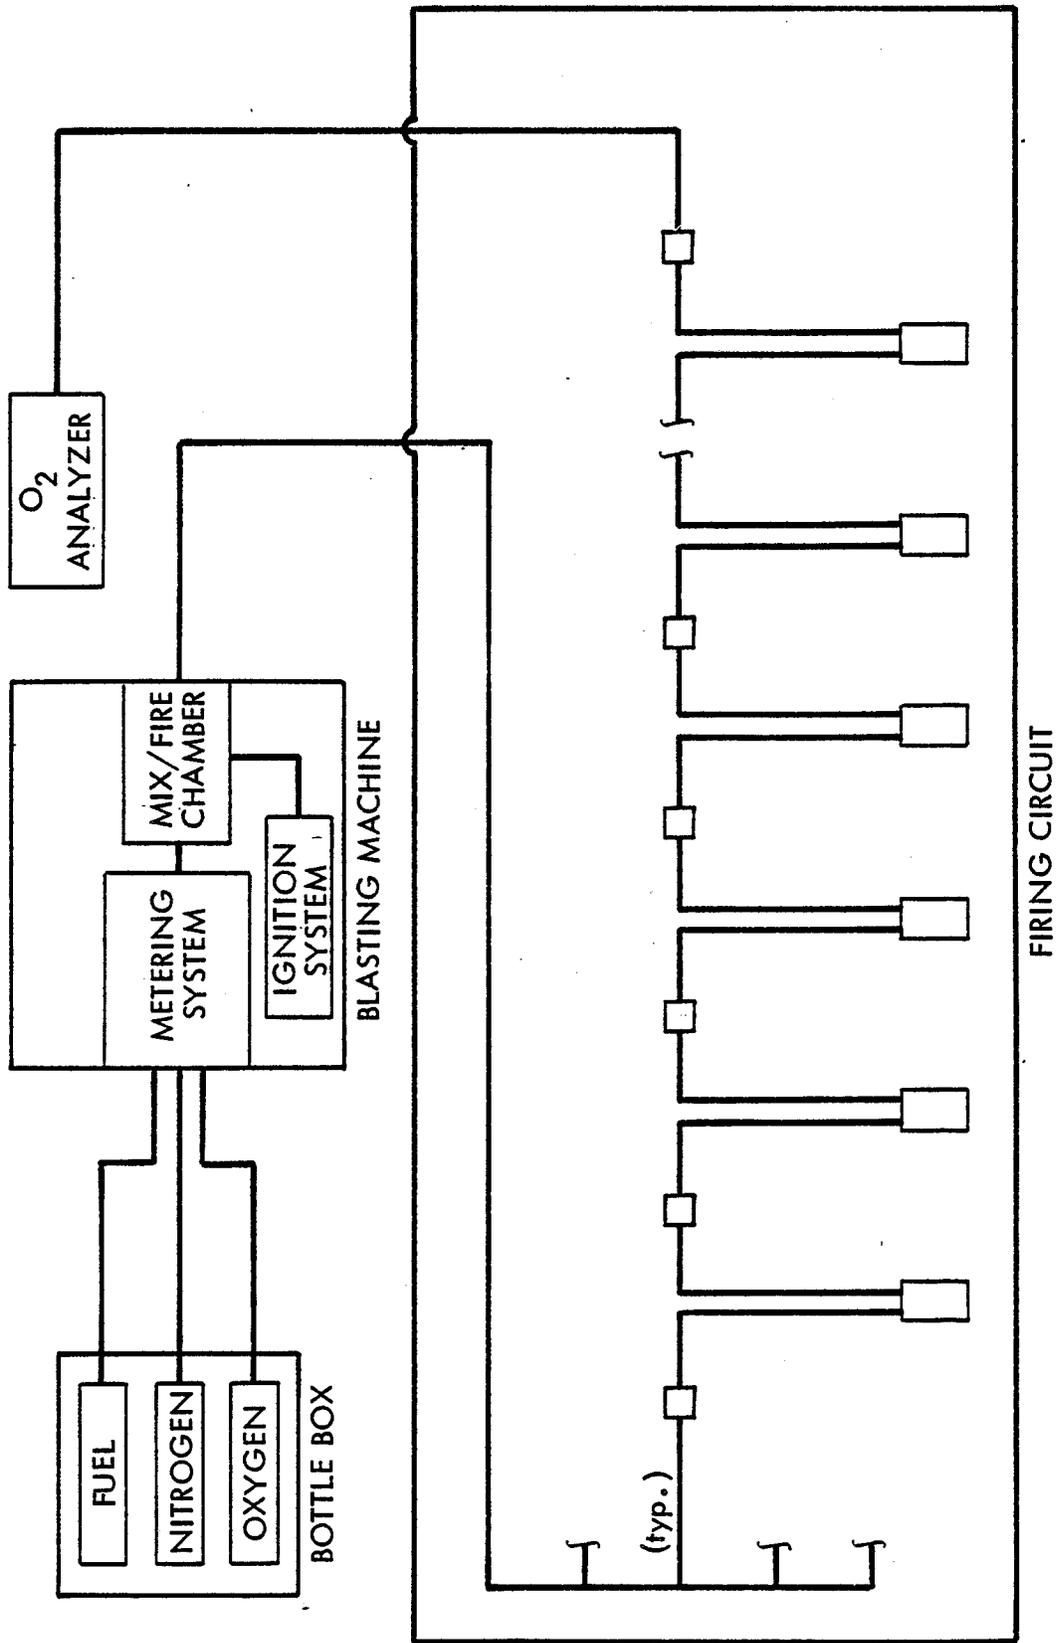
Figure IV-6. Hercudet System Diagram

System Operation - The following system operation describes how a firing circuit is completed and tested, how the circuit is charged and checked, and finally fired. It is based on observation of a quarry shot.

- (1) Individual caps are lowered in holes and holes loaded with explosive and stemming.
- (2) Individual caps are circuit tested with the hand pump tester. Any "bad" caps are marked for replacement.
- (3) Connections are made from cap-to-cap to form the circuit for the several cap-lines.
- (4) Each cap-line is circuit tested.

- (5) The cap-lines are connected to the trunk line and the trunk line and tail lines run from the blast area to the firing point.
- (6) The bottle box is connected to the blasting machine and the blasting machine is connected to the trunk line.
- (7) The blasting machine is actuated to charge the firing circuit until all tail lines indicate approximately 50% O₂ on the O₂ analyzer.
- (8) The shot is fired.
