Investigation of a Worker Death While Agitating Manure in a Non-enclosed Storage

PRACTICE/CASE HISTORY

ABSTRACT

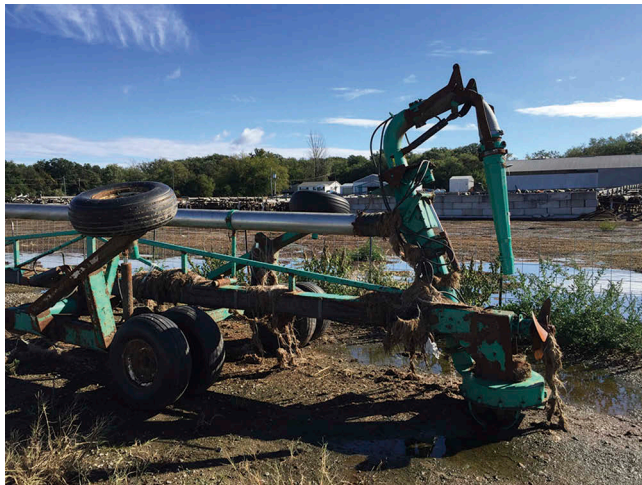
Figure 2. Agitator unit after the incident.

The towed manure agitator unit used at this site was 42-feet long. The machine was backed up by the tractor into the slurry, and the far end (that included a propeller and pump) was then submerged into the contents of the basin. In situations like this, as the agitator is backed up onto a crusted surface, its weight breaks through the crust and

settles down inside of the liquid slurry. This agitator had a large spray gun that remained approximately 6 inches above the top surface. A large tractor's (235 horse power engine) power takeoff operating at 540 rpm served as the agitator's power unit. Agitation action was accomplished via the large propeller at the end of the agitator structure, along with an aggressive 6-inch pump that lifted and sprayed liquid waste outward and to the sides and above the surface of the liquid to help break up crusted surfaces. The agitation and pumping were controlled with levers that actuate hydraulic valves on the agitator unit. Those controls were mounted on the front of the agitator and accessed from ground level. [Figures 2 and 3](#) show the agitator structure and controls, with the agitator having been pulled out of the storage basin after the

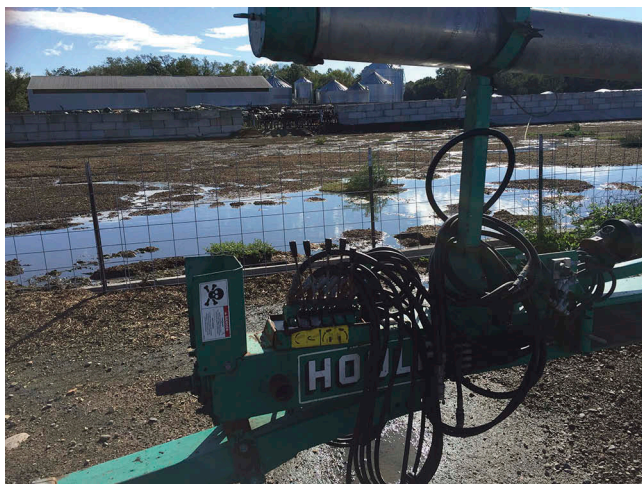
Figure 3. Agitator controls.

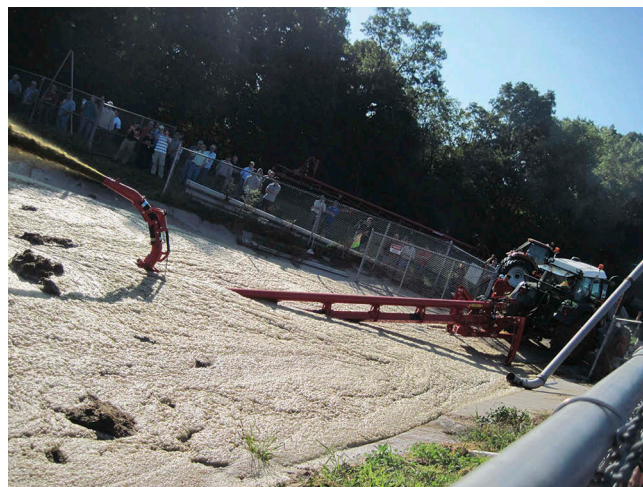
Figure 4. Manure agitation in process at educational field day.

incident. [Figure 4](#) shows an example of a typical agitation process occurring during an educational field day. Manure pumping and spreading contractors often depend on the agitation to be started prior to their arrival, which allows the contractor's crew to begin hauling immediately.
