# Bus stops and pedestrian–motor vehicle collisions in Lima, Peru: a matched case–control study

**Objective** To evaluate the relationship between bus stop characteristics and pedestrian–motor vehicle collisions.

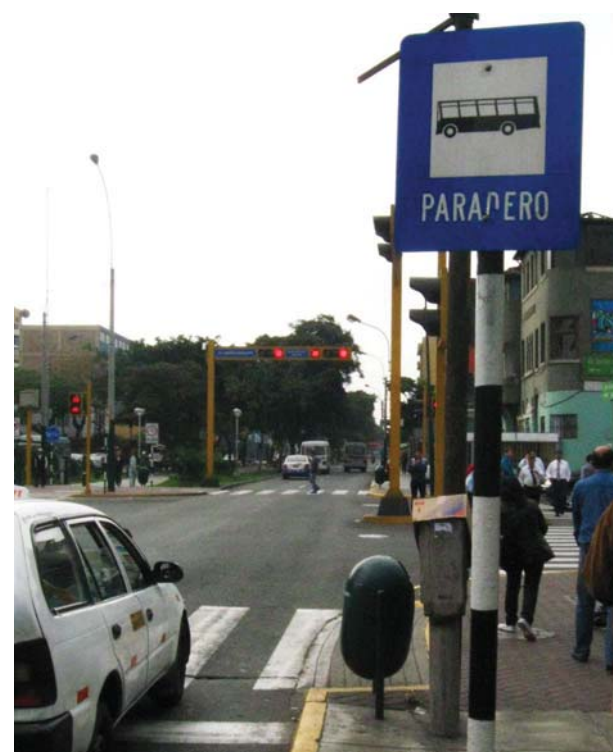
**Figure 2** Sign indicating an authorised bus stop.

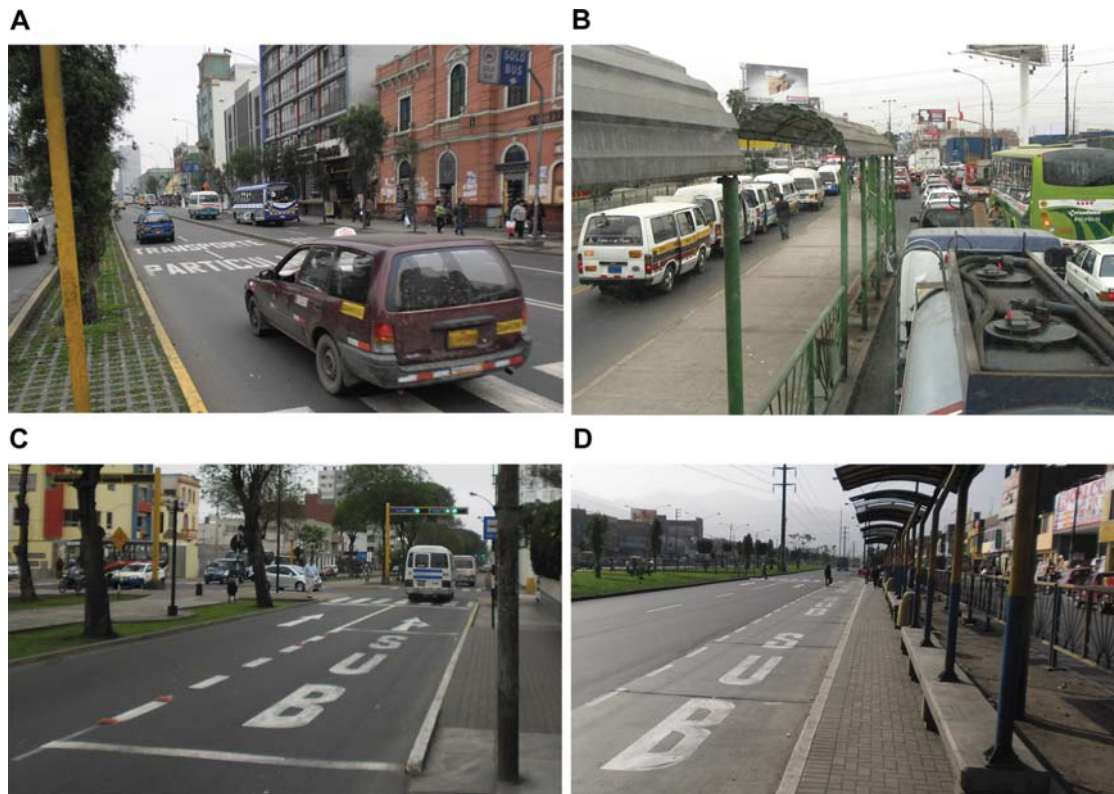
**Figure 3** A) Curb-side or exterior type bus lanes (far right lanes) with private/mixed vehicle traffic in the median lanes. B) Median or interior bus-dedicated lanes (left lanes) with private/mixed traffic lanes on the exterior/curb-side (right two lanes). C) A bus stop with a painted area designating where buses are authorized to alight and board passengers. D) A bus stop with a bus bay or pullout area allowing buses to exit moving traffic to board and alight passengers.

municipal bus stop sign was present. Some of the bus-dedicated traffic lanes were part of a bus rapid transit system in Lima (*El Metropolitano*).
