## A coal rib monitoring study in a room-and-pillar retreat mine

Gamal Rashed\*, Khaled Mohamed, Robert Kimutis

GCB/PMRD//NIOSH/CDC, Pittsburgh, PA 15236, USA

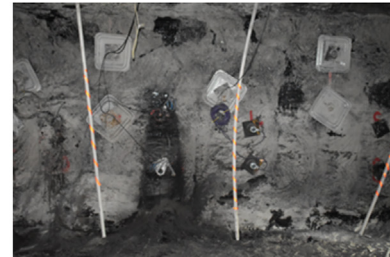
**Fig. 5.** Instrumentation type and location for the cross-cut side of instrumented pillar at site-1.**Table 2**

Figs. 4 and 5 show the layout of instruments at the entry and cross-cut sides of the instrumented pillar. The MPBX near the BPC at 6.0 m was located near the mid-pillar length, and the MPBX in Fig. 5 was located near the mid-pillar width.
