## **A Case Study of Potential Geologic Factors Affecting the Occurrence of Massive Ground Collapses at an Underground Limestone Mine in Southwestern Pennsylvania**

**Nicole Evanek<sup>1</sup>, Anthony Iannacchione<sup>2</sup>, and Thomas Anderson<sup>2</sup>**

<sup>1</sup>National Institute for Occupational Safety and Health (NIOSH)

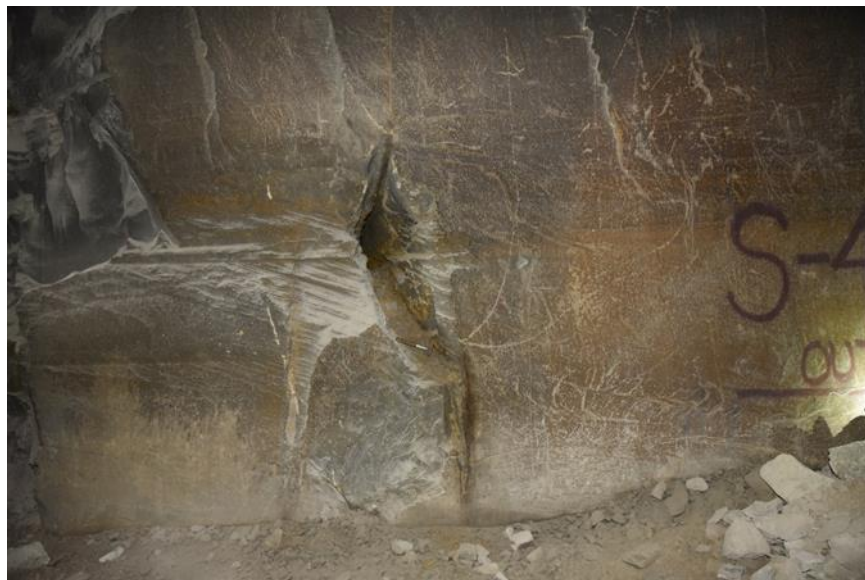
**Figure 4.** One example of a weathered joint with a cavity in one of the pillars adjacent to the collapse area.

When strata extension occurs, groundwater can more easily degrade the rock and dissolve the limestone along existing rock joints (large structural fractures or breaks in the strata). The weathered joints then have the potential to isolate blocks of strata that could be subject to gravity driven movement under low confinement (Iannacchione et al., 2002). Dissolution of the limestone along rock joints was observed near the collapse area (Figure 4).

Four of these weathered joints with cavities were recorded during scanning around the outer edges of the collapse area. These joints may have contained residual fine-grained material that has since been removed by weathering. The 3D static LiDAR scans of this area were used to locate and measure the length of these structural features. One of the largest of these weathered joints is shown in Figure 5. The LiDAR scanner was able to pick up points within the cavity at a depth into the pillar of 6.7 m (22 ft). The formation and orientation of these joints is comparable with those observed in other mines along the Chestnut Ridge anticline (Iannacchione and Coyle, 2002). Iron staining was present on a particular joint set near the collapse area (Figure 6), which indicates some water movement along the joints.

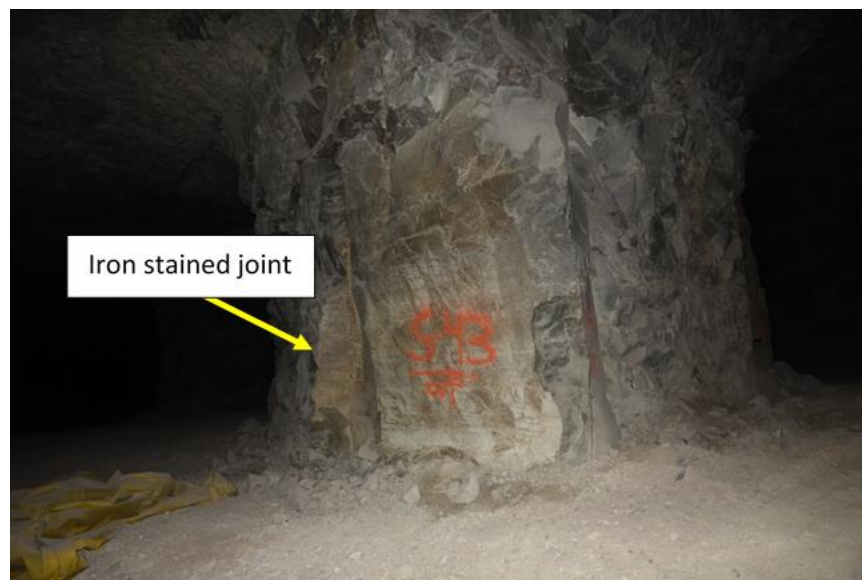
**Figure 6.** Iron stained joint in a pillar on the edge of the collapse area.
