# Roof Stability and Support Strategies Associated with Longwall-induced Horizontal Stress Changes in Belt Entries

Longwall mining is a highly productive and efficient coal mining method used in the USA. During longwall retreating, the belt entry must be maintained stable, and any roof fall in the belt entry would jeopardize mine safety and substantially interrupt the continuous production of coal in the longwall face. Past experience of longwall mining has shown that belt entry stability was the greatest challenge in longwall ground control, and the occurrence of roof falls in belt entries was largely associated with high horizontal stress. To properly support the roof in the belt entry, it is important to understand how longwall-induced horizontal stress changes affect roof stability in belt entries and to strategically install supplementary support to prevent any potential roof falls. Researchers from the National Institute for Occupational Safety and Health (NIOSH) performed horizontal stress measurements in the immediate roof of the belt entries for two Pittsburgh seam longwall panels oriented unfavorably to high horizontal stress. Hollow inclusion cells (HICells) were instal

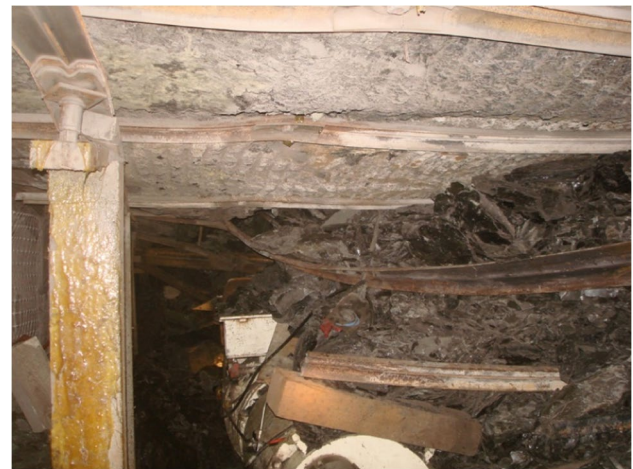
**Fig. 2** Roof fall near the face in the belt entry

With the second roof fall in the mid-block, two 4.9-m post-tension cable bolts with T-3 channels on 1.8-m spacing were also added in the mid-blocks in addition to the intersections. Polyurethane injection was used to further reinforce the roof. The injection holes drilled at the entry corners were 3 m deep and angled at 45° over the pillars. However, a third roof fall still occurred another 91 m outby the second fall in the belt entry (roof fall III in Fig. 1). The fall was 3.0–3.7 m high, 3-m long, and about 27 m inby the nearest intersection outby the face. The roof did not completely collapse but cantilevered over the rib on the chain pillar side. The roof on the panel side touched the stage loader, but the roof on the pillar side still overhung (Fig. 2). On the panel side, the roof broke around the cable bolt plates and fell out between the cable bolts with the 4.9-m cable bolts still firmly anchored in the roof. The scope hole at the intersection outby the fall showed

separations at 2.4 m, 2.6 m, and 3.0 m above the roofline. The hole was scoped one week before and no separations were seen. Scoping near the roof fall found three rider coal seams at 0–0.2 m, 1.1–1.4 m, and 2.1–2.4 m above the roofline. The third roof fall appeared to be associated with these three layers of rider coal within 2.4 m of the immediate roof. The rider coals created weak planes so that under abutment pressure and high horizontal stress, roof separations developed within 2.4–3.0 m above the roofline. As the roof began to sag, the top coal above the cable bolt plate broke, resulting in more roof sagging and eventually a roof fall. With this understanding, two 4.9-m post-tension cable bolts with steel channels were installed on 1.2-m spacing along the rest of the belt entry in the areas where rider coals were found within 4.9 m above the roofline. The rest of the panel was mined without major roof control issues in the belt entry.

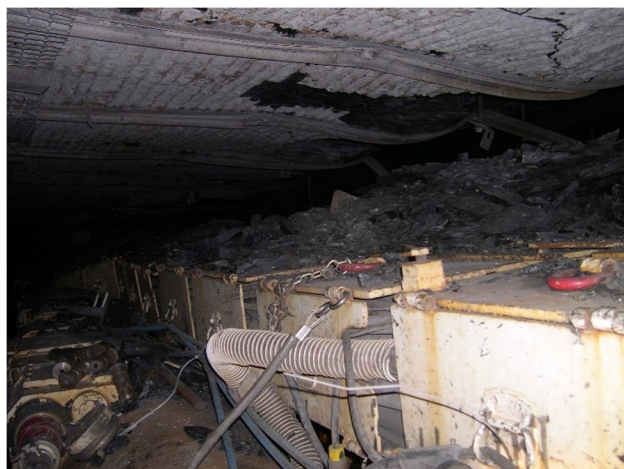
**Fig. 4** Roof cutter developed at the belt entry corner on the panel side

- Roof falls were initiated from either roof cutter at one side of the entry corner or roof sagging at the entry center during longwall retreating. Few roof cutters or sagging occurred during development. The roof cutters, sagging, and separations initiated within about 15 m outby the face and gradually developed into roof falls within about a shift. The roof falls were close to the face, mostly in front of the longwall gate shields.

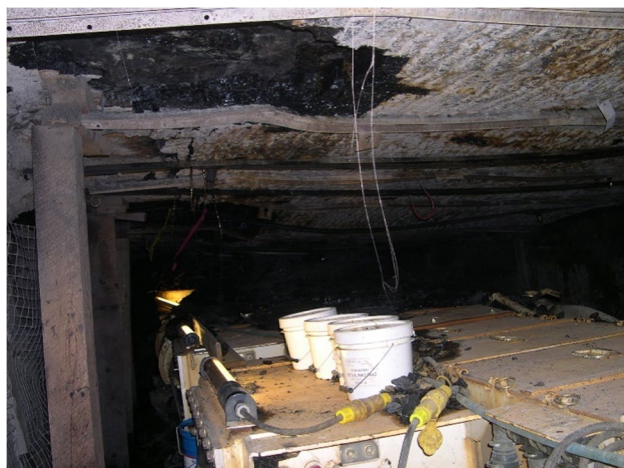
**Fig. 5** Roof cutter developed at the belt entry corner on the chain pillar side
