## GALVANIC CORROSION BETWEEN GRAPHITIC ROCK AND GROUND SUPPORT IN UNDERGROUND MINES

C. Stazick, CDC NIOSH, Spokane, WA  
C. Sunderman, CDC NIOSH, Spokane, WA  
G. Feagan, CDC NIOSH, Spokane, WA

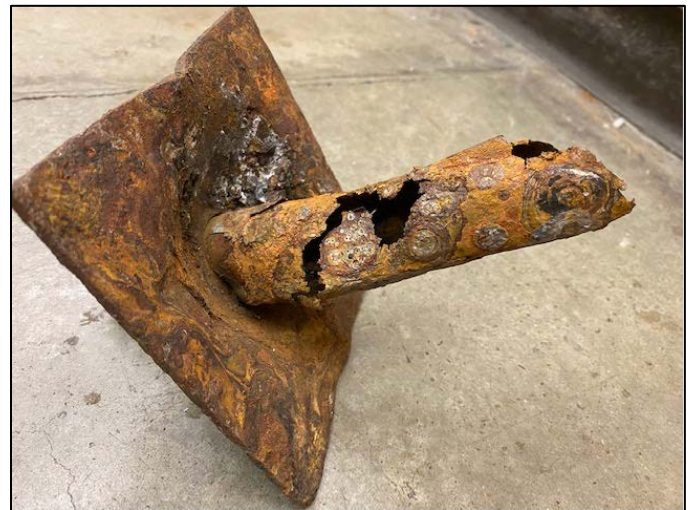
Figure 1. Failed corroded rockbolt from a mine in this study.

Steel rockbolts are used extensively in underground mining to strengthen excavations and provide safe passage of workers and equipment. The combination of high tensile and shear strength and the low cost of mild steel make it an excellent choice to help resist the movement of the rock mass in an excavation. When initially installed, the design strength of a mild steel rockbolt is achieved, and over time it will support the rock mass up to its load-bearing capacity [1]. However, corrosion of steel gradually reduces the load-bearing capacity of a rockbolt and creates safety concerns for the entire ground support system. When the corrosivity of a rock mass is not considered during the design stage, expensive rehabilitation may also be necessary to keep the excavation open for its desired lifespan. Figure 1 shows a rockbolt that has failed pull testing in a partner mine in this study due to advanced corrosion.

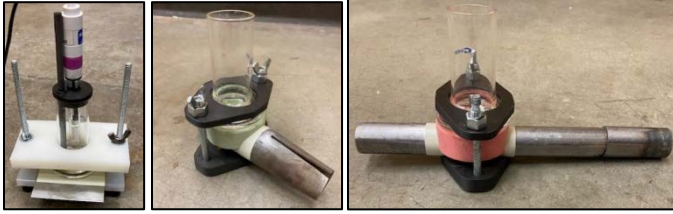
**Figure 2.** Modified paint cells for electrochemical testing.

The goals of this study were to: (1) investigate and quantify the influence of high carbon conductive mine rock on the galvanic corrosion rate of mild steels, (2) compare two electrochemical testing methods for estimating corrosion rates of this galvanic system, and (3) investigate if there is a relationship between rock resistivity and corrosion rate. Bulk rock samples were obtained from two northern United States metal mines, referred to as Mine 1 and 2, and these rock samples were cut into rectangular sections with a flat face for testing. An equal-sized copper plate and piece of ultra-low resistivity carbon foam were placed in contact with the rock to create modified "paint cells" and "para-cells" for electrochemical corrosion analysis, as seen in Figures 2 and 3.

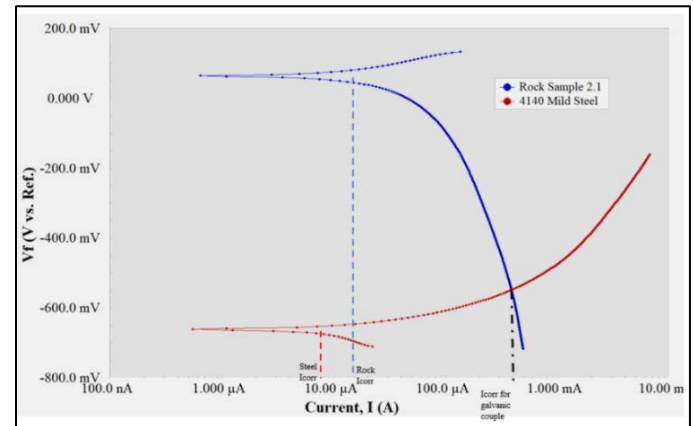
**Figure 5.** Overlay of anodic and cathodic curves for rock and metal samples.

For a galvanic coupling experiment, PDP scans can be utilized to estimate the corrosion current of the system. Individual scans of the two materials can be graphically overlaid, with  $I_{corr}$  and  $E_{corr}$  being represented by the intersection of the cathodic branch of one material with the anodic branch of the other. For the rock samples in this study, input parameters were chosen to run the PDP scans primarily for the cathodic reactions. Scans were run similarly to include primarily the anodic reactions for the metal samples. Figure 5 shows a representative overlay for one of the rock and metal sample combinations.

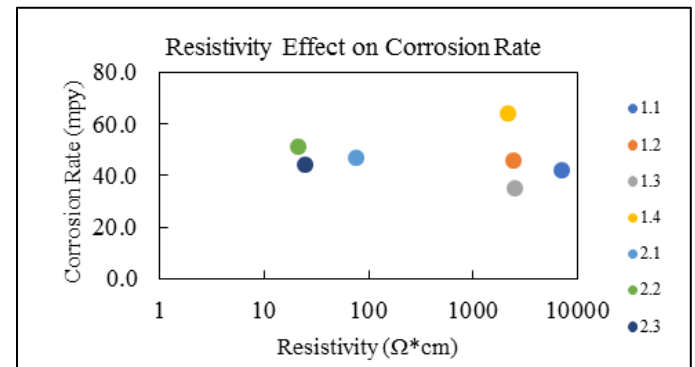
**Figure 7.** Scatter plot of rock resistivity and the corresponding galvanic system corrosion rate.

Resistivity values for each rock sample were measured and plotted against the corrosion rate of 4140 carbon steel. Figure 7 shows the witnessed relationship amongst the rock used in the test.

Rock resistivity was measured on dry rock specimens. From the samples tested, there does not appear to be a strong correlation between the resistivity of the rock and the resulting corrosion rate. The rock samples from both Mine 1 and 2 have much lower resistivity than other typical host rocks encountered underground. Dry rock resistivity below 1 k $\Omega$ -cm can be considered "low resistivity." Typical host dry rock mass resistivity is often in the kilo- or mega-ohm range but is often lower when wet. Figure 7 displays the relation between the resistivity of the rock samples analyzed. Rock samples from Mine 2 had resistivities a magnitude lower than Mine 1; however, corrosion rates fall very close to each other. Despite the weak correlation, it should be noted that low resistivity and high conductivity are important properties of the rock that allow for increased flow of electrons during corrosion reactions.
