Accelerated galvanic corrosion between graphitic rock from underground mines and metal coupons

Abstract

Keywords: *corrosion, galvanic corrosion, metal ground support*

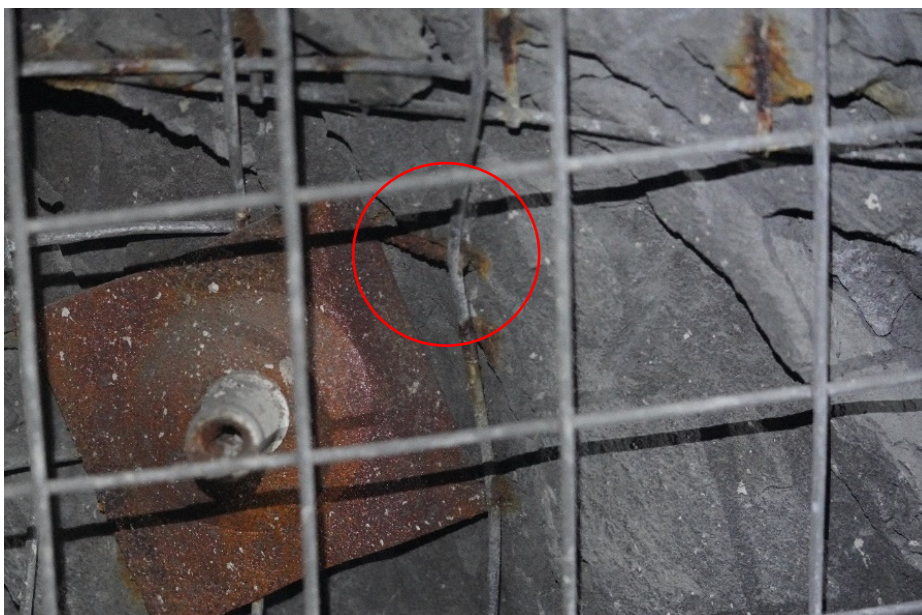
steel in contact with this material. Figure 1 shows an example of heightened corrosion of mesh support at contact points with the graphitic rock mass.

Figure 1 Observed galvanic corrosion in partner mine where metal ground support contacts the graphite-like rock

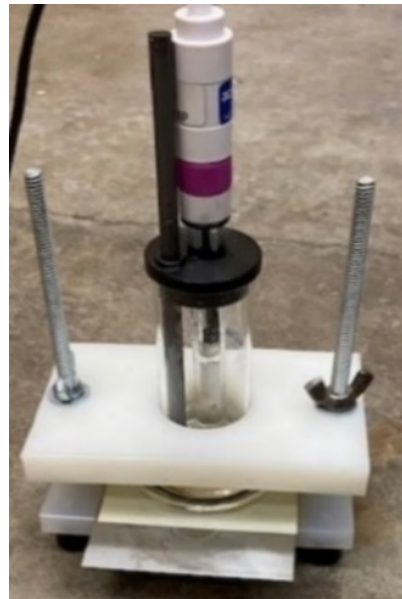
Electrochemical measurements were taken using a potentiostat to obtain baseline corrosion rates for the steel coupons in the standard salt solution. The coupons were inserted into a ‘paint cell,’ as seen in Figure 3. These cells are commonly used to test bare metal samples.

Figure 3 Paint cell used for electrochemical tests to obtain the baseline corrosion rate of a coupon in the standard solution

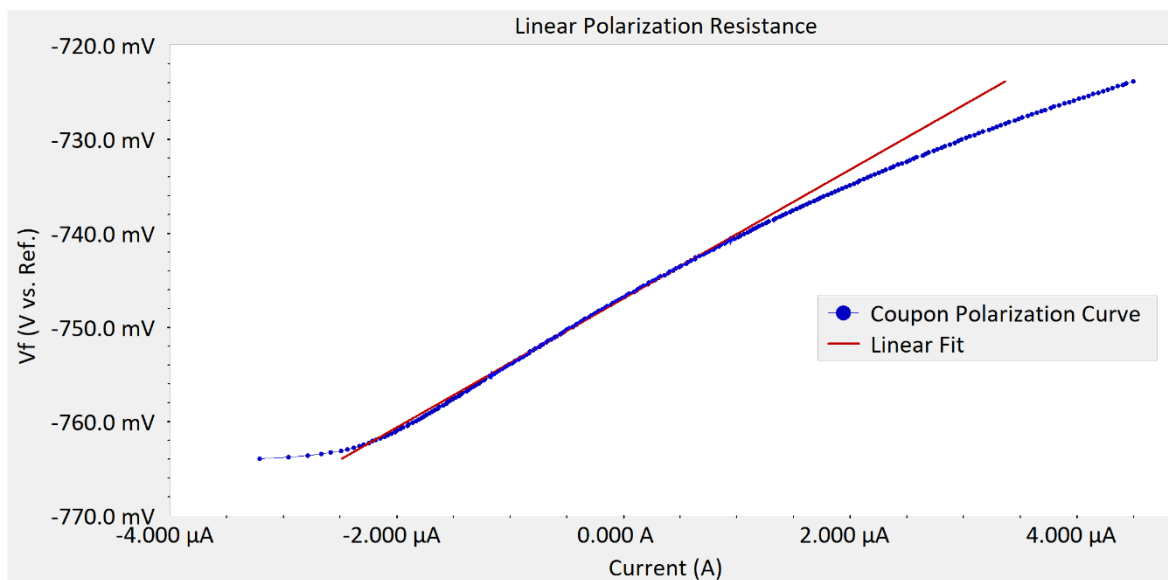
To obtain these baseline corrosion rates, linear polarisation resistance (LPR) scans were performed. LPR scans provide a non-destructive testing method to obtain corrosion rate data. This is achieved by polarising the material +/-10 mV around its open circuit potential, resulting in the material’s resistance to polarisation being measured, as detailed by Gamry Instruments Inc. (n.d.). By applying the Stern–Geary equation, an estimated corrosion rate is provided. This was performed twice, once for each rock sample from the two assemblies. Figure 4 shows the LPR scan for the ambient assembly rock sample and fresh coupon.

Figure 4 Linear polarisation resistance test scan for the control coupon corrosion rate

The corrosion rates for both the ambient and environmental chamber control coupons were calculated using Gamry Echem Analyst™ (Gamry Instruments Inc. 2022). From the LPR scan, the baseline corrosion rate of a metal coupon in the standard salt solution was 0.0638 mm/y, when not galvanically coupled to the rock samples.

Using the LPR potentiostat data, the baseline control coupon corrosion rate in the standard solution was very low at 0.0638 mm/y. When compared to the ZRA scans using the same device for a galvanic couple, the corrosion rate was approximately 39 times higher than when the coupon was not in a coupling with the mine rock. This aligns with in situ observations of ground support in partner mines, which visibly have much greater

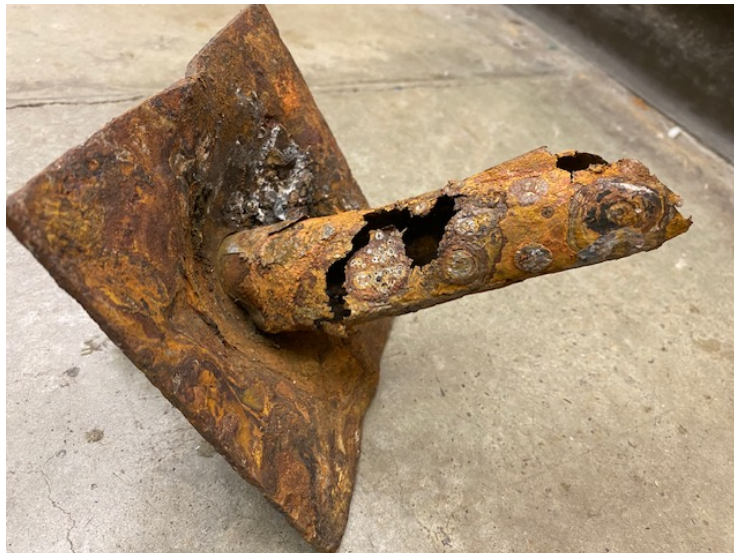
Figure 10 Failed bolt from a partner mine where metal ground support contacts the graphite-like rock

The corrosion rates in Table 1 are reported in mm/y, with the highest rate being 2.2 mm/y. A standard hollow friction bolt is approximately 2.46 mm thick in the United States, indicating that it would corrode through in two years if the rate remained constant in this environment. Inflatable bolts are generally 2 mm thick and would corrode at a similar rate. Figure 10 below shows an inflatable bolt that failed pull testing less than two years after installation in a partner mine. It should be noted that the highest experimental corrosion rates were held at conditions to encourage accelerated corrosion, so in situ rates may be lower depending on the temperature and humidity of the environment.
