Applications of InSAR for Early Indication of Mine Slope Instability: Back Analysis of Satellite Displacement Data

Josef Bourgeois *National Institute for Occupational Safety and Health, Spokane, USA*

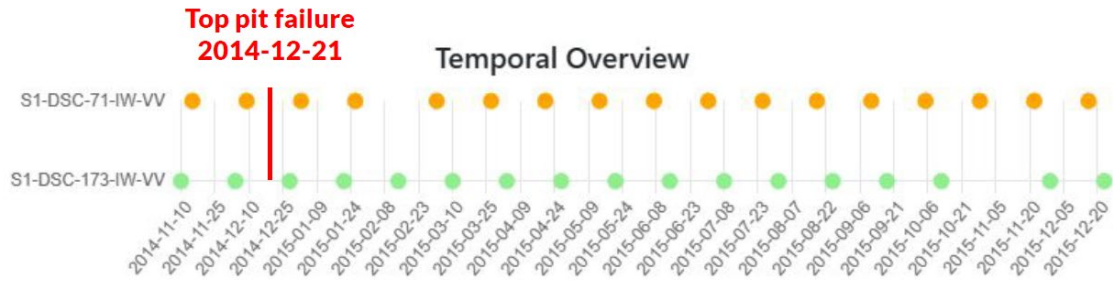
Figure 1. Sentinel-1 satellites used to analyze Top pit East wall slope failure.

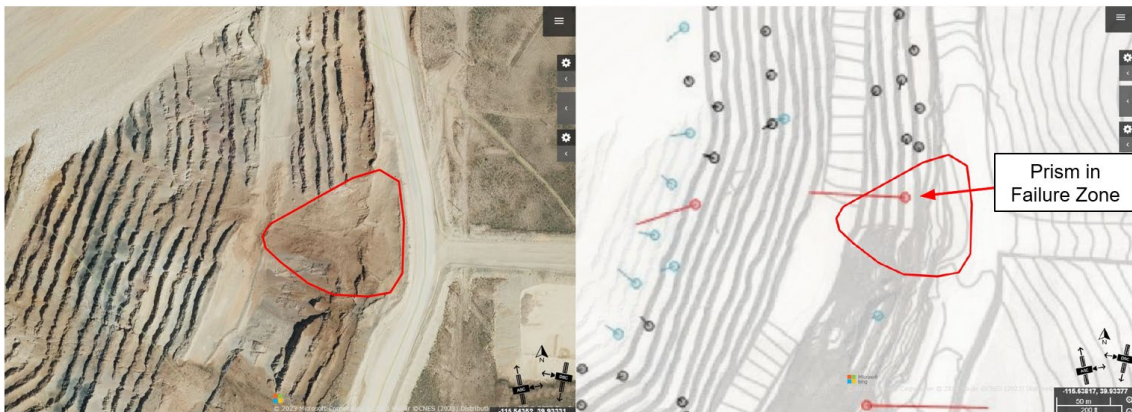
Figure 2. Top pit East wall failure area (red outline) and prism location.

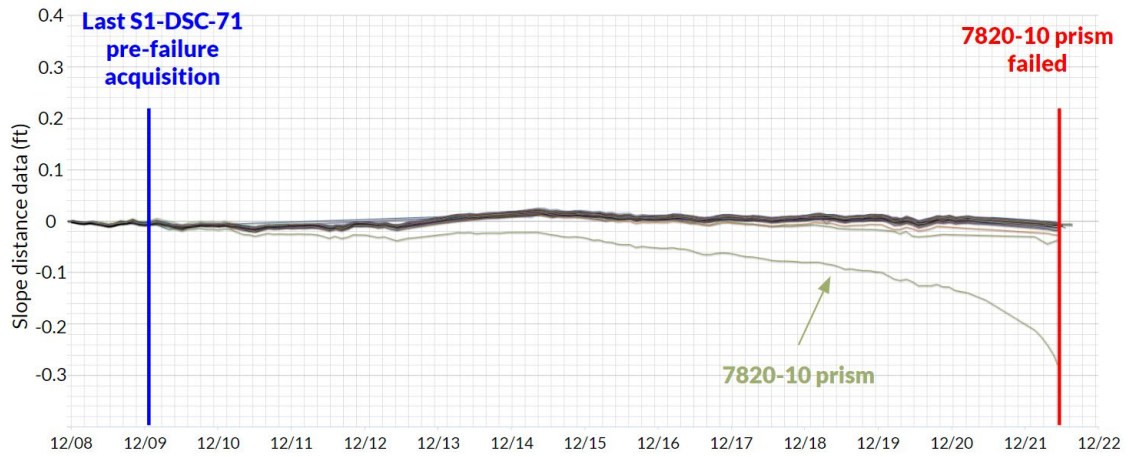
Figure 3. Timeline of 7820-10 prism located in Top pit East wall failure area showing displacement after December 9, 2014 and failure on December 21, 2014.

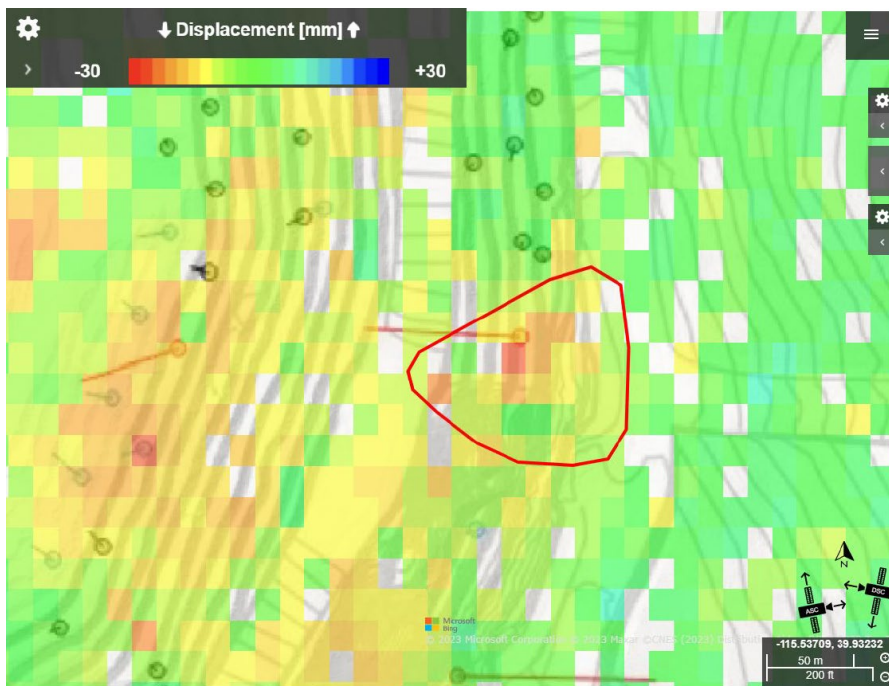
Figure 4. Sentinel 1 descending 71 data of Top pit East wall failure area with prism locations showing differential line of sight displacements from November 15, 2014 to December 9, 2014.

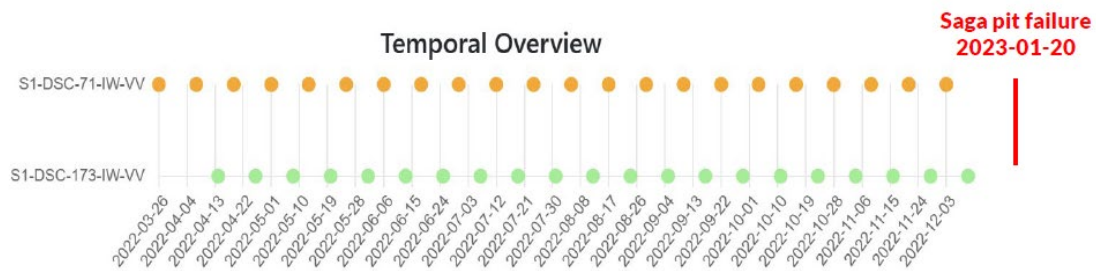
Figure 5. Sentinel-1 satellite orbits and acquisitions used to analyze Saga pit North wall slope failure.

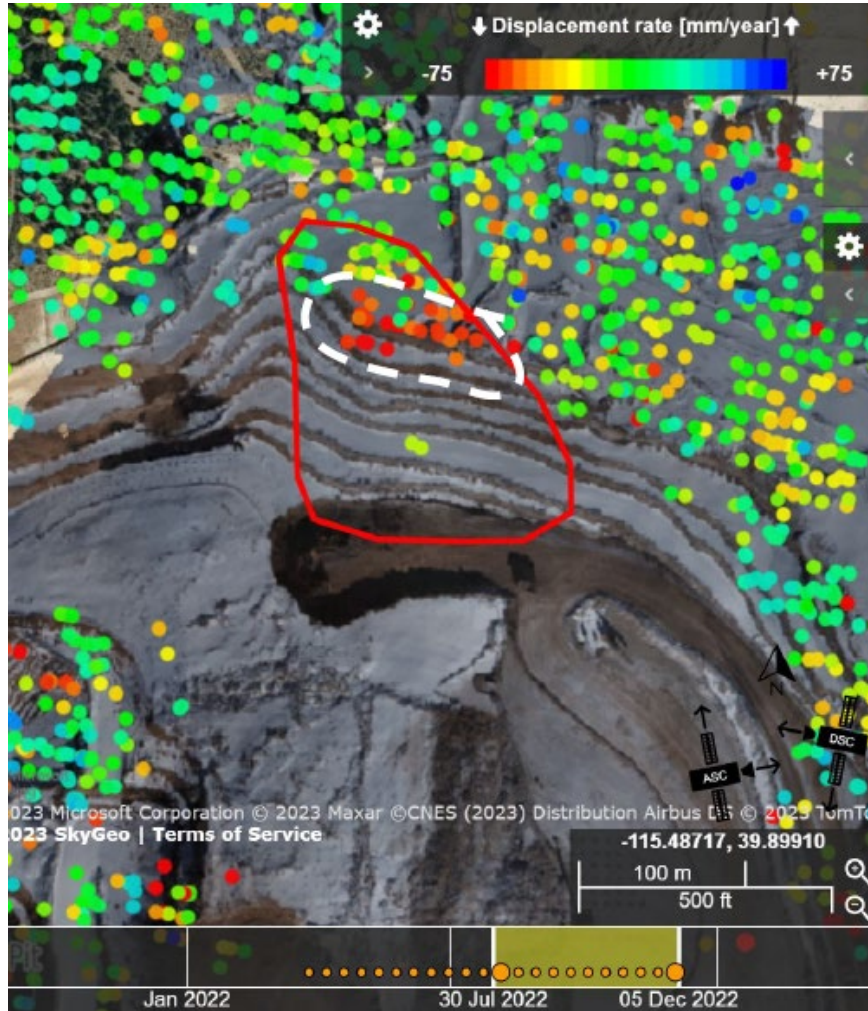
Figure 6. Displacement rates estimated from Sentinel-1 descending orbit 71 data for the period July 30, 2022 to December 5, 2022. Background: pre-failure optical image of the Saga pit North Wall. Red outline: failure area. White outline: group of InSAR points showing an increase in displacement rate preceding the failure.

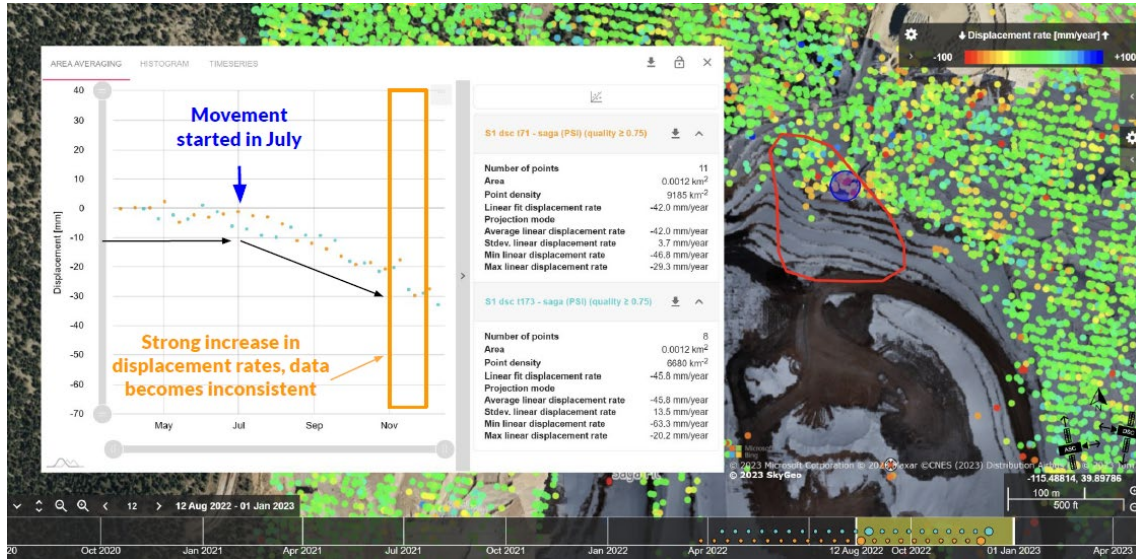
Figure 7. Sentinel-1 descending 71 and Sentinel 1 descending 173 data of Saga pit North wall failure area showing displacement map and average time series of the crest points within the blue shaded circle selected for analysis.
