Rockfall Barrier Testing in an Open Pit Mine: Comparing Empirical and Modeled Rockfall Dynamics

This paper was prepared for presentation at the 58th US Rock Mechanics/Geomechanics Symposium held in Golden, Colorado, USA, 23-26 June 2024. This paper was selected for presentation at the symposium by an ARMA Technical Program Committee based on a technical and critical review of the paper by a minimum of two technical reviewers. The material, as presented, does not necessarily reflect any position of ARMA, its officers, or members. Electronic reproduction, distribution, or storage of any part of this paper for commercial purposes without the written consent of ARMA is prohibited. Permission to reproduce in print is restricted to an abstract of not more than 200 words; illustrations may not be copied. The abstract must contain conspicuous acknowledgement of where and by whom the paper was presented.

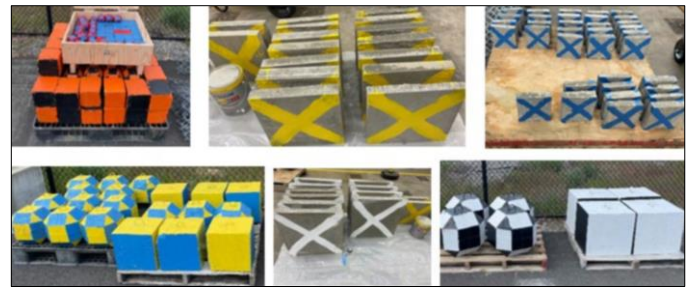
Figure 2. Variety of synthetic rocks created by NIOSH for rockfall testing (from Warren et al., 2022).

The tests utilized synthetic 'rocks' made of cast concrete and fiber reinforcement created by the NIOSH team, with various dimensions as shown in Figure 2. The variety in size and dimensions of the synthetic rocks is meant to mimic the natural variety of loose rock that may become rockfall hazards (Warren et al., 2022).

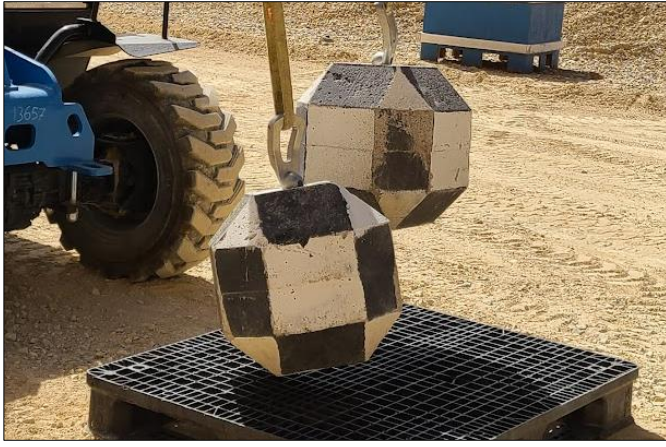
Figure 3. R1-type synthetic rhombicuboctahedron-shaped rocks.

Rockfall tests were initiated from the upper haul road (UHR) using a telehandler tractor by loading the rocks onto a wooden pallet, setting the pallet on a flat-top berm on the highwall crest along the UHR, and using another pallet attached to the telehandler forks to push the rocks over the edge. Most rocks were caught by intermediate benches, however several successfully made it to the lower haul road (LHR), impacting the rockfall barrier system described below. Over 300 rocks were sent down the slope during the daylong test, and the NIOSH team plans to analyze the full results of these tests with respect to bench performance. A solitary rhombicuboctahedron-shaped rock measuring 46 cm in diameter and weighing ~172 kg, known here as R1 (Figure 3), impacted the barrier with appreciable force and is the focus of this analysis.
