# A Study of the Key Factors Associated with a Massive Pillar Failure in an Underground Limestone Mine using Numerical Models

Rashed, G., Yuting X., and Evanek N.

*NIOSH Pittsburgh Mining Research Division, Pittsburgh, PA, USA*

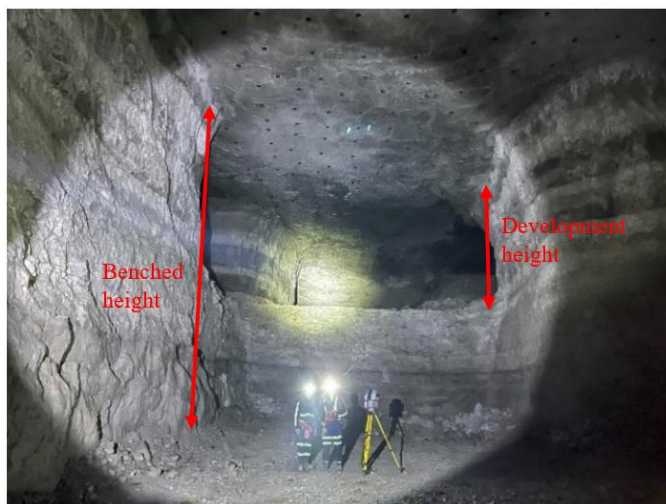
**Figure 1: Development pillar height versus benched pillar height in an underground limestone mine.**

Mining the floor increases the pillar height which creates slender pillars. The strength and stiffness of slender (fully benched) pillars are less than wider (development) pillars of the same cross-sectional area due to the reduction in the w/h ratio of the pillar (Rumbaugh et al., 2022). The reduction in pillar strength can be estimated using the S-Pillar or any other empirical pillar strength equation for hard rock mine (Hoek, et al., 1995; Martin and Maybee, 2000; Esterhuizen et al., 2011).

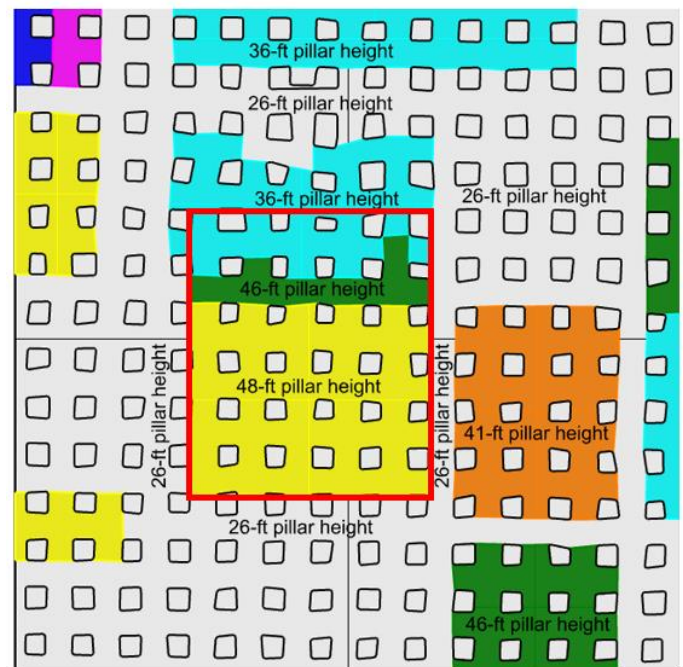
**Figure 2: Massive ground collapse periphery is surrounded by a red box; different colors reflect different floor benching height. The maximum pillar height is 48 ft (14.6 m) after floor benching.**

The massive collapse that has been modeled/investigated in this study occurred only in benched areas with most of the collapse

occurring in the full bench area with a pillar height of 48 ft (14.6 m). The collapse did not propagate to the unbenced areas where the pillar height is 26 ft (~8 m). The collapse encompassed a 5x6 array of pillars; see Figure 2 which shows the collapse periphery (red box) at the study mine. Some pillars in the collapsed area have a w/h ratio <0.8 which is not recommended by the S-Pillar guidelines for stone pillar design (Esterhuizen, et al., 2011).

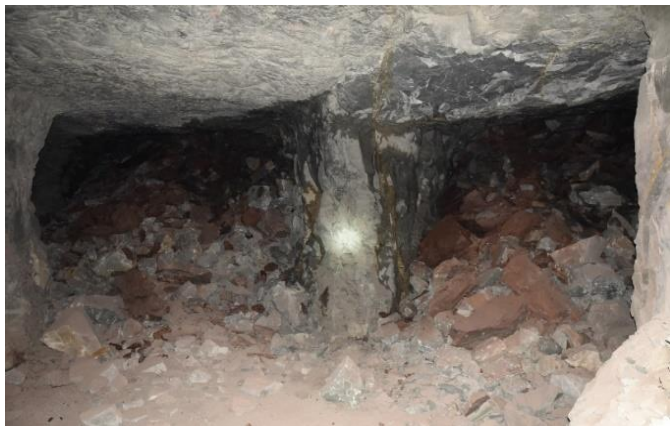
**Figure 3: Two near-vertical, large iron-stained joints in a pillar nearby the collapsed area.**

Some joints around the collapsed area were iron stained, especially in the dominant joint set (J1). Figure 3 shows two near-vertical, large iron-stained joints in a pillar on the southwestern side of the collapsed area. Iron staining in joints indicates open apertures that easily transmit water and offer little to no cohesion between opposing blocks of rock (Phillipson, 2012). Details of the mining and geological conditions are presented in Rashed et al. (2023).

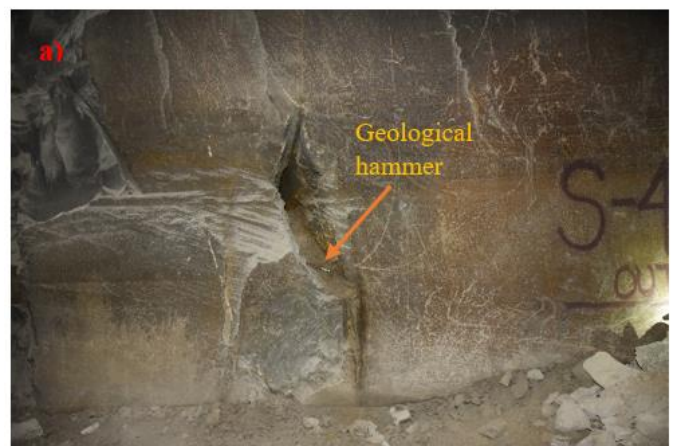
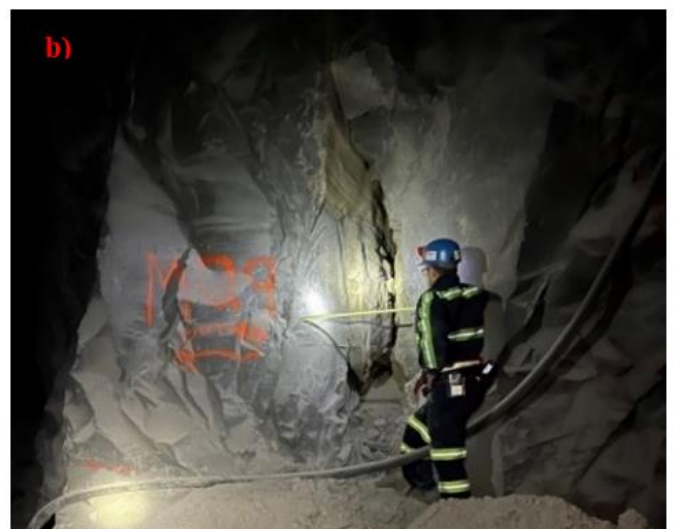
**Figure 4: Karst cavities of different sizes observed nearby the collapsed area in the study mine: a) small size and b) large size.**

Karst cavities of various sizes with an elliptical shape were observed in the area nearby the collapsed region in the study mine, Figure 4 shows two examples for karst cavities of different sizes. The width of the cavity shown in Figure 4b is about 2.5 ft (0.8 m), and it decreases in size toward the pillar core; the height of that cavity is about 9.5 ft (2.9 m), and its depth is about 17 ft (5.2 m) deep inside the pillar, determined from the LiDAR scan. The scanner may not have captured the full extent of the karst cavity into the pillars. On the other hand, the dimension of the cavity shown in Figure 4a is relatively small compared to Figure 4b.

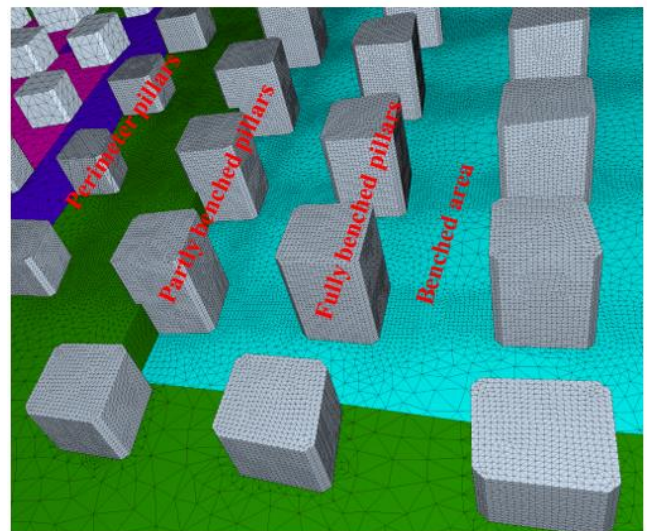
**Figure 7: 3DEC model illustrating fully benched, partly benched, and perimeter pillars in the study mine.**

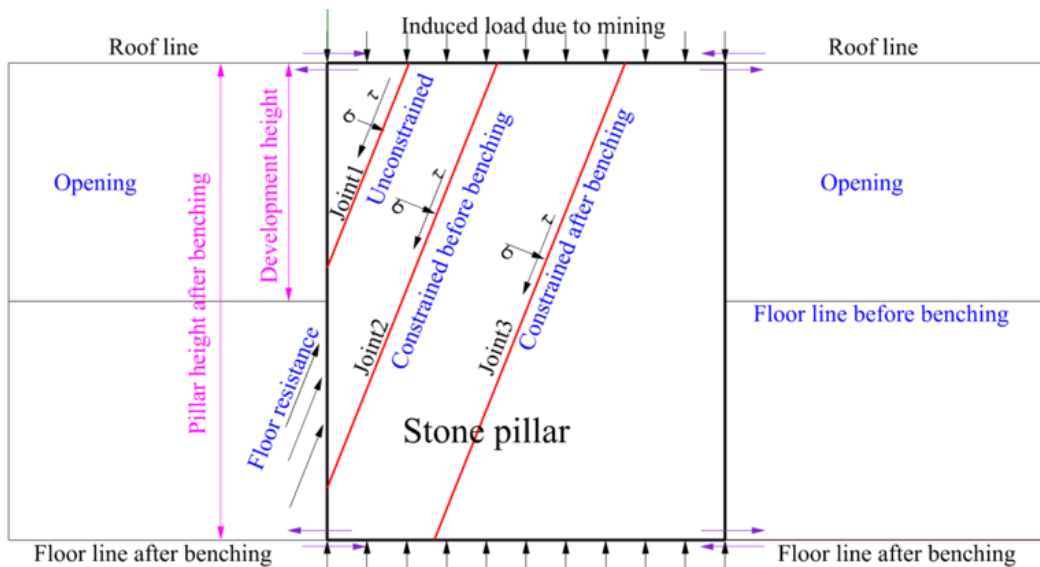
**Figure 10: Schematic for constrained and unconstrained joints in an underground stone pillar.**

At shallow depths, structurally controlled failures may be the prime concern in excavation design (Brady and Brown, 2004). Slipping along pre-existing planes of weakness occurs if the driving shear force is greater than the resisting force. Floor benching may trigger a slip along one or more pre-existing joints by converting the joint from being constrained to being unconstrained. Figure 10 shows a schematic for both constrained and unconstrained joints. Constrained joints receive supplemental resistance and friction at both ends of the joints. After development, Joint2 shown in Figure 10 was constrained before floor benching where the floor was acting like a retaining wall that prohibit/minimize sliding along joint2. Once the floor was removed, joint2 became an unconstrained joint and its potential for sliding increased.

In the previous section, the study pillar was presumed massive which is not the case in most underground stone mines. In this section, the study pillar is jointed (and has four joints) to gain more insight about the combined effect of floor benching and geological discontinuities on pillar stability (see Figure 6). Two of the four joints in the study pillar are constrained joints, while the other two are similar to joint1 and joint2 shown in Figure 10.

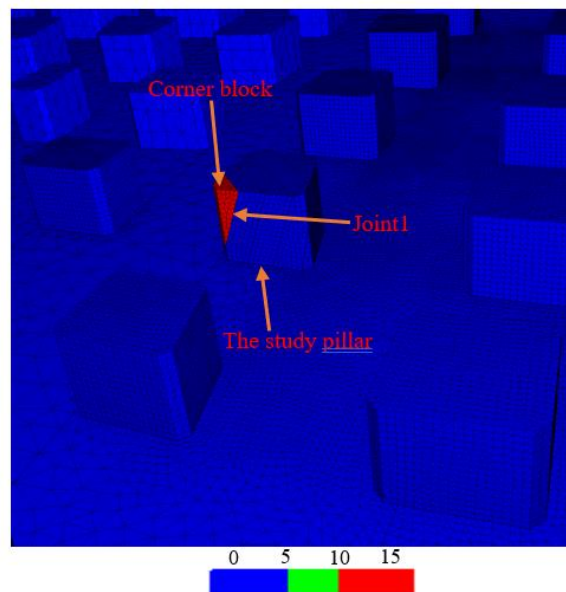
**Figure 11: Displacement magnitude in mm for the development stage; the corner block of the jointed study pillar was removed from the model when its displacement reached 60 mm during benching.**

Figure 11 shows the displacement magnitude for some pillars including the study pillar in the development stage. The displacement magnitude for the corner block of the study pillar was significantly high compared to other pillars. The shear displacement along joint1 was also high indicating shear failure. Both the displacement magnitude and joint shear displacement increased further with floor benching activities. The corner block was removed from the 3DEC model once its displacement magnitude reached about 60 mm. On the other hand, sliding along the other three constrained joints in the study pillar was prevented because of the floor resistance and friction generated at the ends of the joints.

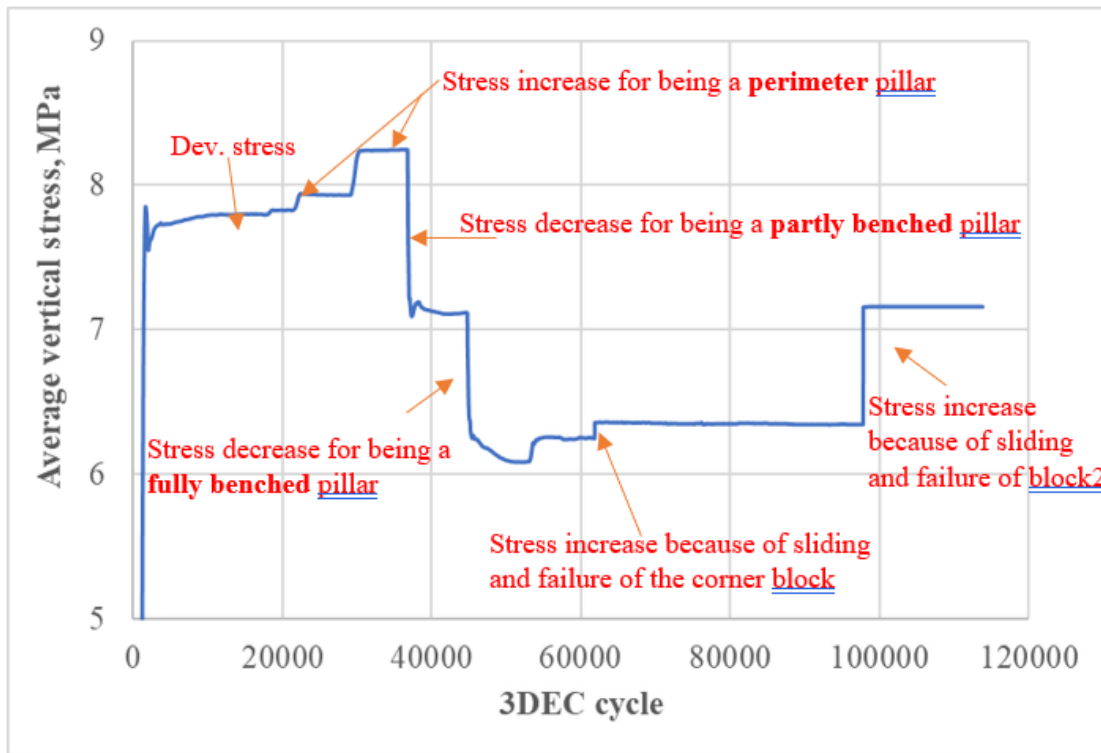
**Figure 14: Loading cycle for an underground pillar from being a development pillar to become a fully benched pillar from a 3DEC model.**

During floor benching activities, pillars are subjected to a cycle of “loading-unloading-reloading.” Figure 14 shows the average vertical stress in the study pillar from the development stage to the fully benched stage. The average vertical stress in the study pillar was calculated 13 ft from the roofline. After development, the loading cycle started with floor benching such that the average vertical stress increased in the pillar for being a perimeter pillar. The unloading cycle occurred when the pillar became partly benched and the stress relaxation increased further when the pillar was fully benched. As floor benching continues and the benched area increases, the stress in the fully benched pillars is expected to gradually increase back to the tributary stress, “reloading” again. This loading cycle is shown in Figure 14. The average stress in the pillar increases further when some blocks from the pillar slide and fail. This cycle of “loading-unloading-reloading” might cause failure and initiate cracks in the sidewalls of fully benched pillars.

During floor benching activities, pillars are subjected to a cycle of “loading-unloading-reloading.” Figure 14 shows the average vertical stress in the study pillar from the development stage to the fully benched stage. The average vertical stress in the study pillar was calculated 13 ft from the roofline. After development, the loading cycle started with floor benching such that the average vertical stress increased in the pillar for being a perimeter pillar. The unloading cycle occurred when the pillar became partly benched and the stress relaxation increased

further when the pillar was fully benched. As floor benching continues and the benched area increases, the stress in the fully benched pillars is expected to gradually increase back to the tributary stress, “reloading” again. This loading cycle is shown in Figure 14. The average stress in the pillar increases further when some blocks from the pillar slide and fail. This cycle of “loading-unloading-reloading” might cause failure and initiate cracks in the sidewalls of fully benched pillars.
