EVALUATION OF A COMMERCIAL VACUUM SYSTEM  
FOR ASBESTOS REMOVAL

A SAFETY AND COST EVALUATION

PREPARED FOR  
NEW JERSEY STATE DEPARTMENT OF HEALTH  
DIVISION OF EPIDEMIOLOGY AND DISEASE CONTROL

UNDER  
NIOSH CENTER FOR DISEASE CONTROL  
GRANT NO. 1 R18 OH 01071-01

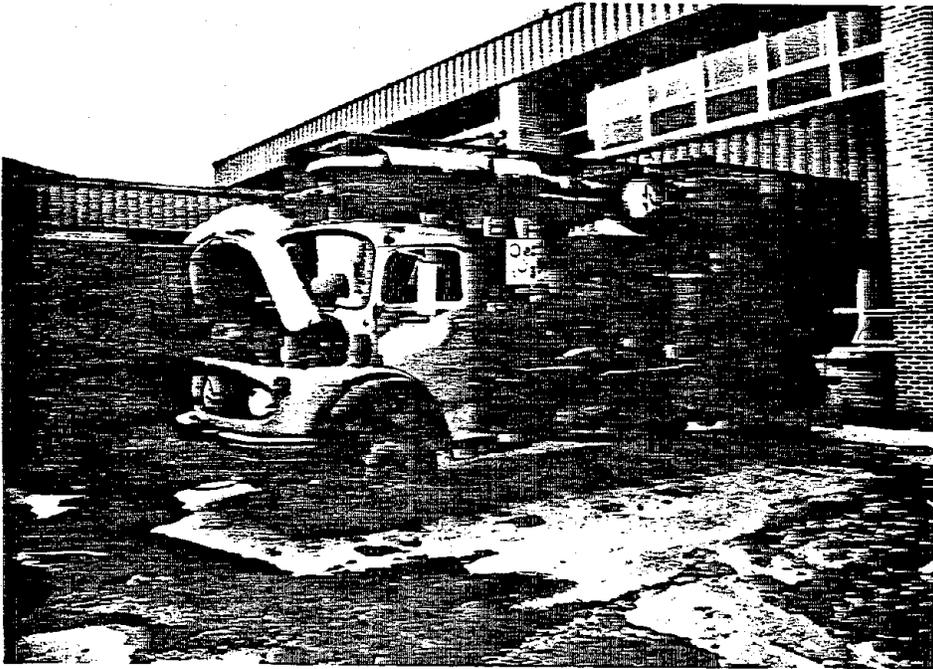
"PHOTO #3"

- Photo # 3 & 4 Truck mounted vacuum system, Diversified Vacuum Systems, AS-10, Montville High School.
- Photo # 5 Contractor's staging area with vacuum truck, Packaging Unit and waste container.

The vacuum truck consisted of a receiving chamber (without spray nozzles operating), two stages of exhaust filtration, a vacuum blower, and a final, HEPA filter (See Figure 1 and Photo 3) The intake of the vacuum was located on top of the receiving chamber and was connected to the packaging unit through a 6" ID ribbed plastic hose. This same type hose connected the packing unit to the work area.
